December 6, 2021

Subject: 2021 Semi-annual Inspection Report – Second Report  
Stoughton City Landfill, Stoughton, Dane County, Wisconsin  
USEPA ID #WID980901219; WDNR BRRTS #02-13-000880

## Operation and Maintenance Semi-Annual Inspection Report

### Stoughton City Landfill Stoughton, Wisconsin

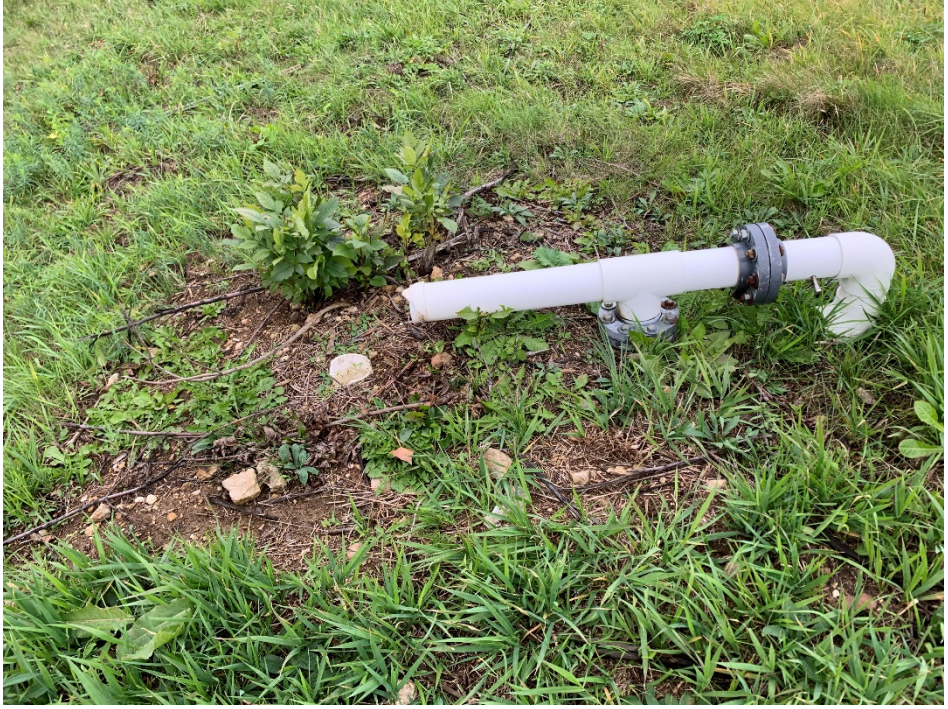
<b>Client Name:</b> Wisconsin Department of Natural Resources		<b>Site Location:</b> Stoughton City Landfill	<b>Project No.:</b> 375007.0001
<b>Photo No.</b> 1	<b>Date</b> 10/29/2021

<b>Time:</b> 14:06  <b>Weather:</b> Sunny / 45°F  <b>Description:</b> Gas vent GV-11 during inspection.  <b>Photographer:</b> <i>Wesley J Braga</i> <hr/> Wes Braga

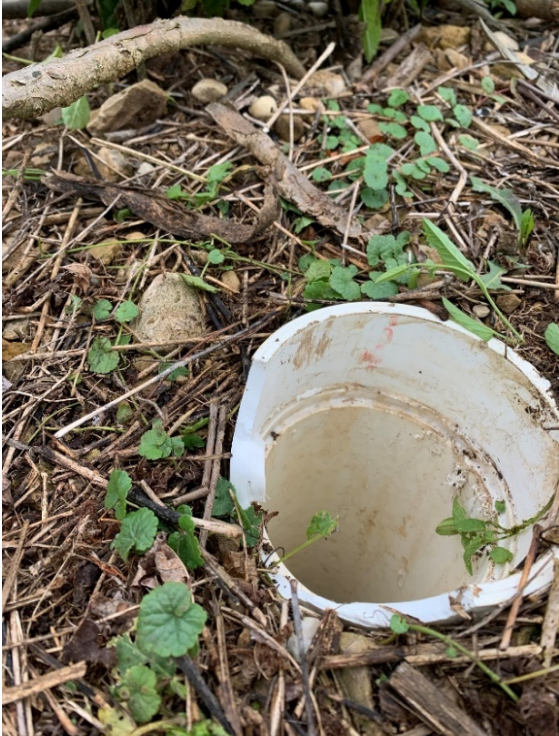
<b>Photo No.</b> 2	<b>Date</b> 10/29/2021

The Site contains 21 gas vents (GV) throughout the limits of the landfill. Each vent was inspected by TRC and GV-11 was found to be damaged. The PVC vent riser was found broken at the coupling near the ground surface. TRC temporarily placed the PVC riser back in place during the Site inspection and the vent was repaired on November 29, 2021 by Onsite Environmental Services, Inc. The repair was completed by installing a new coupling at the ground surface and the original vent riser pipe was reattached.

<b>Time:</b> 14:07  <b>Weather:</b> Sunny / 58°F  <b>Description:</b> Gas vent GV-11 PVC coupler broken at ground surface.  <b>Photographer:</b> <i>Wesley J Braga</i> <hr/> Wes Braga

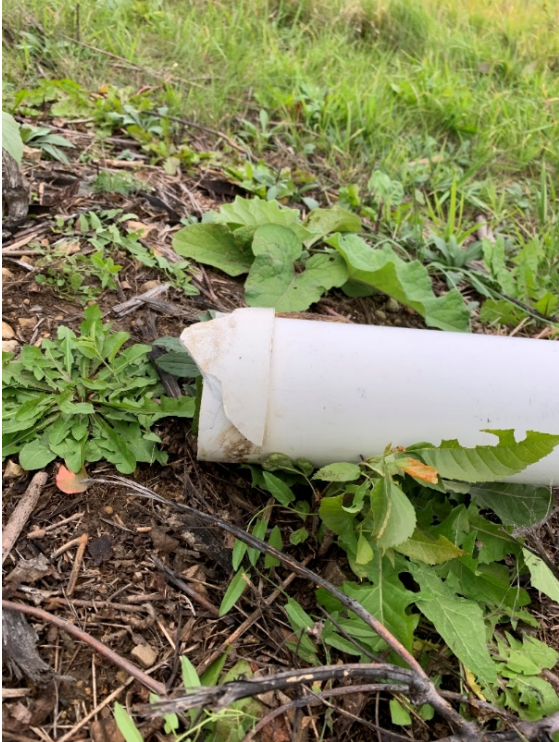
<b>Client Name:</b> Wisconsin Department of Natural Resources		<b>Site Location:</b> Stoughton City Landfill	<b>Project No.:</b> 375007.0001
<b>Photo No.</b> 3	<b>Date</b> 10/29/2021

<b>Time:</b> 14:09			
<b>Weather:</b> Sunny / 45°F			
<b>Description:</b> Gas vent GV-11 standpipe with broken coupler.			
<b>Photographer:</b> <i>Wesley J Braga</i>			
Wes Braga

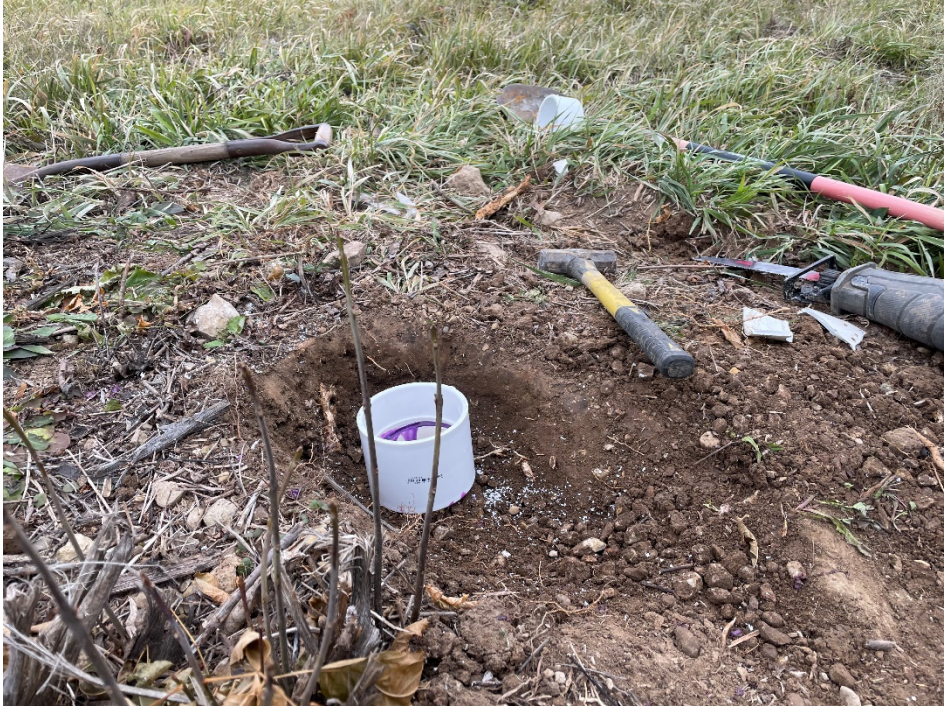
<b>Client Name:</b> Wisconsin Department of Natural Resources		<b>Site Location:</b> Stoughton City Landfill	<b>Project No.:</b> 375007.0001
<b>Photo No.</b> 5	<b>Date</b> 11/29/2021

<b>Time:</b> 8:35			
<b>Weather:</b> Sunny / 30°F			
<b>Description:</b> Gas vent GV-11 new coupler.			
<b>Photographer:</b> <i>Wesley J Braga</i>			
Wes Braga

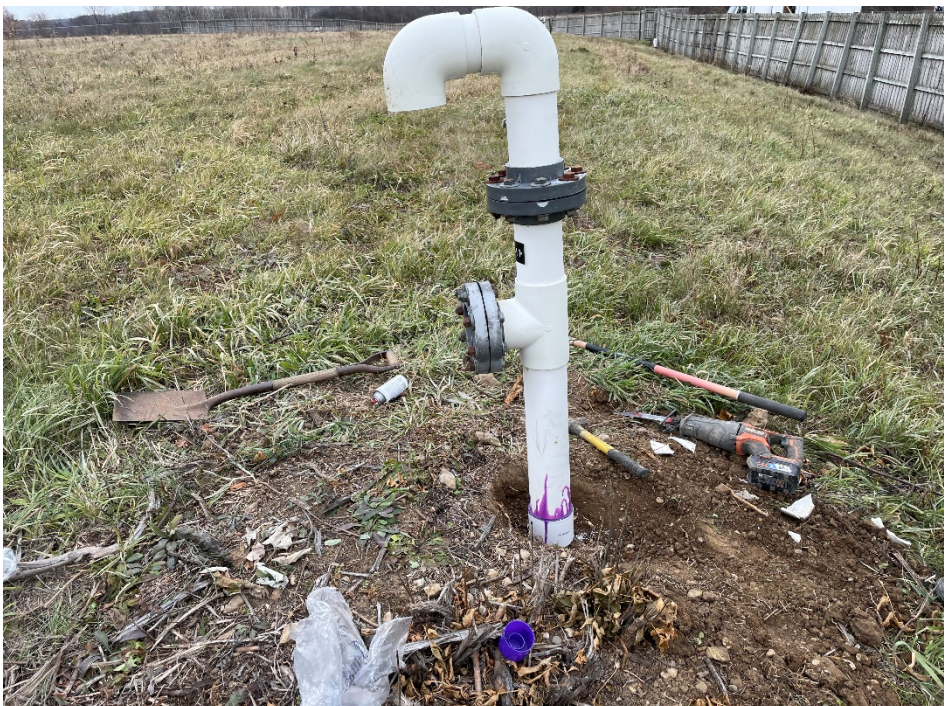
<b>Photo No.</b> 6	<b>Date</b> 11/29/2021

<b>Time:</b> 8:45			
<b>Weather:</b> Sunny / 30°F			
<b>Description:</b> Gas vent GV-11 repaired.			
<b>Photographer:</b> <i>Wesley J Braga</i>			
Wes Braga

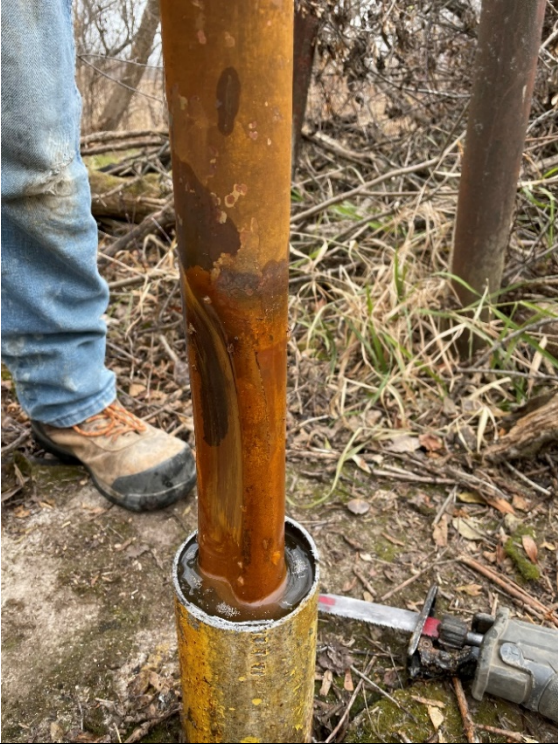
- MW-7I is an artisan well, and the expandable cap at the time of this inspection was preventing groundwater flow from the well. TRC attempted to install a mechanical packer into the well on October 28, 2021, to prevent artisan flow. However, due to a deformation along the stainless-steel well riser, the packer could not be installed properly. The well riser and protective casing were repaired on November 29, 2021. The repair was completed by cutting the existing stainless steel riser below the deformation and a new schedule 40 PVC riser was installed using a Fernco coupler fitting. A new protective casing was installed, and sand was placed between the riser and protective casing to stabilize the well. Additionally, new weep holes were drilled to prevent future damage to the well during freeze/thaw. Photo documentation of the damaged well and repaired well is included in Attachment 2. Following repair of the well, the mechanical packer was installed on December 2, 2021, and will continue to be inspected to ensure artesian flow is prevented from the well.

<b>Time:</b> 9:23  <b>Weather:</b> Sunny / 35°F  <b>Description:</b> Monitoring Well MW-7I with deformed stainless riser.  <b>Photographer:</b> <i>Wesley J Braga</i> <hr/> Wes Braga			
<b>Photo No.</b> 8	<b>Date</b> 11/29/2021

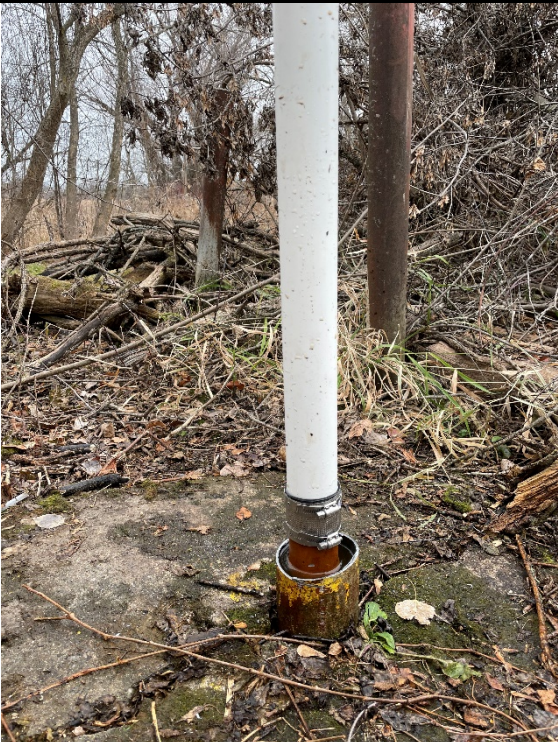
<b>Time:</b> 9:35  <b>Weather:</b> Sunny / 45°F  <b>Description:</b> Monitoring Well MW-7I repaired with Fernco coupler and PVC riser.  <b>Photographer:</b> <i>Wesley J Braga</i> <hr/> Wes Braga

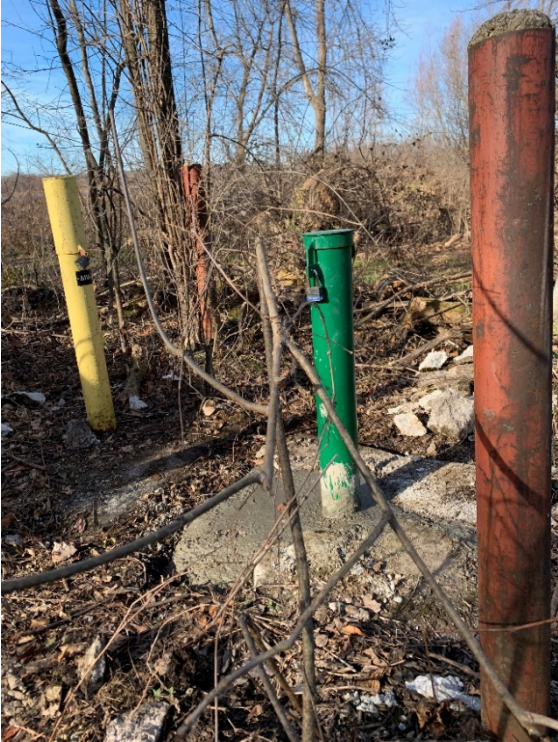
<b>Client Name:</b> Wisconsin Department of Natural Resources		<b>Site Location:</b> Stoughton City Landfill	<b>Project No.:</b> 375007.0001
<b>Photo No.</b> 9	<b>Date</b> 12/2/2021

<b>Time:</b> 9:16			
<b>Weather:</b> Sunny / 40°F			
<b>Description:</b> Monitoring Well MW-71 repaired protective casing.			
<b>Photographer:</b> <i>Wesley J Braga</i>			
Wes Braga

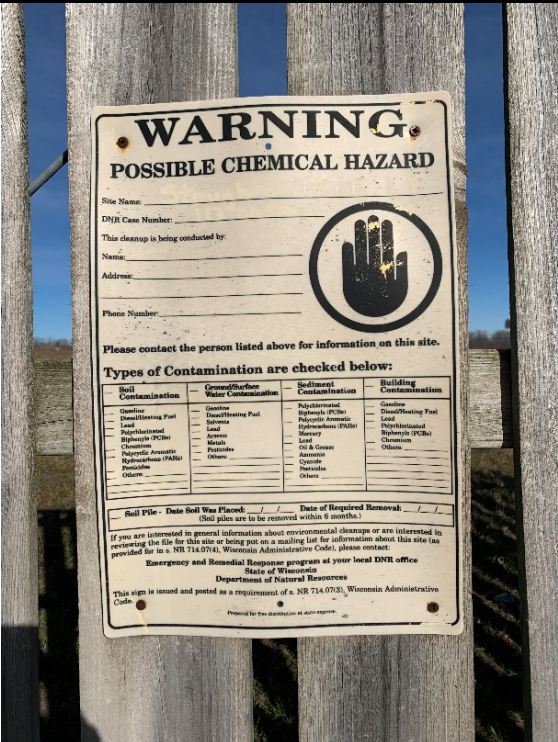
<b>Photo No.</b> 10	<b>Date</b> 12/2/2021

Signs are located along the exterior of the fence surrounding the landfill. The signs were in good condition, however the labeling on the landfill gate sign was fading. TRC relabeled the sign with the WDNR Bureau for Remediation and Redevelopment Tracking System (BRRTS) Site number and United States Environmental Protection Agency (EPA) Site number.

<b>Time:</b> 10:55			
<b>Weather:</b> Sunny / 45°F			
<b>Description:</b> Faded signage on landfill gate.			
<b>Photographer:</b> <i>Wesley J Braga</i>			
Wes Braga

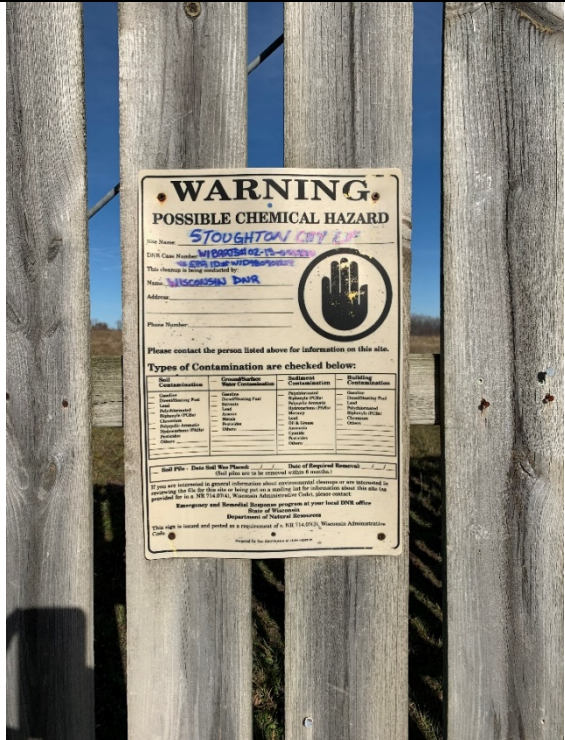
<b>Client Name:</b> Wisconsin Department of Natural Resources		<b>Site Location:</b> Stoughton City Landfill	<b>Project No.:</b> 375007.0001
<b>Photo No.</b> 11	<b>Date</b> 12/2/2021

<b>Time:</b> 11:05			
<b>Weather:</b> Sunny / 45°F			
<b>Description:</b> Relabeled signage on landfill gate with BRRTS# and EPA ID#.			
<b>Photographer:</b>
