Subject: 2022 Semi-annual Inspection Report – First Report
Stoughton City Landfill, Stoughton, Dane County, Wisconsin
USEPA ID #WID980901219; WDNR BRRTS #02-13-000880

Photographic Log

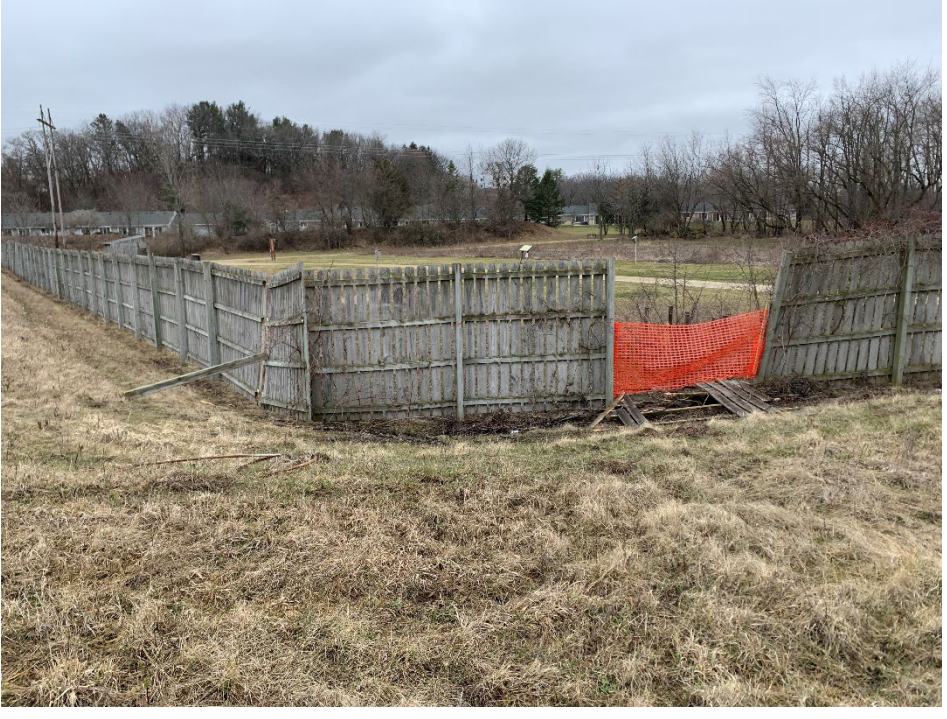
Client Name: Wisconsin Department of Natural Resources		Site Location: Stoughton City Landfill	Project No.: 375007.0002
Photo No. 1	Date 4/6/2022

The chain link fence that surrounds a portion of the landfill was in good condition. The gate was in good condition and the lock was functioning. There was a large section of broken fencing near the western gated entrance and to the north. The damage was likely caused from a tornado that touched down in Stoughton on March 5, 2022. The WDNR is aware of the issue and is working to schedule a subcontractor to complete the repairs.

Time: 13:06			
Weather: Raining/ 45°F			
Description: Broken fence looking southwest.			
Photographer: <i>Wesley J Braga</i>			
Wes Braga

TRC plans to repair ruts created during the 2022 groundwater monitoring event. Per the request for proposal document, TRC can assist with the repair of the broken fence as needed.

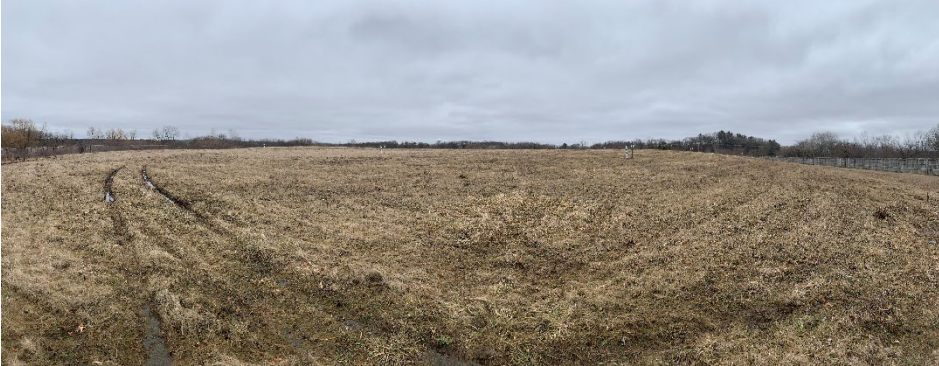
Client Name: Wisconsin Department of Natural Resources		Site Location: Stoughton City Landfill	Project No.: 375007.0002
Photo No. 3	Date 4/8/2022

SUMMARY OF DEFICIENCIES AND/OR CORRECTIVE ACTIONS: Rutting occurred during the April 2022 sampling event while accessing the MW-5 well nest on west side of landfill. Ruts were approximately 6 inches deep and occurred when a field vehicle got stuck in overly saturated soil. Vehicle was towed to southern gate by a small track loader to avoid additional rutting. TRC plans to repair the ruts this summer when a vehicle can safely access the area.

Time: 14:10 Weather: Overcast/ 35°F Description: Rutting that occurred during April 2022 sampling event. Photographer: <i>Wesley J Braga</i> <hr style="width: 100%;"/> Wes Braga

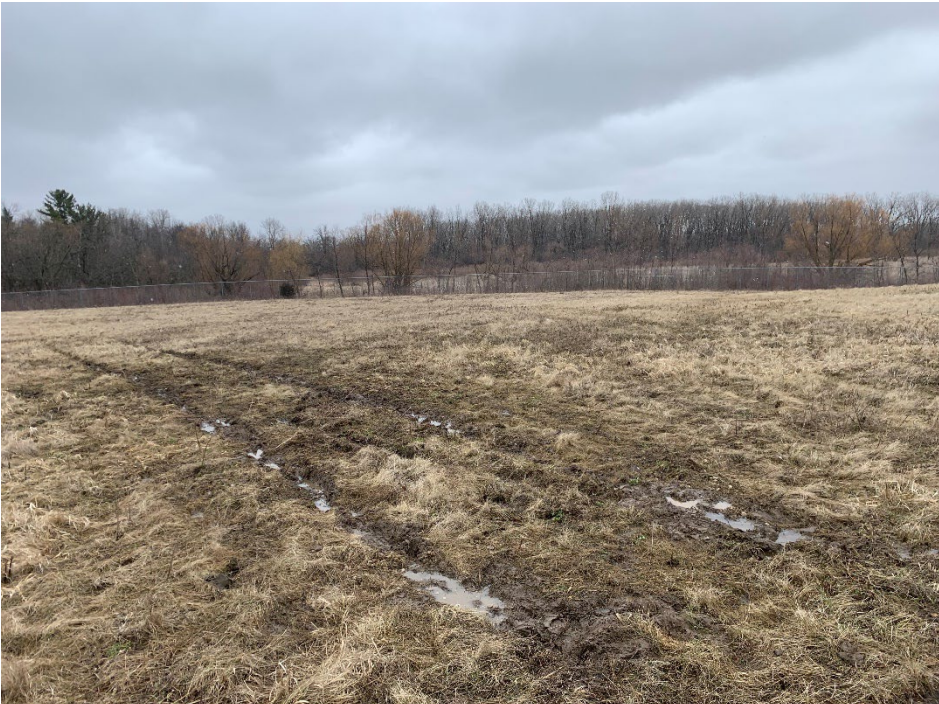
Photo No. 4	Date 4/8/2022

Time: 14:15 Weather: overcast/ 35°F Description: Rutting that occurred during April 2022 sampling event. Photographer: <i>Wesley J Braga</i> <hr style="width: 100%;"/> Wes Braga
