Subject: 2022 Semi-annual Inspection Report – Second Report
Stoughton City Landfill, Stoughton, Dane County, Wisconsin
USEPA ID #WID980901219; WDNR BRRTS #02-13-000880

Operation and Maintenance Semi-Annual Inspection Report

Stoughton City Landfill
Stoughton, Wisconsin

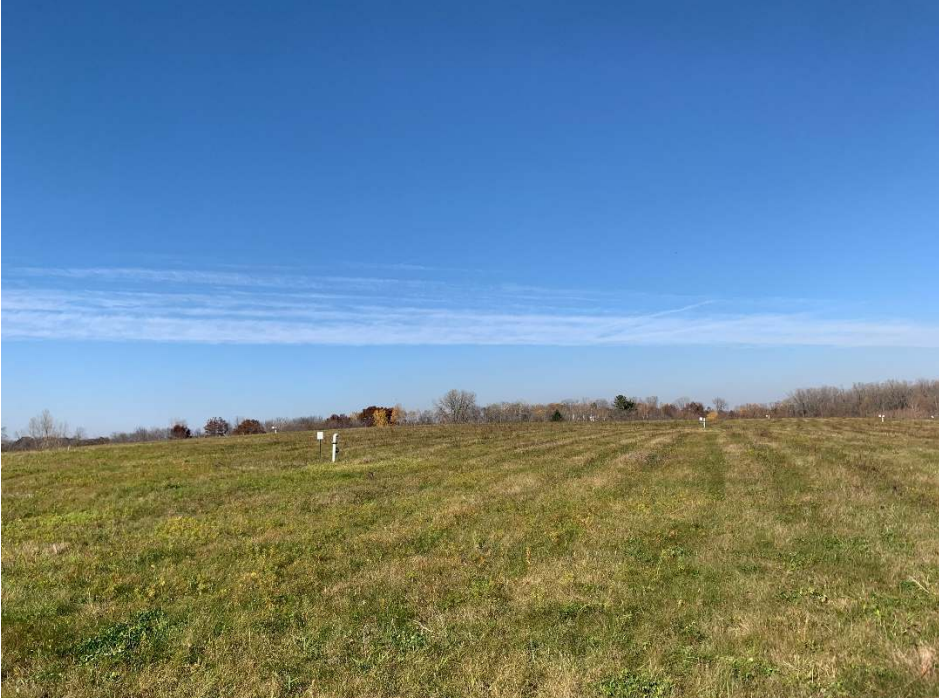
Client Name: Wisconsin Department of Natural Resources		Site Location: Stoughton City Landfill	Project No.: 375007.0002
Photo No. 1	Date 10/31/2022

Time: 13:26			
Weather: Clear			
Description: Landfill cap conditions looking north from gate entrance.			
Photographer: <i>Wesley J Braga</i> Wesley Braga

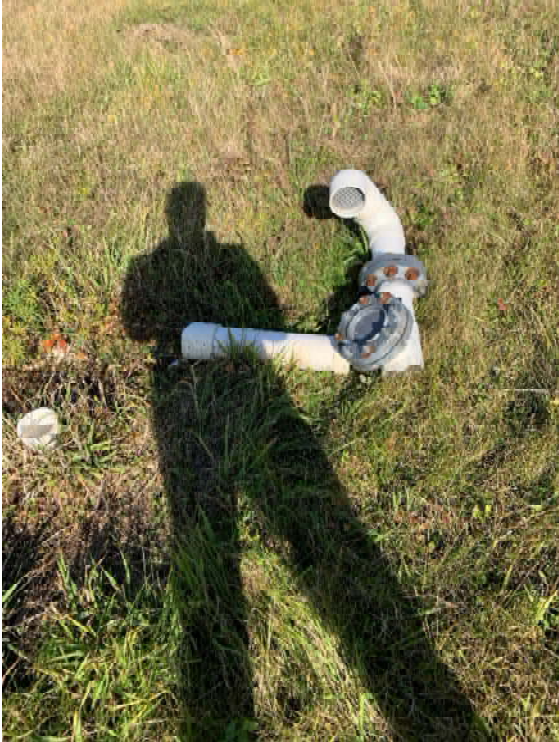
Client Name: Wisconsin Department of Natural Resources		Site Location: Stoughton City Landfill	Project No.: 375007.0002
Photo No. 3	Date 10/31/2022

The Site contains 21 gas vents (GV) throughout the limits of the landfill. Following the August 2022 mowing event, each vent was inspected by TRC to ensure that no damage had occurred during the mowing. During this inspection GV-18 was found to be damaged at the polyvinyl chloride (PVC) coupler near the ground surface. TRC temporarily placed the PVC riser back in place and notified the WDNR of the issue and the plan to repair the vent during the October landfill inspection. During the October 2022 inspection, TRC noticed that not only was the coupler at the ground surface damaged but a PVC t-fitting on the vent was also damaged. TRC removed the entire vent assembly and replaced the coupler near the ground surface. The t-fitting which connected the upper portion of the vent, and a 4-inch access flange was taken apart and TRC reassembled the vent with just a single coupler. The WDNR project manager was made aware of the issue with the gas vent and approved the modification to the existing design. Photos of the broken and repaired vent are included in Attachment 2. No other issues with the gas vents were discovered during these site inspections.

Time: 14:11 Weather: Clear Description: Broken GV-18 gas vent. Photographer:

SUMMARY OF DEFICIENCIES AND/OR CORRECTIVE ACTIONS: Rutting that occurred during the April 2022 sampling event was repaired by TRC staff during October 2022 inspection. GV-18 stand pipe was found damaged following the annual mowing event in August 2022. TRC staff replaced the stand pipe during the October 2022 inspection.

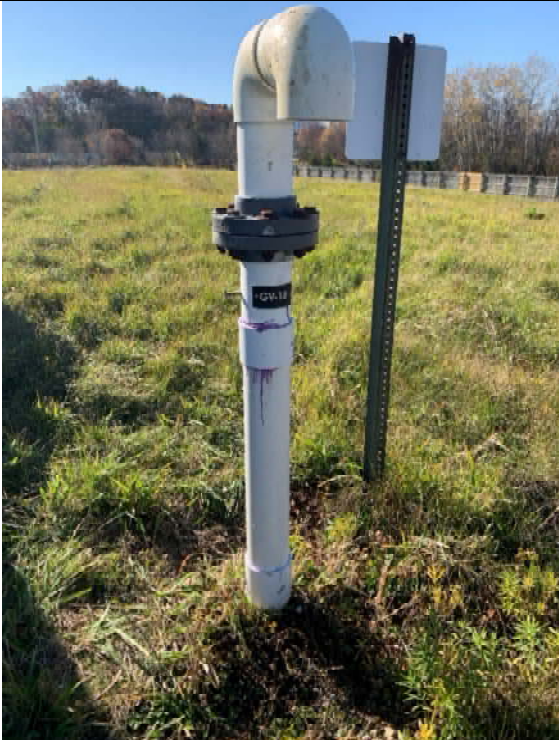
Photo No. 4	Date 11/1/2022

Time: 11:36 Weather: Clear Description: GV-18 following repair by TRC staff. Photographer:
