June 8, 2023

Subject: 2023 Semi-annual Inspection Report – First Report
Stoughton City Landfill, Stoughton, Dane County, Wisconsin
USEPA ID #WID980901219; WDNR BRRTS #02-13-000880

Operation and Maintenance Semi-Annual Inspection Report

**Stoughton City Landfill
Stoughton, Wisconsin**

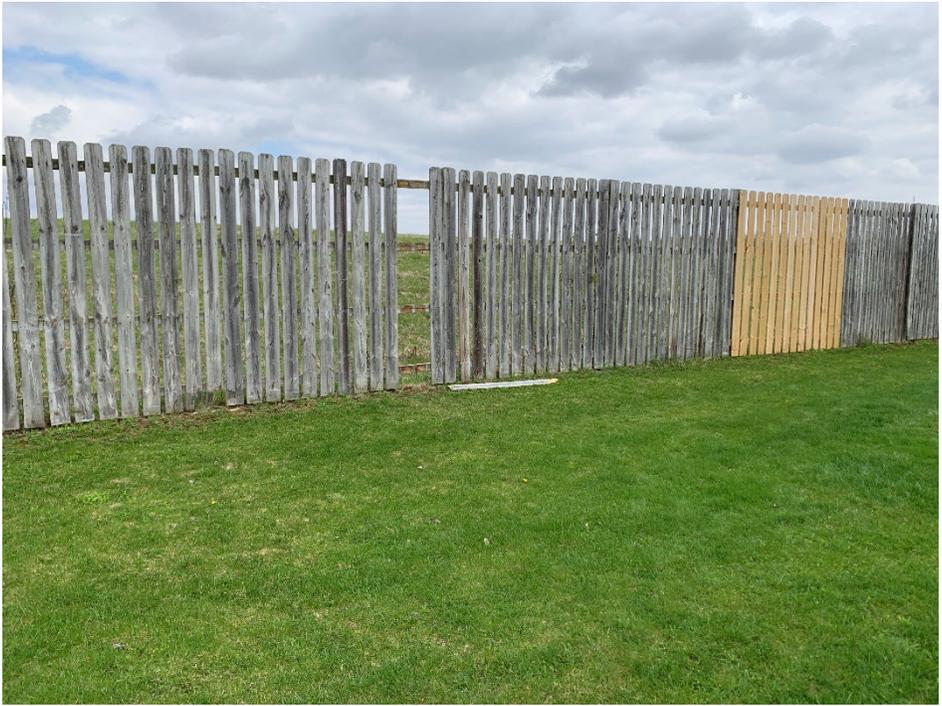
Client Name: Wisconsin Department of Natural Resources		Site Location: Stoughton City Landfill	Project No.: 375007.0004
Photo No. 1	Date 4/25/2023

The chain link fence that surrounds a portion of the landfill was in good condition. The gate was in good condition and the lock was functioning; however, it is becoming difficult to lock and should be replaced before winter of 2023. There is a section of broken fencing along the western side of the landfill that will need to be repaired. Two of the wooden slats were removed.

Time: 13:06			
Weather: Overcast/ 43°F			
Description: Broken fence looking southeast.			
Photographer: <i>Wesley J Braga</i>			
Wes Braga

Repairs to the wooden fence should be completed, TRC can assist with the repair if needed. Future inspections should make special note of increased animal activity along the eastern fence line as well as any evidence of ponding between GV-15 and GV-16. A new main gate lock should also be purchased and installed for the Site before winter of 2023.

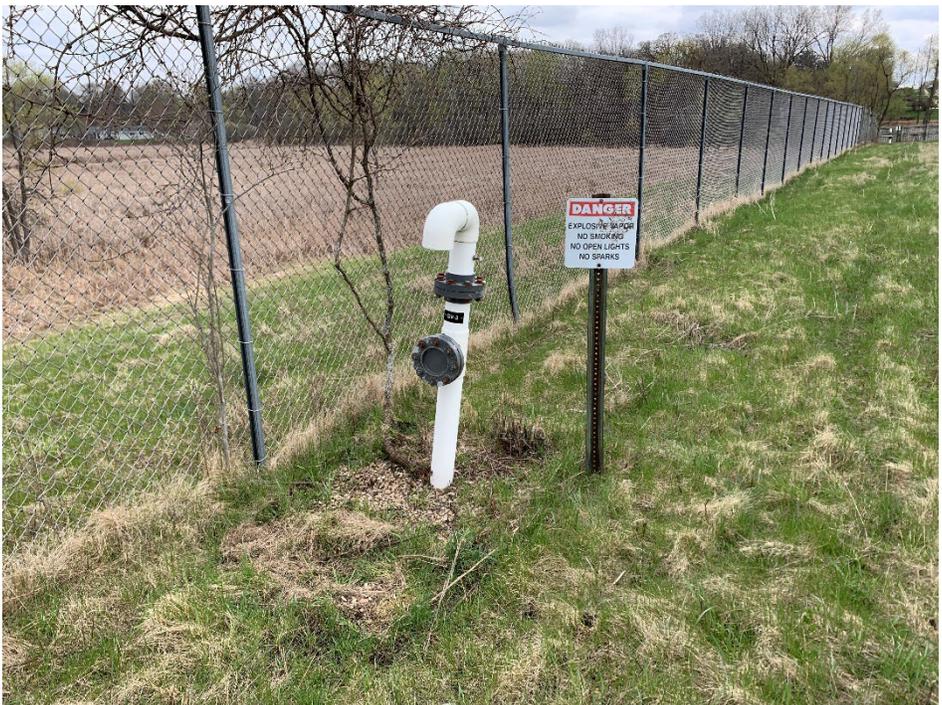
Photo No. 2	Date 4/25/2023

The Site contains 21 gas vents throughout the limits of the landfill. Each vent was inspected by TRC and the only issue found was the signage near GV-3 had fallen over; the base of the sign appeared to be rusted and broken. TRC staff drove the fence post back into the ground, however, it may need to be replaced if issue continues. Additionally, the vents are constructed of, PVC which is beginning to become brittle due to age and there is an increased risk of couplers failing and gas vents falling over. This issue should be monitored and repaired as needed.

Time: 13:30			
Weather: Overcast/ 43°F			
Description: Sign repaired at GV-3.			
Photographer: <i>Wesley J Braga</i>			
Wes Braga

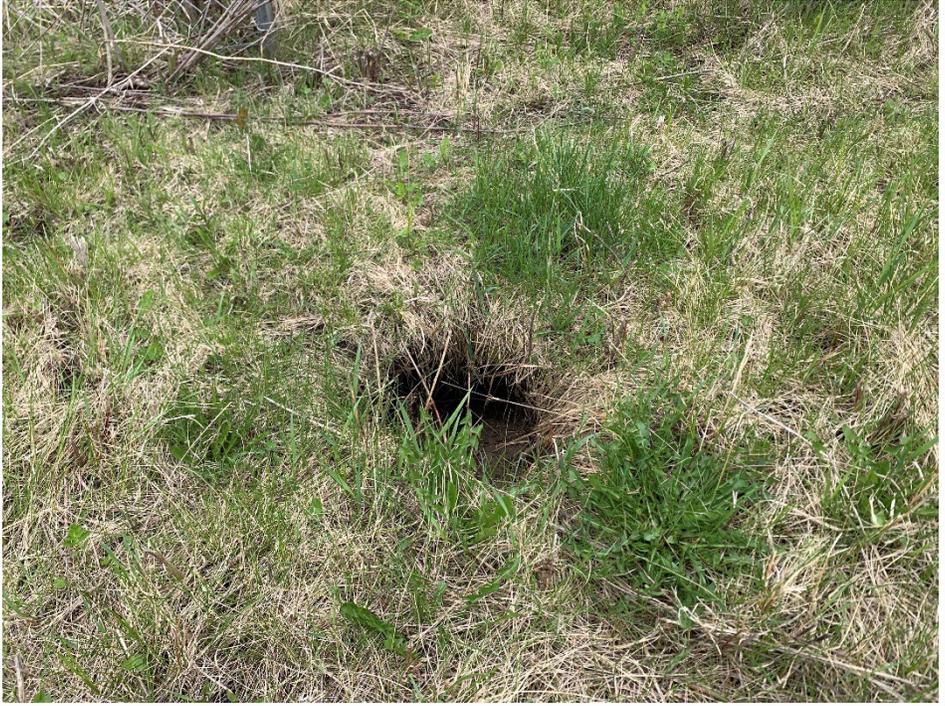
Client Name: Wisconsin Department of Natural Resources		Site Location: Stoughton City Landfill	Project No.: 375007.0004
Photo No. 3	Date 4/25/2023

No issues were observed with the landfill cover that require immediate maintenance, however there are a small number of animal burrows along the eastern fence adjacent to the wetlands. There are three to four localized areas where animals have dug burrows from inside of the fenced area out to the adjacent wetlands. Trapping animals and filling these burrows would not be a permanent solution due to the high amount of animal activity in the in the area. These areas should be monitored during future inspection events to ensure that these burrows are not expanding into the limits of the waste.

Time: 13:45 Weather: Overcast/ 43°F Description: Animal burrow near east fence. Photographer: <i>Wesley J Braga</i> <hr/> Wes Braga

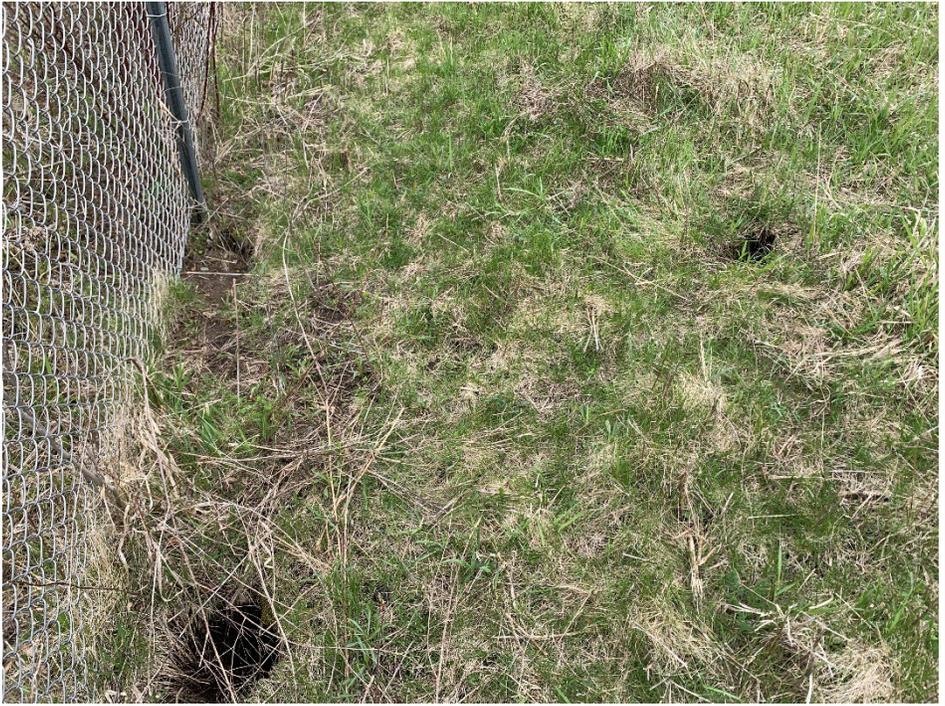
Photo No. 4	Date 4/25/2023

Time: 13:50 Weather: Overcast/ 43°F Description: Animal burrow near east fence. Photographer: <i>Wesley J Braga</i> <hr/> Wes Braga
