May 22, 2024

Subject: 2024 Semi-annual Inspection Report – First Report  
Stoughton City Landfill, Stoughton, Dane County, Wisconsin  
USEPA ID #WID980901219; WDNR BRRTS #02-13-000880

# Operation and Maintenance Semi-Annual Inspection Report

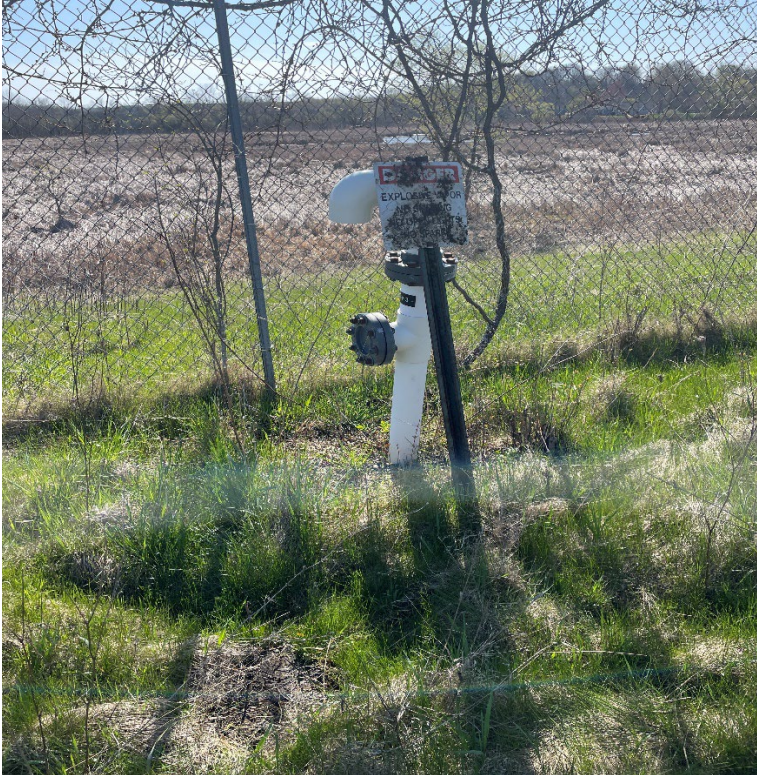
<b>Client Name:</b> Wisconsin Department of Natural Resources		<b>Site Location:</b> Stoughton City Landfill	<b>Project No.:</b> 576123.0000
<b>Photo No.</b> 1	<b>Date</b> 4/22/2024

The Site contains 21 gas vents throughout the limits of the landfill. Each vent was inspected by TRC and the only issue noted was the caution sign for GMP-3 had fallen over. An attempt to fix this sign had previously been completed in 2023 by using a mallet to drive the steel signpost back into the ground. This fix appears to have failed and the signpost will have to be replaced due to the base being rusted out. TRC plans to make these repairs prior to the fall inspection event.

<b>Time:</b> 09:23 <b>Weather:</b> Sunny/ 55°F <b>Description:</b> Sign damage for GMP-3. <b>Photographer:</b> <i>Wesley J Braga</i> <hr/> Wes Braga

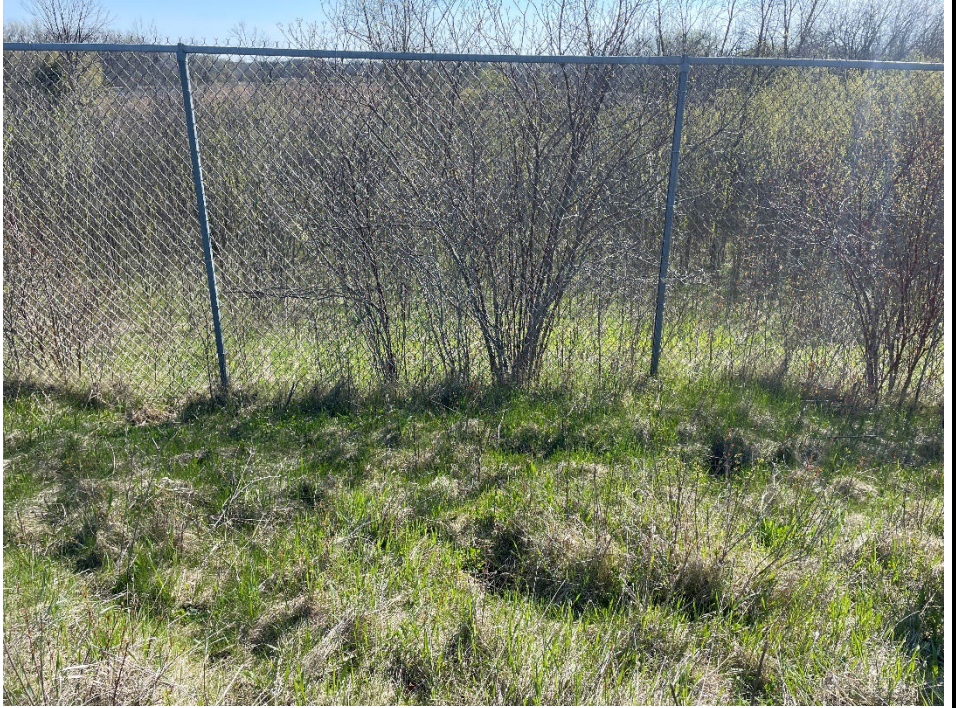
<b>Client Name:</b> Wisconsin Department of Natural Resources		<b>Site Location:</b> Stoughton City Landfill	<b>Project No.:</b> 576123.0000
<b>Photo No.</b> 3	<b>Date</b> 4/22/2024

No issues were observed with the landfill cover that require immediate maintenance. There were several small animal burrowing's (less than 4-inches) at various spots on the landfill cover, nothing extensive that requires additional maintenance. Additionally, the three to four localized areas of larger burrowing (greater than 4-inches) along the eastern fence line remain similar in size and number to the ones identified in the Spring 2023 Inspection Report. Because this area of the landfill is directly adjacent to a wetland, trapping animals and filling these burrows would not be a permanent solution due to the high amount of animal activity in the area. These areas should continue to be monitored during future inspection events to ensure that they do not expand into the limits of the waste.

<b>Time:</b> 9:26  <b>Weather:</b> Sunny/ 55°F  <b>Description:</b> Smaller animal burrows on the east side of the landfill next to chain link fence.			
<b>Photographer:</b> <i>Wesley J Braga</i> <hr/> Wes Braga
