October 14, 1986

SUBJECT: Oconomowoc Electroplating Company, Inc.
RCRA Facility Assessment
WID 006100275

RCRA FACILITY ASSESSMENT (RFA)
Oconomowoc Electroplating Company, Inc. (OECI)

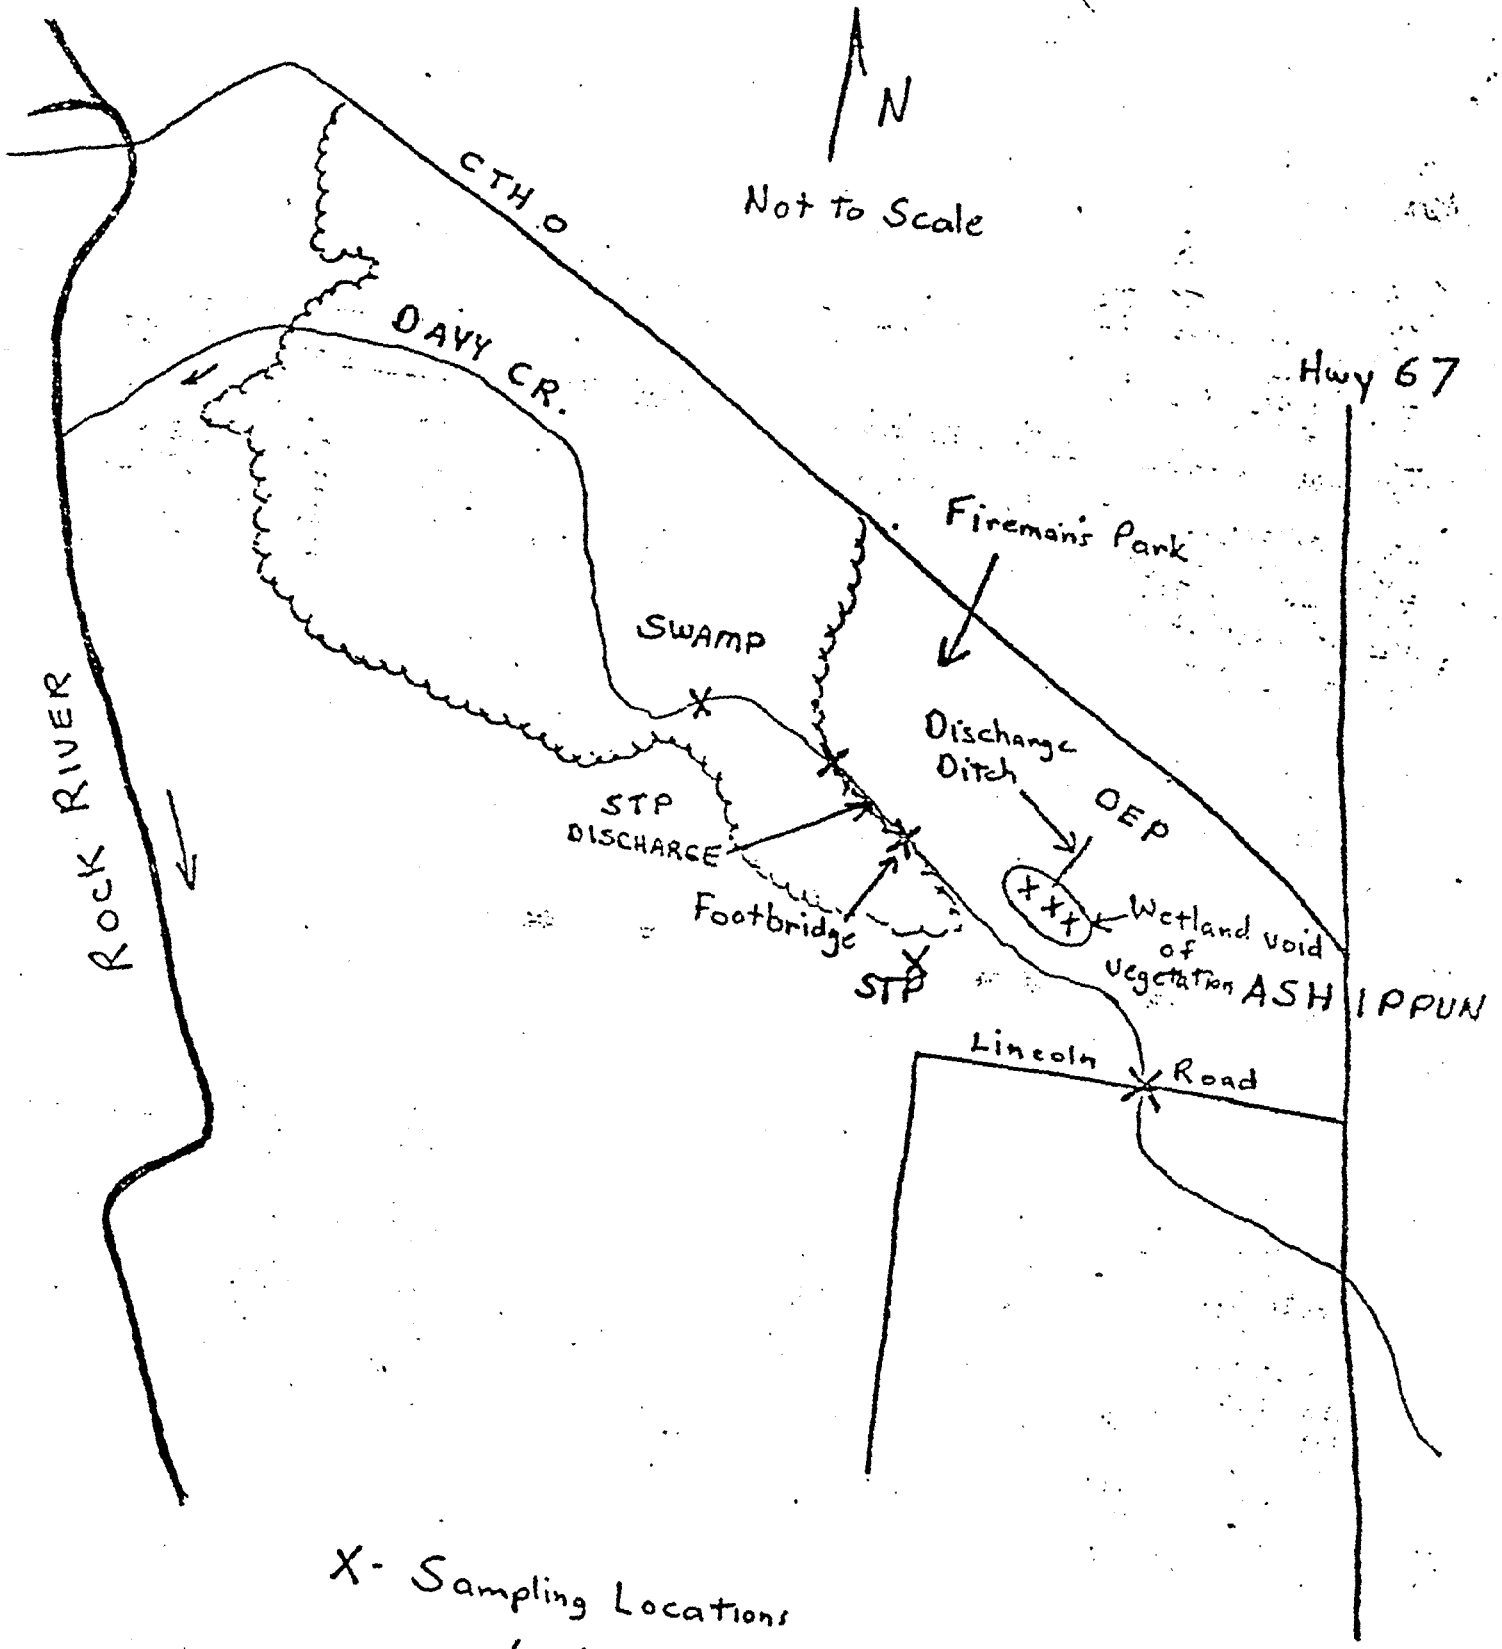
X- Sampling Locations
 10/30/79

In 1979, a water quality verification study was conducted at Davy Creek (see Attachment 5). In that study, four stream sediment samples and three representative soil samples of the top five inches of the wetland were tested for aluminum, cadmium, chromium, and nickel. The results show that there was a thick sludge layer at all three sampling sites downstream of the facility's outfall, and there is no sludge present above OECI discharge point. The sludge layer ranged from 0.2 feet to 3.2 feet thick. Sludge was also observed outside the stream bed, in the wooded area below Fireman's Park, where it had apparently settled out during periods of high water. The soil samples taken from the wetland show very high concentrations of the tested heavy metals.

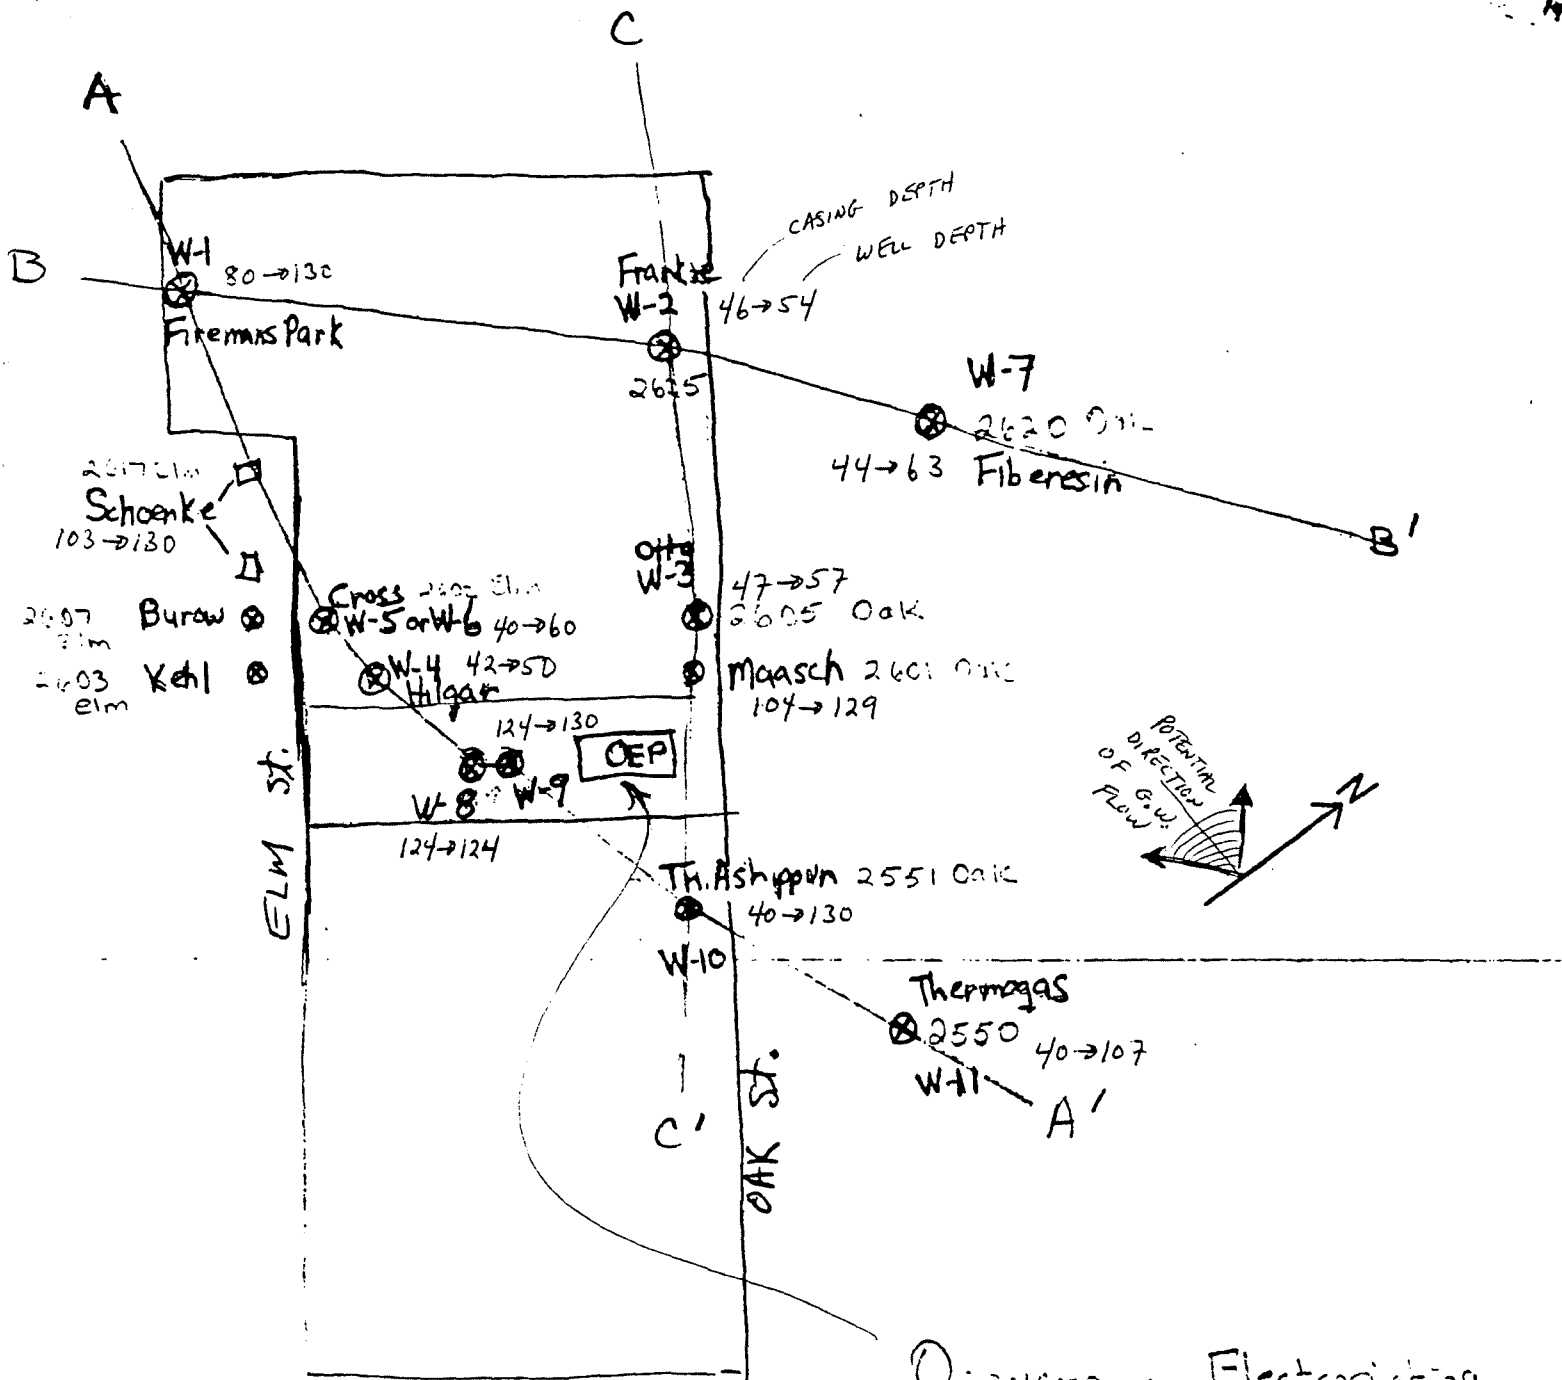
Oscarmonoc Electroplating
 Private Wells with Logs or
 Private Wells Sampled
 1/1 to 1/2

Groundwater samples (see Attachment 8) taken from private wells adjacent to the site and monitoring wells installed at the facility show that pollutants have entered the groundwater (from the unlined lagoons, from spilled materials, or from the wastewater discharge area). DNR has received reports (see Attachment 9) about drums being buried on-site. On October 23, 1984, two test pits (see Attachment 9 for locations) were dug following an investigation with a metal detector (reliable depth 12 to 18 inches). Badly deteriorated sheet metal, metal scrap, and a 1/4 inch metal wire were found in test pit #1 and a sheet metal was found in test pit #2. More extensive investigation excavations are necessary to determine if buried drums are located on-site.

GROUNDWATER FLOW DIRECTION
 MAY RANGE BETWEEN NORTHWEST
 AND SOUTHWEST.

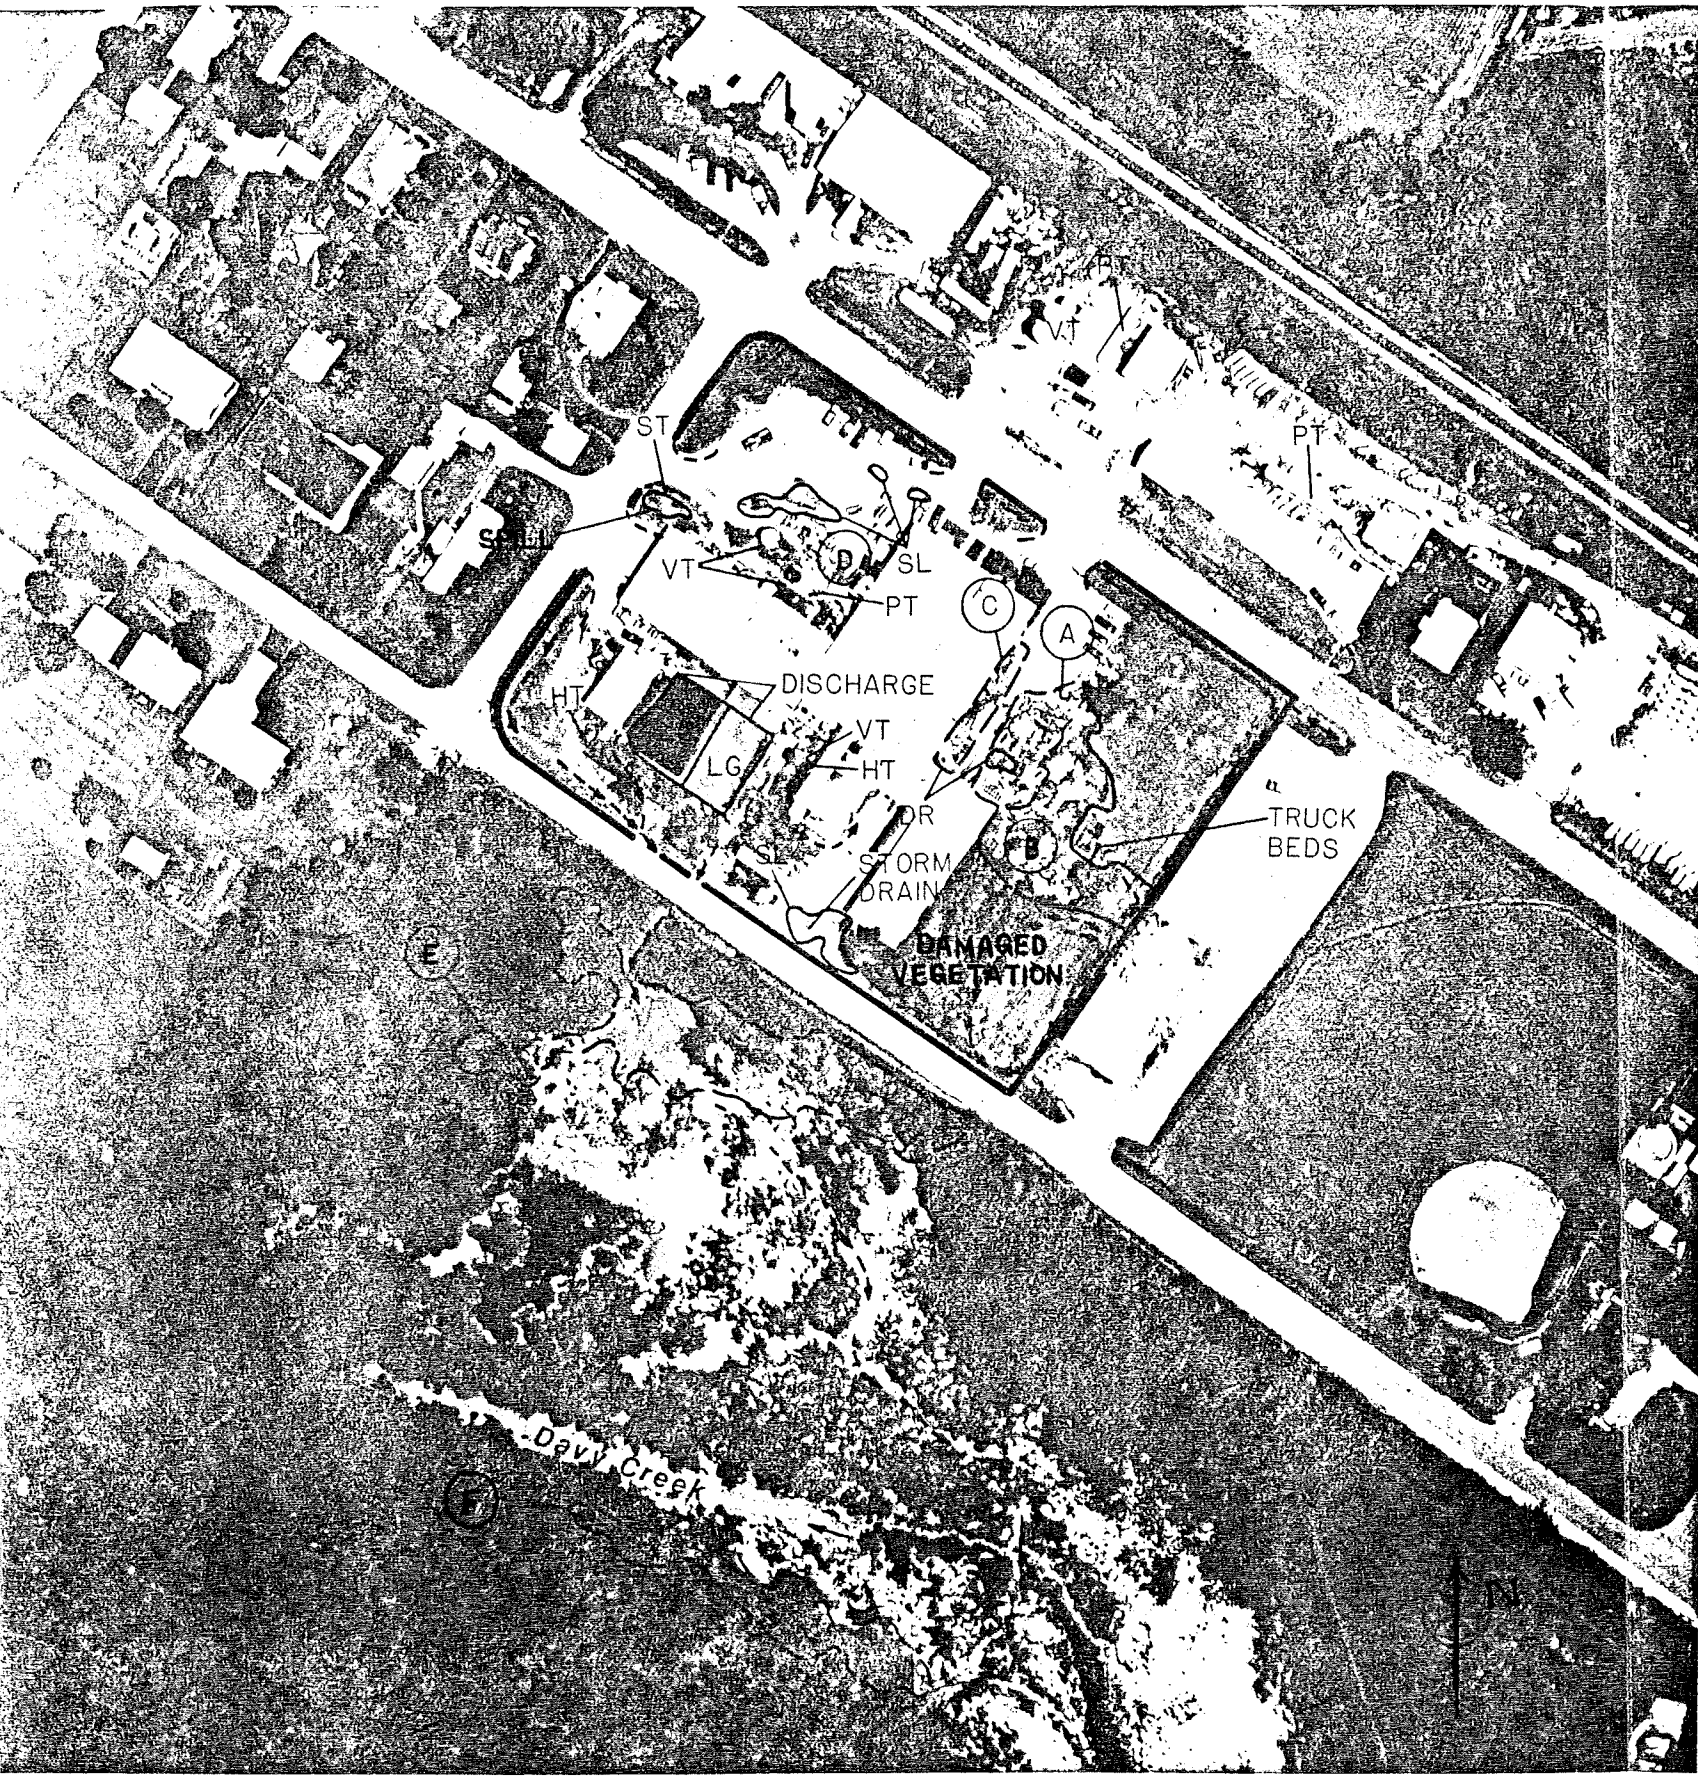
- Annotation A : scrap stockpile containing drums and miscellaneous scrap metal.
- Annotation B : open dump containing solid waste and extensive liquid staining.
- Annotation C : open storage area of unidentified material.
- Annotation D : open storage area containing support equipment.
- Annotation E : an area of discoloration and sludge deposits that appear to have come from the site.
- Annotation F : an area of possible vegetation damage west of Davy Creek.

All surface drainage is shown by flow arrows and lead to the wetlands just south of the site.
