**MONTHLY MONITORING REPORT
FOR THE
OCONOMOWOC ELECTROPLATING
GROUNDWATER TREATMENT FACILITY**

ASHIPPUN, WISCONSIN

**MONTHLY OPERATIONS AND MAINTENANCE REPORT
FOR THE
OCONOMOWOC ELECTROPLATING
GROUNDWATER TREATMENT FACILITY**

January 1998

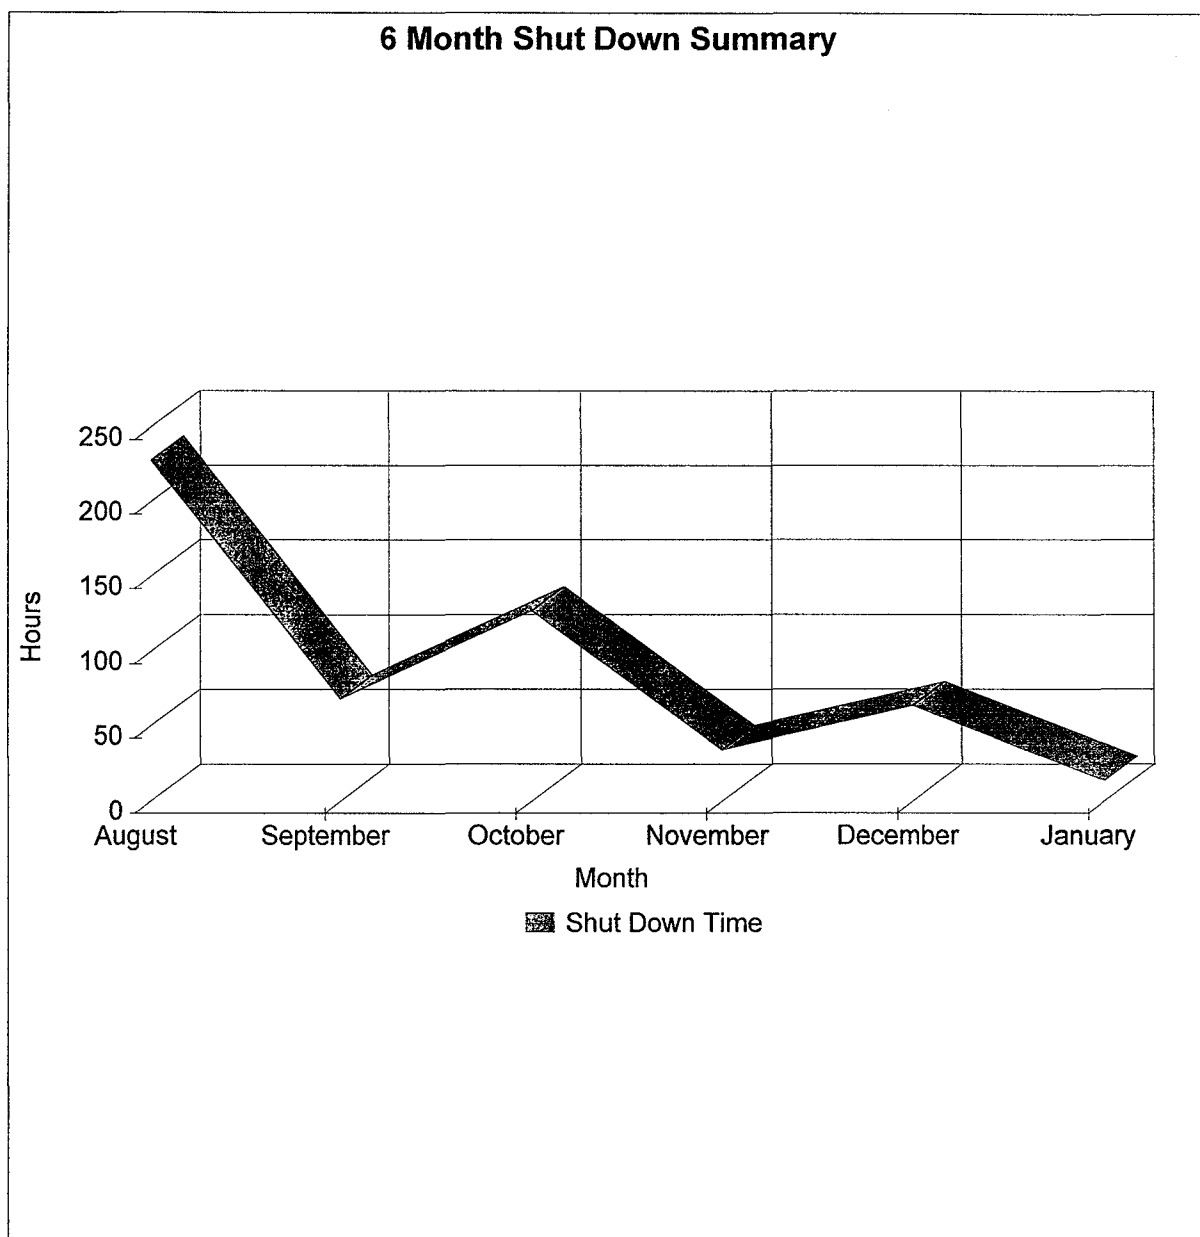
The following Graph summarizes the 6 month plant down time:
