**MONTHLY MONITORING REPORT  
FOR THE  
OCONOMOWOC ELECTROPLATING  
GROUNDWATER TREATMENT FACILITY  
ASHIPPUN, WISCONSIN**

**March 31, 1998**

**MONTHLY OPERATIONS AND MAINTENANCE REPORT  
FOR THE  
OCONOMOWOC ELECTROPLATING  
GROUNDWATER TREATMENT FACILITY**

2572 Oak Street  
ASHIPPUN, WISCONSIN

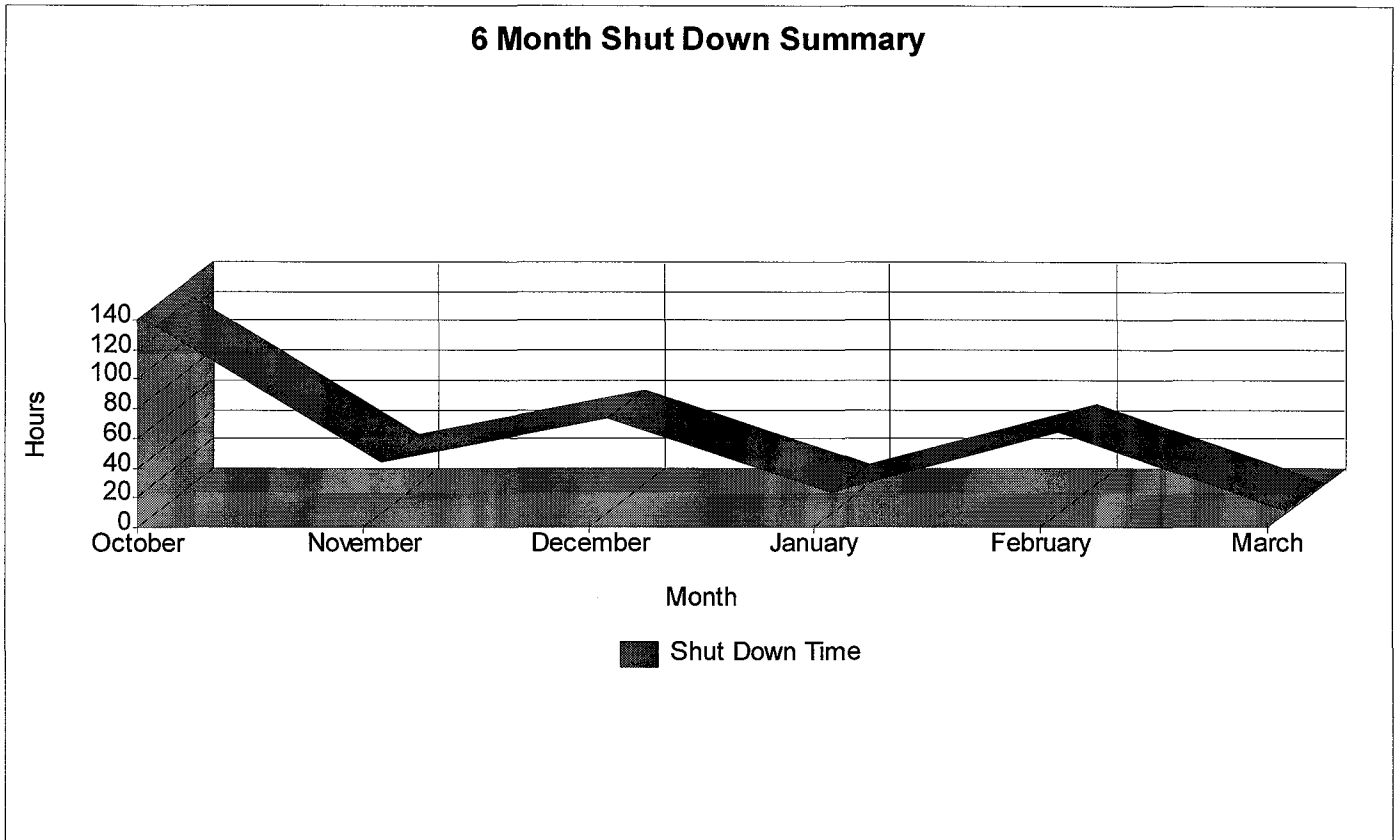
CHART 1

During the month of March, the plant was shut down for a total of 2 hours.

The airlift line for the Tertiary Filter (TF-600) became clogged with sand and was removed and cleaned.

Chart 1, 6 Month Shut Down Summary, displays the shut down times for the last six months.
