# Five-Year Review Report

Third Five-Year Review Report
for
Ripon City Landfill
(a/k/a Ripon FF/NN Landfill)
Town of Ripon, Fond du Lac County, Wisconsin

September 2011

Prepared by:
Wisconsin DNR for the
United States Environmental Protection Agency
Region 5
Chicago, Illinois

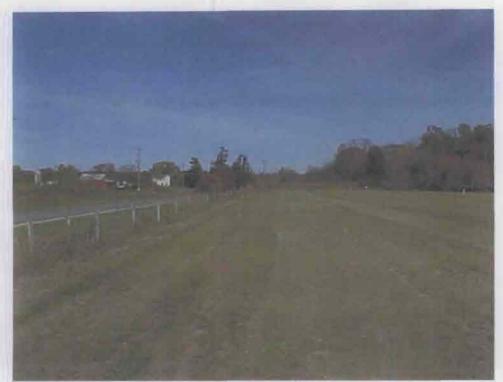
Photo 1 Looking N along fence line from SW corner

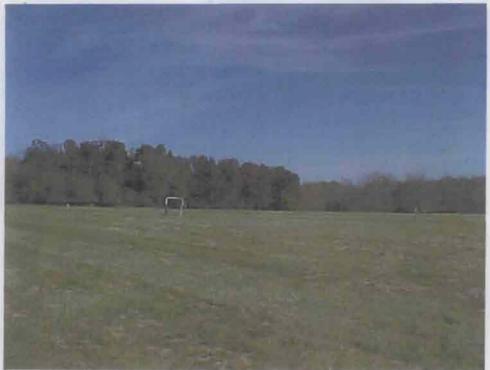
Photo 2 Looking NE onto LF from SW corner; shows gas piping from leachate well LC-3

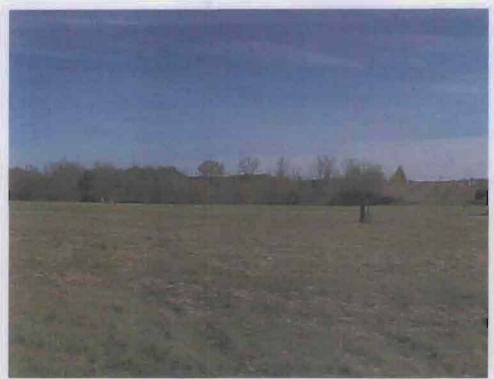
Photo 3 Looking NE onto LF from SW corner

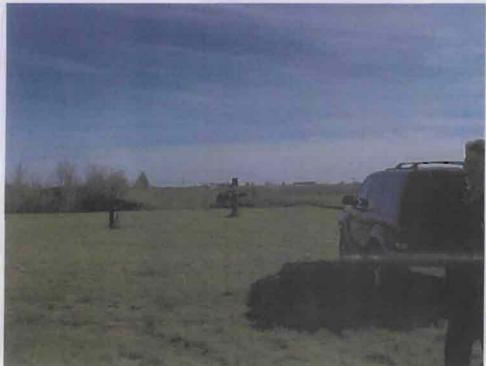
Photo 4 Looking E onto LF from SW corner

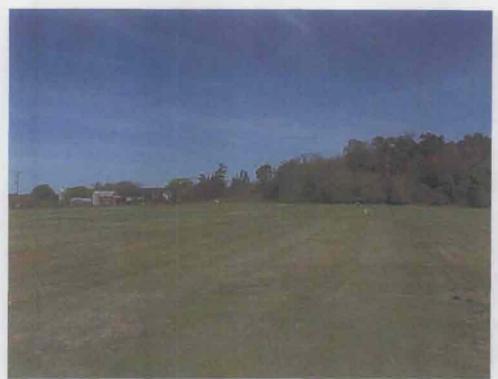
Photo 5 Looking NNW onto LF from S side

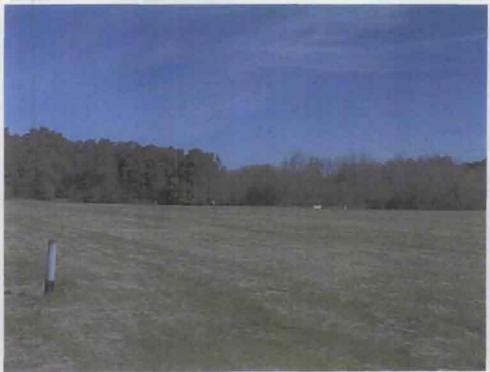
Photo 6 Looking N onto LF from S side

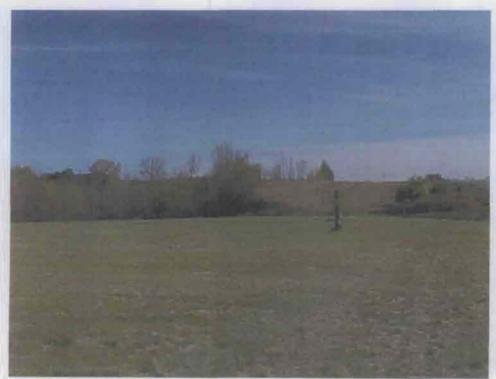
Photo 7 Looking E from S side

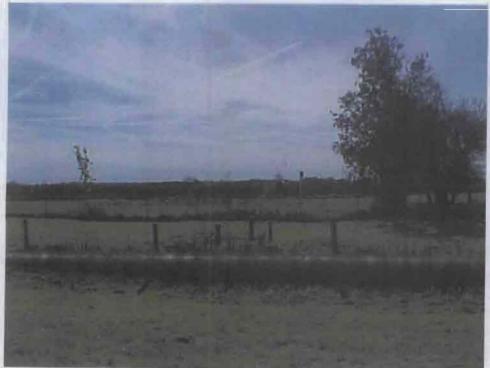
Photo 8 Looking S from S side towards well MW-103

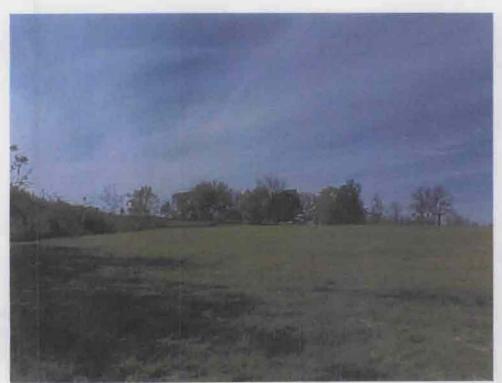
Photo 9 Looking S from E side of LF

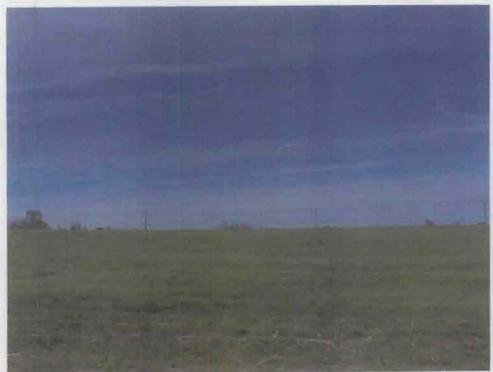
Photo 10 Looking W towards LF from E side of LF

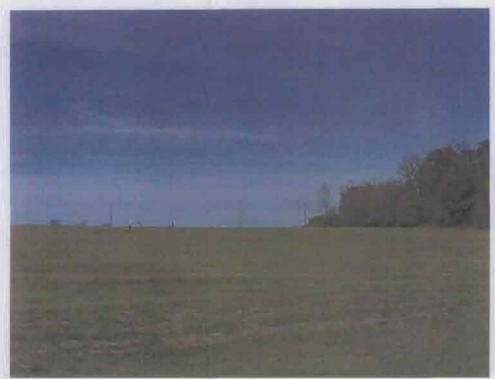
Photo 11 Looking WNW towards LF from E side of LF

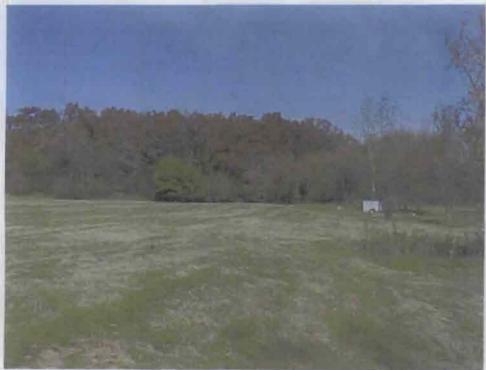
Photo 12 Looking N towards gas venting equipment from E side of LF

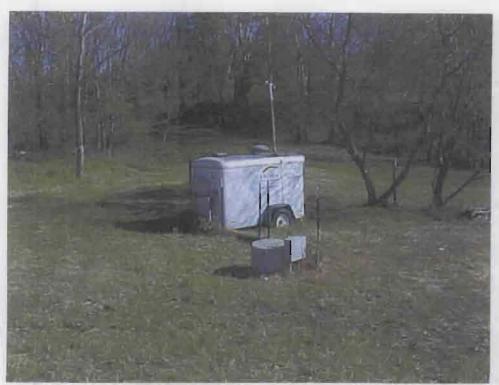
Photo 13 Active gas venting equipment; foreground drip tank, background is blower system trailer

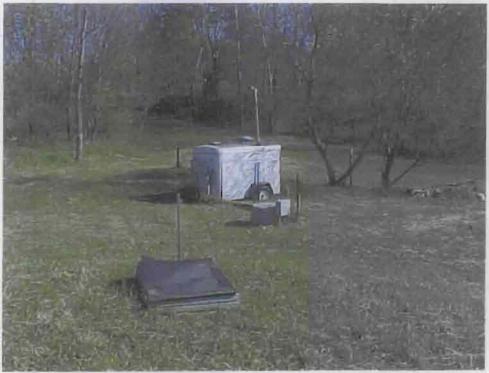
Photo 14 Active gas venting equipment; foreground is manifold box then behind that is the drip tank then behind that blower system trailer

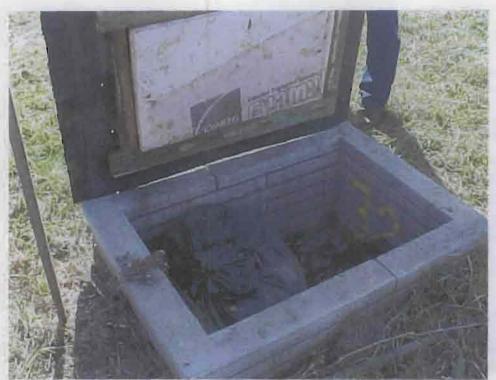
Photo 15 Manifold box with insulation added in bags and on underside of cover

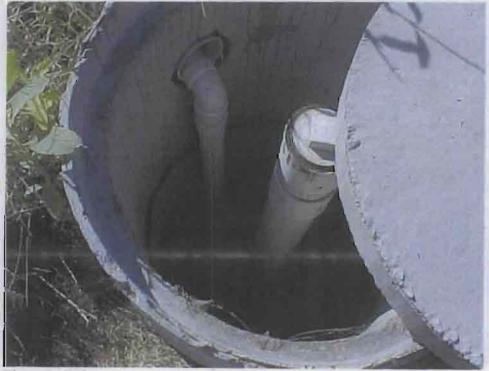
Photo 16 Drip tank

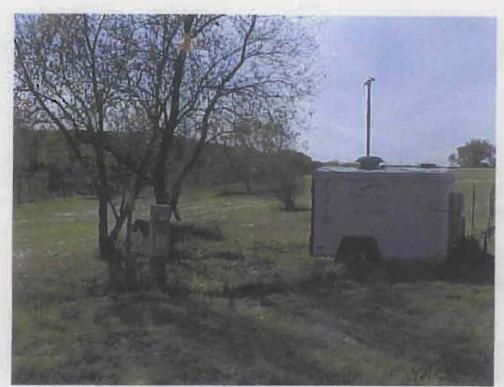
Photo 17 Electrical meter and blower trailer

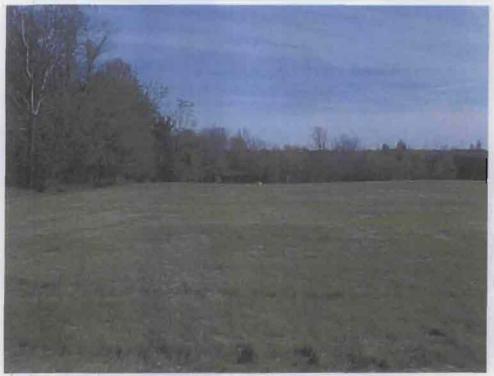
Photo 18 Looking E towards LF from NW corner

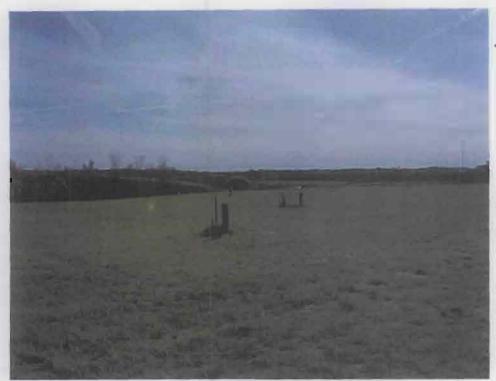
Photo 19 Looking SE towards LF from NW corner

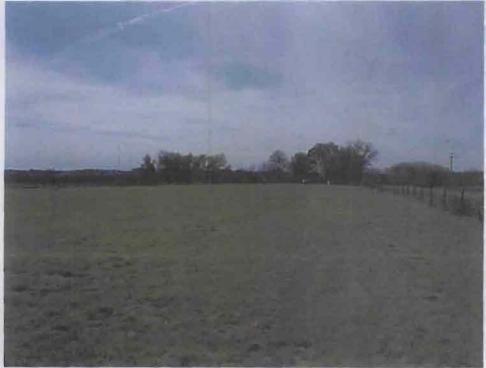
Photo 20 Looking S along fence line from NW corner
