**McLAREN/HART
ENVIRONMENTAL ENGINEERING CORPORATION**

Hein-Werner Corporation
2120 Pewaukee Road
Waukesha, Wisconsin 53188

**SITE INVESTIGATION REPORT
(TRENCHING INVESTIGATION)
MALLORY IMPROVEMENTS PROPERTY
1005 PERKINS AVENUE
WAUKESHA, WISCONSIN
FID #268091890**

August 22, 1996

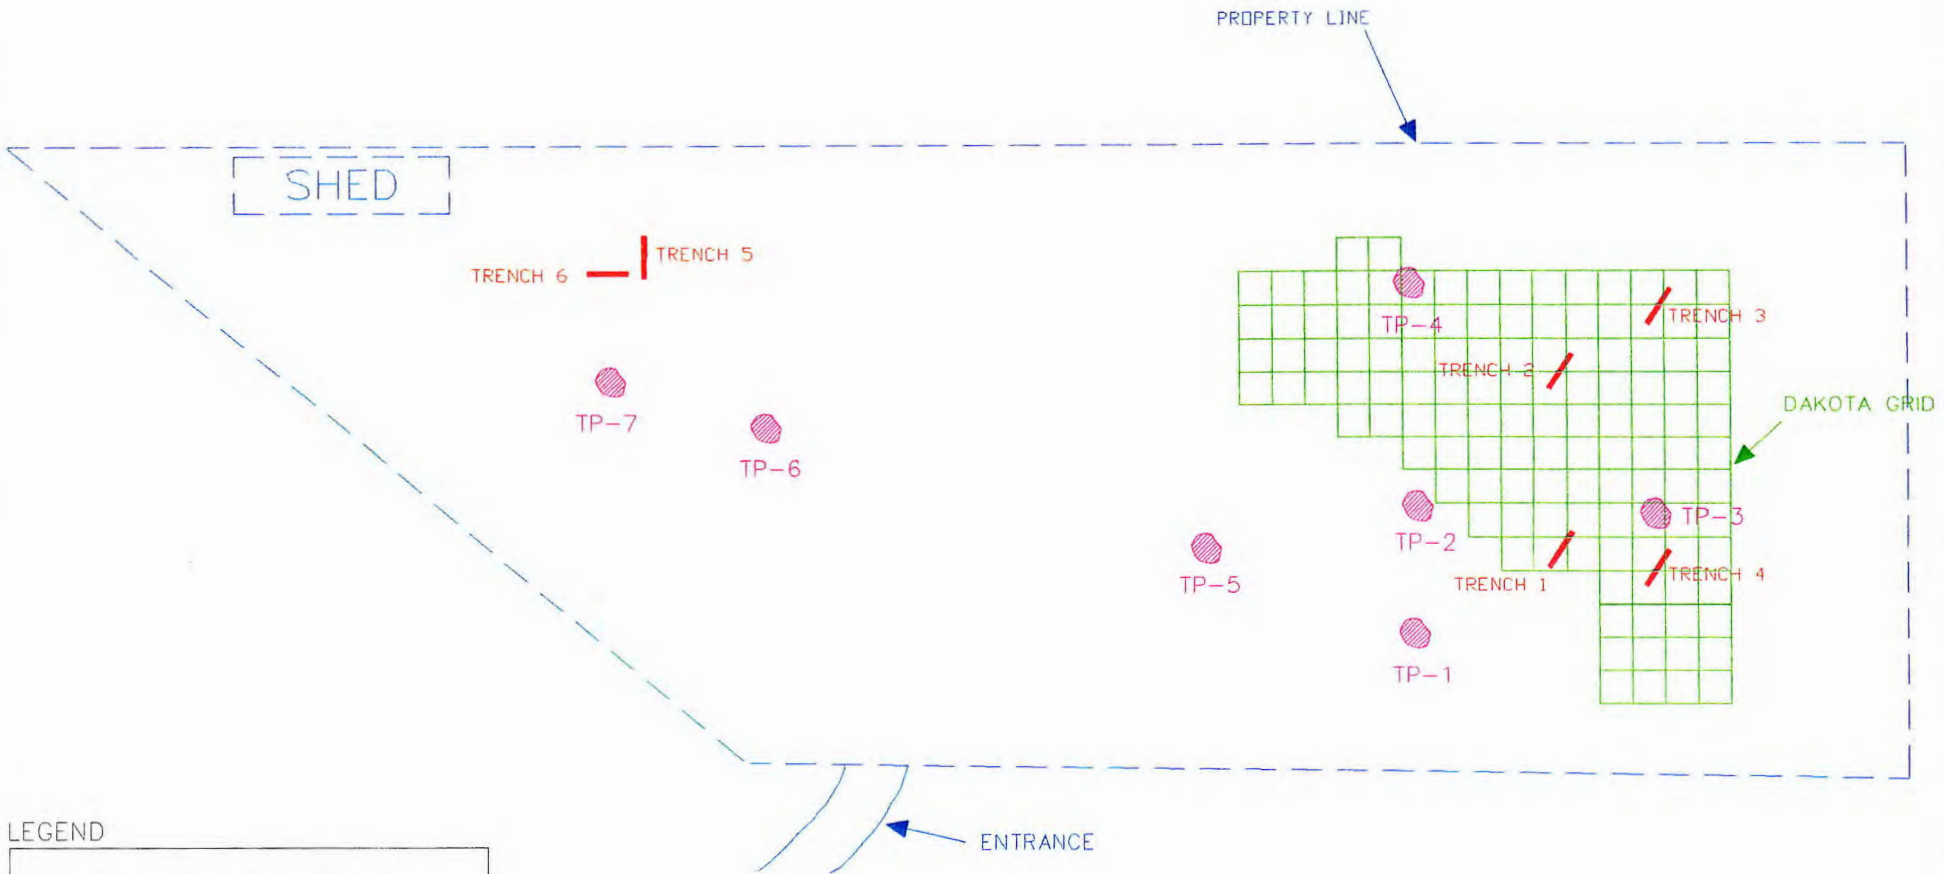
FIGURE 1
APPROXIMATE TRENCH LOCATIONS
MALLORY IMPROVEMENTS PROPERTY
1005 PERKINS AVENUE, WAUKESHA, WI

Figure 1 shows the location of site investigations conducted on the eastern portion of the Property, including test pits placed by Versar in 1993, a magnetometer survey conducted by Dakota Environmental in December 1995, and the six exploratory trenches excavated under this Work Plan.

Six exploratory trenches were completed as part of the investigation activities. Approximate locations of the trenches are indicated in Figure 1. Specific measurements for each trench are presented below. As provided in the Work Plan, four of the trenches were excavated in areas previously identified and marked as potentially containing buried ferrous metal (trenches #1-#4). Two additional trenches (#5 and #6) were excavated in areas selected by Mr. Ellenbecker.
