**DAKOTA  
INTERTEK  
CORP.**

Re: Key Engineering Group, LTD. December 18, 2000 Final Report for the Former Hein-Werner Property, 1005 Perkins Avenue, Waukesha, Wisconsin; Key Engineering Group, LTD. File No. 0810009  
WDNR FID No. 268091890

Attachment A  
Figures

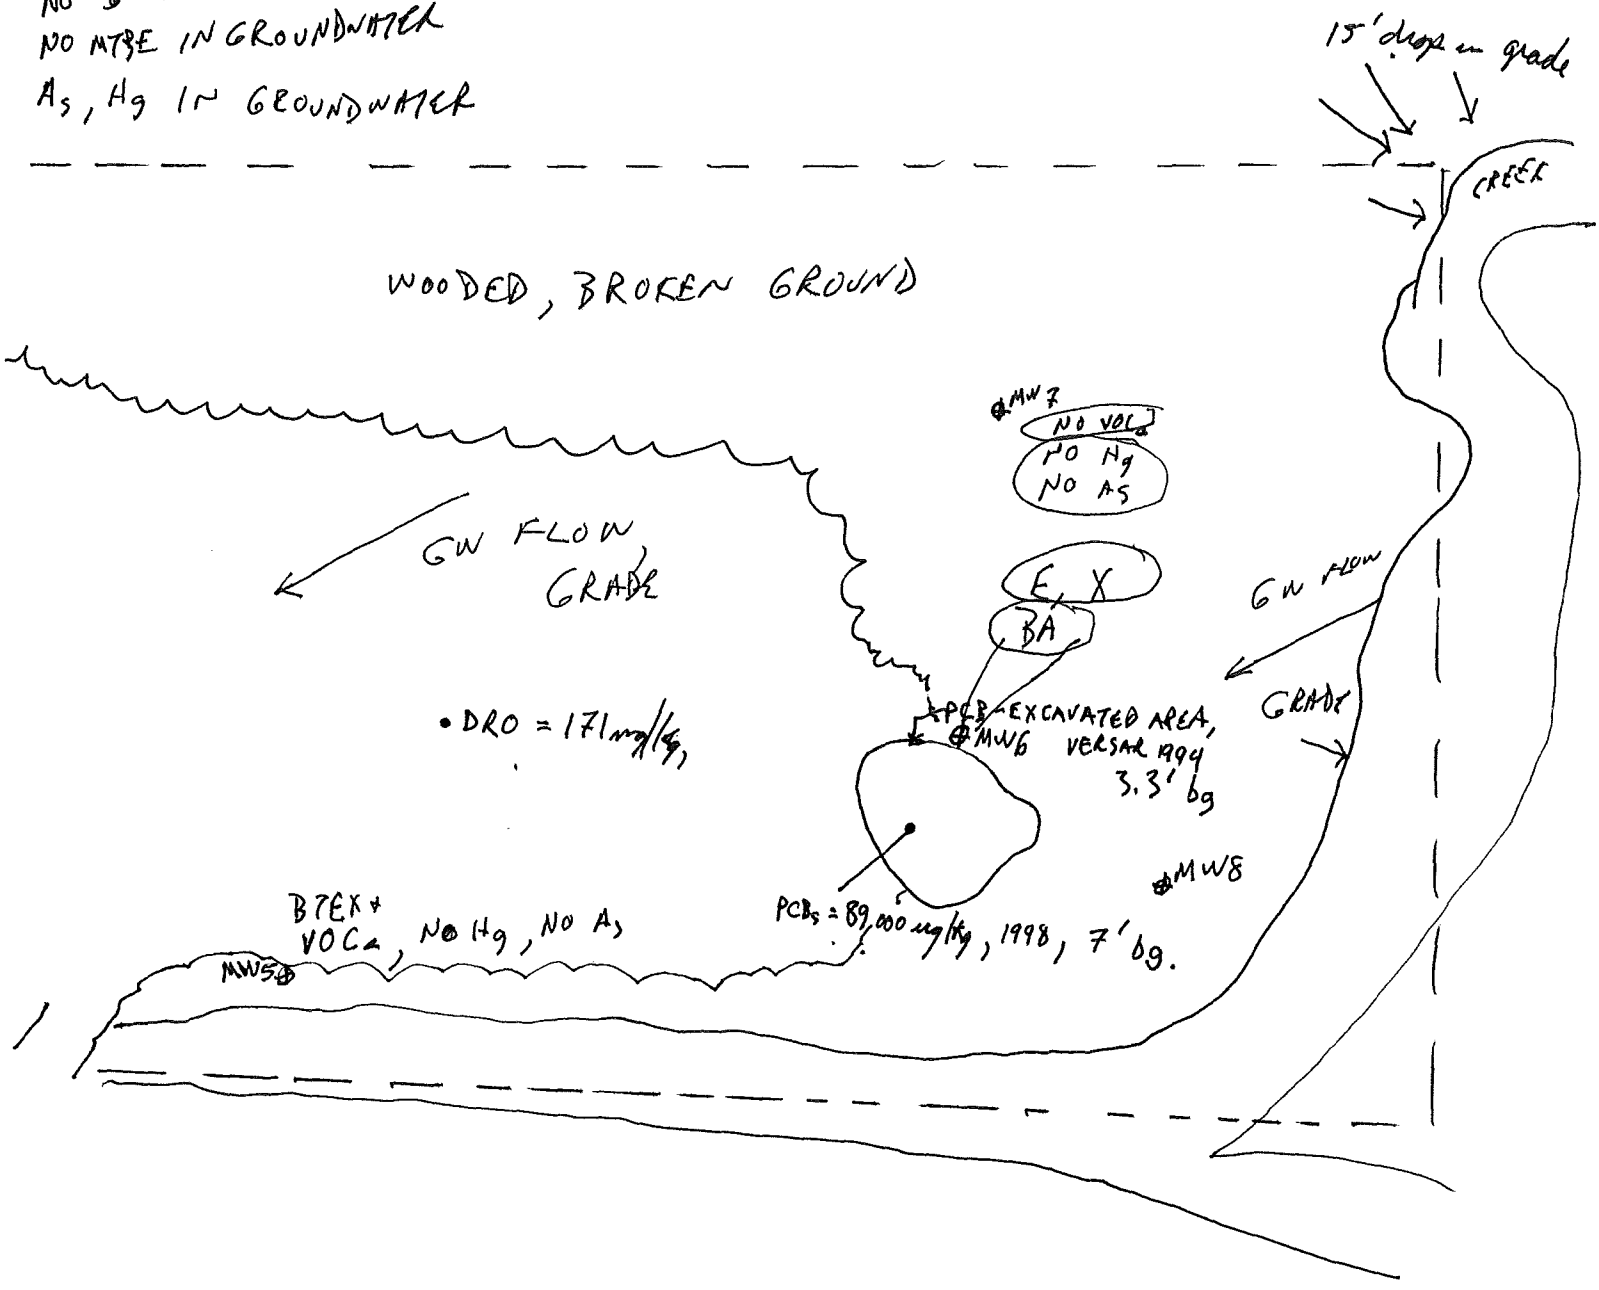
FIGURE 1

- There are no Key borings or monitoring wells in the immediate vicinity of laboratory-confirmed PCB and DRO-impacted soils (groundwater not tested), nor historic TCE-impacted groundwater (Figure 1 of Attachment A, "Figures");

- There are no Key borings or monitoring wells downgradient of laboratory-confirmed PCB and DRO-impacted soils, nor historic TCE-impacted groundwater (Figure 1, Attachment A);

NO B IN GROUNDWATER  
NO MTBE IN GROUNDWATER  
As, Hg IN GROUNDWATER

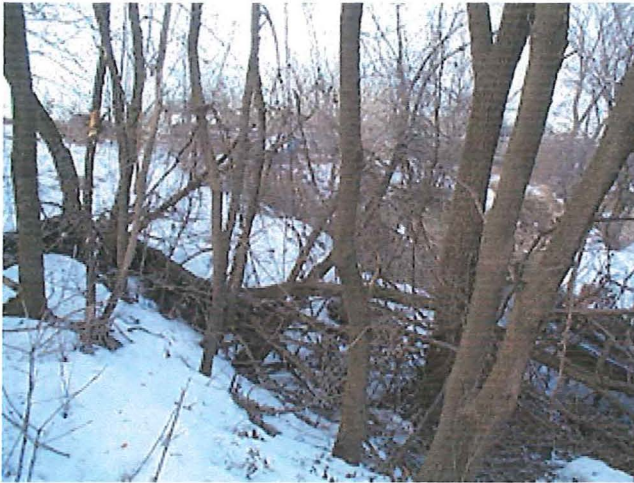
- Sampling of surface run off and surface water did not reveal VOCs;
  - Grade in Waukesha Iron & Metal property near the eastern former Hein Werner site area drops dramatically toward the creek (Attachment D);

#1 – Slope toward Creek – Standing on Site, Looking Toward Waukesha Iron & Metal

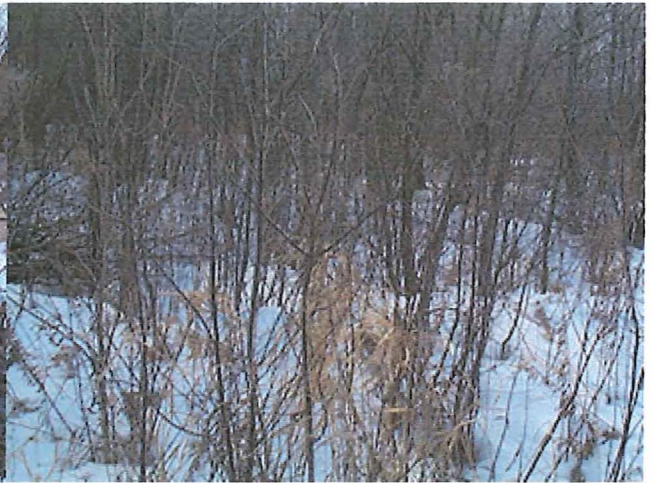
- Run off would have to travel hundreds of feet through wooded and heavily broken ground (Figure 3, Attachment A; Attachment D, "Photographs")
  - Grade established by Key would preclude run off from impacting the eastern portion of the site (Figure 3, Attachment A);

Wooded Area of Broken Ground Facing WI&M

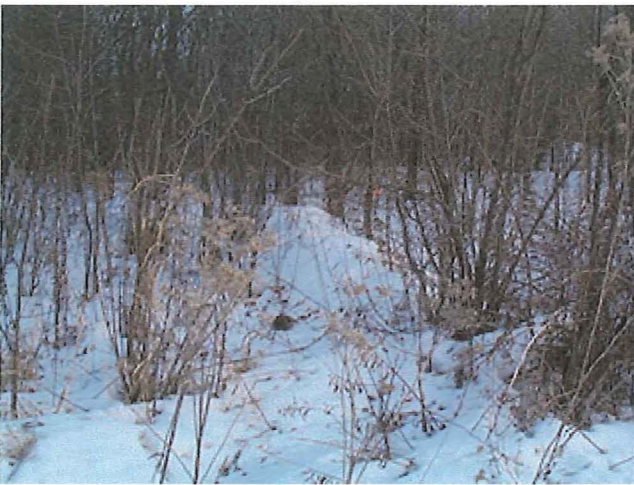
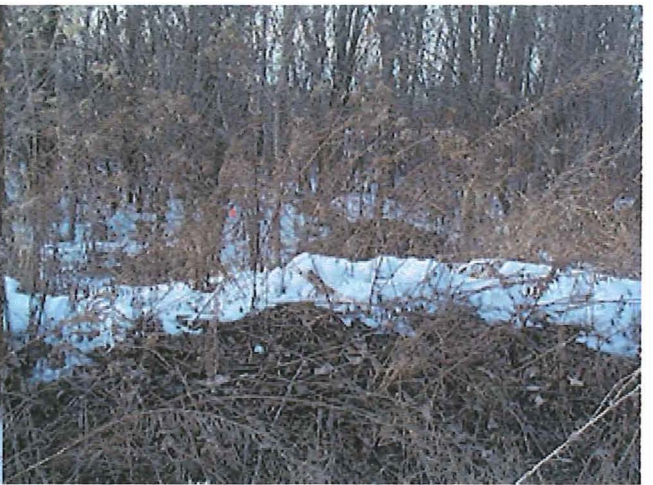
More Wooded Areas of Broken Ground Between Central Site and Waukesha Iron & Metal. Note Orange Flags from Dakota's 1/2-day Inspection. Some Paint Solids and Barrel Remnants Still Remain Next to Flagged Areas.

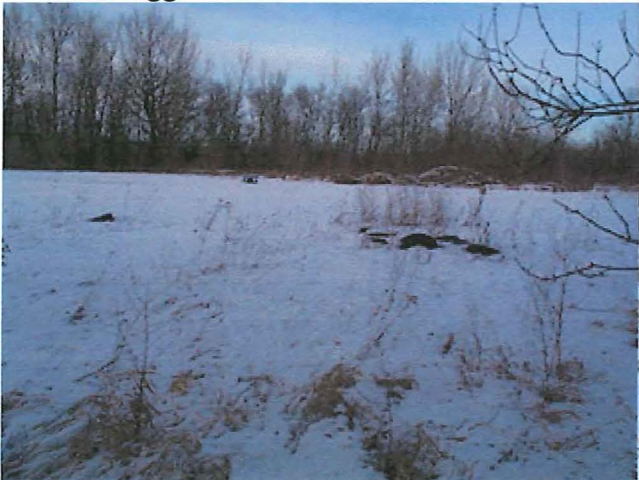
Southern Site Area. As a "sheet," run off would have to cross the wooded section, the clearing, and the southern wooded section to impact all vadose soils.

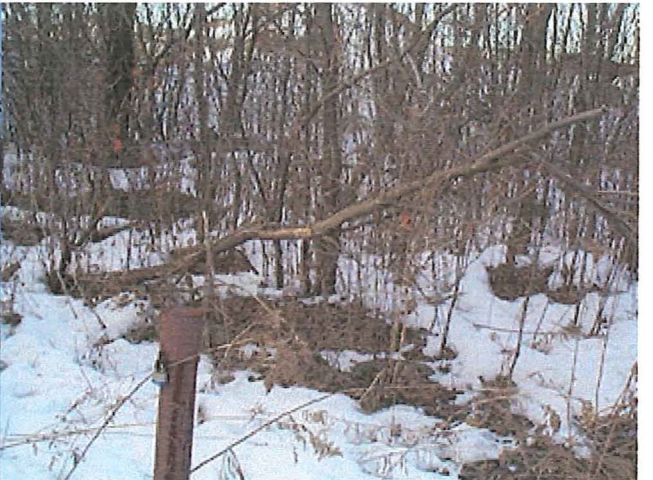
Embankment at the property line near MW7. Note more broken ground
