Subject: Vapor Mitigation System Documentation and Maintenance Plan
Monona Classic Cleaners, 3918 Monona Drive, Madison, Wisconsin
BRRTS #02-13-368525

Post Mitigation Report

Project: Java Cat Mitigation, 3918 Monona Dr., Monona, WI 53716

VAPOR MITIGATION SYSTEM MAINTENANCE PLAN
3916/3918 Monona Drive, Madison, Wisconsin

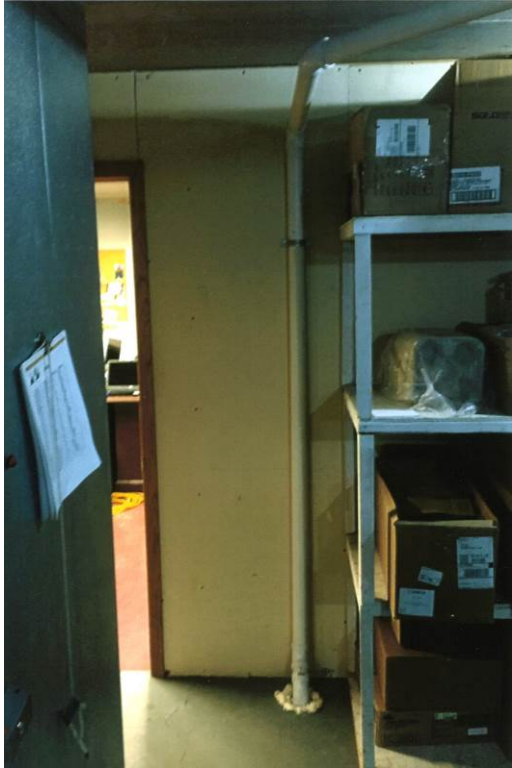
Photo 1: 3918 Monona Drive basement looking east at west vapor mitigation system (VMS) pickup point.

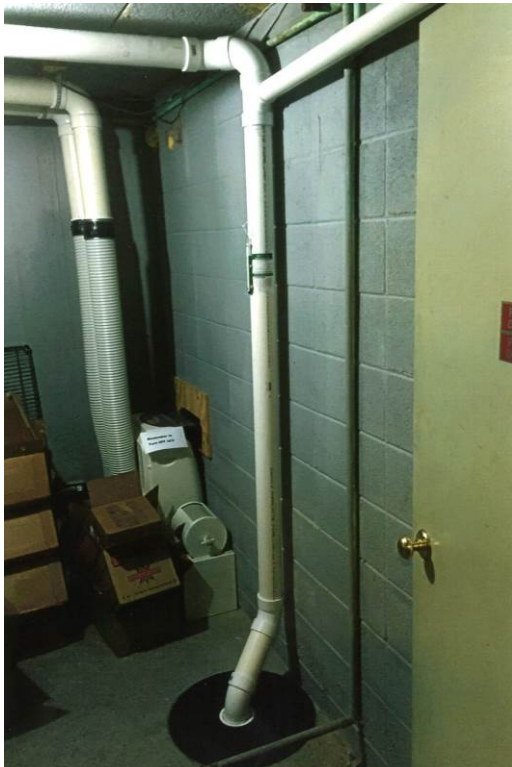
Photo 2: 3918 Monona Drive looking southwest at east VMS pickup point and 2-inch line from west pickup point.

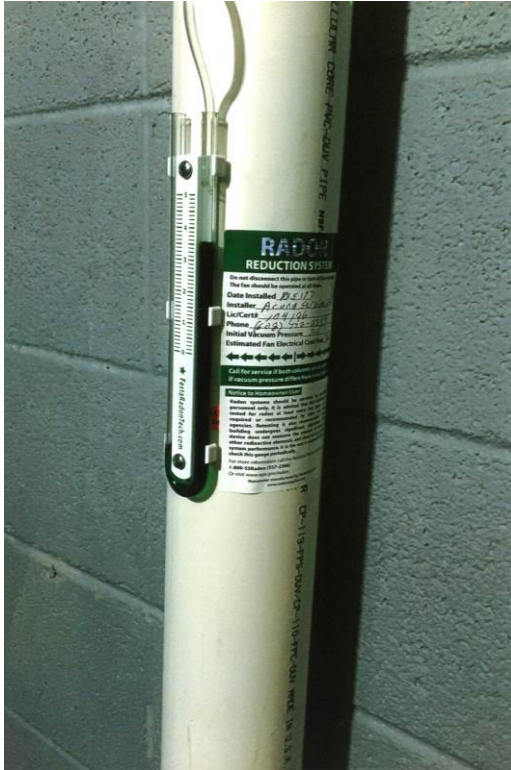
Photo 3: 3918 Monona Drive VMS monometer mounted to east pickup point.

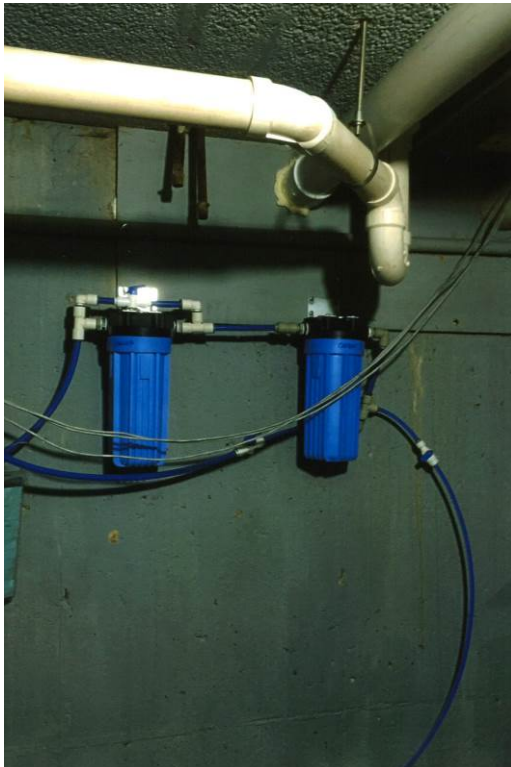
Photo 4: 3918 Monona Drive looking south at VMS piping exiting south end of building.

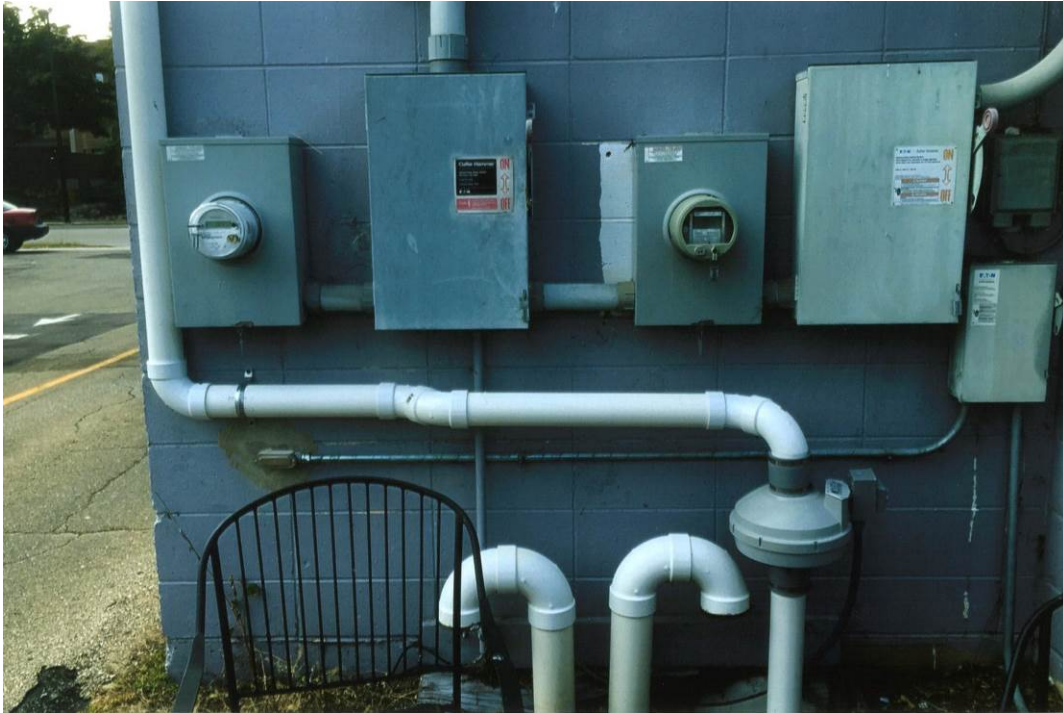
Photo 5: Looking west at east side of 3918 Monona Drive VMS fan and discharge piping.

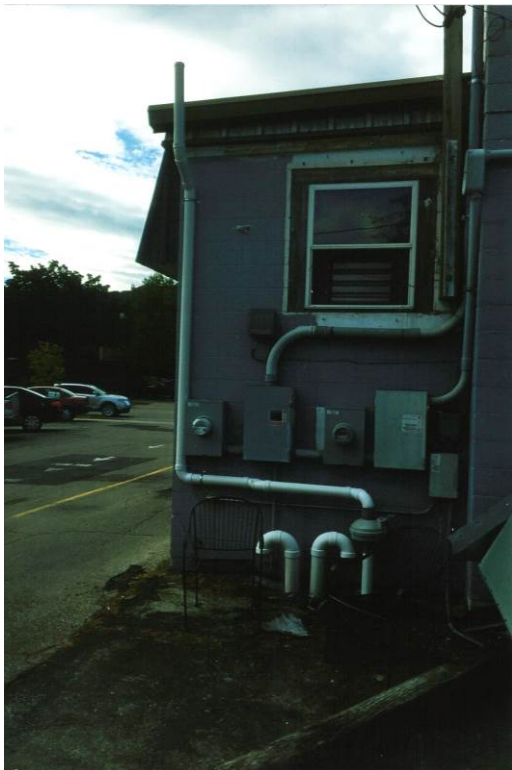
Photo 6: Looking west at east side of 3918 Monona Drive VMS fan and discharge piping.

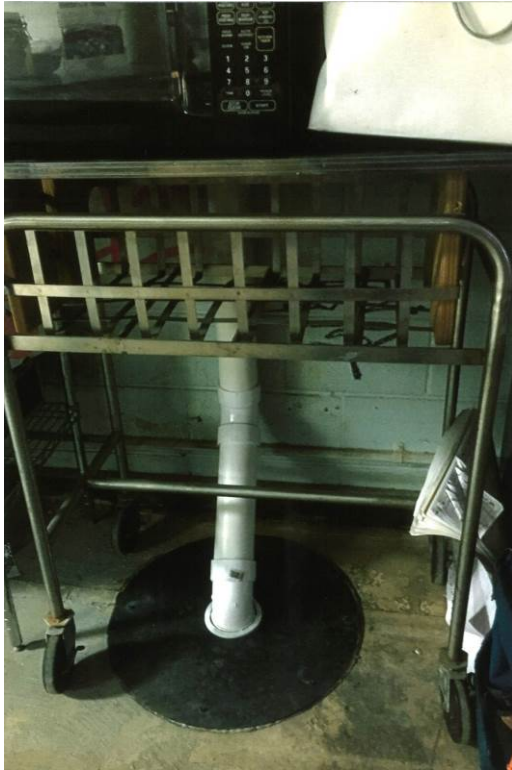
Photo 7: Looking north at 3916 Monona Drive VMS pickup point.

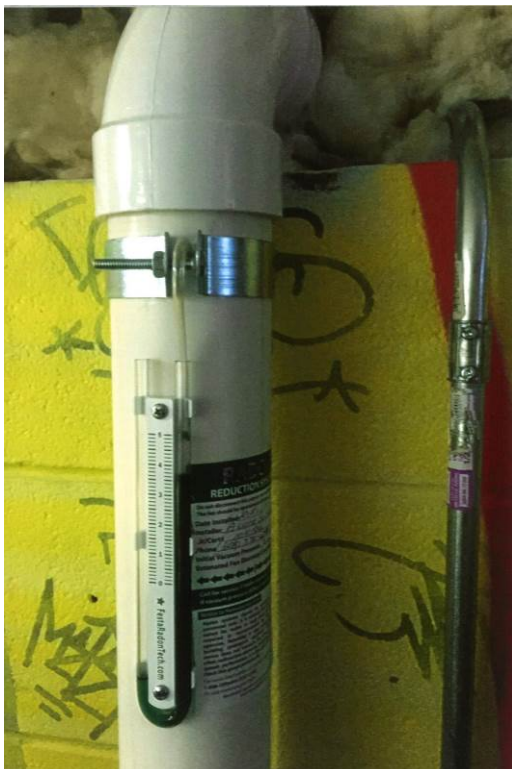
Photo 8: Monometer on 3916 Monona Drive pickup point.

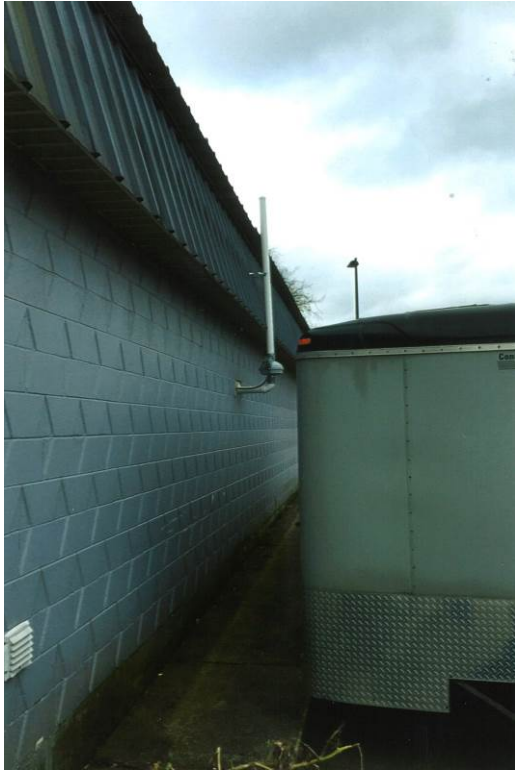
Photo 9: Looking west at fan and exhaust along north wall of 3916 Monona Drive.
