September 13, 2017

Subject: Response to May 2017 Site Investigation Report
Troy Laundry & Cleaners, 320 Pine St., Sheboygan Falls, Sheboygan County, WI
DNR BRRTS Activity #: 02-60-385641

September 13, 2017
Ms. Marilyn Walsh-Berlin
Response to May 2017 Site Investigation Report
Troy Laundry & Cleaners, 320 Pine St., Sheboygan Falls, WI
BRRTS #: 02-60-385641

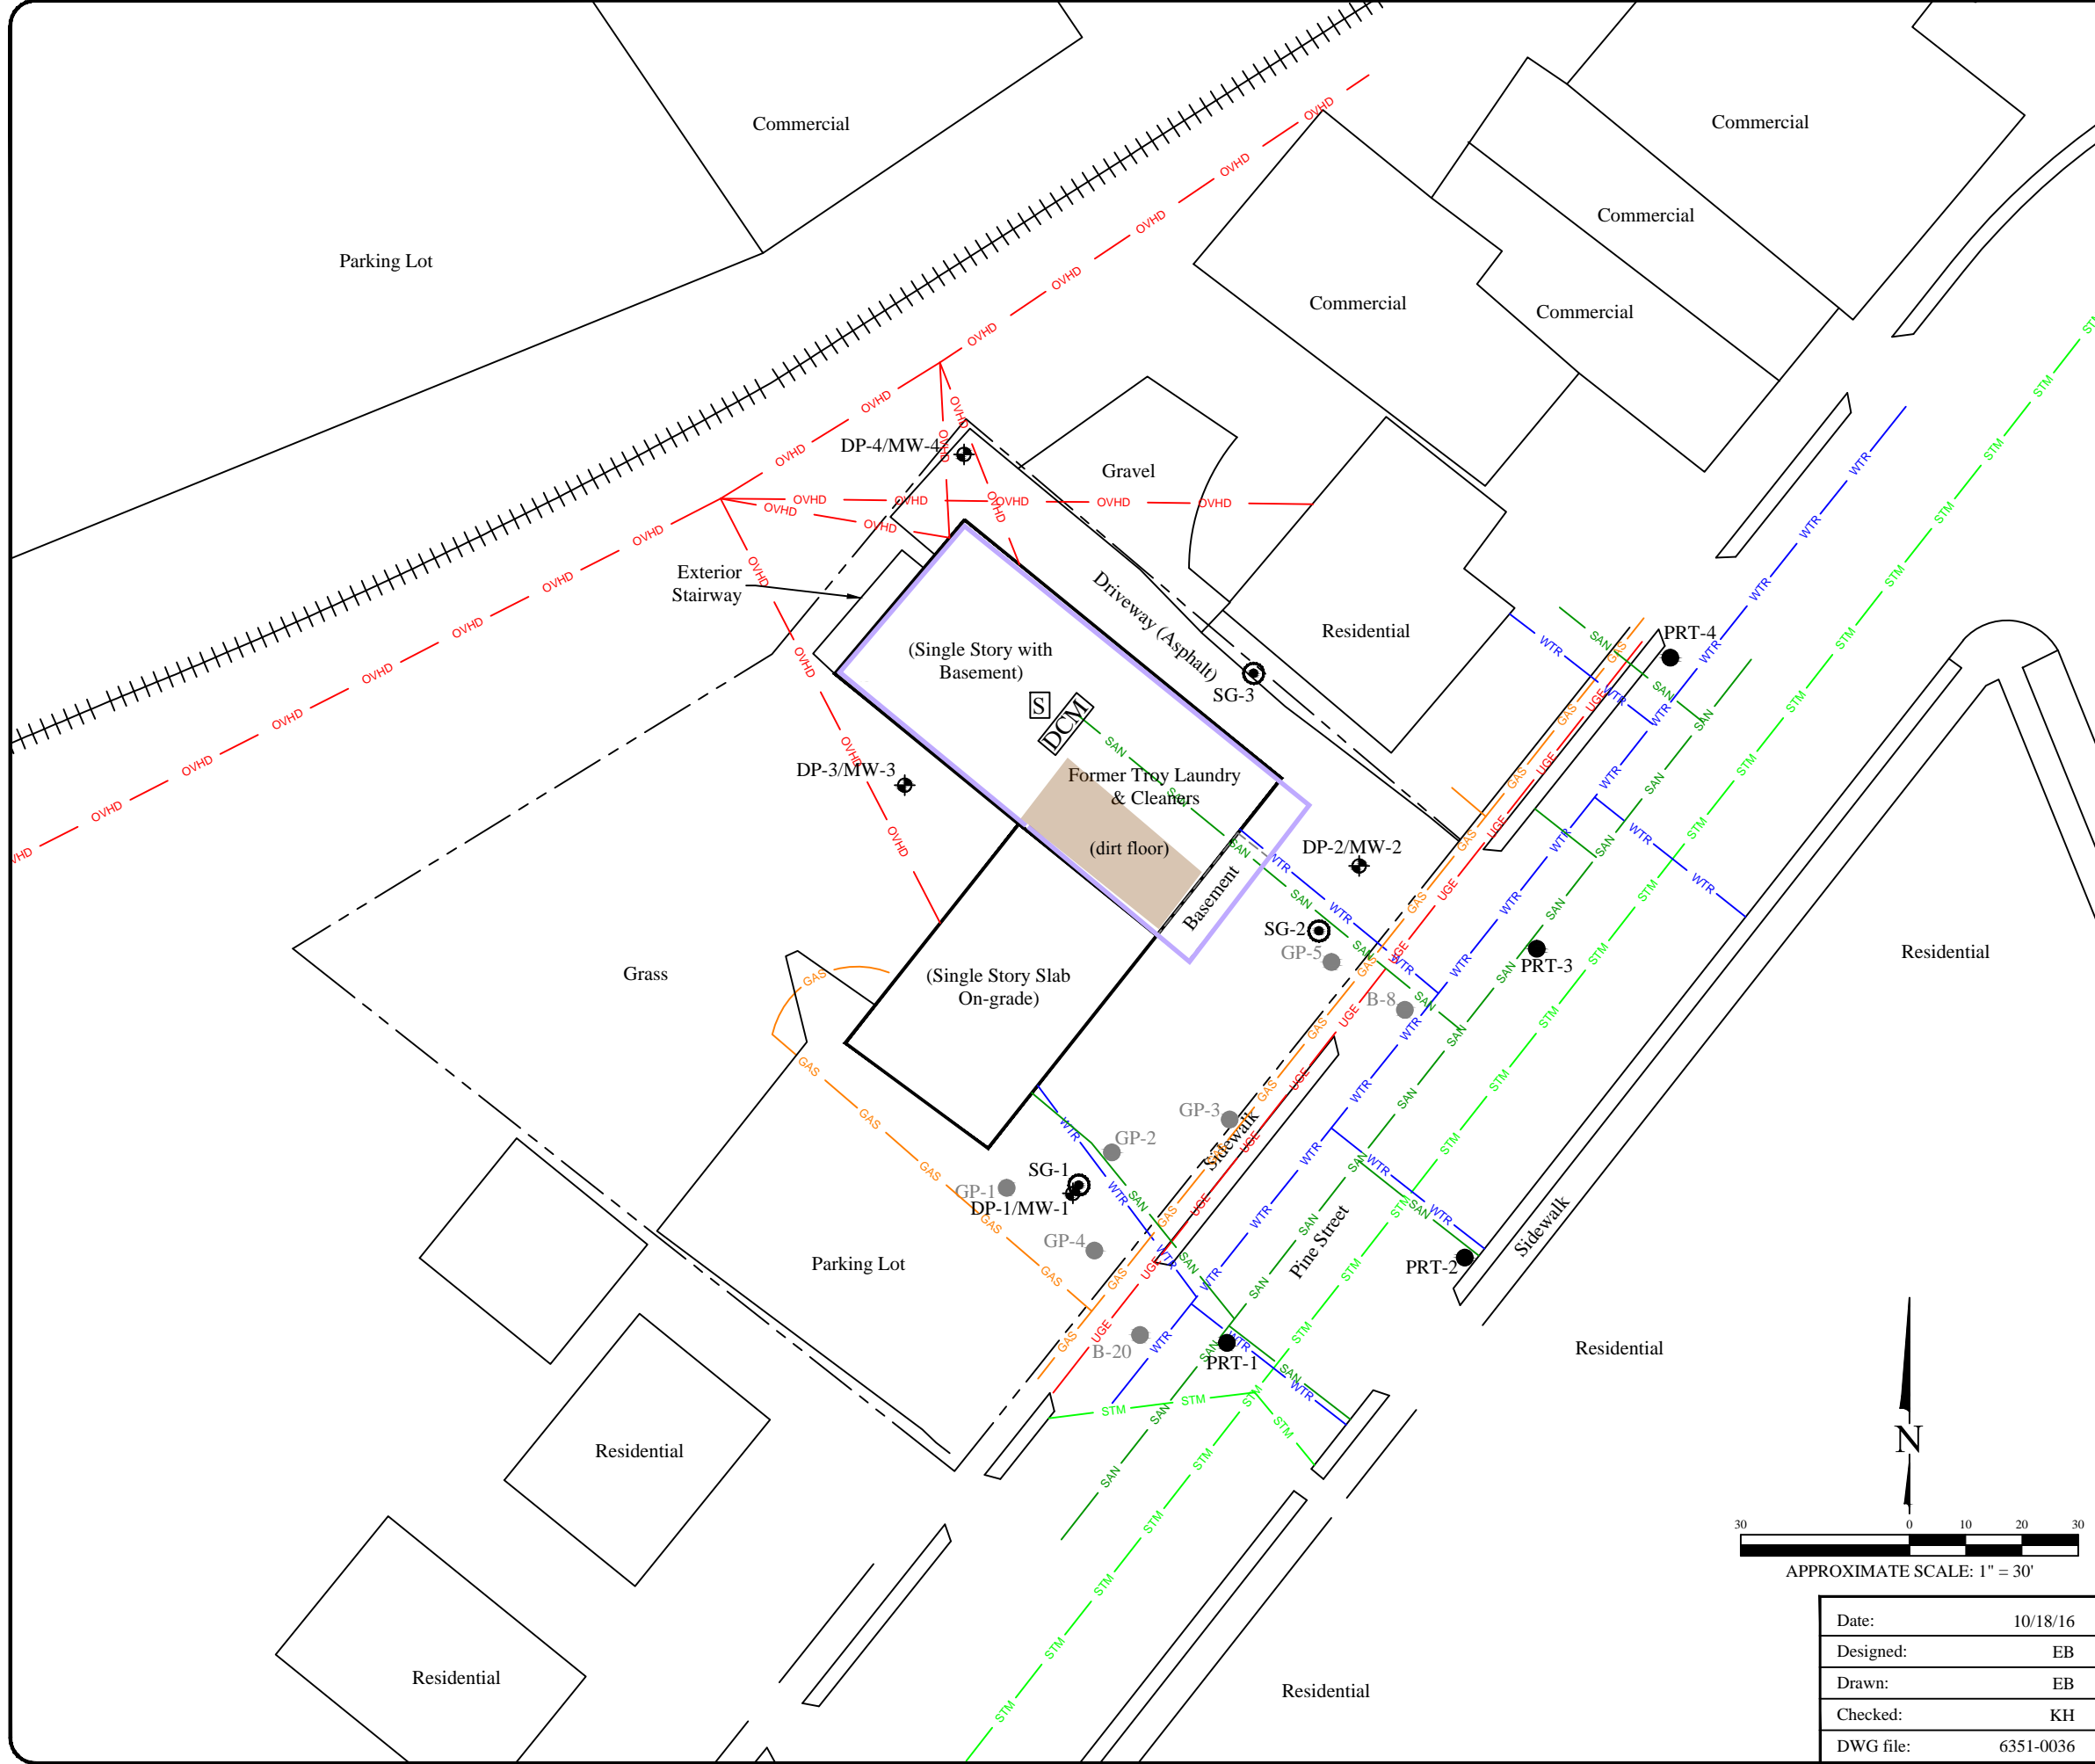
1. Tetrachloroethylene ("PCE") contamination in groundwater identified in grab samples collected from borings GP-5 and B-8 (see attached Figure 2 – Site Layout) have not been verified or collected from a monitoring well that was constructed in accordance with ch. NR 141, Wis. Adm. Code as required under s. NR 726.05(7)(c), Wis. Adm. Code. An additional monitoring well needs to be installed in the vicinity of boring GP-5 to assess contamination concentrations and trends near the source area. Based on the groundwater analytical results obtained from this monitoring well, additional monitoring points maybe required to define the extent of groundwater contamination to the southeast and/or along utility lines.

5. It appears that soil borings SB-1 through SB-4 were inadvertently identified as DP-1 through DP-4 on the figures. Please revise on future site maps so there is consistency throughout the document.

7. The property boundaries as shown on the figures included in the May 2017 SIR do not match what is listed on the Sheboygan County Land Information website. The Sheboygan County Land Information website lists the main building with the basement (Parcel # 59282907080) as 320 Pine Street and the slab-on-grade portion of the building (Parcel # 59282907070) as 326 Pine Street. This is important information that is needed at the time of closure in order to provide proper notifications and continuing obligations for each parcel. This needs to be clarified in the text and figures of future submittals.
