Phase I Environmental Assessment Report

**Try Chem Corporation Site
1333 W. Pierce Street
Milwaukee, WI**

August 1996

Waste Management Specialist/ Project Manager
Brownfield Environmental Assessment Pilot
Wisconsin Department of Natural Resources

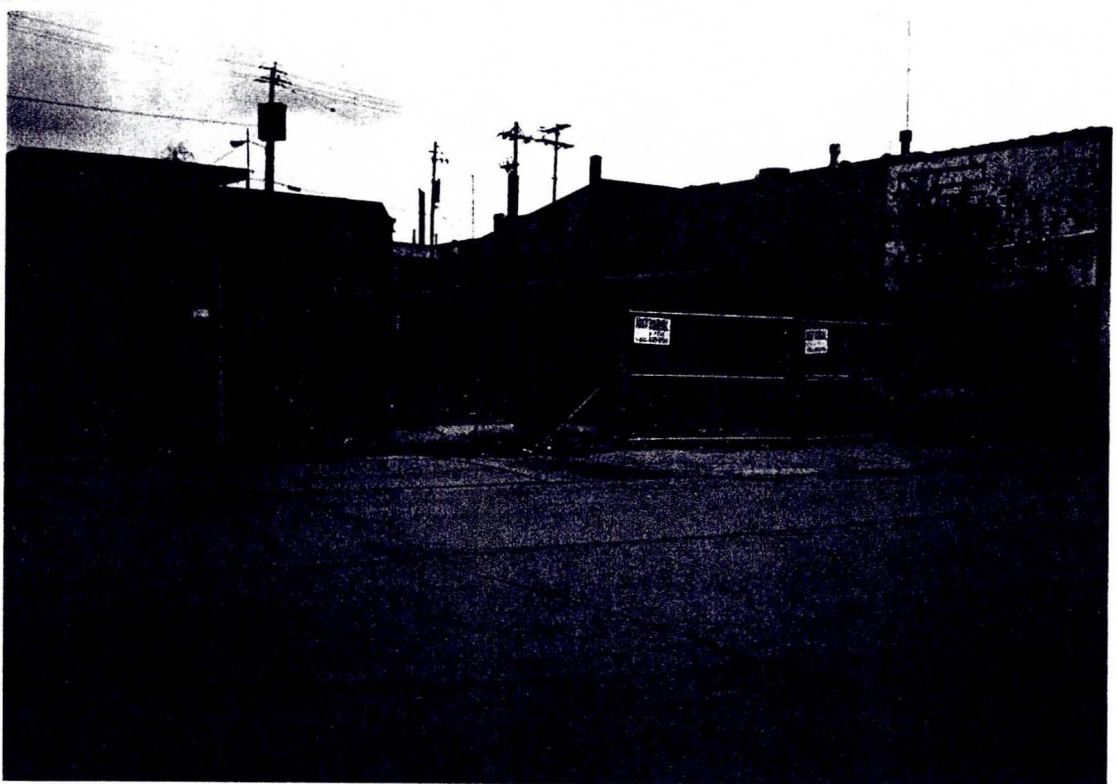
1 TRY CHEM
 SITE: 1333 W. PIERCE
 DATE: 05/20/96
 TIME: ~12:30
 DIR: SW
 PHOTOGRAPHED BY:
A. PARKINSON
 SAMPLE ID #: N/A
 DESCRIPTION:

EAST LOT AND LOADING DOCKS. MAIN BUILDING ON RIGHT
NITRIDING SHED LEFT BACKGROUND.

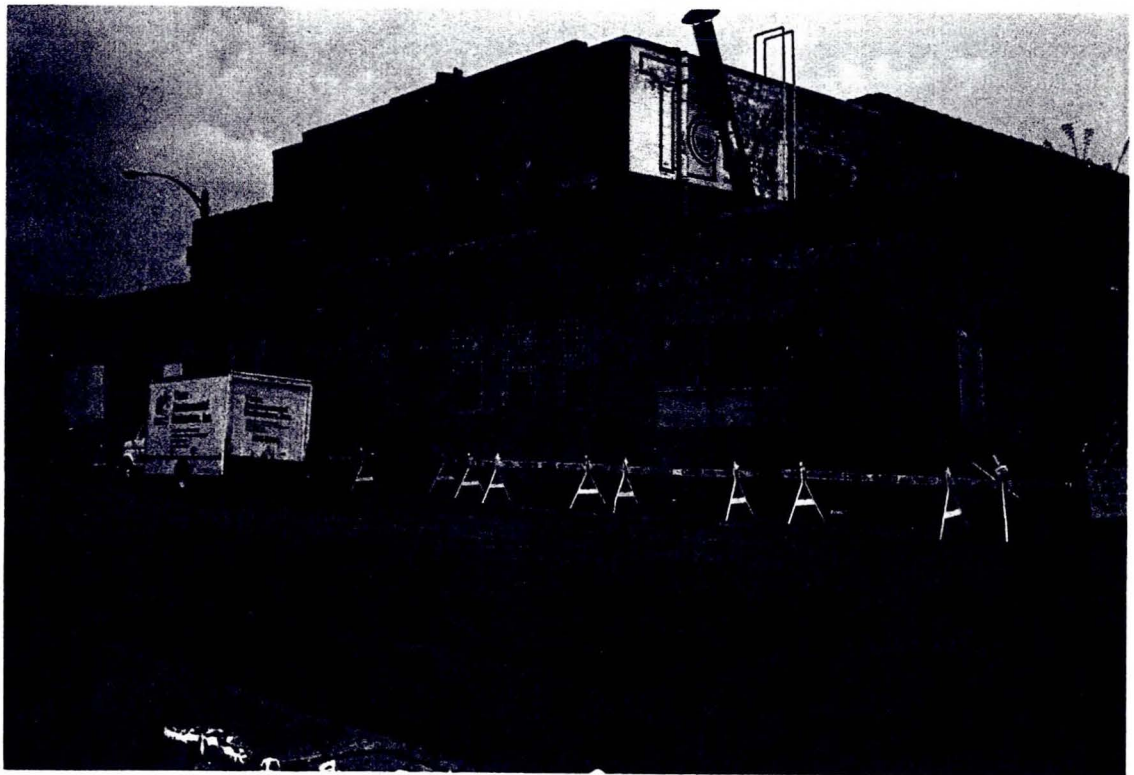
2 TRY CHEM
 SITE: 1333 W. PIERCE
 DATE: 05/20/96
 TIME: ~12:30
 DIR: SE
 PHOTOGRAPHED BY:
A. PARKINSON
 SAMPLE ID #: N/A
 DESCRIPTION:

fence on both sides of the building and had begun the preparations for demolition of the building (note environmental contractors truck in Photo 2). The majority of the site was covered by the building or paved with concrete. Surface runoff from the site flows north to Pierce Street and into two storm sewers (catch basins) in the street in front of the building. The two catch basins appear to be clogged; standing water was located in the basins, above the height of the side outlet. The sidewalk and gutter from the northeast corner of the building foundation to the easterly catch basin was etched due to chemicals leaking from the building (Photos 21-25). The previously etched area around the easterly catch basin appeared to have been patched. Orange-brown stains on the driveway concrete of the east lot appeared to indicate liquids flowing from the east lot directly to the storm sewer. This may have occurred during the removal of the kolene wastes. This east-west running storm sewer turns north at 12th Street and discharges to the Burnham shipping canal which discharges to the Menomonee River. The two lots were paved with concrete but the concrete is cracked with vegetation growing in the cracks. There was only a small strip of soil behind the warehouse.

MAIN BUILDING FROM W. PIERCE STREET.

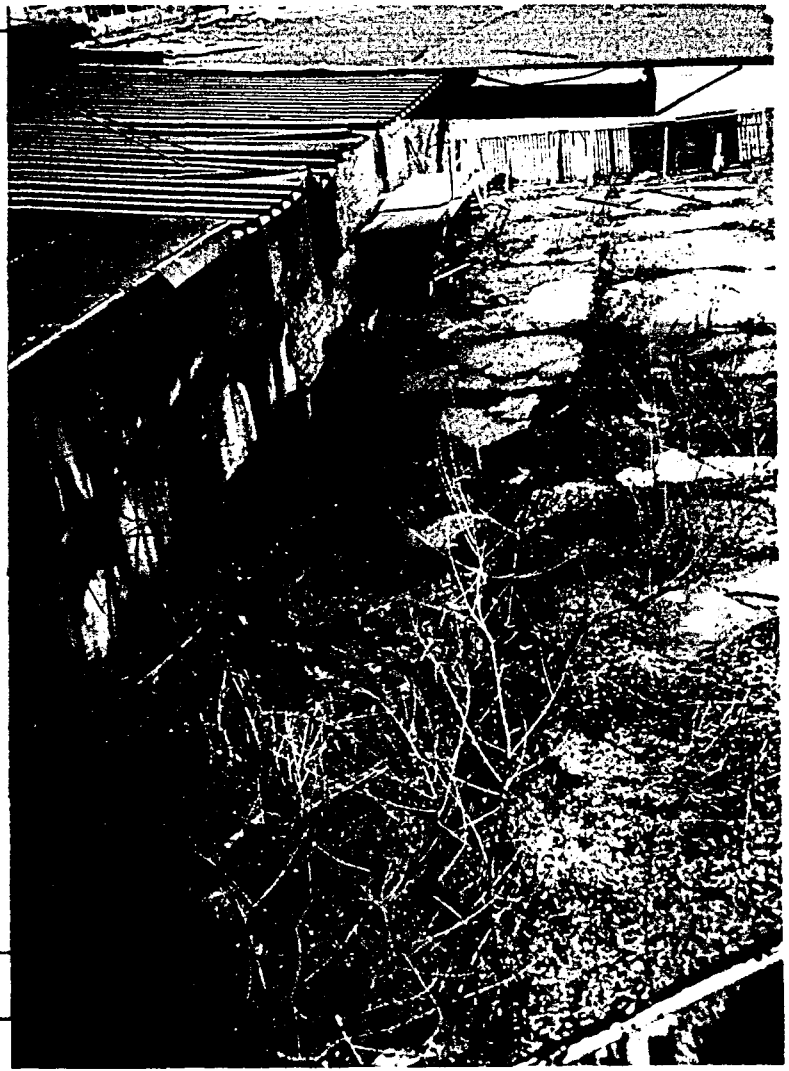
4 TRY CHEM
SITE: 1333 W. PIERCE

On April 4, 1996, photos were taken of the outdoor storage area and access driveway from National Avenue (see Photos 4,5,17,18, &19). The photos show approximately 25 drums of unknown substances located in the outdoor storage area behind the building. These drums were not evident in photos taken by WDNR in 1987. A close-up photo of the drums shows a bulging drum bottom and stained areas around the drums. Six to eight abandoned cars were also located in the driveway to the rear of the site. (The City of Milwaukee subsequently removed and disposed of the drums and vehicles.)

The storage shed was boarded up and appeared to be emptied of the kolene wastes that were piled there after the removal action by TCC in 1983-84 (Photo 12). The roof was damaged allowing rain and snow to enter the building. A few rusted drums were noted in the building but there was no access inside to investigate further. Photos of the east lot from the storage shed document deterioration of the building foundation at the loading doors, presumably from spilled chemicals (Photos 4 & 6).

EAST LOT AND LOADING DOCKS FROM NITRIDING SHED

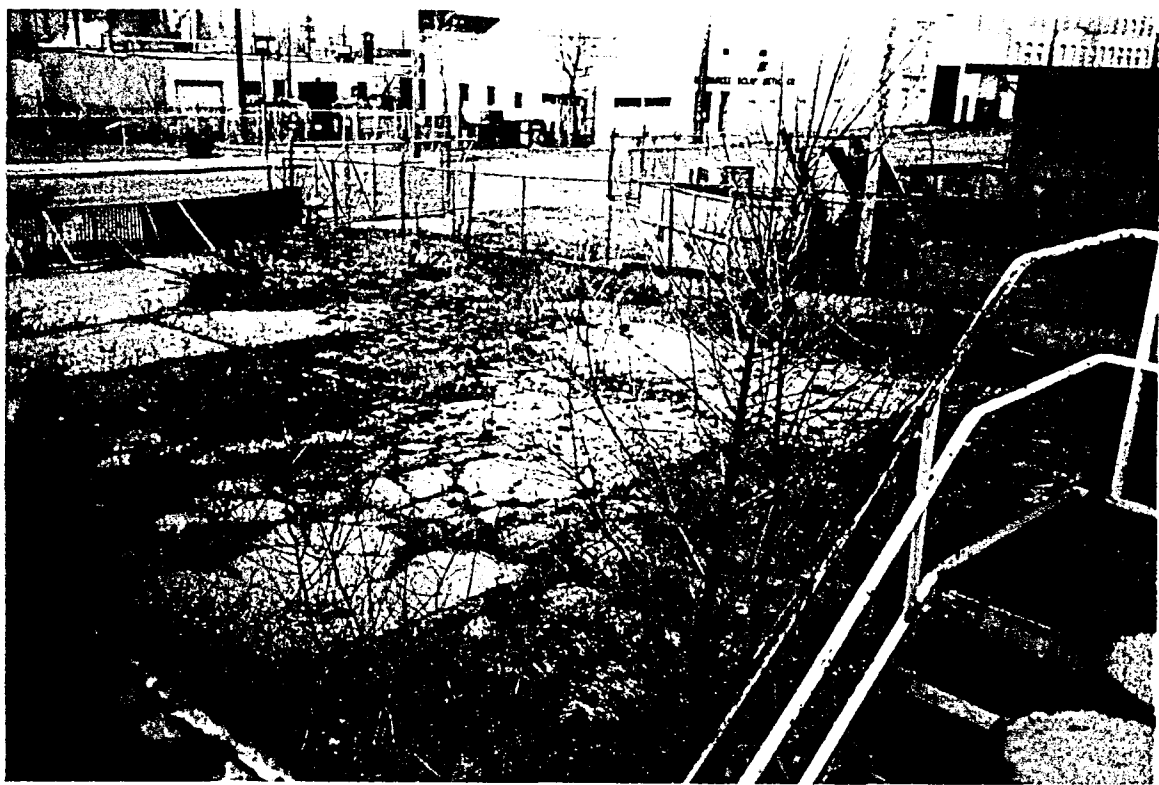
5 TRY CHEM
 SITE: 1333 W. PIERCE
 DATE: 04/04/96
 TIME: ~ 13:00
 DIR: NE
 PHOTOGRAPHED BY:
A. PARKINSON
 SAMPLE ID #: N/A
 DESCRIPTION:

EAST LOT

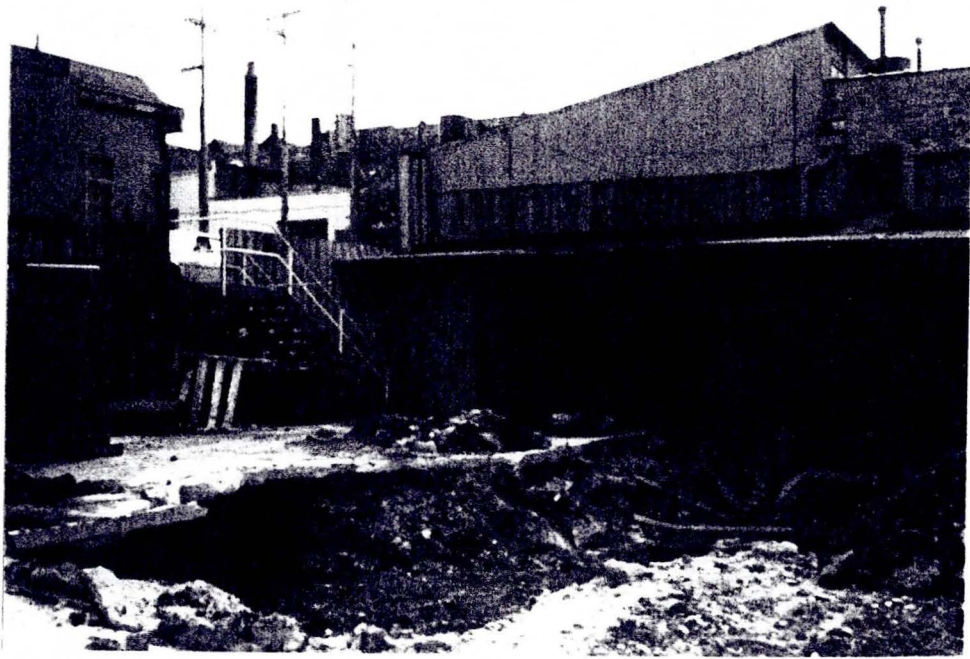
7 TRY CHEM
 SITE: 1333 W. PIERCE
 DATE: 07/14/83
 TIME: —
 DIR: SE
 PHOTOGRAPHED BY:
V. PAPPAS
 SAMPLE ID #: N/A
 DESCRIPTION:

EAST LOT DURING REMOVAL OF KOLENE + OTHER WASTES. NOTE HEIGHT OF CONCRETE PAD.

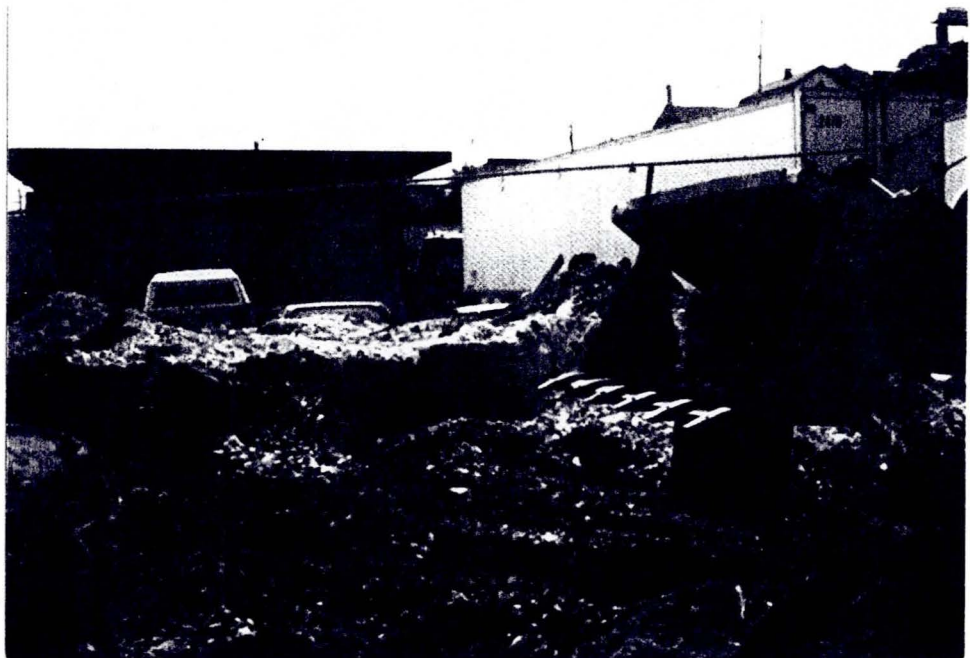
8 TRY CHEM
 SITE: 1333 W. PIERCE
 DATE: 07/22/83
 TIME: —
 DIR: E.
 PHOTOGRAPHED BY:
V. PAPPAS
 SAMPLE ID #: N/A
 DESCRIPTION:

DRUMS OF WASTE IN FILL DURING REMOVAL ACTION IN EAST LOT.

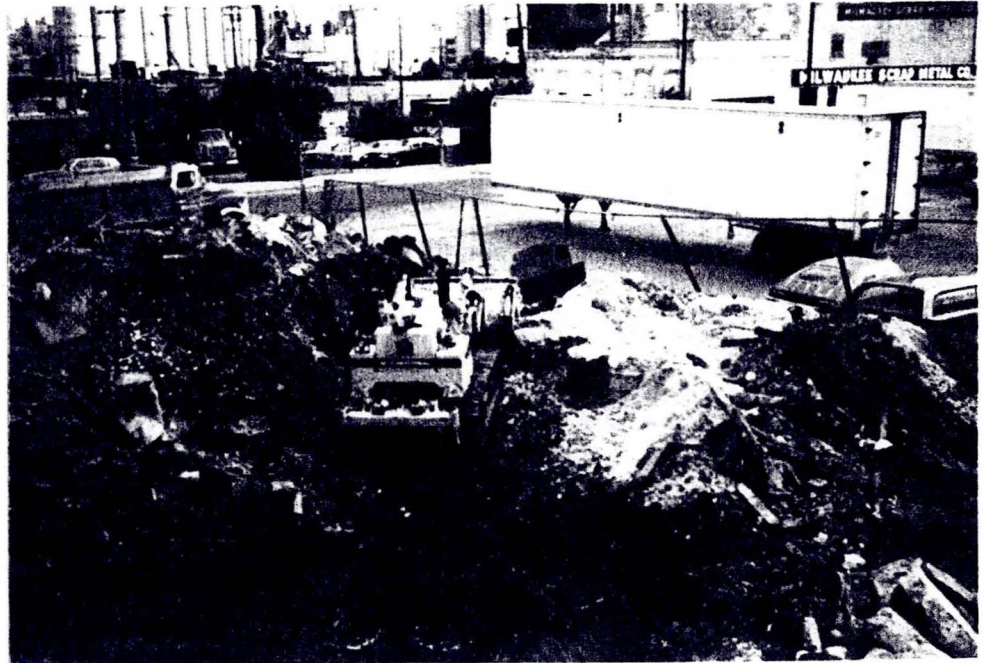
9 TRY CHEM
 SITE: 1333 W. PIERCE
 DATE: 07/22/83
 TIME: —
 DIR: N
 PHOTOGRAPHED BY:
V. PAPPAS
 SAMPLE ID #: N/A

REMOVING WASTE FROM FILL IN EAST LOT.

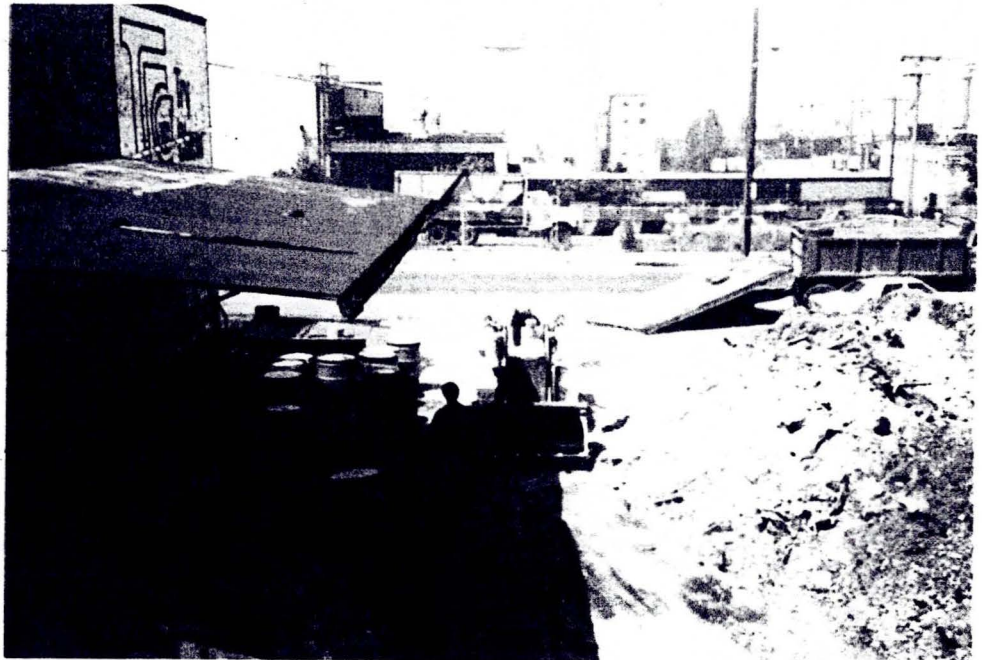
10 TRY CHEM
 SITE: 1333 W. PIERCE
 DATE: 07/19/83
 TIME: —
 DIR: N
 PHOTOGRAPHED BY:
V. PAPPAS
 SAMPLE ID #: N/A

VIEW OF EAST LOT DURING REMOVAL ACTION
FROM NITRIDING SHED.

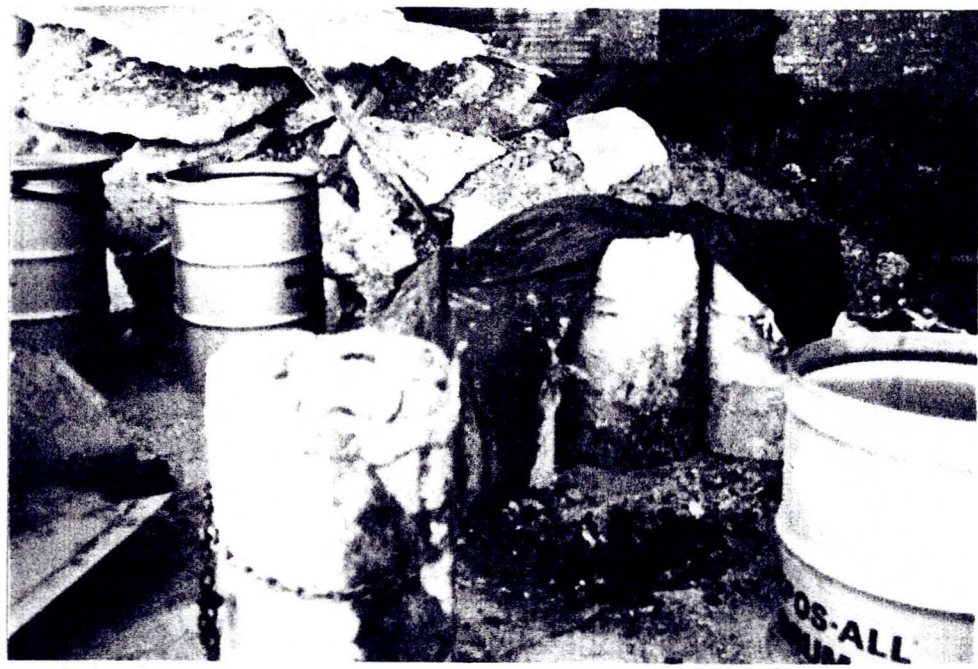
11 TRY CHEM
 SITE: 1333 W. PIERCE
 DATE: 07/19/83
 TIME: —
 DIR: —
 PHOTOGRAPHED BY:
V. PAPPAS
 SAMPLE ID #: N/A

DRUMS OF KOLENE SLUDGE EXTRACTED FROM
FILL IN EAST LOT.

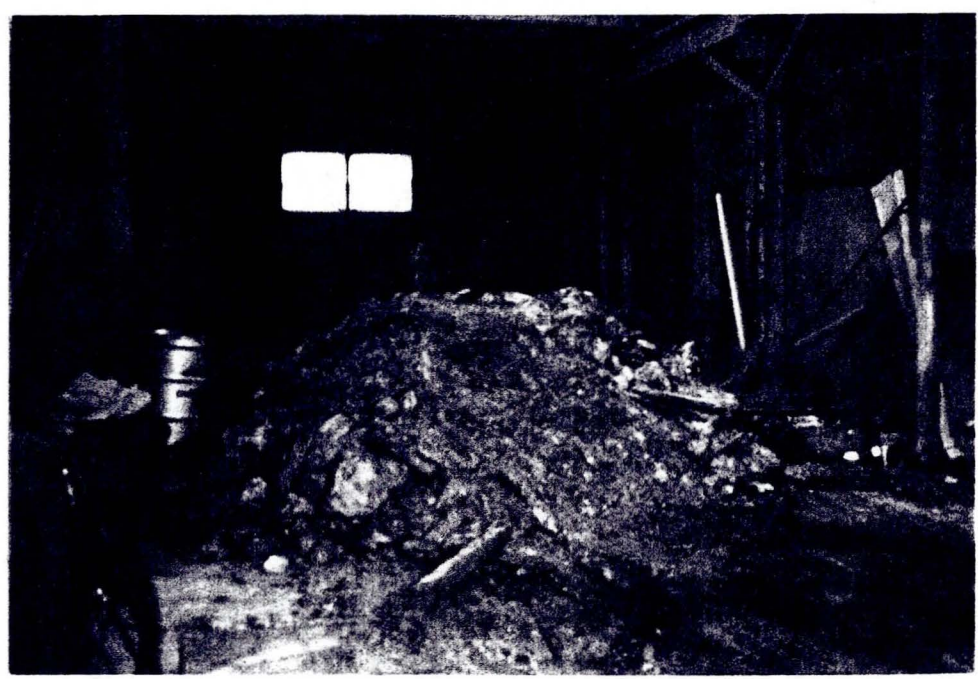
12 TRY CHEM
 SITE: 1333 W. PIERCE
 DATE: 07/15/83
 TIME: —
 DIR: W
 PHOTOGRAPHED BY:
V. PAPPAS
 SAMPLE ID #: N/A

EXTRACTED WASTE FROM EAST LOT IN NITRIDING
SHED.

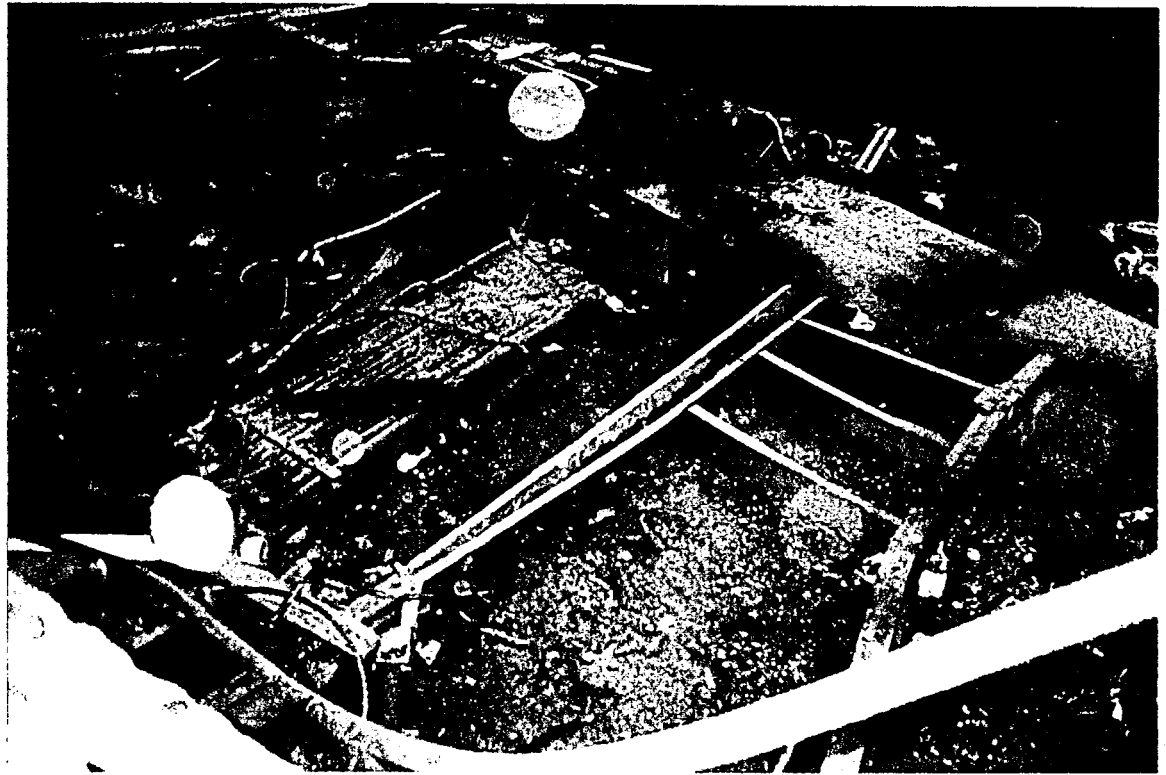
14 TRY CHEM
 SITE: 1333 W. PIERCE
 DATE: 04/04/96
 TIME: ~ 13:00
 DIR: —
 PHOTOGRAPHED BY:
A. PARKINSON
 SAMPLE ID #: N/A
 DESCRIPTION:

The building was secured and a 6' chain link fence prevented access to the east and west lots and the upper storage area. Inside the building the floors were covered with debris (scrap metals, dust, etc - Photos 13 & 14). A portion of the warehouse ceiling has collapsed and the roof of the building was in severe disrepair. Not all areas of the building were accessible due to the dangerously damaged nature of the building. The large pit and the smaller pit appeared to be connected via a hole in the wall separating them. The mortar in the brick wall separating these two pits was severely eroded. The drain of the former wastewater pretreatment unit appeared to be purposely closed off. The drywell near the former zinc cyanide line was open but a manhole cover was noted nearby. Little exploration of the remainder of the building was attempted due to the condition of the structure.

DEBRIS ON FLOOR IN PROCESSING AREA, TAKEN
THROUGH HOLE IN WALL.

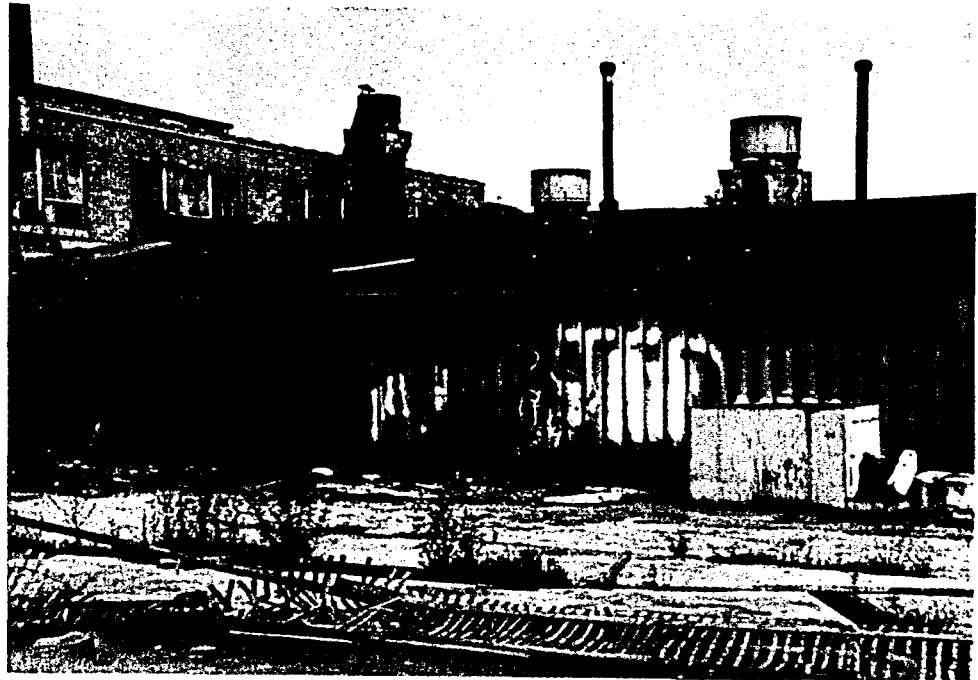
16 TRY CHEM
 SITE: 1333 W. PIERCE
 DATE: 09/24/87
 TIME: 10:00
 DIR: NE
 PHOTOGRAPHED BY:
R. COOKS
BUILDING INSPECTOR
 SAMPLE ID #: N/A

DESCRIPTION:
OUTDOOR STORAGE AREA - 1987.

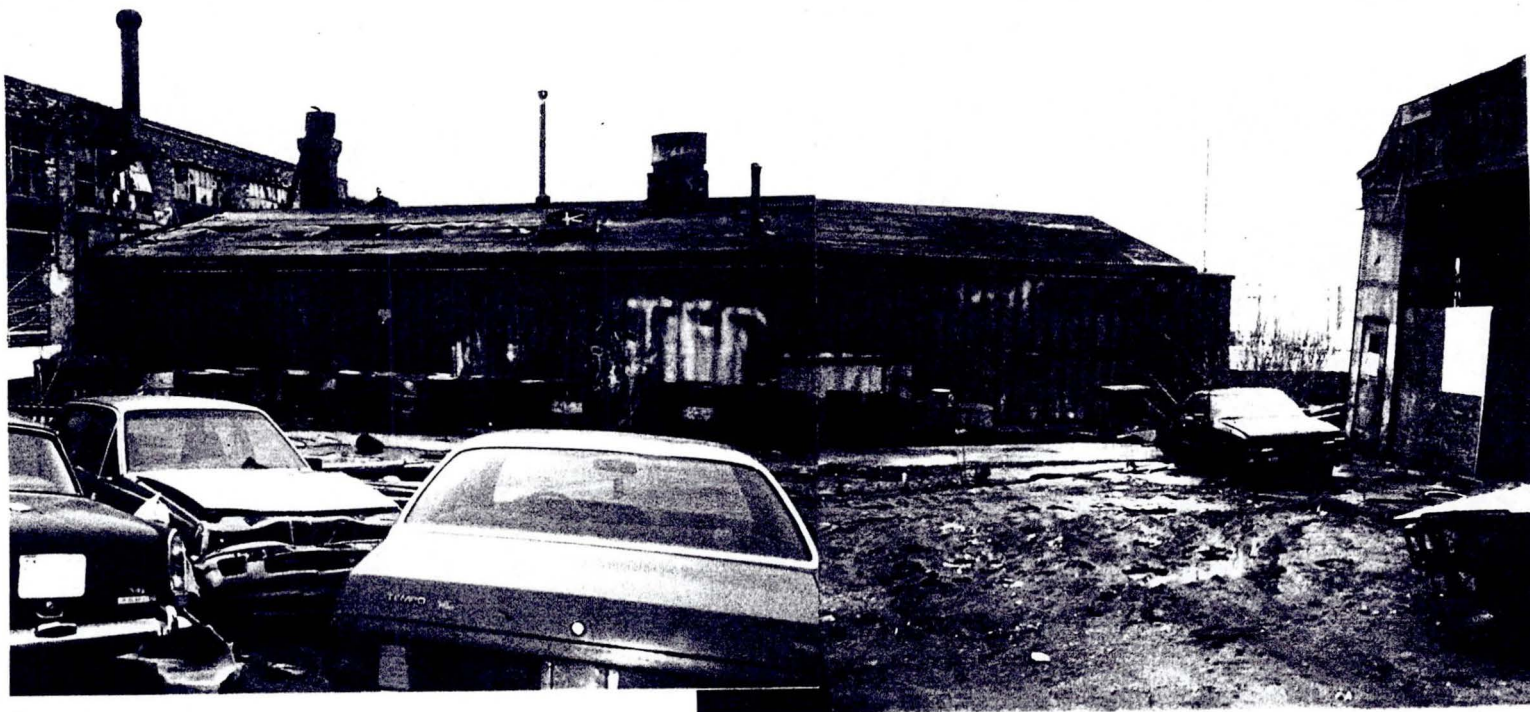
OUTDOOR STORAGE AREA + NITRIDING SHED.

~ 25 DRUMS + ABANDONED CARS PRESENT.

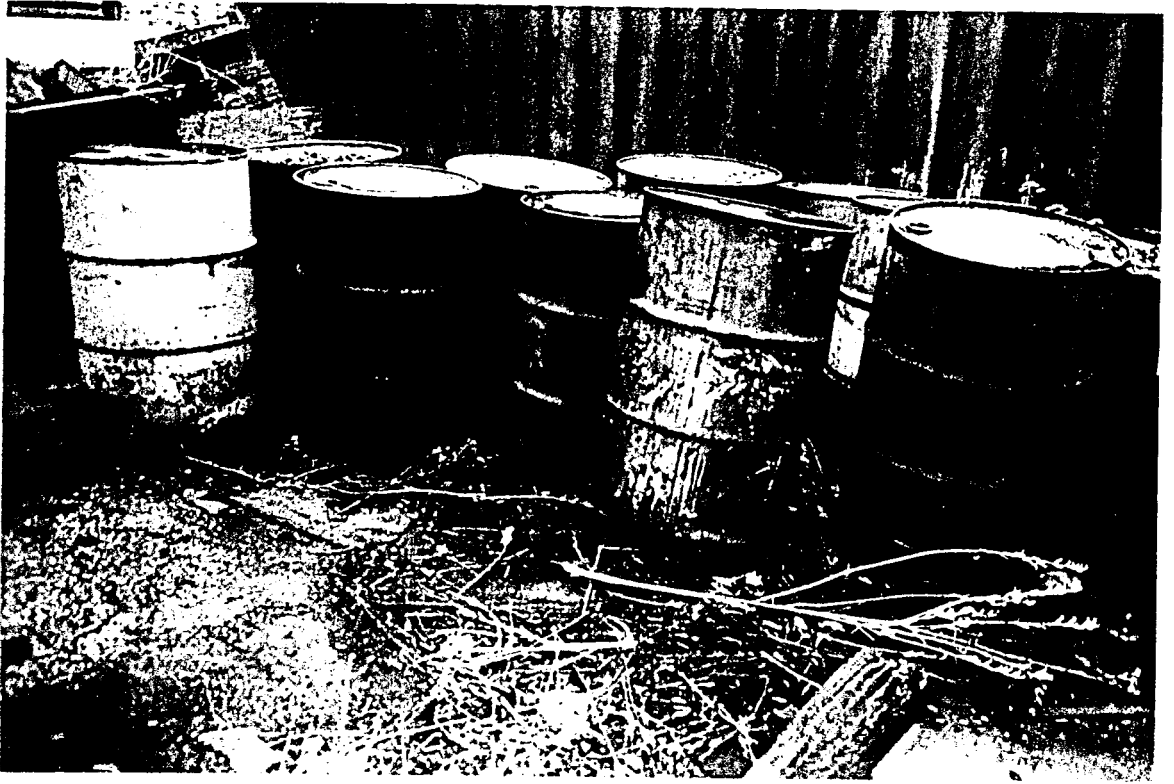
18 TRY CHEM
SITE: 1333 W. PIERCE

CLOSE UP OF DRUMS + STAINING ON GROUND IN
OUTDOOR STORAGE AREA.

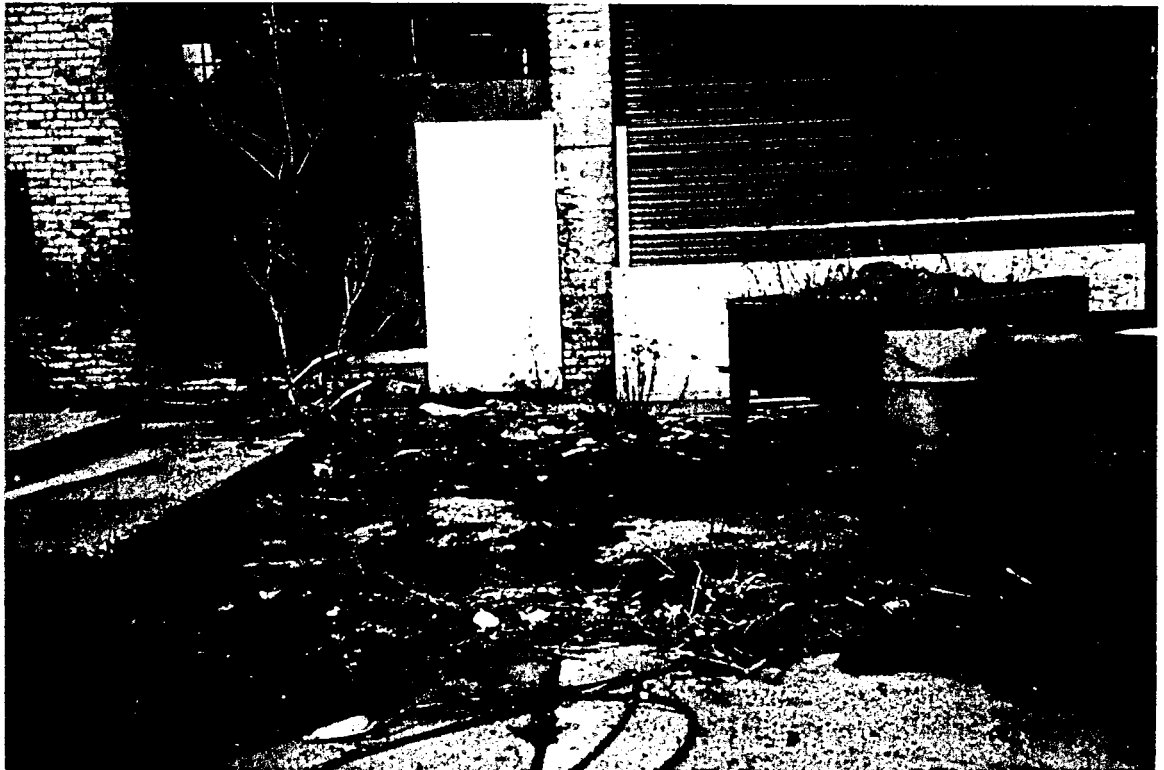
19 TRY CHEM
SITE: 1333 W. PIERCE

The driveway leading from National Avenue is sloped down to the site. The outdoor storage area (the upper lot) and access road from National Avenue, constructed of concrete, was damaged, oil stained and covered with patches of soil and debris washed down the steep driveway presumably by surface runoff. Sand, litter and debris had accumulated at the bottom of the slope due to surface water runoff (see Photo 17). Trenches were used to direct surface water runoff around the retaining wall. A view of the inside of the building from a hole in the wall showed processing vats filled with liquids (presumably rain water) and metal and processing debris on the floor (Photos 13, 14 &15).

DRIVEWAY FROM NATIONAL AVENUE TO OUTDOOR STORAGE
AREA + NITRIDING SHED (ON RIGHT).

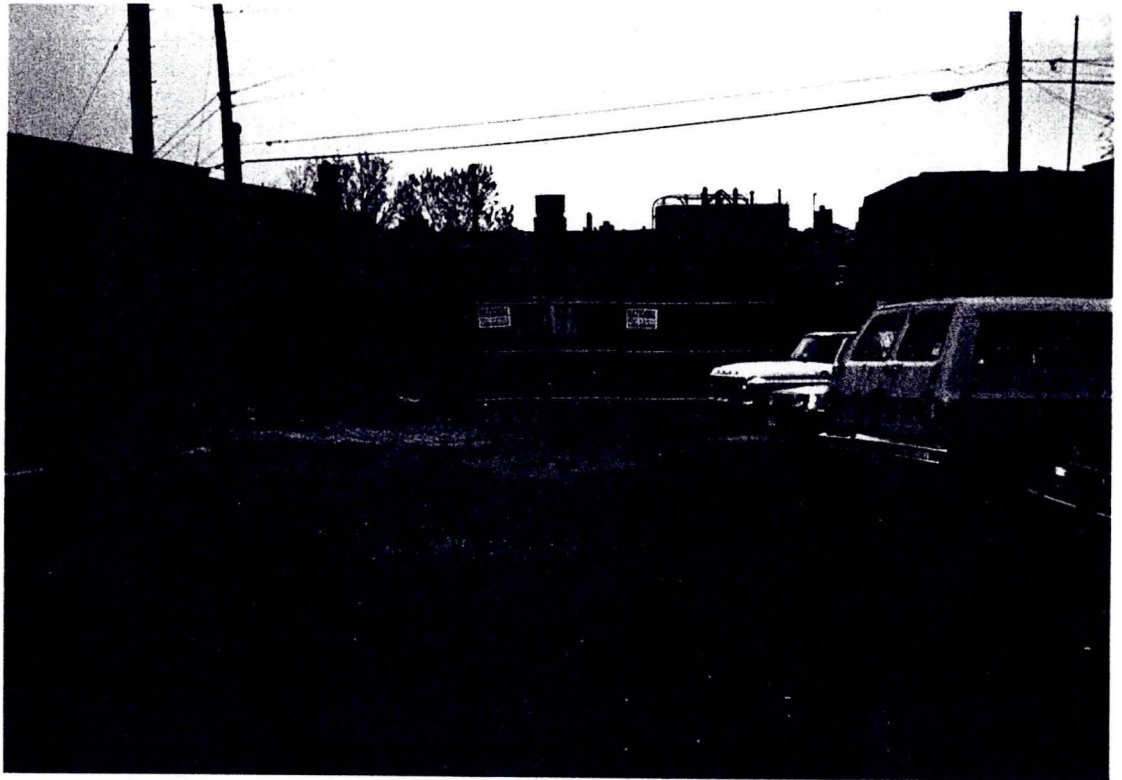
21 TRY CHEM
SITE: 1333 W. PIERCE

Chemicals released through the northeast and northwest corners of the building, which etched the concrete sidewalk and gutter, drained into the stormsewer and discharged to the Burnham Canal and ultimately to the Menomonee River (Figure 1 & 11). MHD and WDNR files document the leaking of chemicals through the building foundation beginning in 1983 and continuing intermittently until fall 1984. Samples of the leaking liquids were analyzed and found to contain chromium, nitrates, zinc, phosphate, fluoride, lead, cyanide, cadmium, and hydrochloric acid with pH ranging from 0.3 - 10.0. The types of chemicals and their concentrations detected in the liquids sampled varied with each sample, ranging from .01 - 10,000 parts per million (ppm) (Appendix M).

DISCHARGE FROM BUILDING ENTER-
ING STORM SEWER ON W. PIERCE.

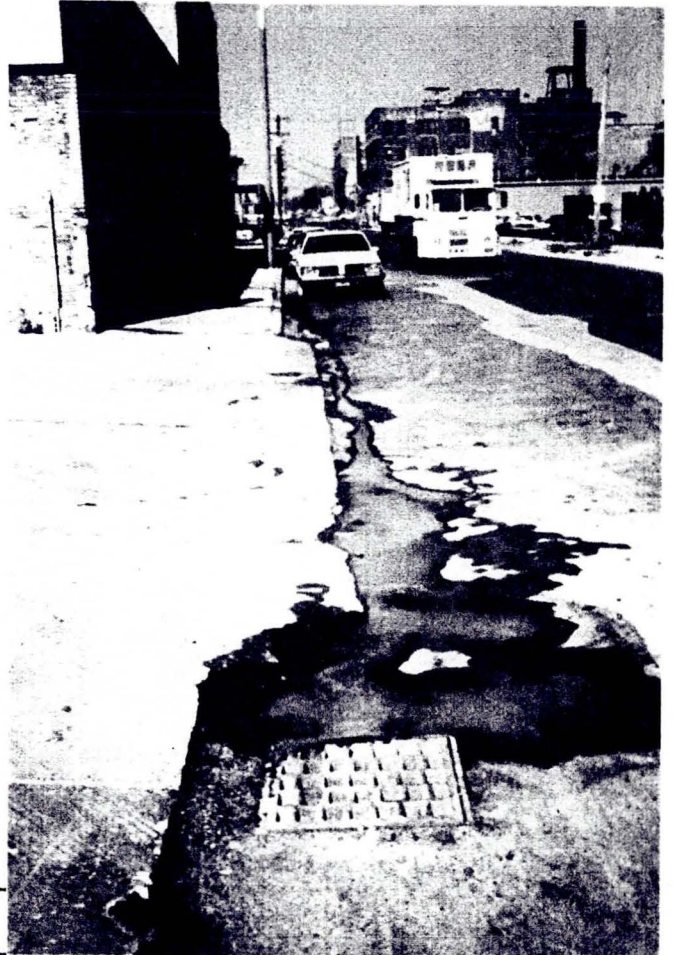
22 TRY CHEM
SITE: 1333 W. PIERCE

DISCHARGE OF LIQUIDS FROM BUILDING ACROSS
SIDEWALK TO GUTTER

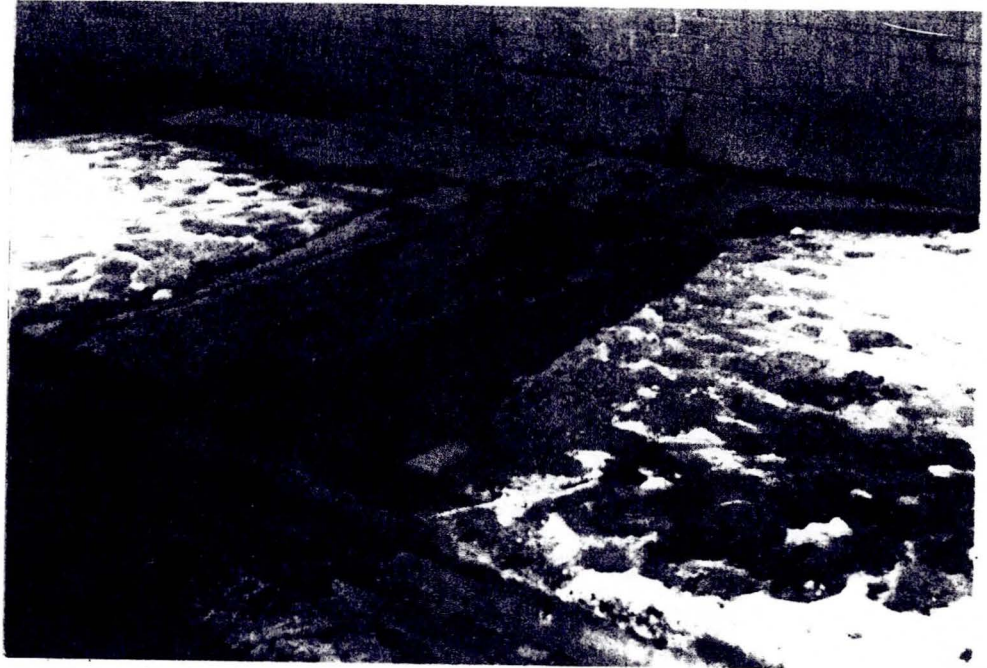
23 TRY CHEM
SITE: 1333 W. PIERCE

DAMAGED SIDEWALK + GUTTER
FROM BUILDING DISCHARGE.

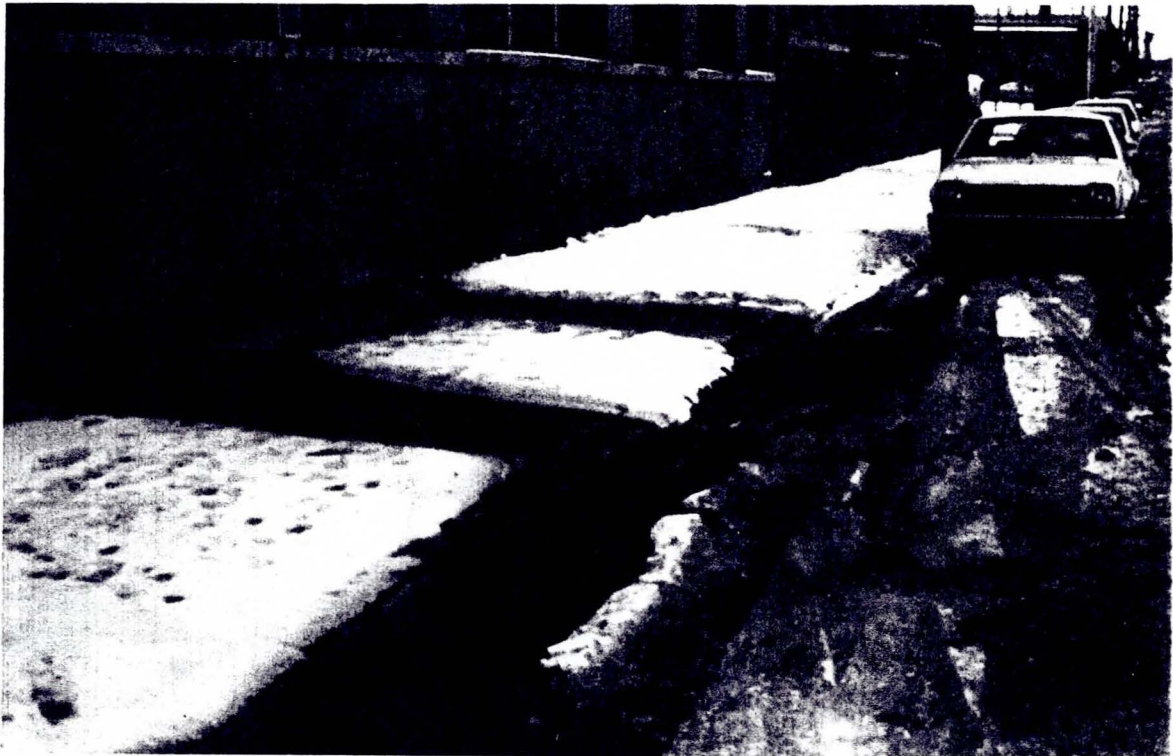
24 TRY CHEM
 SITE: 1333 W. PIERCE
 DATE: 1983-84?
 TIME: —
 DIR: SW
 PHOTOGRAPHED BY:
V. PAPPAS
 SAMPLE ID #: N/A
 DESCRIPTION:

DISCHARGE FROM BUILDING FLOWING ACROSS SIDEWALK
INTO GUTTER.

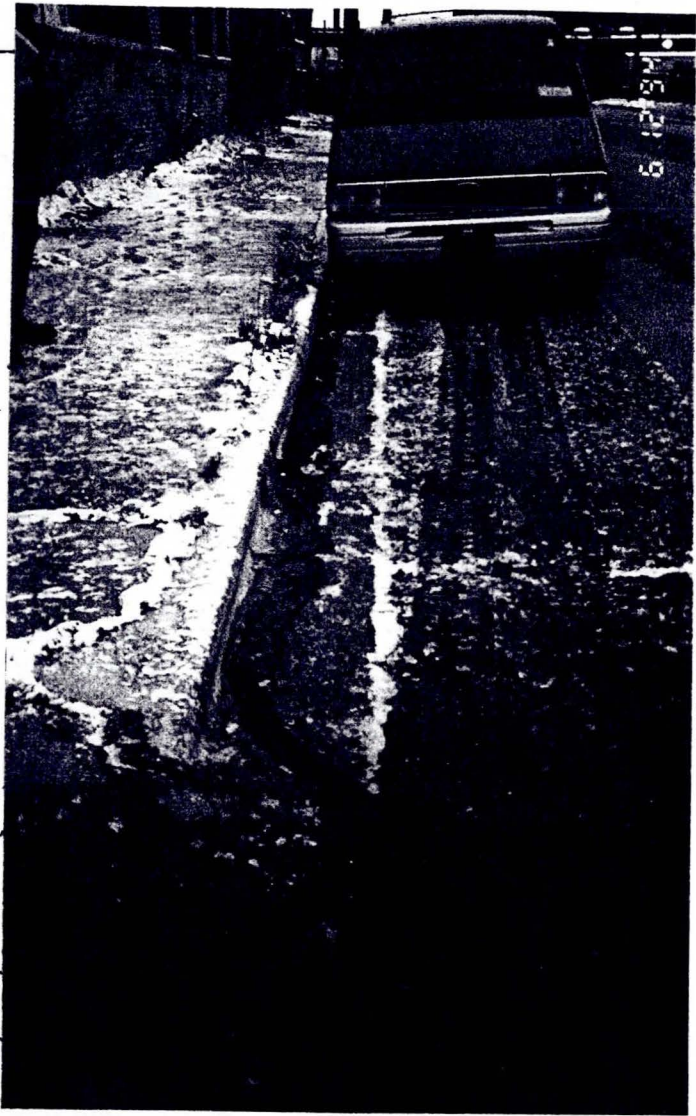
25 TRY CHEM
 SITE: 1333 W. PIERCE
 DATE: 12/06/94
 TIME: ~ 15:00
 DIR: W
 PHOTOGRAPHED BY:
A. PARKINSON
 SAMPLE ID #: N/A

DESCRIPTION:
ETCHED GUTTER ON W. PIERCE
STREET IN FRONT OF TRY CHEM
