SEYMOUR ENVIRONMENTAL SERVICES, INC.

**Re: Investigation Workplan
Miller's Liquor Property
2401 University Avenue
Madison, Wisconsin**

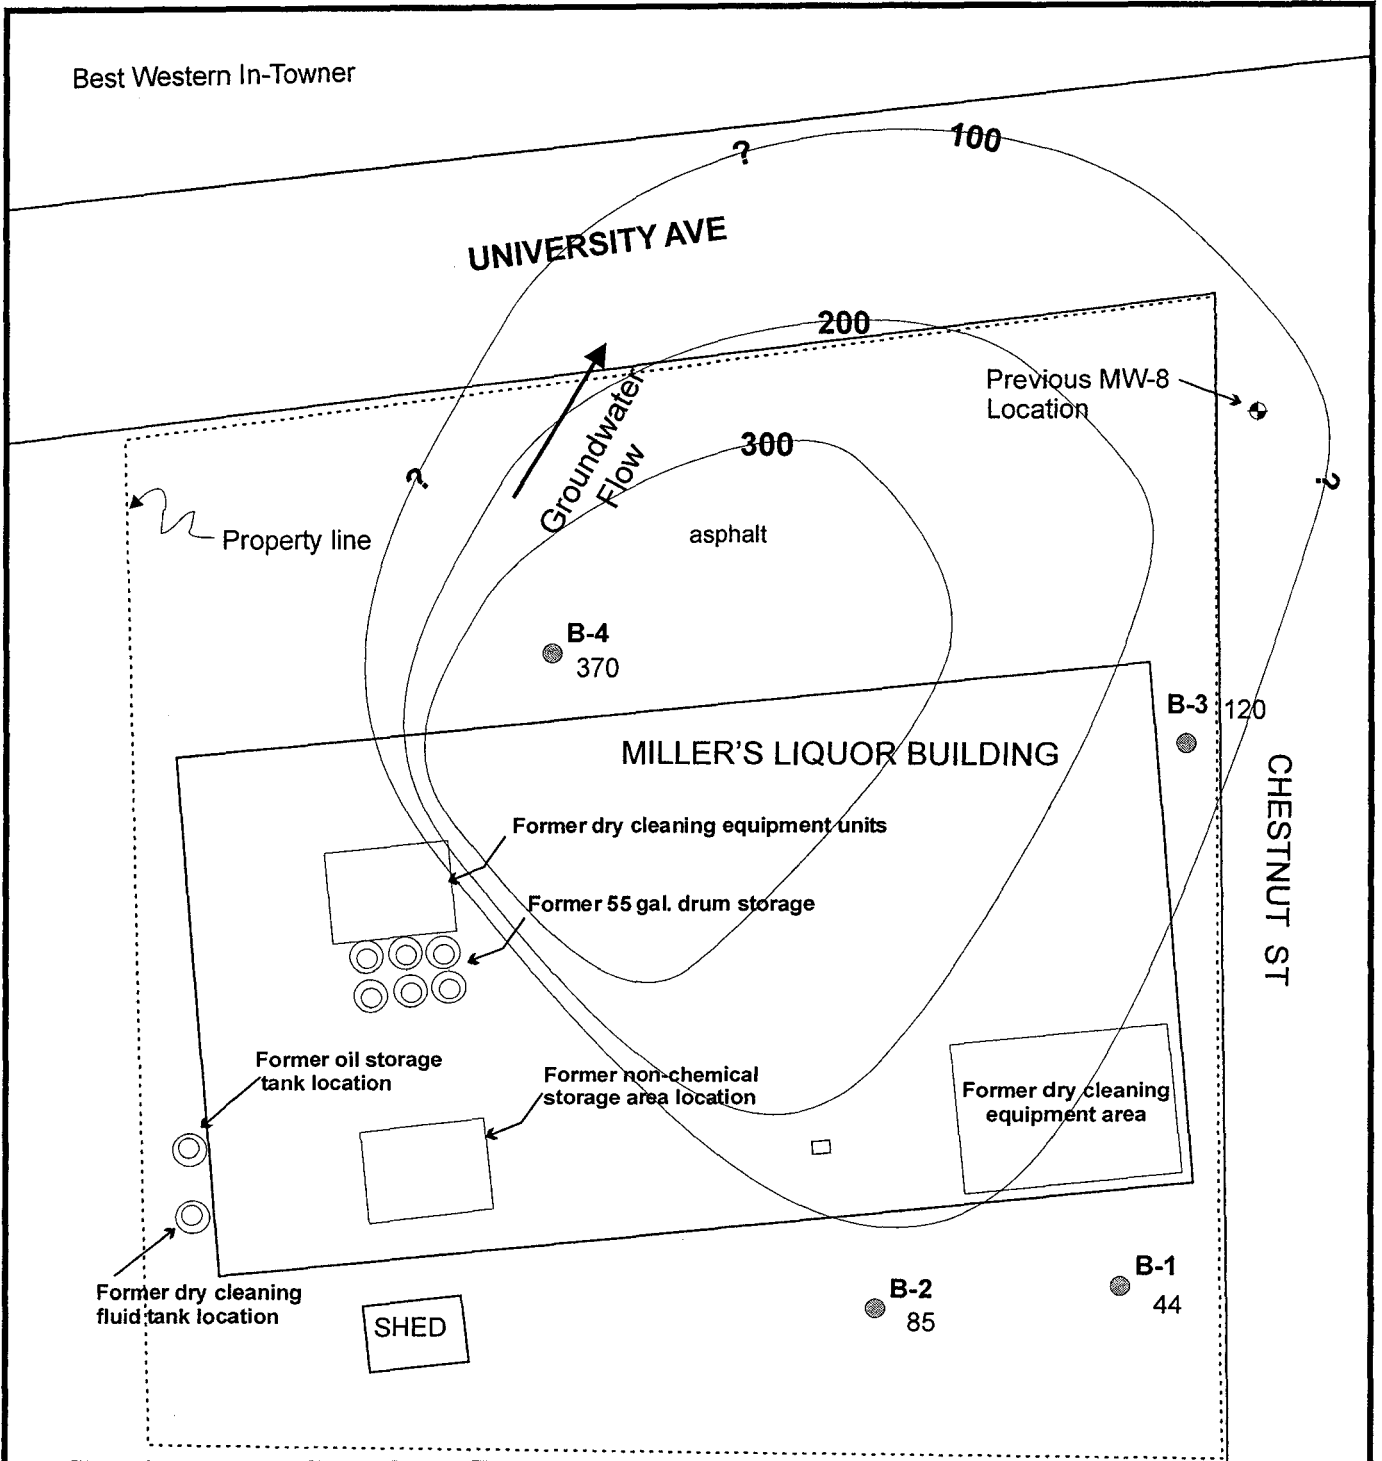
FIGURE
3

Groundwater analytical data indicate that the property is a source of contaminants related to dry-cleaning operations. Perchloroethene was present in all of the groundwater samples above the NR140 Enforcement Standard. Trichloroethene also was present in all of the groundwater samples collected. The concentrations exceeded the NR140 PAL. Generally, PCE levels in the groundwater flowing onto the site (from the south) are relatively low. PCE levels increased in groundwater samples collected along the north side of the building. The distribution of PCE in groundwater is shown on Figure 3.

PCE in Groundwater (ug/l)
 Miller's Liquor Property
 2401 University Avenue
 Madison, Wisconsin

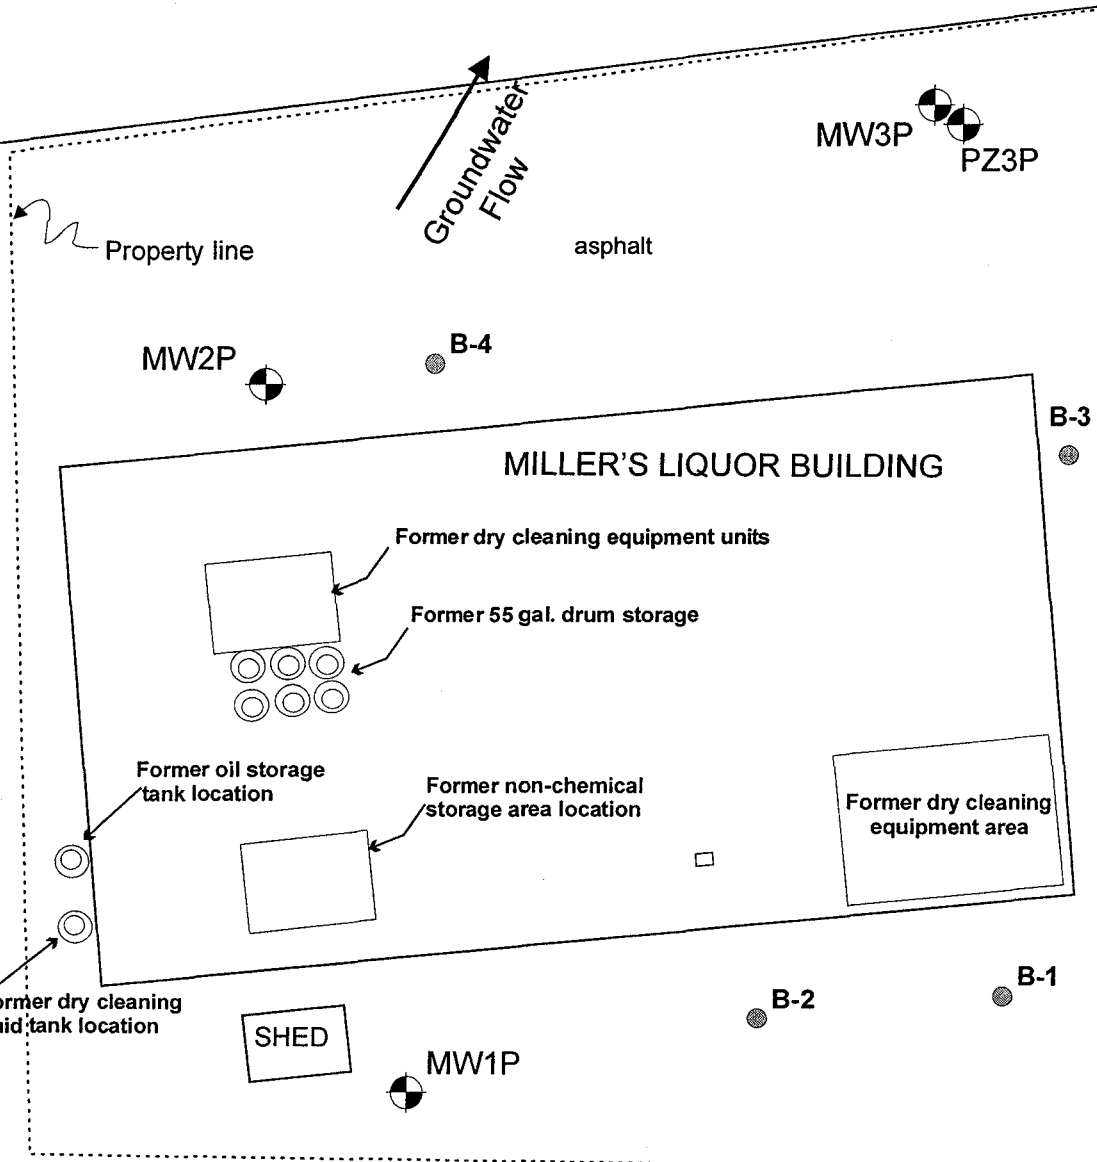
FIGURE
 4

PROPOSED MONITORING WELL LOCATIONS
 Miller's Liquor Property
 2401 University Avenue
 Madison, Wisconsin

- 2) Install three water-table monitoring wells and one piezometer to evaluate the groundwater flow (horizontal and vertical), and contaminant distribution at the site (Figure 4). The monitoring wells will be set so the 10-foot screens intersect the water table - approximately 30 feet deep. The piezometers will be set so that there is 10 feet of separation between the bottom of the monitoring well screen and the top of the piezometers screen.
