**Remediation & Redevelopment  
 Continuing Obligation Review**

**BRRTS ID No. 02-52-472623**

Site Name: Village Clean

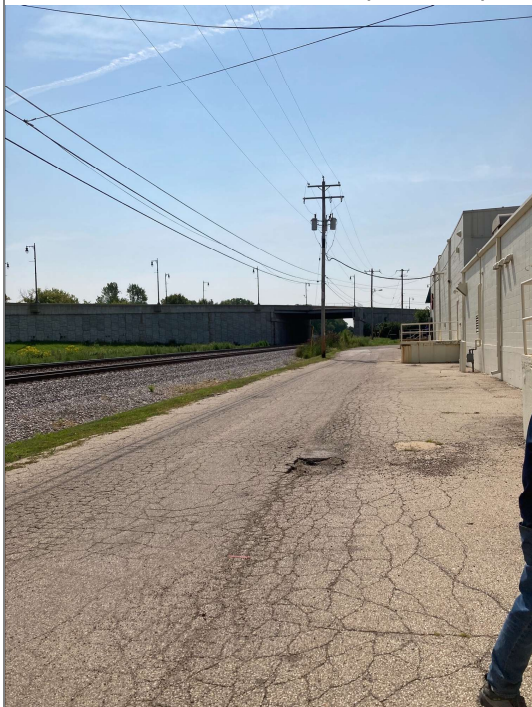
The soil cap of asphalt needs repairs. The building floor is still intact. The property manager said that they are repaving everything outside soon. I notified them that they should request permission from the DNR to replace the cap.

- Yes
- No – Describe what's not in compliance and the reasons for noncompliance:  
The asphalt cap needs repairs.

Title: Village Clean - View of Alley Soil Cap, soil cap needs repair

- No
- Yes – Summarize the actions needed to return the site to compliance and identify who is responsible:  
Asphalt cap needs repairs. The property manager informed me that repaving would happen soon as they were already planning on it.

- No
- Yes:  contact or enforcement to return site to compliance with continuing obligation
- updating BRRTS for the CO PDF (adding or modifying a packet)
- reopen site (add ACs 186, 12 and 13)
- other: Owner should request permission to repave the cap. Notify DNR w/ photographs of new cap.

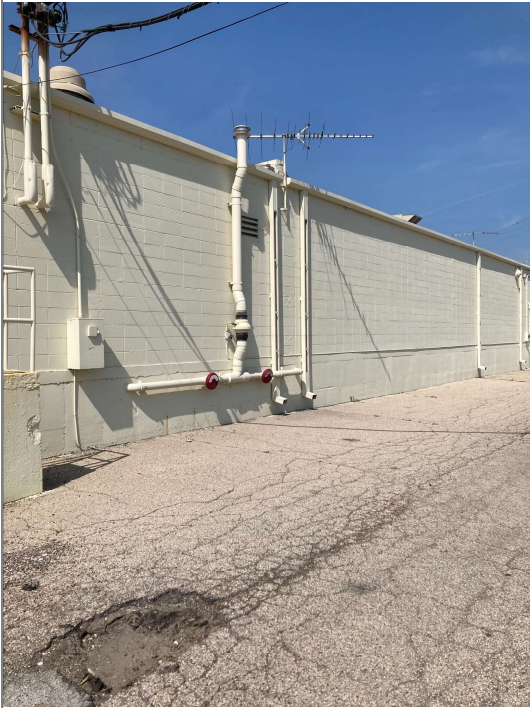
The VMS is operating successfully. It was recommended to replace the screen on the outlet pipe with something that is up to today's standard, and that the fan should be replaced as needed.

Title: Village Clean - View of VMS and Soil Cap, VMS operating successfully, soil cap needs repair

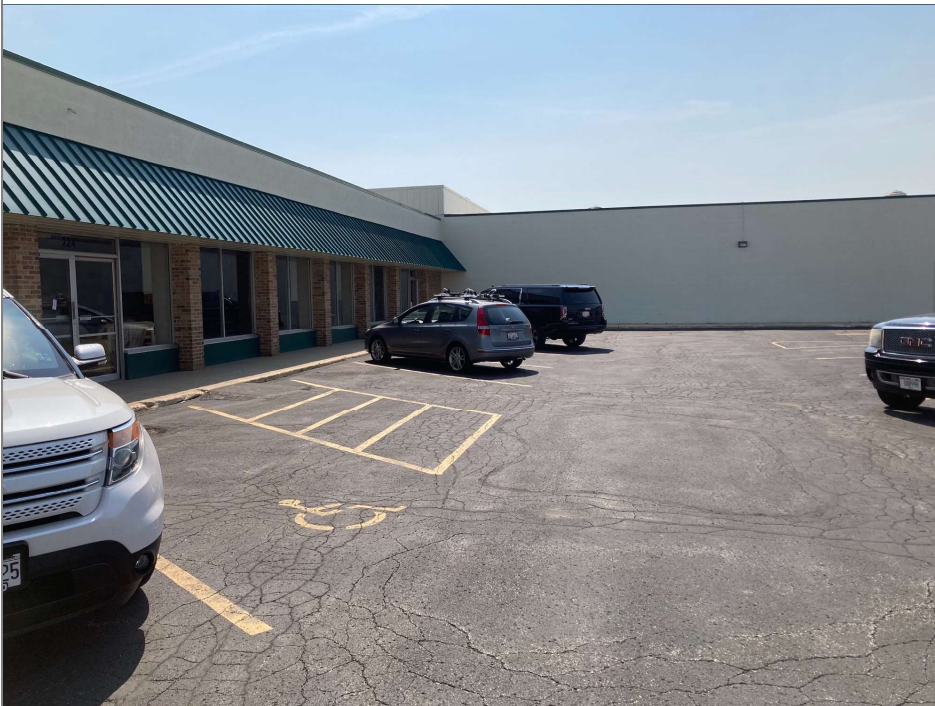
Title: Village Clean - View of Parking Lot Soil Cap, soil cap needs repair

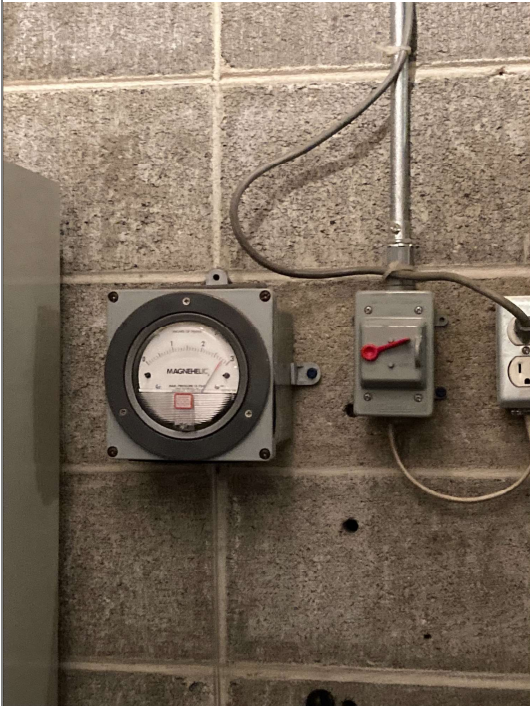
Title: Village Clean - VMS Meter, operating successfully

A pressure monitor is present, operating, and is accessible.  Y  N (active systems only, e.g., U-Tube manometer, cylinder, or gauge.) Pressure Reading: 2.7 inch h2o

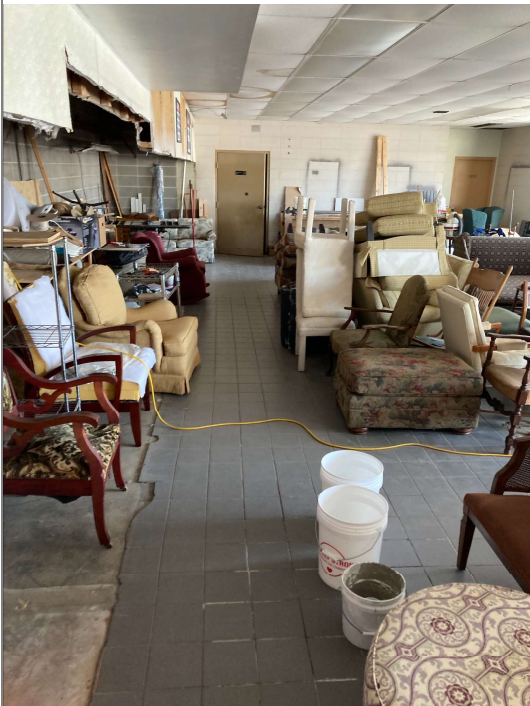
Title: Village Clean - View of Indoor Soil Cap building floor slab and tiles, no repairs needed

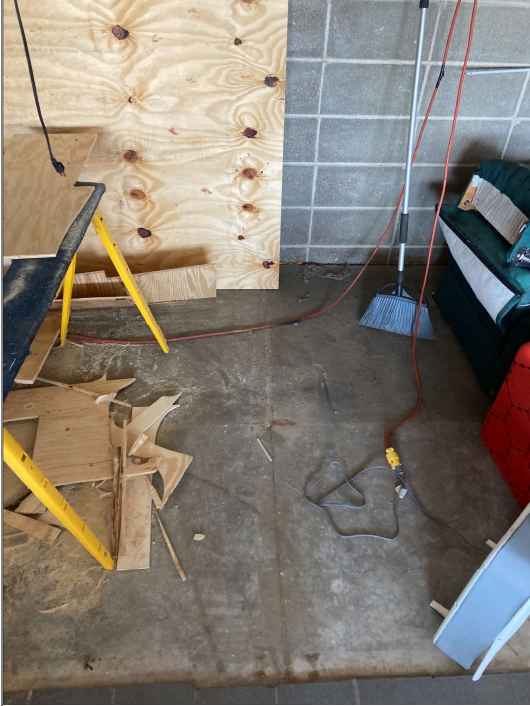
Title: Village Clean - View of Indoor Soil Cap building floor slab, no repairs needed
