Supplemental Checklist for Vapor Mitigation Continuing Obligations

BRRTS Site Name Village Clean Activity Number 02-52-472623

System Address(es) 224 S Pine Street Current Site Use(s): Upholstery

Inspected By: R. Hoverman/ H. Hulsey Date 2023/08/21

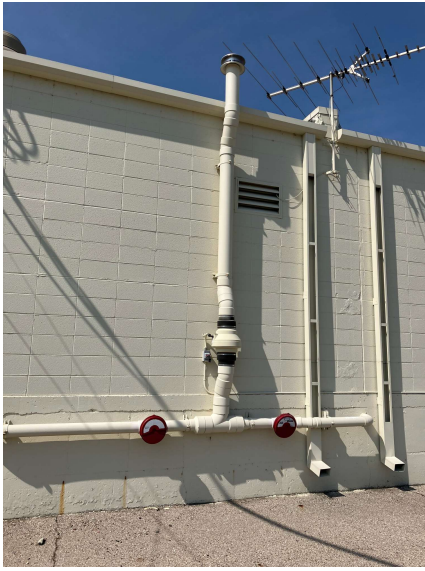
Notes: Cap should be removed from discharge.

Description: Fan, valves, and discharge

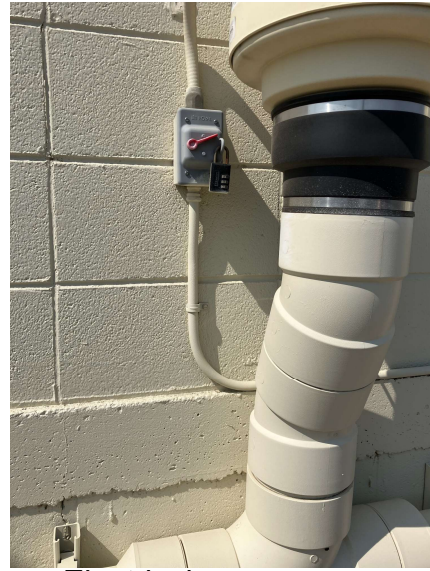
Description: Electrical

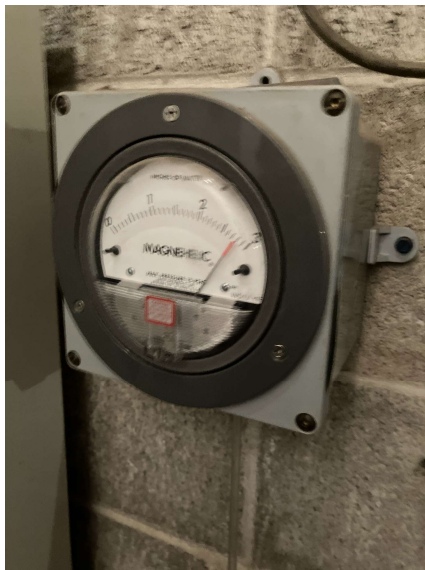
A pressure monitor is present, operating, and is accessible. Y N (active systems only, e.g., U-Tube manometer, cylinder, or gauge.) Pressure Reading: 2.7 inch h2o

Description: Magnahelic
