September 13, 2023

Subject: Cap Maintenance Inspection - Repair/Replacement Required
Village Clean, 180 S. Pine St., Burlington, WI
BRRTS #02-52-472623 FID #252202170

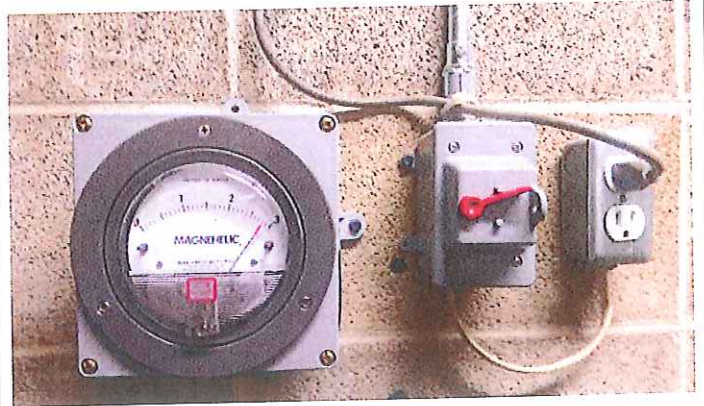
2. View of the Magnehelic pressure gage mounted behind the dry cleaning machine. The pressure gage is reading 2.5 inches of water.

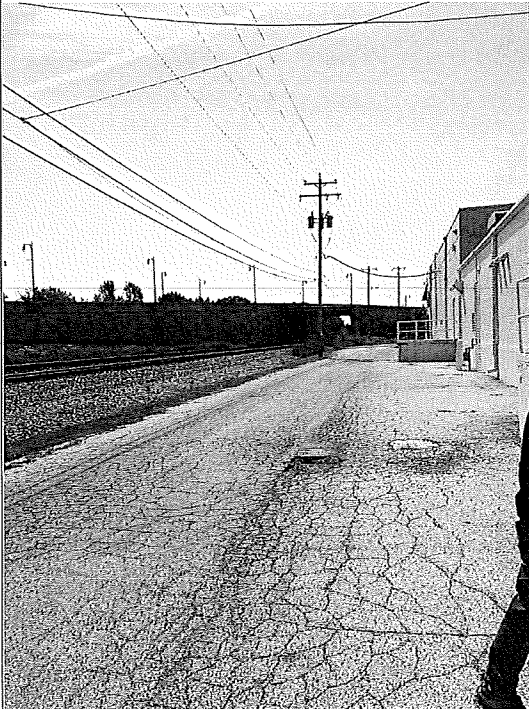
Based on conditions noted during the DNR's August 21, 2023 inspection, the asphalt cap at your property needs repairs or replacement to be in compliance with the site closure criteria. The asphalt cap consists of the alleyway east of the building and parking area west of the building. The DNR's inspection noted fatigue cracks and moderate to severe potholes in the asphalt that must be repaired, if possible, or replaced. The inspection report with photographs is attached for your review.

Title: Village Clean - View of Alley Soil Cap, soil cap needs repair

You are required to complete the needed asphalt repair/replacement within one year of the date of this letter. Within one month, **by October 13, 2023**, provide a written response with an expected timeline to repair or replace the asphalt pavement. When completed, we will need to perform a follow-up inspection of the cap to confirm compliance with the closure criteria. Let me know when the repairs have been completed to set-up another inspection date and time.

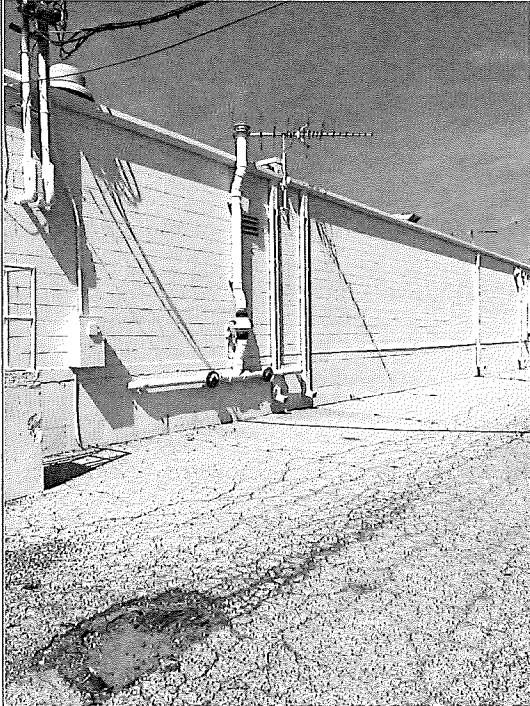
Title: Village Clean - View of VMS and Soil Cap, VMS operating successfully, soil cap needs repair

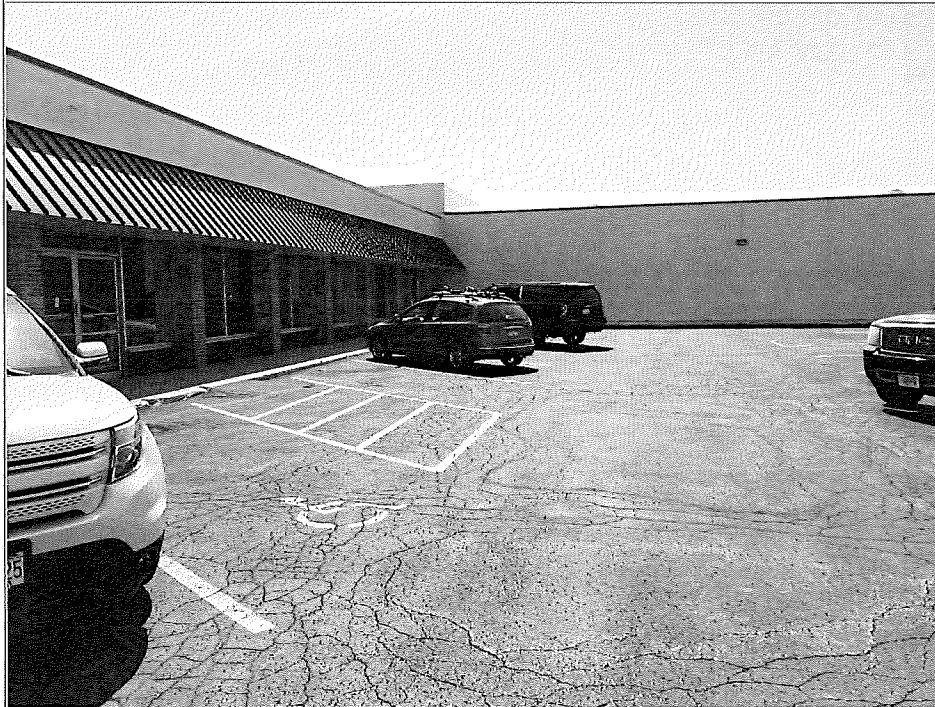
Title: Village Clean - View of Parking Lot Soil Cap, soil cap needs repair

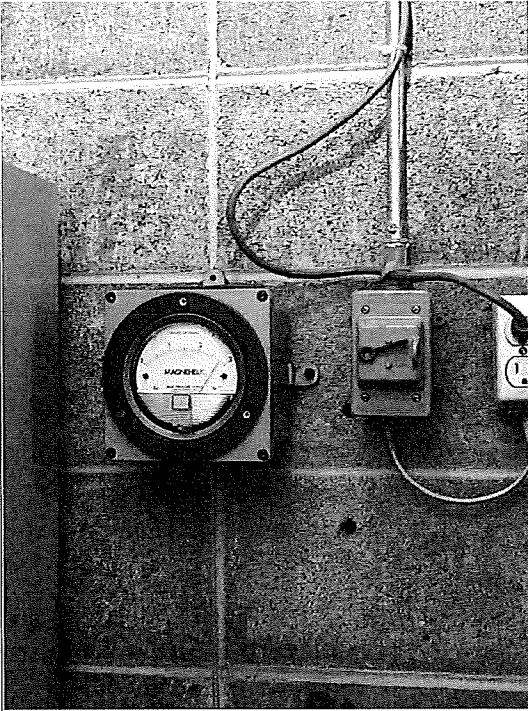
Title: Village Clean - VMS Meter, operating successfully

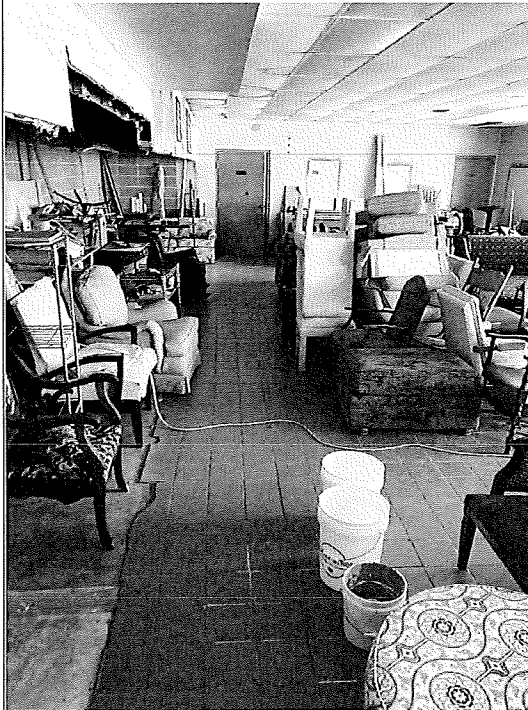
Title: Village Clean - View of Indoor Soil Cap building floor slab and tiles, no repairs needed

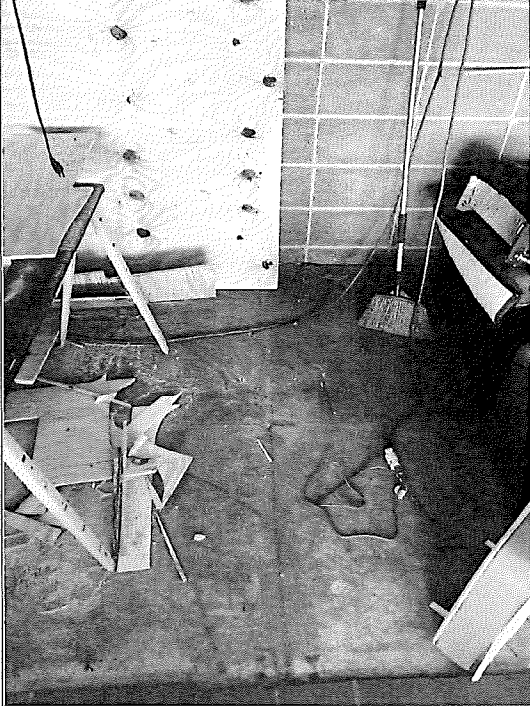
Title: Village Clean - View of Indoor Soil Cap building floor slab, no repairs needed
