SUBJECT: Spill of Approximately 151 Gallons of Aviation Fuel at the
Chippewa Valley Regional Airport

Ayres Associates was retained by the Chippewa Valley Regional Airport, Eau Claire, Wisconsin, to conduct an investigation into an aviation gasoline spill located at the airport. Investigation activities were conducted on August 31 and September 1, 1992. The purpose of this report is to document the technical findings of the investigation and to present recommendations regarding the site status.

SPILL INVESTIGATION
CHIPPEWA VALLEY
REGIONAL AIRPORT
EAU CLAIRE, WISCONSIN

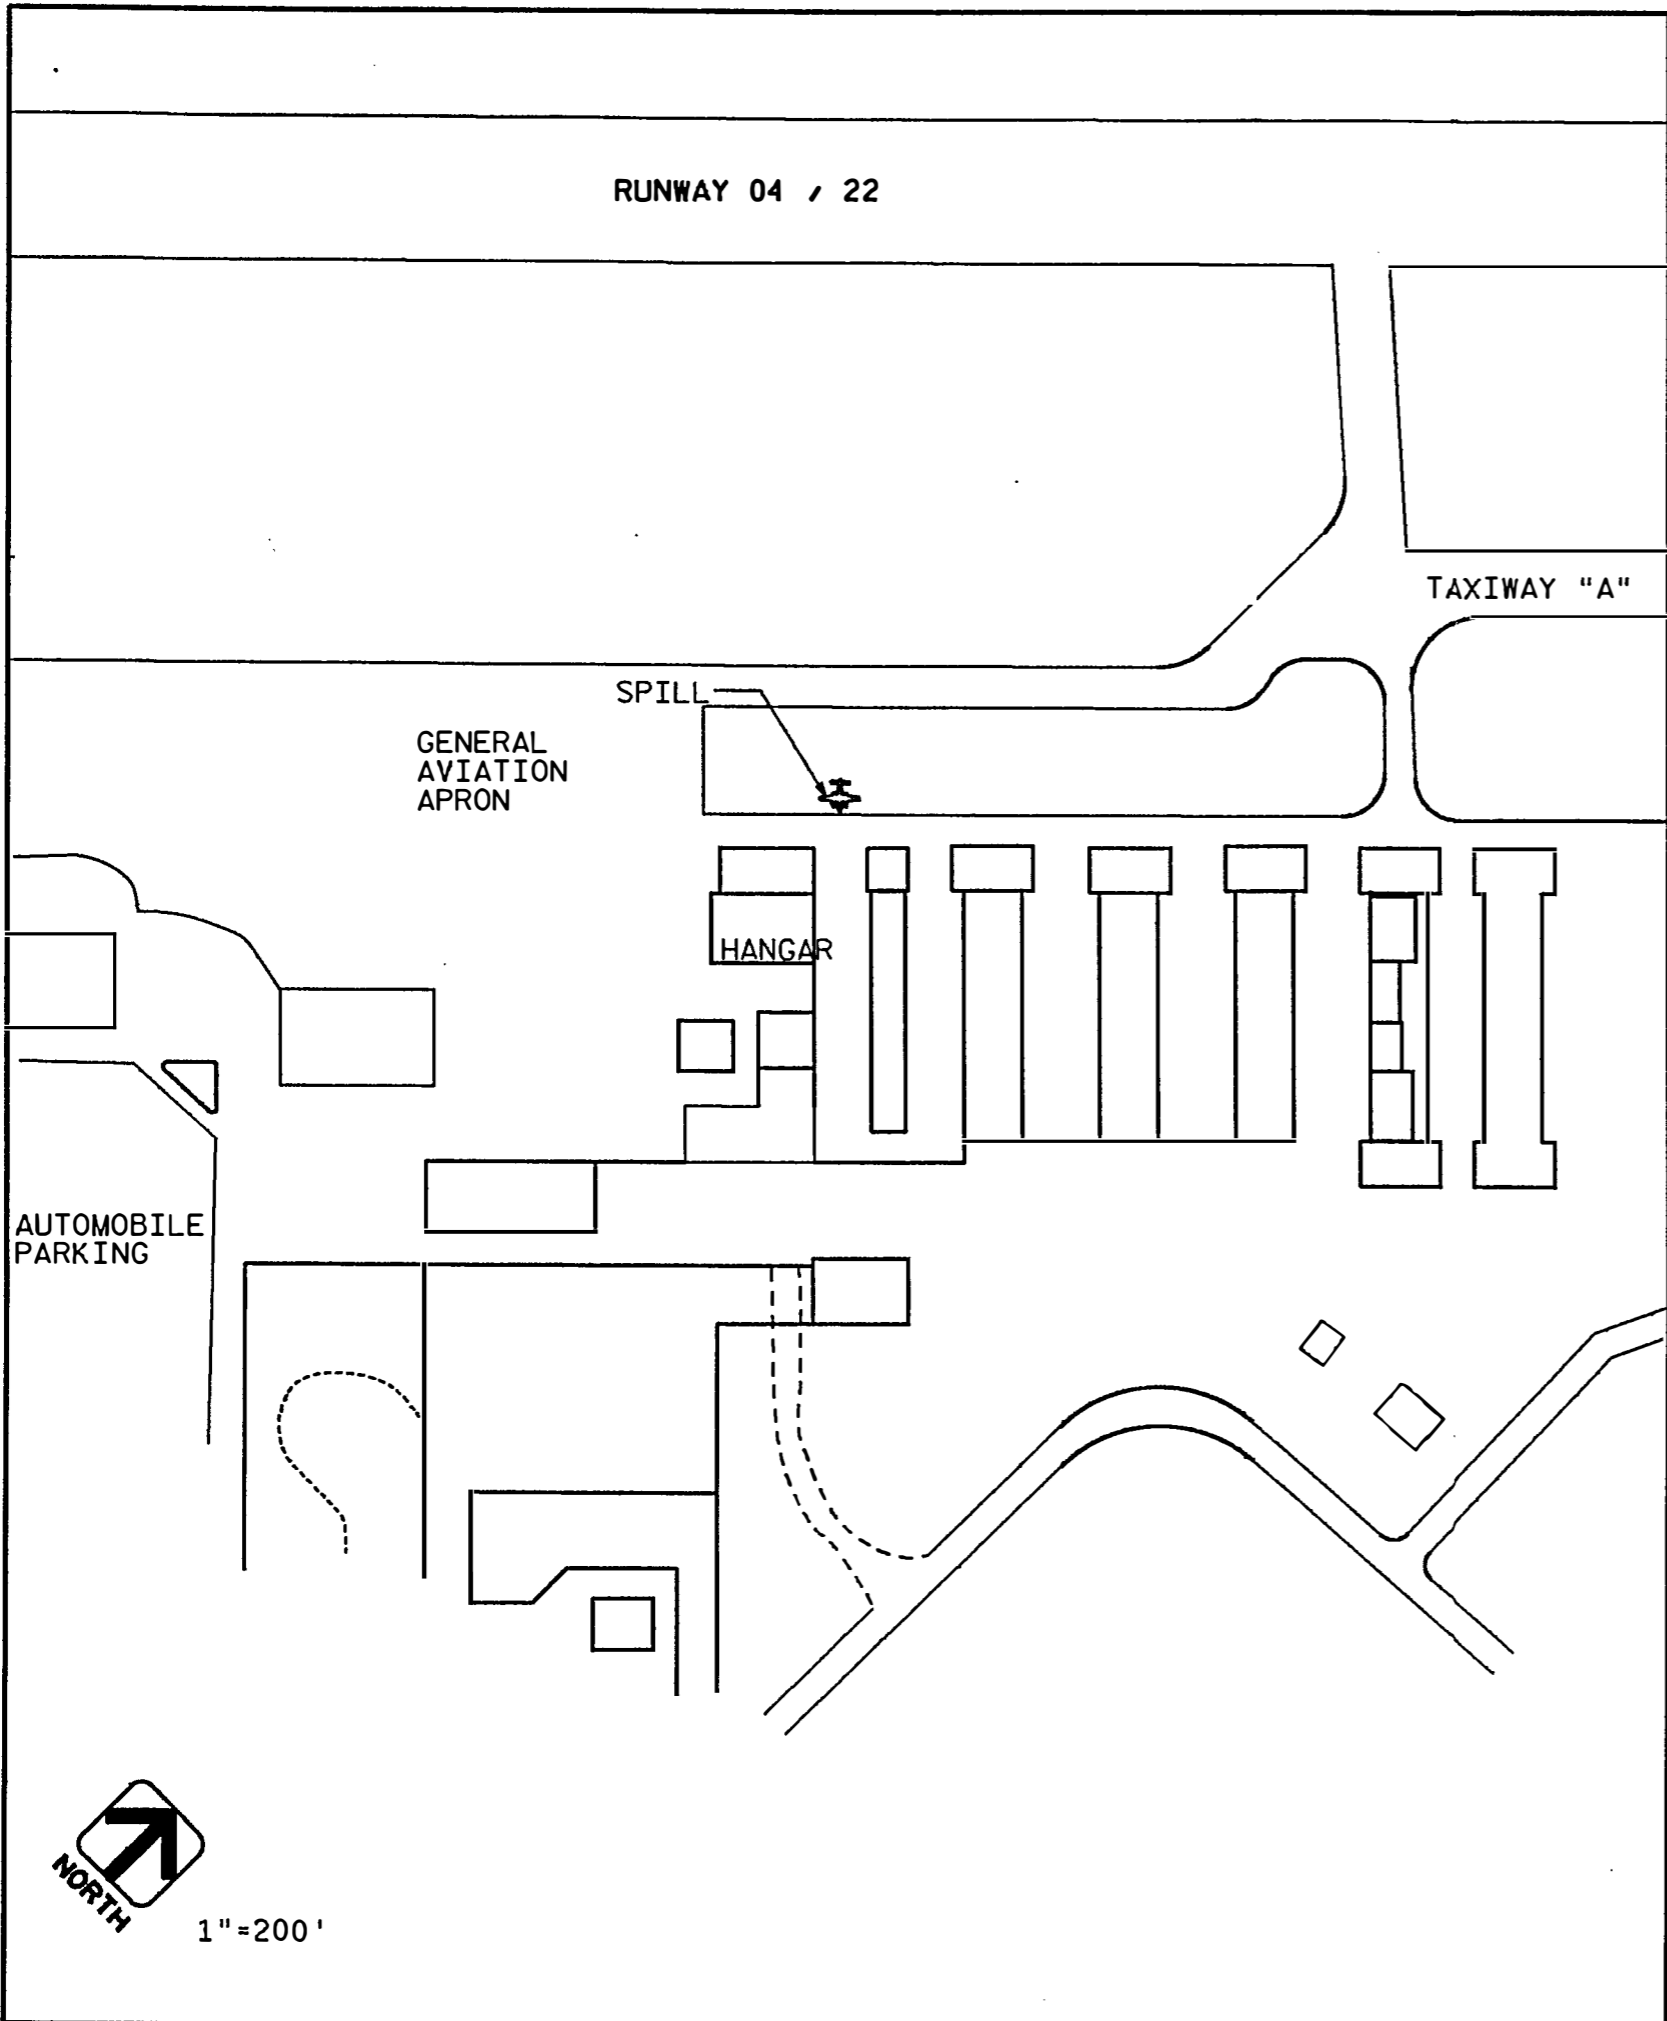
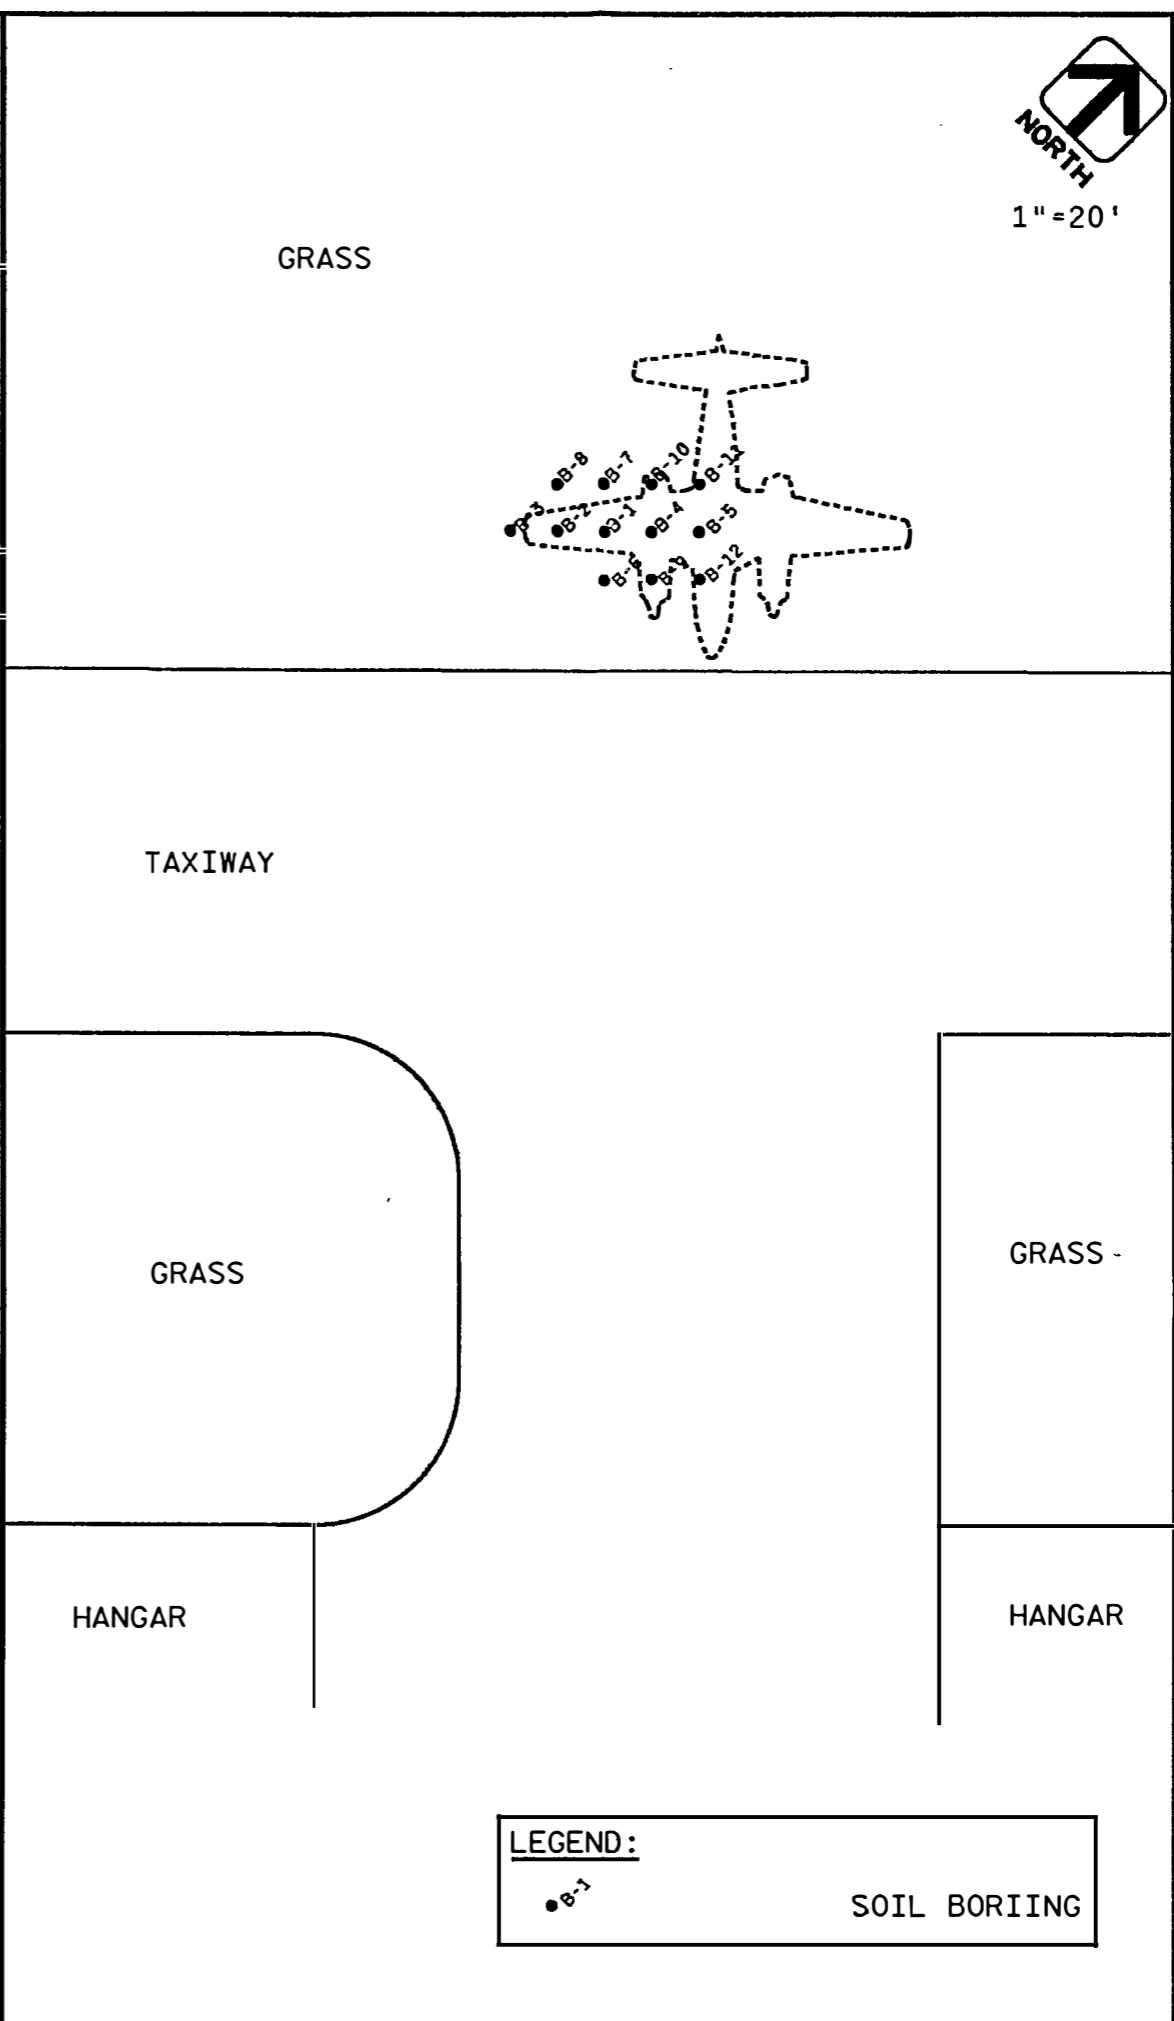
SITE PLAN	
DWG. BY: MLE <i>MLE</i> CDD. BY: JOH <i>JOH</i> DATE: OCT 1992	
SPILL INVESTIGATION CHIPPEWA VALLEY REGIONAL AIRPORT EAU CLAIRE, WISCONSIN	
FIGURE 2

Figure 2, "Site Plan", shows the spill location relative to the source (airplane), boring locations, taxiways, and hangars. The site is located within the Eau Claire corporate limits, which is served by a municipal sewer and water system.

An employee of Gibson Aviation assisted in locating the position of the airplane within the cordoned area. A panoramic view of the area is included in Appendix A, "Site Photographs". Figure 2, shows the plane's location superimposed over the boring locations.

Initially, borings B-1 through B-12 were installed to a depth of 1 foot, at a 5 foot horizontal grid pattern. Following sample collection and field screening, the borings were extended to a depth of approximately 5 feet, except B-2. A layer of gravel with cobbles was encountered in B-2 at a depth of approximately 3 feet, preventing installation of hand auger boring beyond the 3 foot depth.

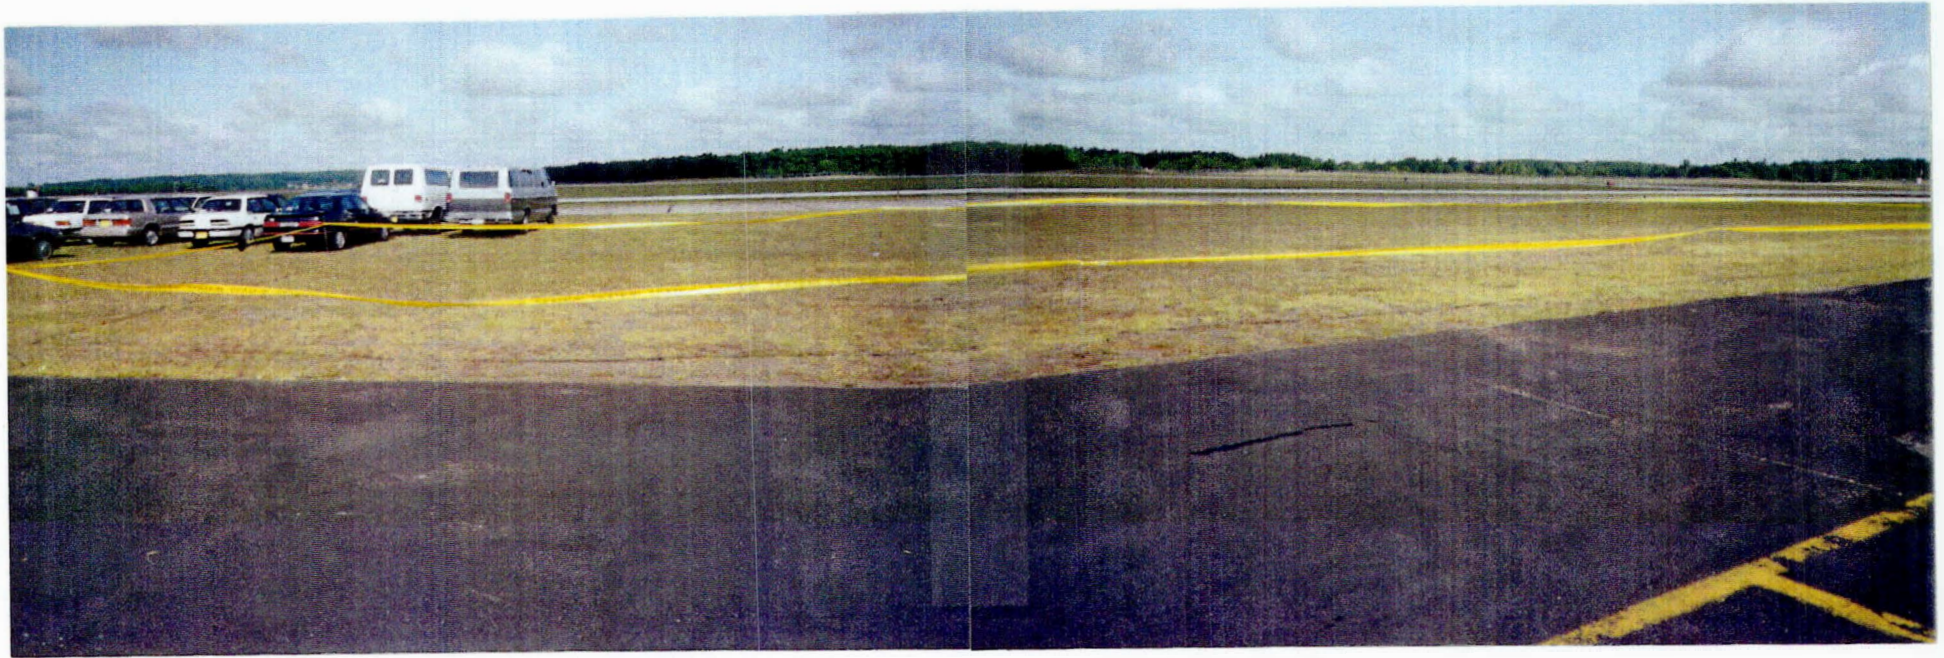
No odor or staining was observed in any of the soil samples. Based on the hand auger borings, a brief description of the soil profile, a classification based on the Unified Soil Classification System, is defined as follows:

GRO at 0.58 and 0.12 ppm was reported in the soil samples submitted for laboratory quantitative analysis. No petroleum staining/odor was observed on the ground surface or in the hand auger borings. No PID field screenings exceeded 1.0 i.u.. Since no petroleum contamination was found to exceed the WDNR guideline of 10 ppm in soils, it is recommended that no further investigation or remediation take place at this site. Based on the weather conditions at the time of the spill, and the lack of contamination detected in the soil borings, it is presumed that the majority of the fuel evaporated.

Panoramic View of Spill Area, Looking Northwest
