## 1.0 INTRODUCTION

Central Wisconsin Engineers, Inc. (CWE) was retained by Crawford and Company Insurance Adjusters, Inc. (Crawford & Co.) of Wausau, Wisconsin, to conduct a site investigation to assess the environmental impacts of a diesel spill to the soil as a result of an accident with a semi-truck. Crawford & Company is the insurance adjuster for Great West Casualty who represents Konkol Feed and Grain, the company which owns the semi-truck.

The accident occurred on December 10, 1992 at approximately 6:30 am. Personnel from Konkol Feed and Grain estimate that approximately 100 gallons of diesel fuel were discharged as a result of the accident.

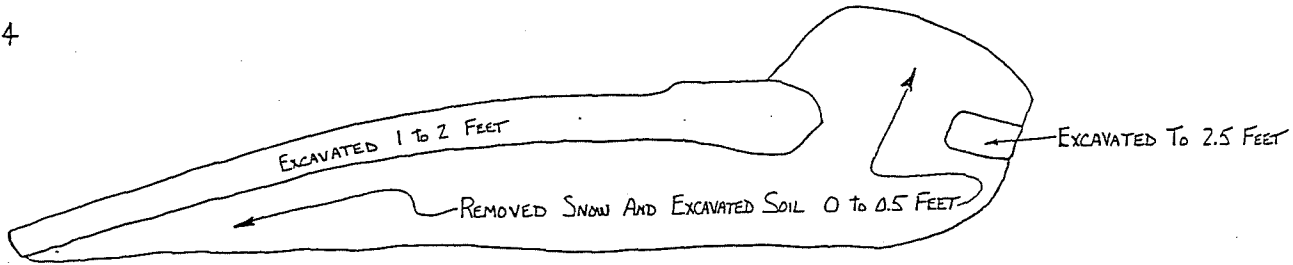
FIGURE 3  
SITE PLAN

A backhoe was used to remove the contaminated soil. Initially all snow and the top 6 inches of topsoil west of the skid and in the area where the vehicle rested was removed. It appeared diesel fuel was sprayed onto the snow as the truck skidded. Soils were screened with a field instrument to identify areas of contamination. Field screening identified that diesel fuel was spilled directly under the truck as it skidded. The area of

the skid was excavated from 1.0 to 1.5 feet in depth. The area under the tractor required excavation to 2.0 feet.

It was reported that after the vehicle came to rest, diesel fuel leaked into the trailer. This was confirmed, as field screening and soil staining identified contaminated soil at the back end of the trailer. When the vehicle came to rest, the trailer sloped towards the back of trailer. The diesel fuel apparently ran through the trailer and exited the back end into the soil. Excavation in this area was to 2.5 feet to obtain clean samples.

The excavation was backfilled with clean fill and covered with topsoil. See Figure 3 for a Site Plan.

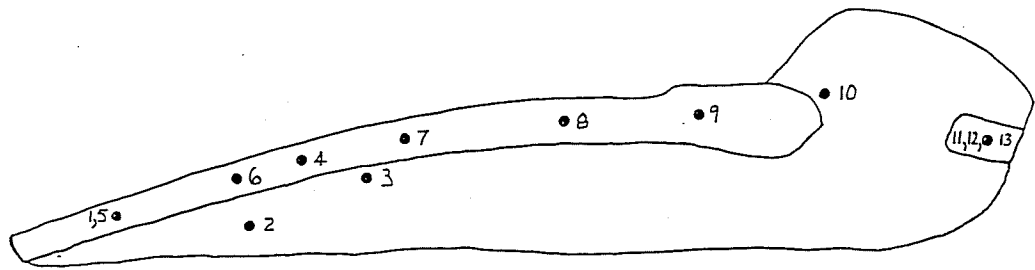
FIGURE 4  
 FIELD SAMPLES

**Table 1**  
**Field Sample Results**

<u>Sample #</u>	<u>Depth in Feet</u>	<u>ppm*</u>
1	0.5	34.3
2	0.5	2.8
3	0.5	2.2
4	0.5	3.5
5	1.5	2.2
6	1.0	1.2
7	1.0	1.2
8	1.0	0.9
9	2.0	0.9
10	0.5	0.9
11	0.5	141.8
12	2.0	5.3
13	2.5	0.9

Sample locations are indicated on Figure 4.

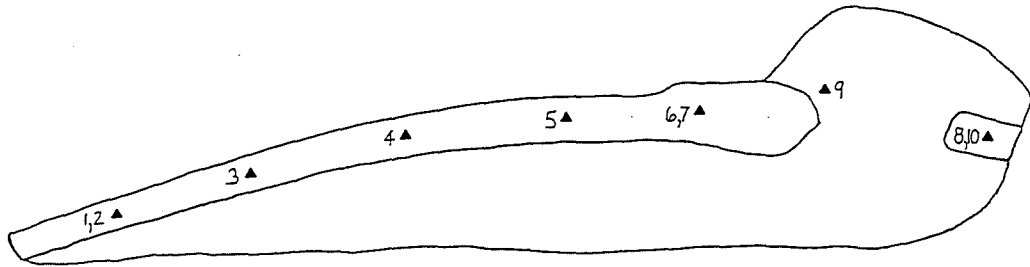
FIGURE 5  
LAB SAMPLES

<b><u>Parameter</u></b>	<b><u>1</u></b>	<b><u>2</u></b>	<b><u>3</u></b>	<b><u>4</u></b>	<b><u>5</u></b>	<b><u>6</u></b>	<b><u>7</u></b>	<b><u>8</u></b>	<b><u>9</u></b>	<b><u>10</u></b>
Benzene	ND	ND	ND	ND	ND	ND	ND	.034	ND	ND
Ethylbenzene	.042	ND	ND	ND	ND	ND	ND	1.960	ND	ND
Toluene	.009	ND	ND	ND	ND	ND	ND	1.720	ND	ND
o-Xylene	.176	ND	ND	ND	ND	ND	ND	4.820	ND	ND
m&p-Xylene	.134	ND	ND	ND	ND	ND	ND	4.970	ND	ND
MTBE	ND	ND	ND	ND	ND	ND	ND	ND	ND	ND
1,2,4-Trimethyl- benzene	1.290	ND	ND	ND	ND	ND	ND	7.790	ND	ND
1,3,5-Trimethyl- benzene	160	ND	ND	ND	ND	ND	ND	2.580	ND	ND
Diesel Range Organics	160	ND	BQL	BQL	ND	ND	ND	6680	ND	ND
Depth	0.5	1.5	1.0	1.0	1.0	2.0	2.0	0.5	0.5	2.5
Field Sample #	1	5	6	7	8	9	9	11	10	13

Sample locations are indicated on Figure 5.

Samples 1 and 8 which showed detections of petroleum volatile organic compounds were taken to verify soil contamination. These areas were excavated deeper to obtain clean samples, #2 and #10 respectively.

Based on field screening and laboratory data (as obtained and prepared in accordance with WDNR requirements), it appears this site has been closed clean with no contamination left. Central Wisconsin Engineers recommends this site go before the WDNR Closure Committee for closure. No further work is needed.

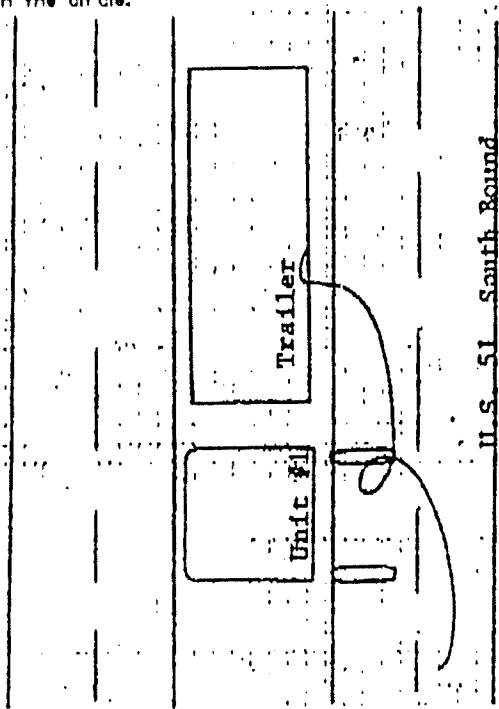
PICTORIAL REPRESENTATION OF NARRATIVE

Narrative: Unit #1 was south bound on U.S. 51 when the operator lost control of the vehicle and the vehicle then jackknifed, slid off the road and then overturned on its side.

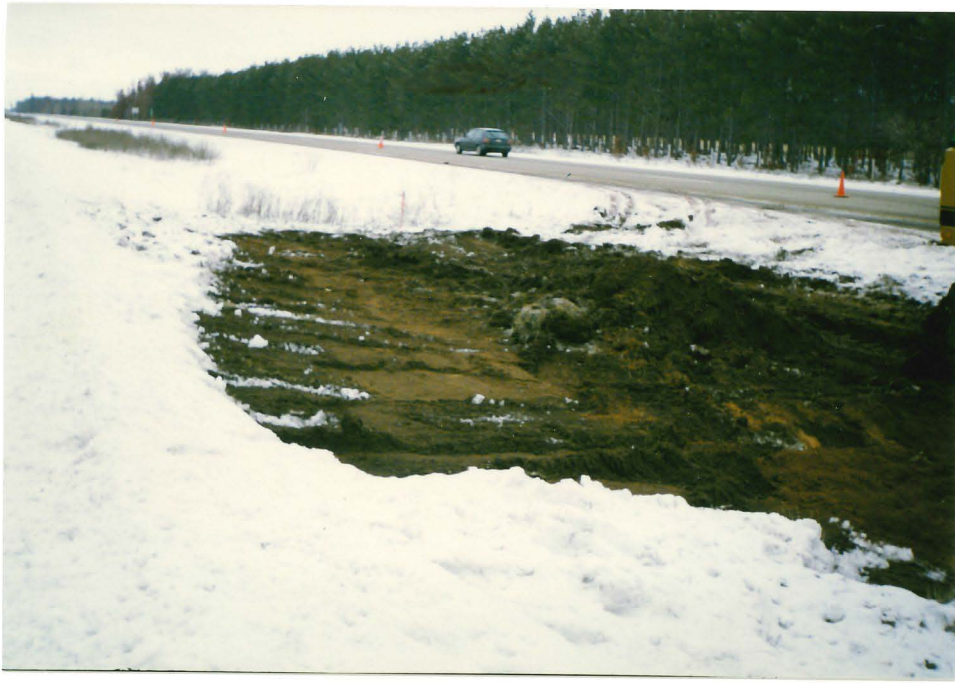
Photo 5

1. Looking South at Accident Site
2. Looking North at Accident Site
3. Looking at North End of Excavation
4. Looking South along Excavation
5. Looking at South End of Excavation
6. Looking at Excavation of Soil under the Trailer
7. Backfill with Topsoil
8. Truck after Accident

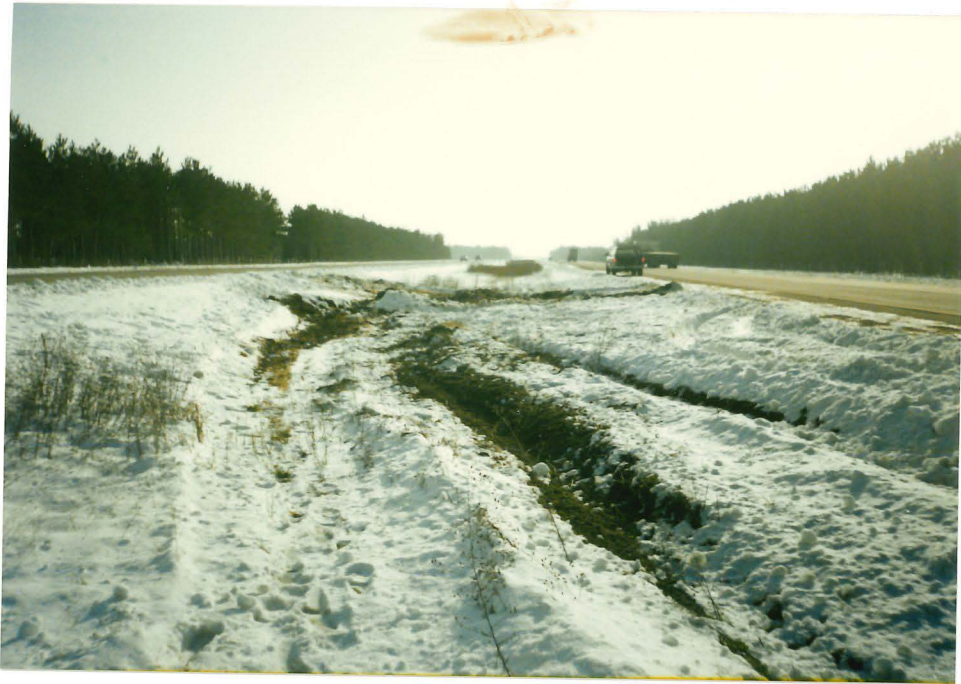
Photo 1

At the time of inspection, some diesel odor was noted. Small amounts of diesel stained snow was observed on the west side of the median. The contaminated soil appeared to be the topsoil loosened from the accident. From the site inspection it was determined the contaminated soil could be excavated to remediate the site.

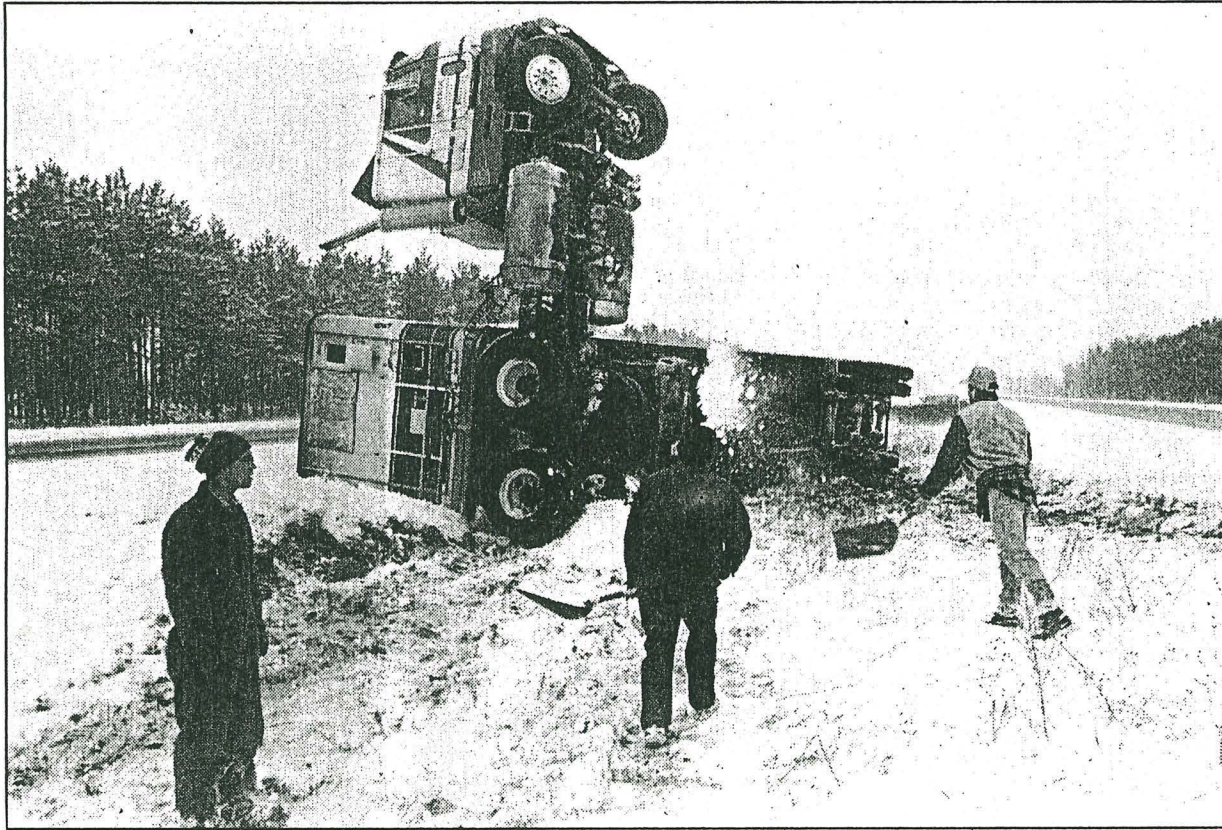
Photo 8

As the truck entered the median, the diesel fuel tank on the driver's side was ruptured and leaked diesel fuel. The fuel tank leaked a small amount of fuel as it slid in the median. When the vehicle came to rest on its back tires, the fuel tank leaked fuel into the trailer. Approximately 100-125 gallons of diesel fuel was reportedly lost. The fuel tank on the passenger side was empty.
