**Remedial Action at Plant 2 Sump
Sta-Rite Industries,
Delavan Operations**

**Sta-Rite Industries, Inc.
Water Equipment Division
Delavan, Wisconsin**

**Donohue & Associates, Inc.
Engineers & Architects**

Re: Report of Remedial Action at
Plant 2 Sump, Delavan Operations
Donohue Project No. 12894.002

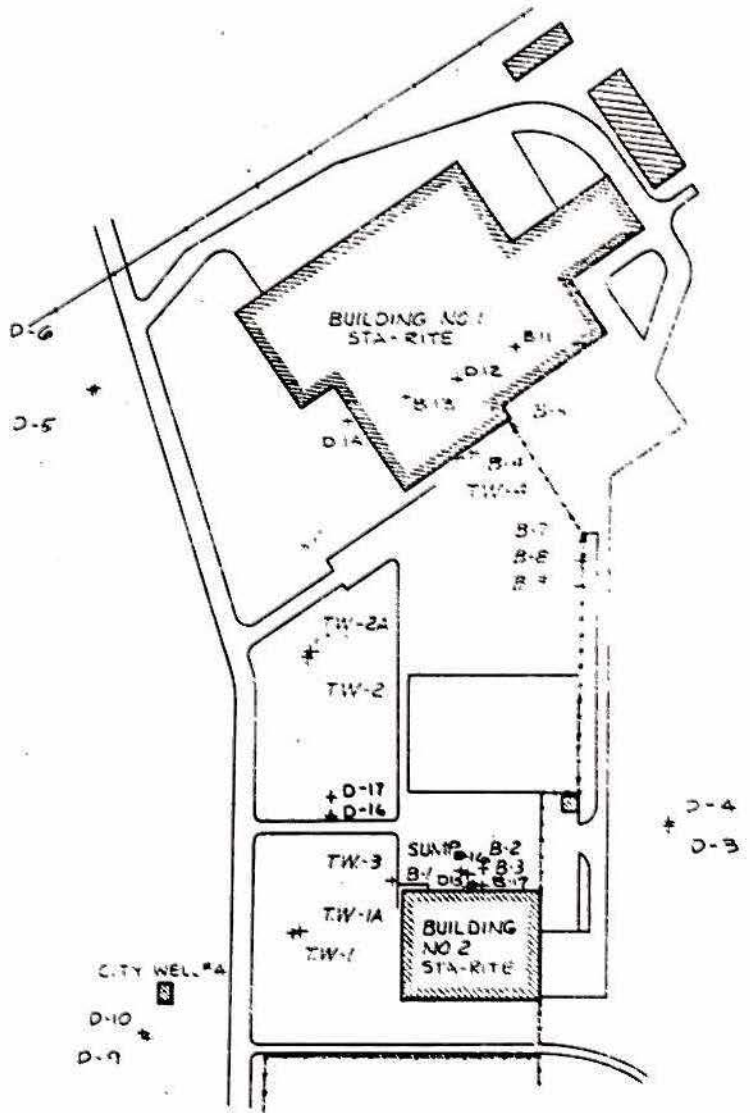
FIGURE 1

The extent of contamination in the vicinity of the sump at Plant 2 was investigated by Warzyn Engineering and Donohue. Borings and monitoring wells in the vicinity of the sump are shown on Figure 1. Location of the borings, wells, and the specific soil and groundwater samples collected are discussed in more detail in Table 1. Warzyn collected two soil samples in the
