December 7, 2022

RE: SME Serial Letter #81  
2022 Tecumseh Site Inspection and Maintenance  
Sheboygan River and Harbor Site  
Former Tecumseh Products Company Plant  
428 Cleveland Street, Sheboygan Falls, Wisconsin  
SME Project No. 069638.00.070

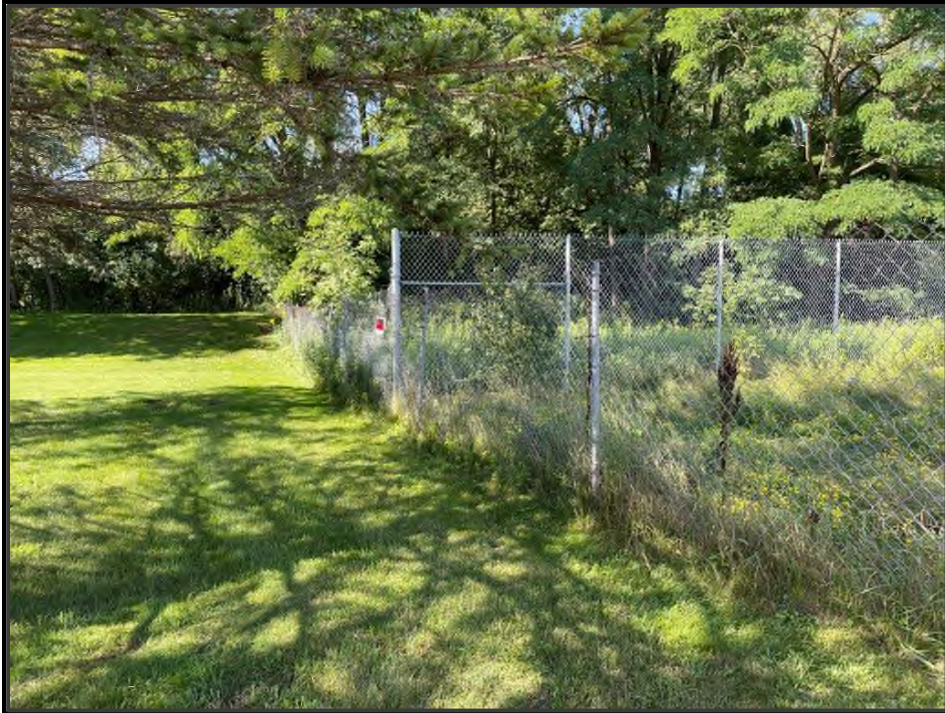
SME completed inspection and maintenance activities on the Site in August 2022. SME staff evaluated the site security fence for signs of damage. No major damage was noted. Photographs of the site fencing are included in Attachment 1. The site security fence was evaluated by SME to be in sufficient quality to deter and preclude the Site from unapproved access from trespassers.

**PHOTO NO. 1: View of fence along the east side of the Site.**

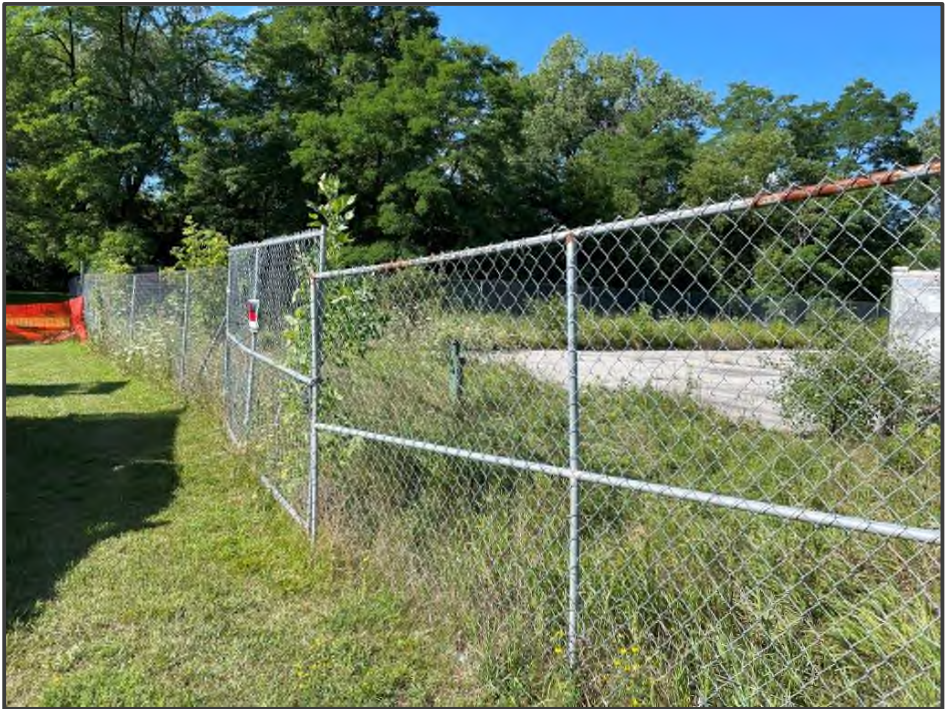
**PHOTO NO. 2: View of fence along the east side of the Site.**

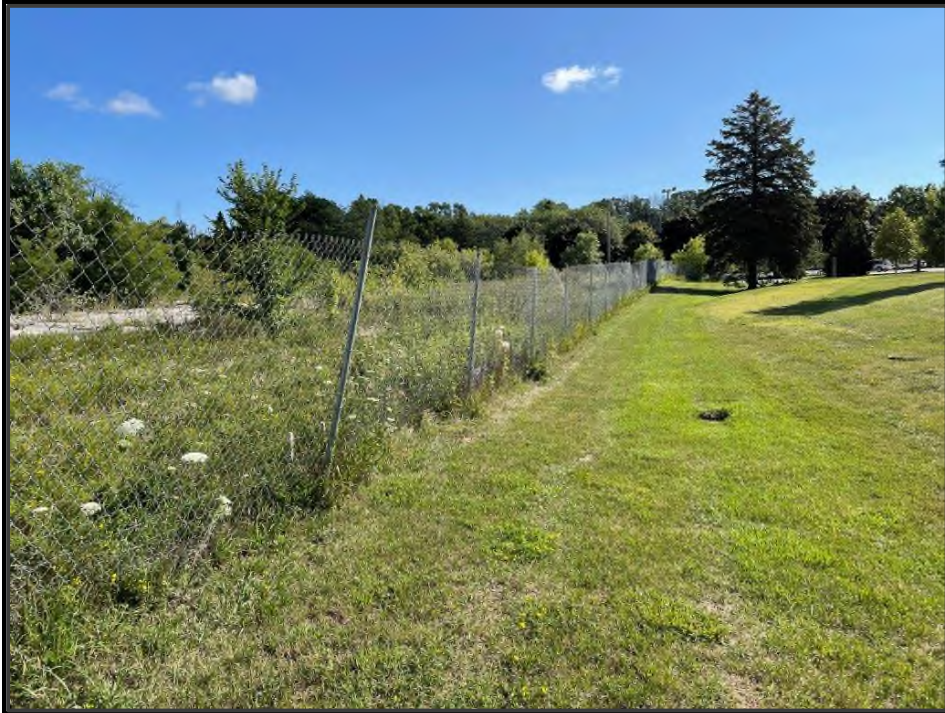
**PHOTO NO. 3: View of fence along the east side of the Site.**

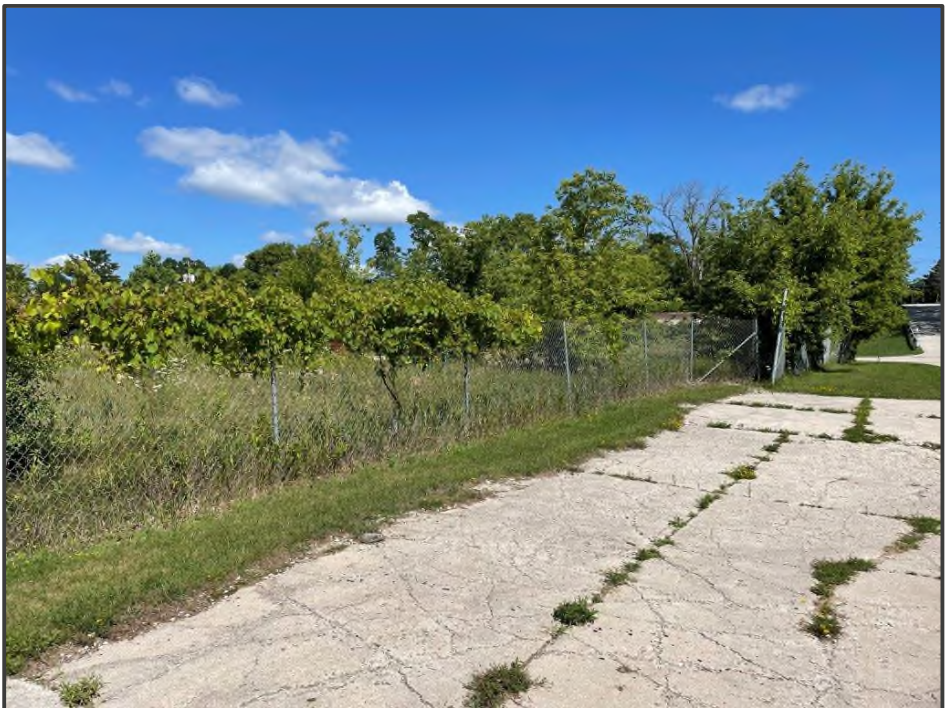
**PHOTO NO. 4: View of fence along the east side of the Site.**

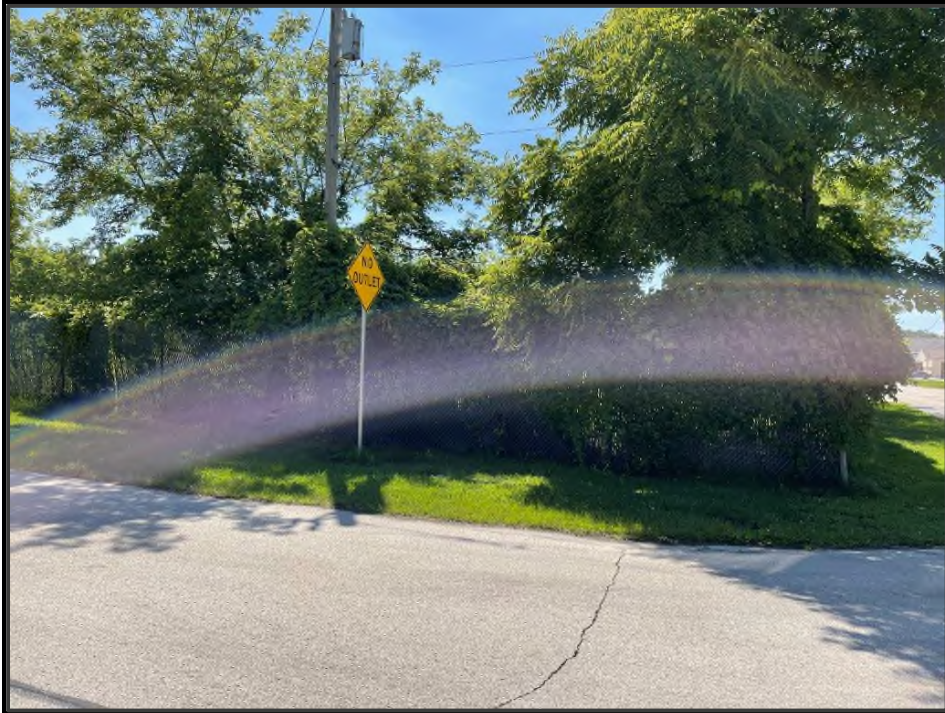
**PHOTO NO. 5: View of fence along the east side of the Site.**

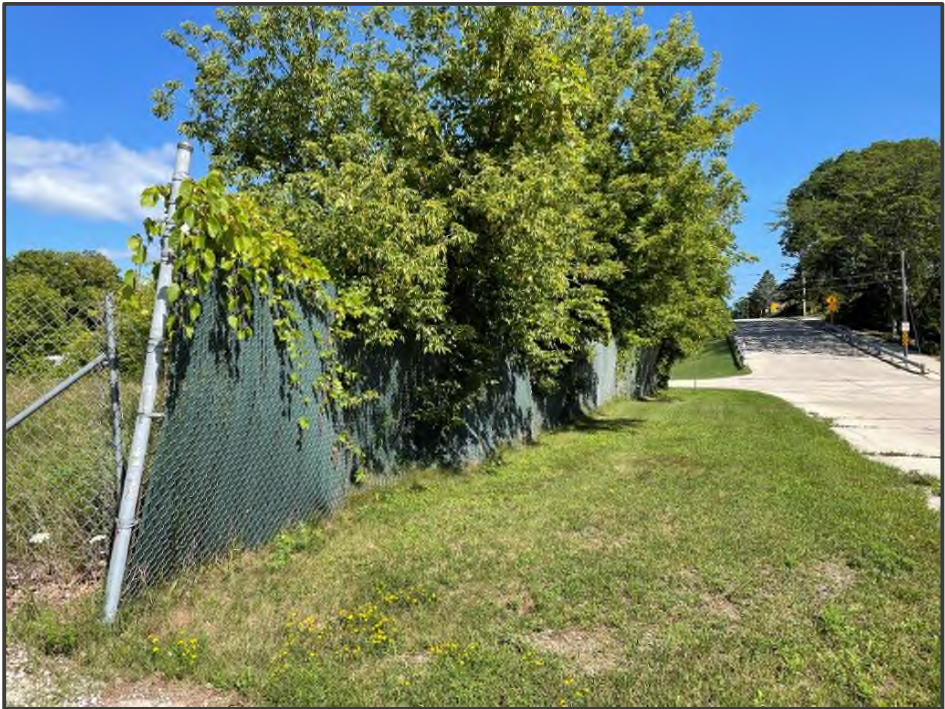
**PHOTO NO. 6: View of fence along the north side of the Site.**

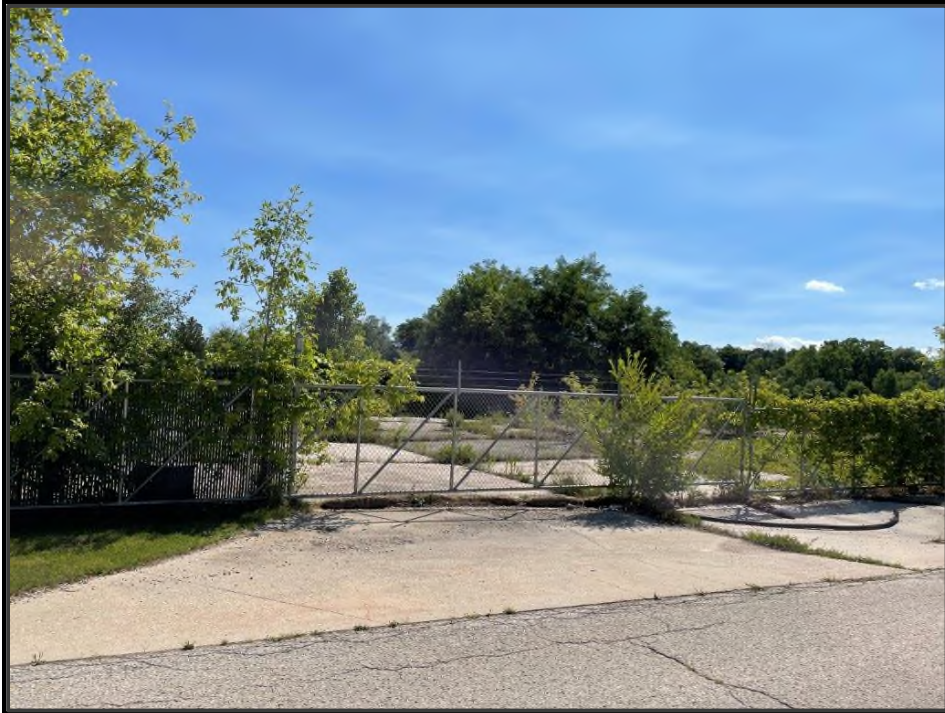
**PHOTO NO. 7: View of fence along the north side of the Site.**

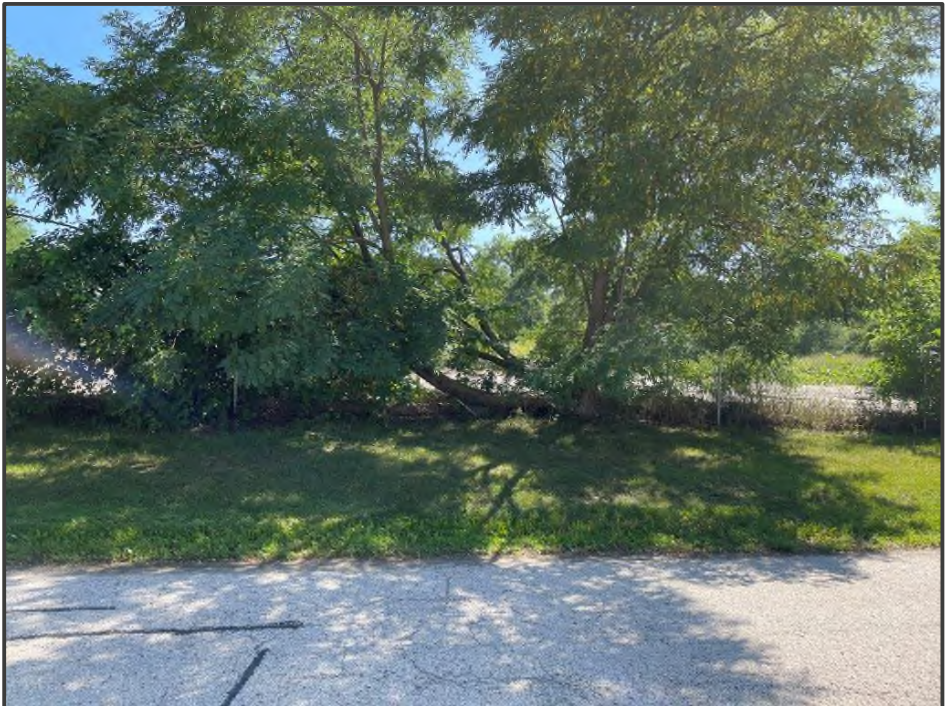
**PHOTO NO. 8: View of fence along the north side of the Site.**

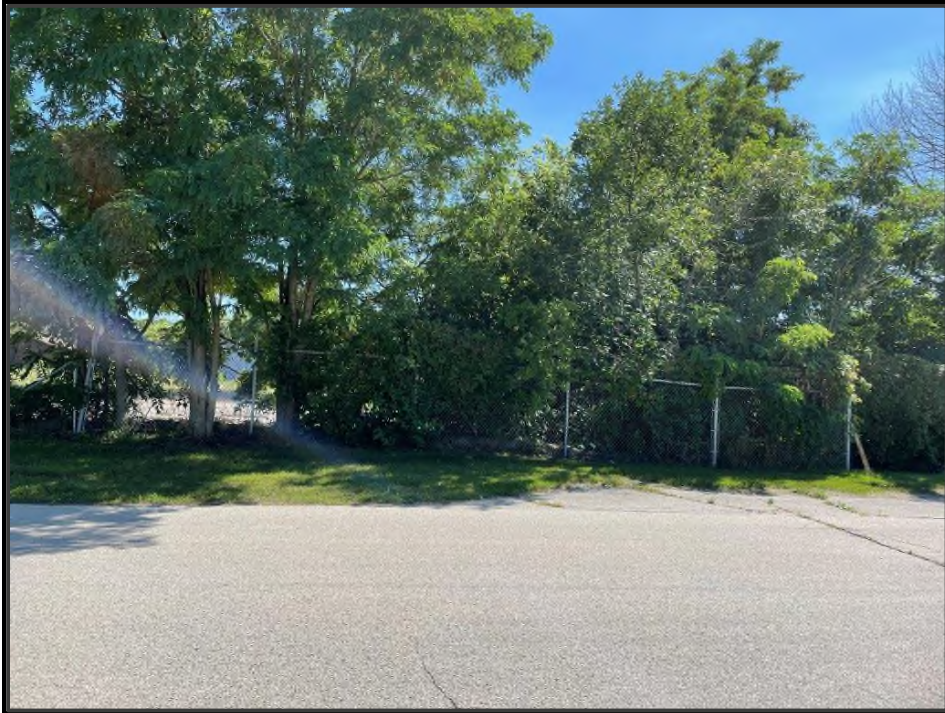
**PHOTO NO. 9: View of fence along the north side of the Site.**

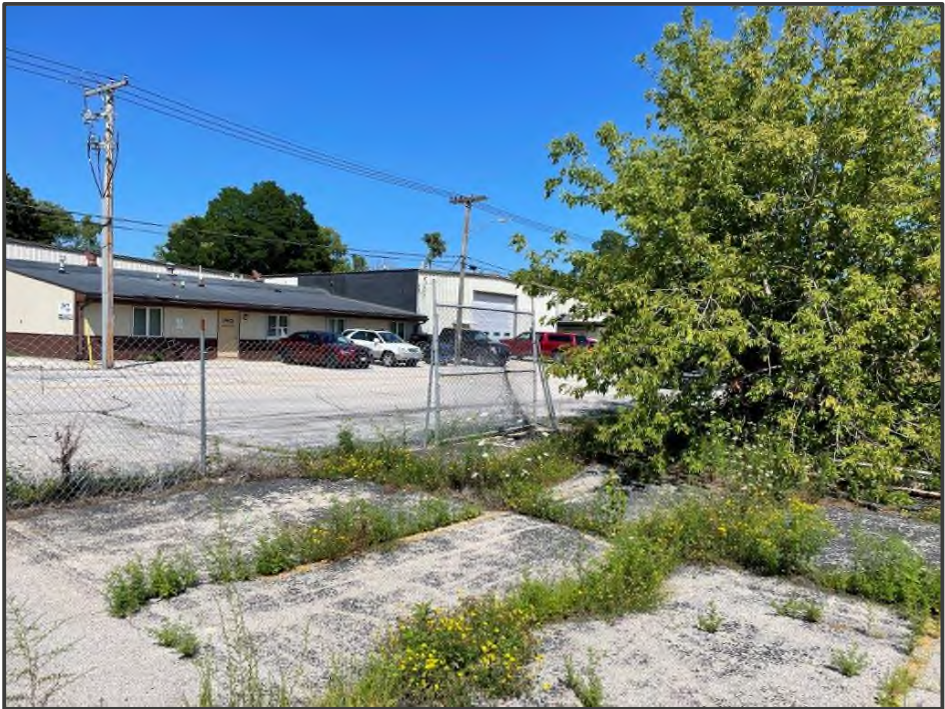
**PHOTO NO. 10: View of fence along the north side of the Site.**

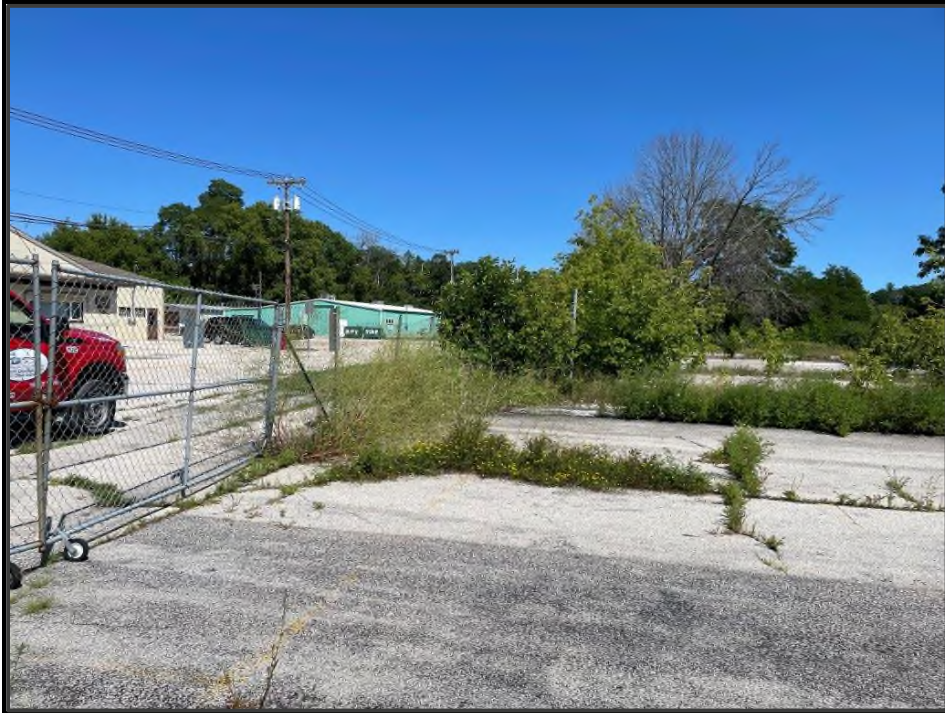
**PHOTO NO. 11: View of fence along the north side of the Site.**

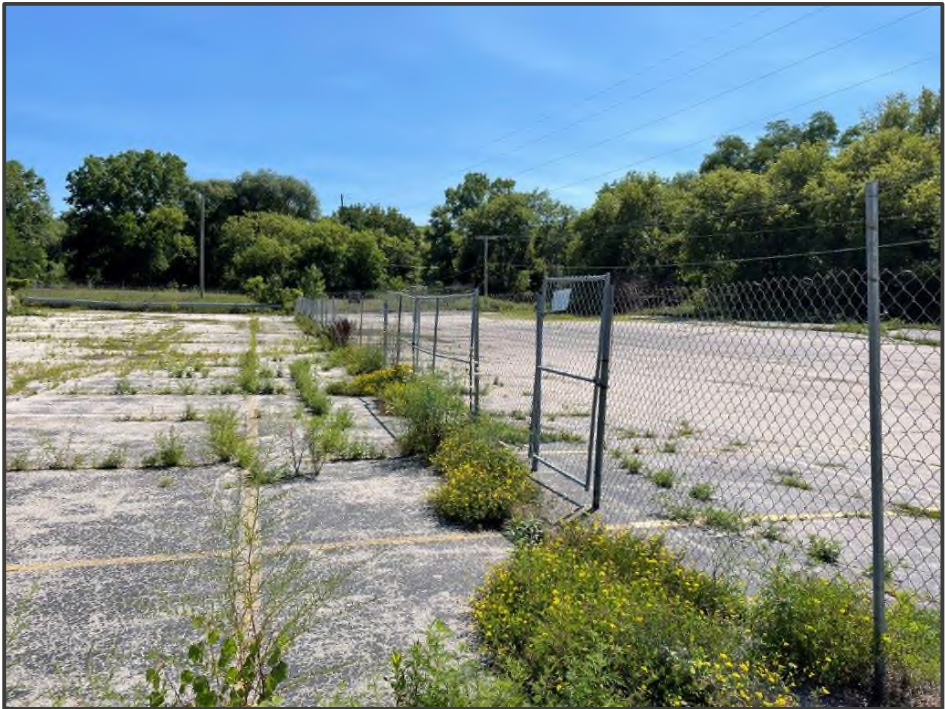
**PHOTO NO. 12: View of fence along the west side of the Site.**

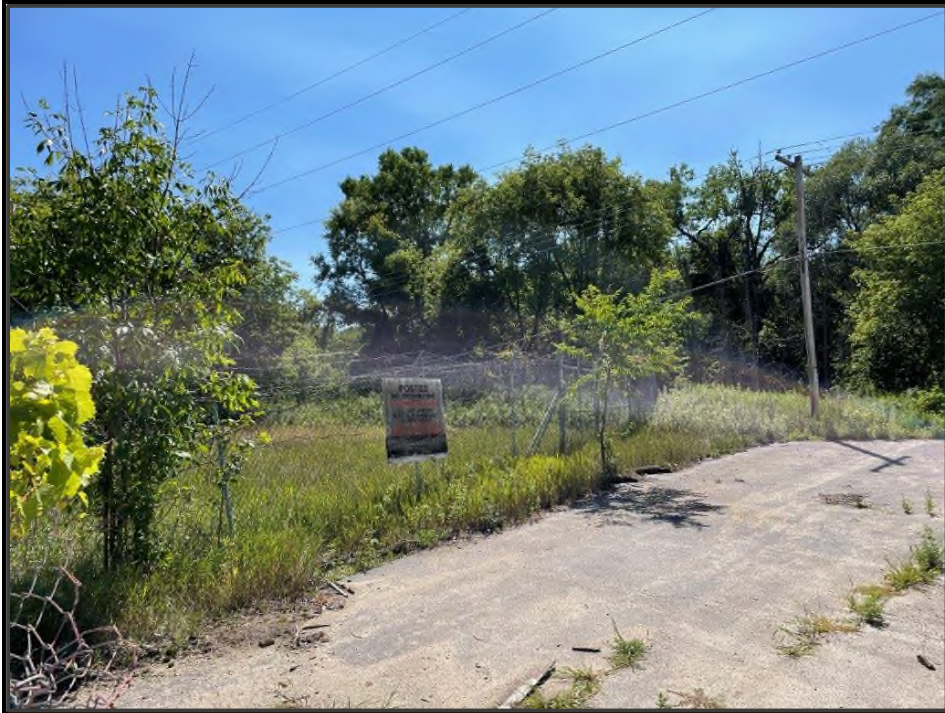
**PHOTO NO. 13: View of fence along the south side of the Site.**

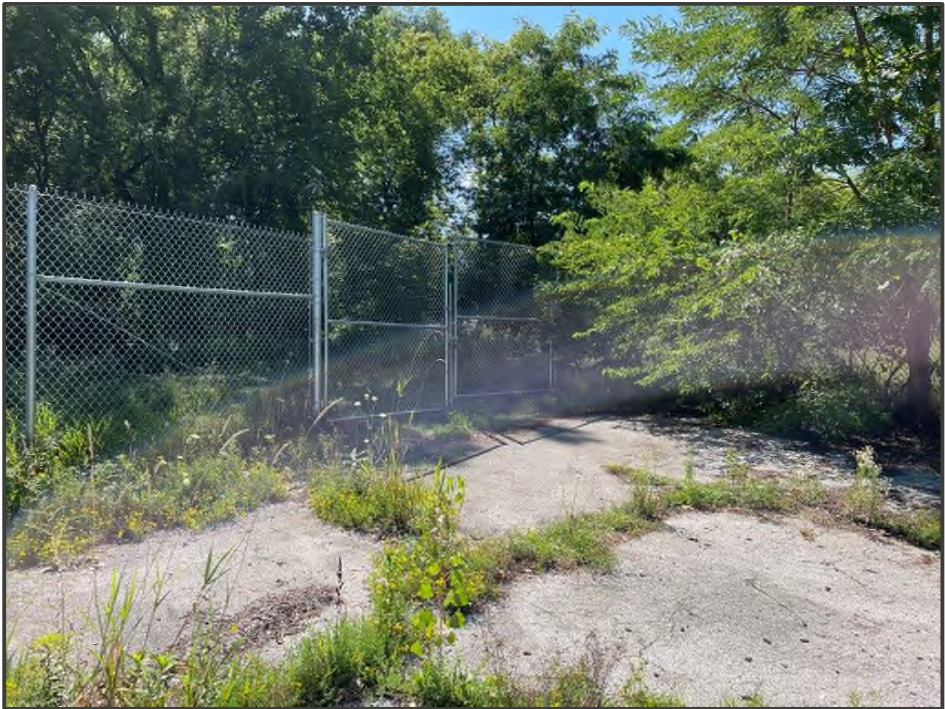
**PHOTO NO. 14: View of fence along the south side of the Site.**

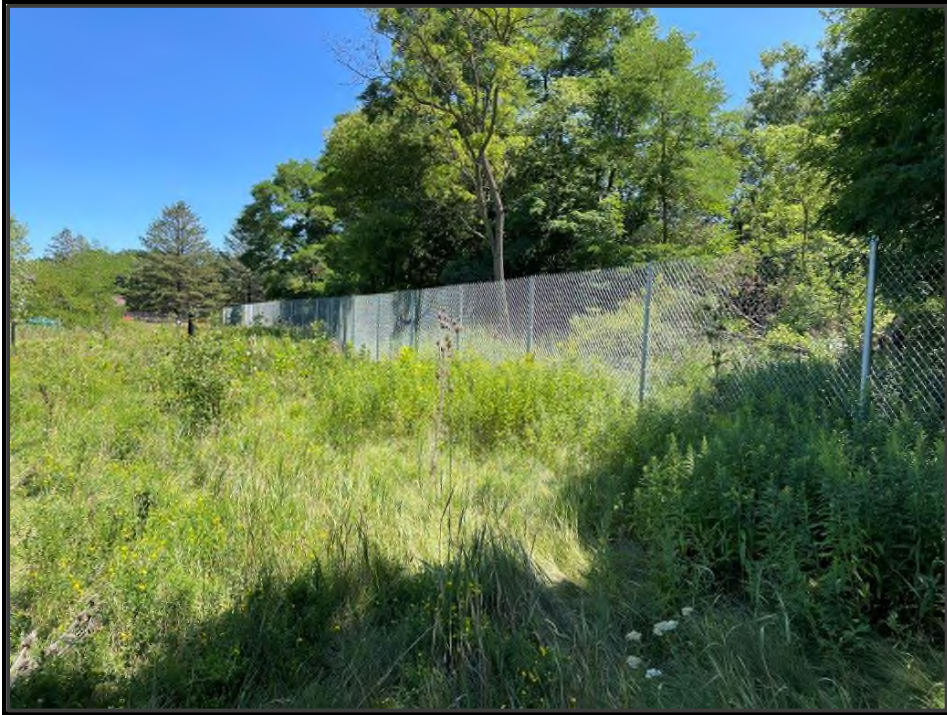
**PHOTO NO. 15: View of fence along the south side of the Site.**

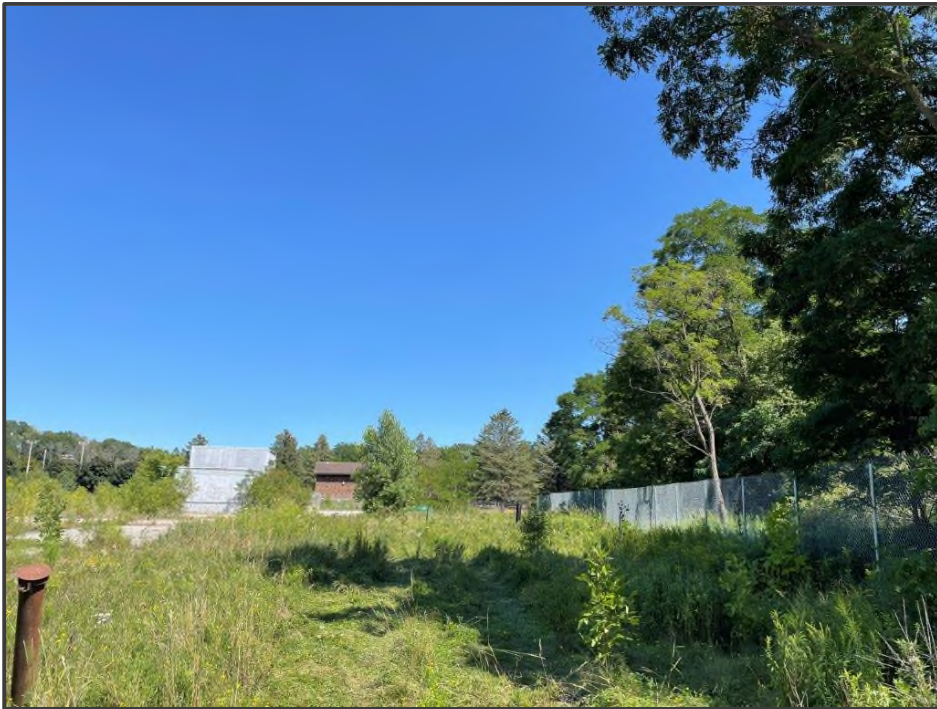
**PHOTO NO. 16: View of fence along the south side of the Site.**

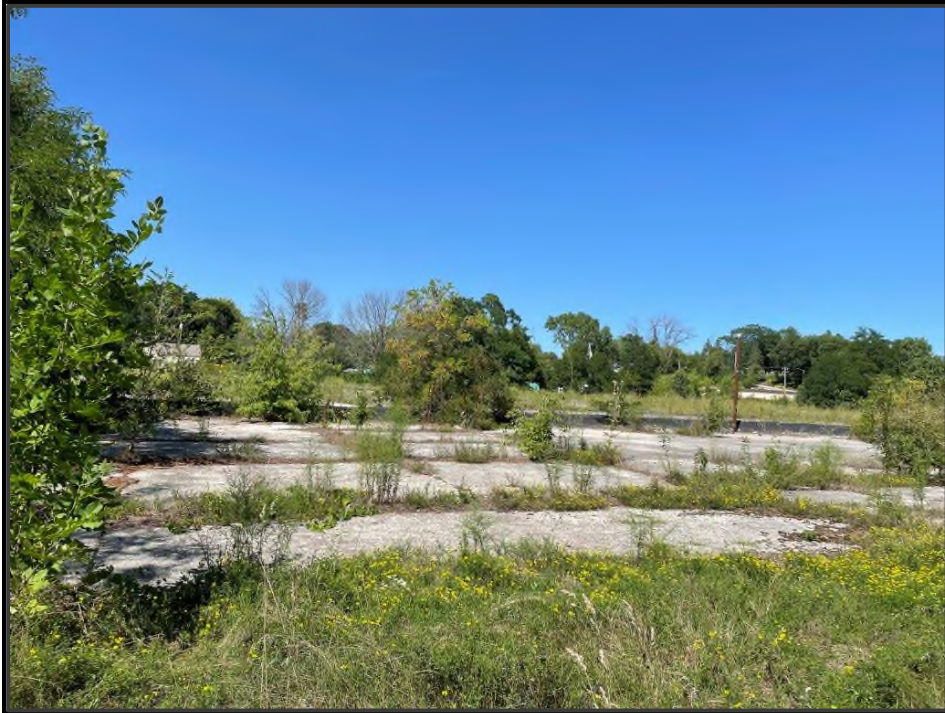
Since limited maintenance activities have been conducted on the Site since 2005, vegetative growth in the concrete and asphalt areas is significant and would require additional evaluation and significant maintenance activities. Portions of the concrete slab of the former manufacturing area were planned to be removed during remedial excavation of PCB-impacted soil in this area. Following excavation and backfill of the area, a concrete engineered barrier was planned to be installed in this area; however, this plan is currently on hold while further investigation is conducted in this area. Further assessment and maintenance of this concrete area will be completed if the concrete will not be removed. In the interim, areas of significant vegetative growth could compromise the integrity of the engineering control will be addressed.

**PHOTO NO. 17: View of pavement in the eastern portion of the Site.**

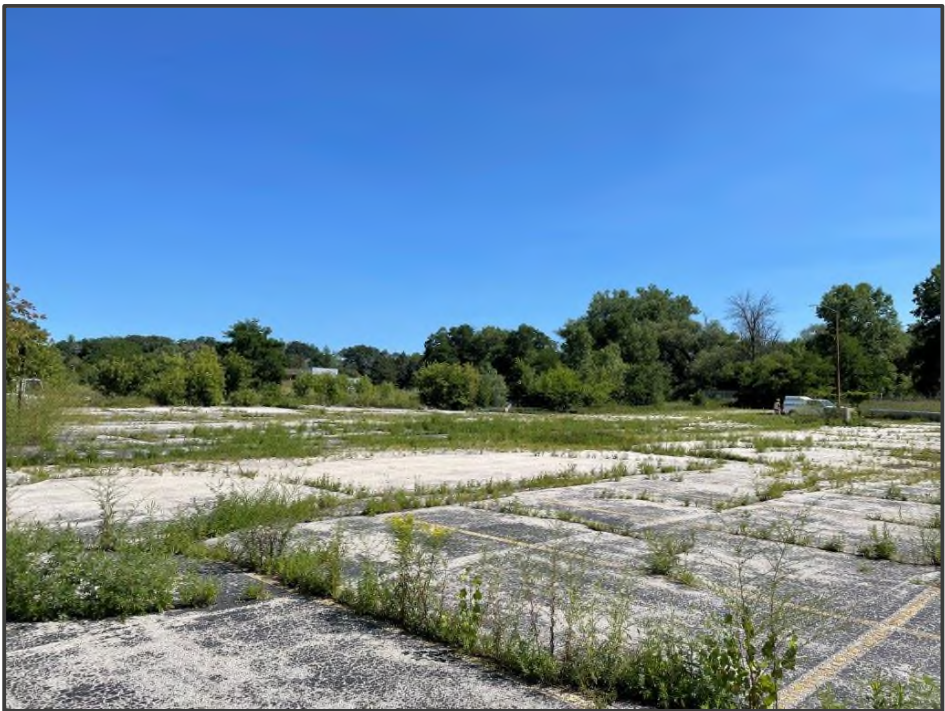
**PHOTO NO. 18: View of pavement in the central portion of the Site.**

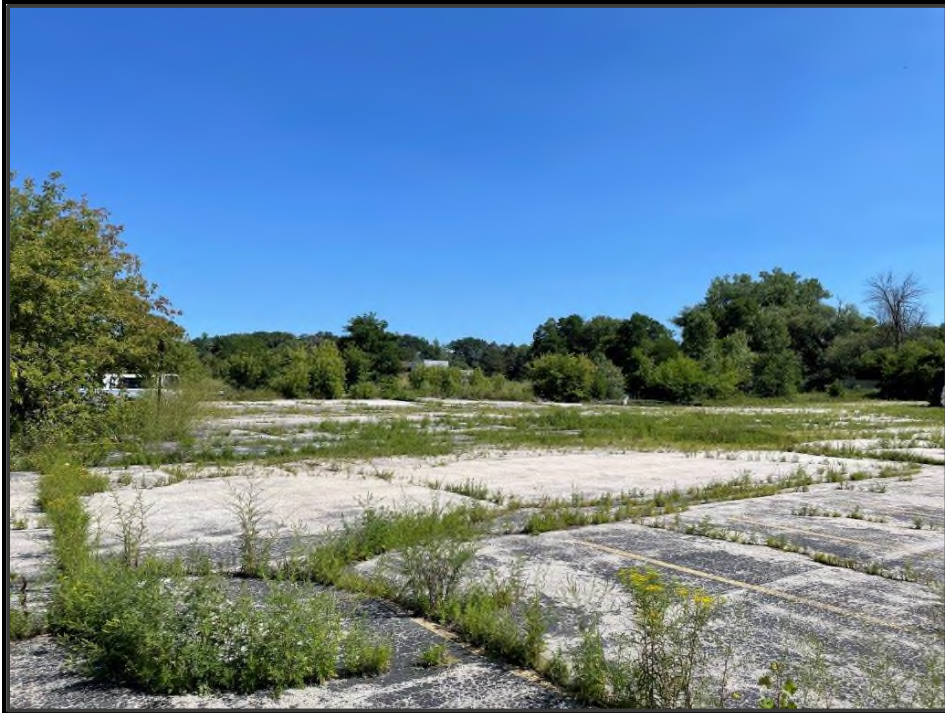
**PHOTO NO. 19: View of pavement in the central portion of the Site.**

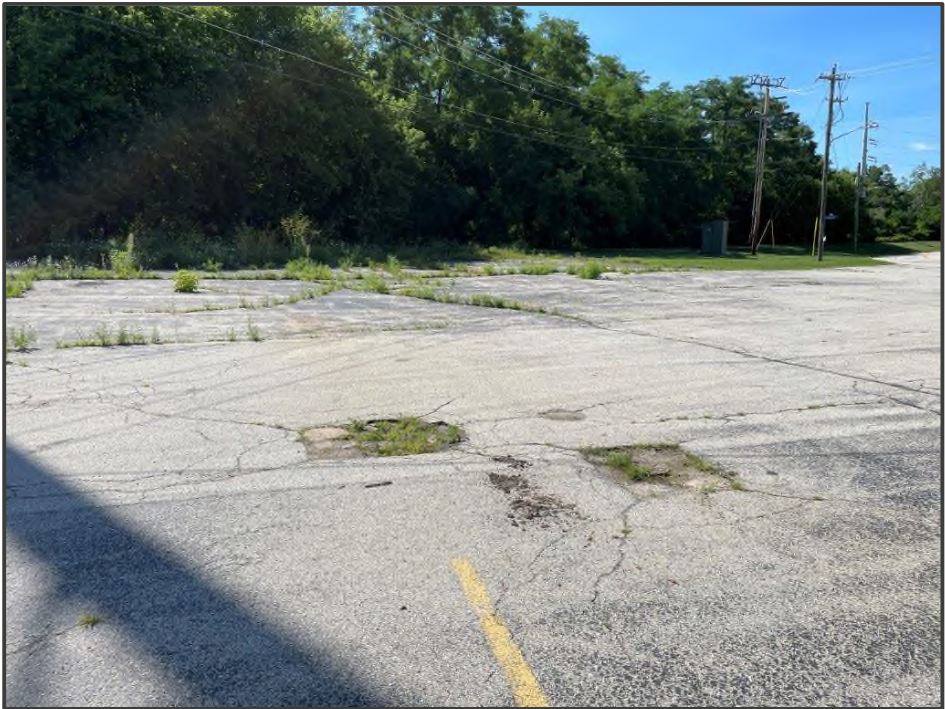
**PHOTO NO. 20: View of pavement in the central portion of the Site.**

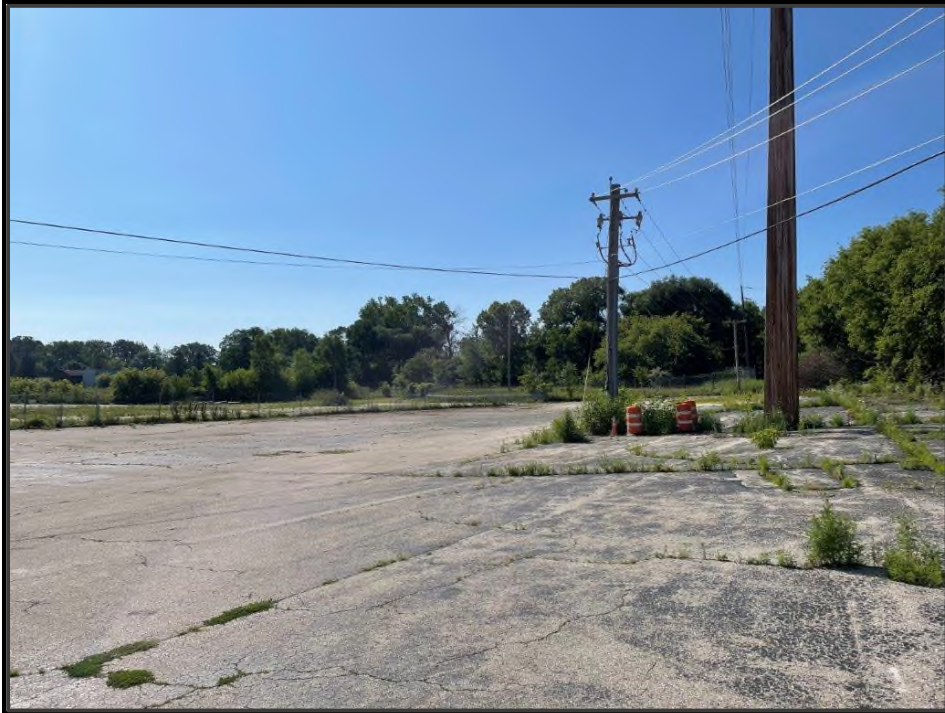
**PHOTO NO. 21: View of pavement in the western portion of the Site.**

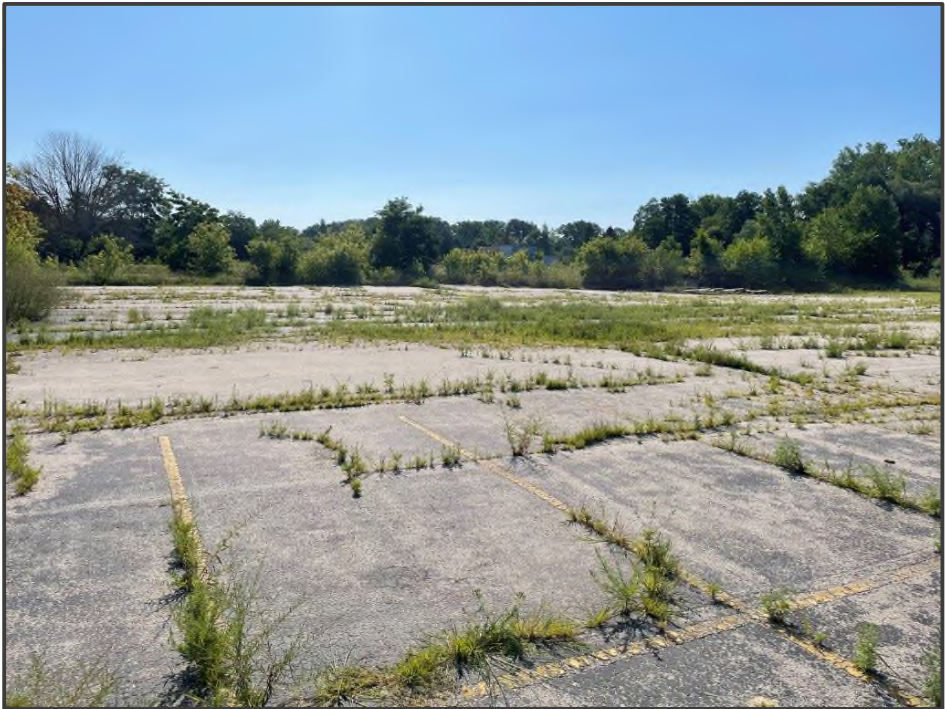
**PHOTO NO. 22: View of pavement in the western portion of the Site.**
