**BRRTS ID No. 02-41-531327**

Review Date: 08/07/2015

Site Name: VACANT LOT

Site Address 3009 N HUMBOLDT AVE	City MILWAUKEE	ZIP Code 53212
County Parcel Identification Number (PIN) 281-1104-9000	FID Number 241853150

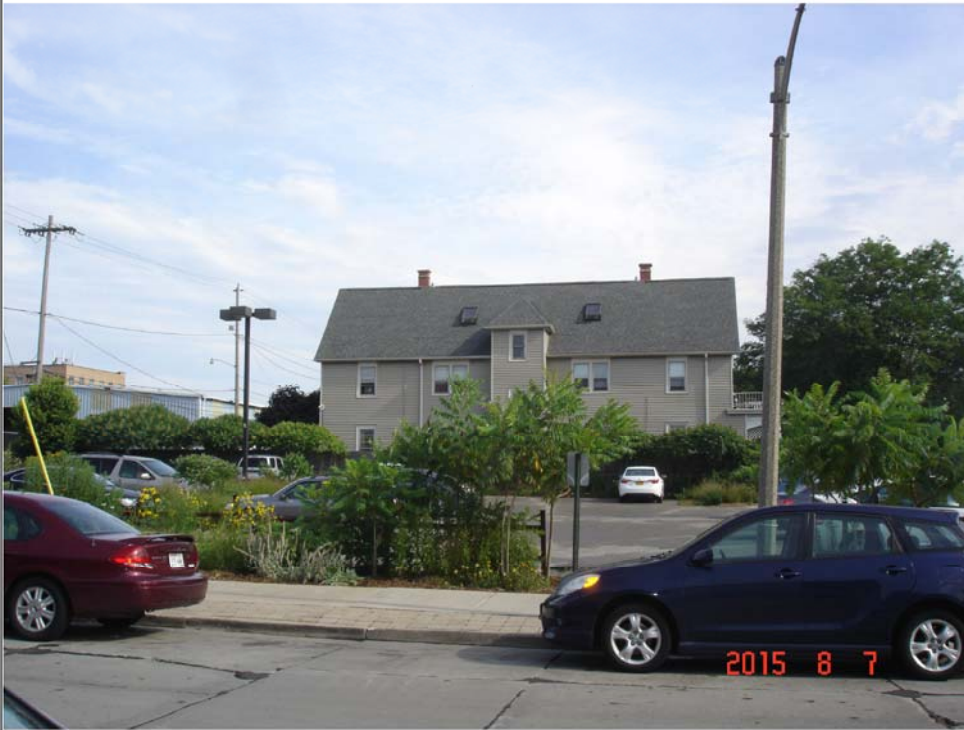
Title: Photo #1. The parking lot at 3009 Humboldt Blvd. from across Chambers St. Colectivo Coffee is located at the SW corner of Chambers St. and Humboldt Blvd.

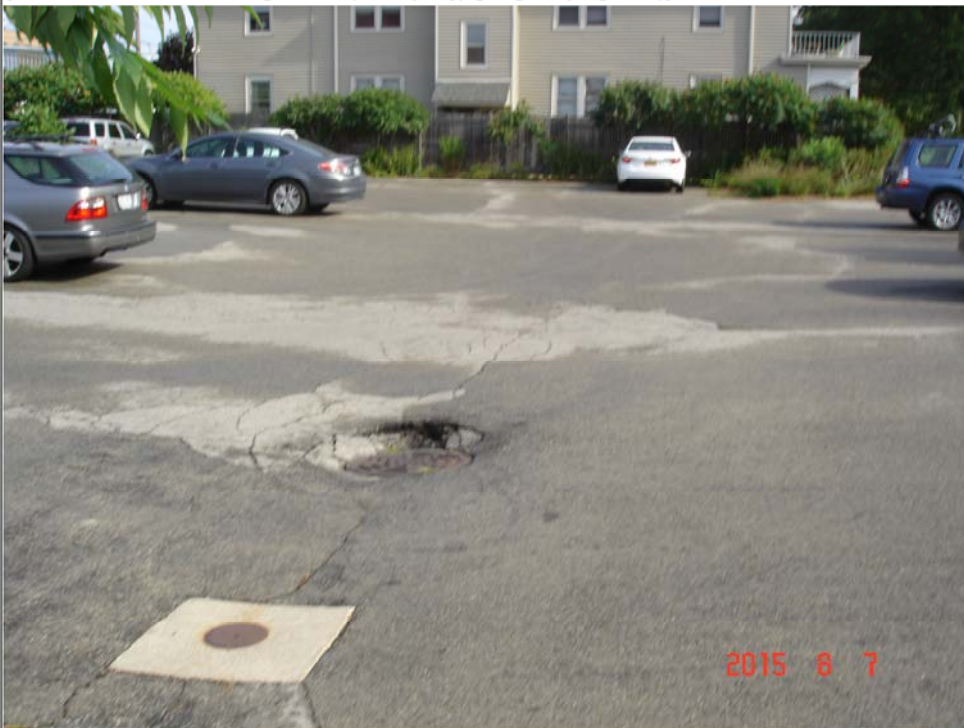
Title: Photo #2. Storm drain at the parking lot. This drain is not indicated in any map in the GIS Registry.

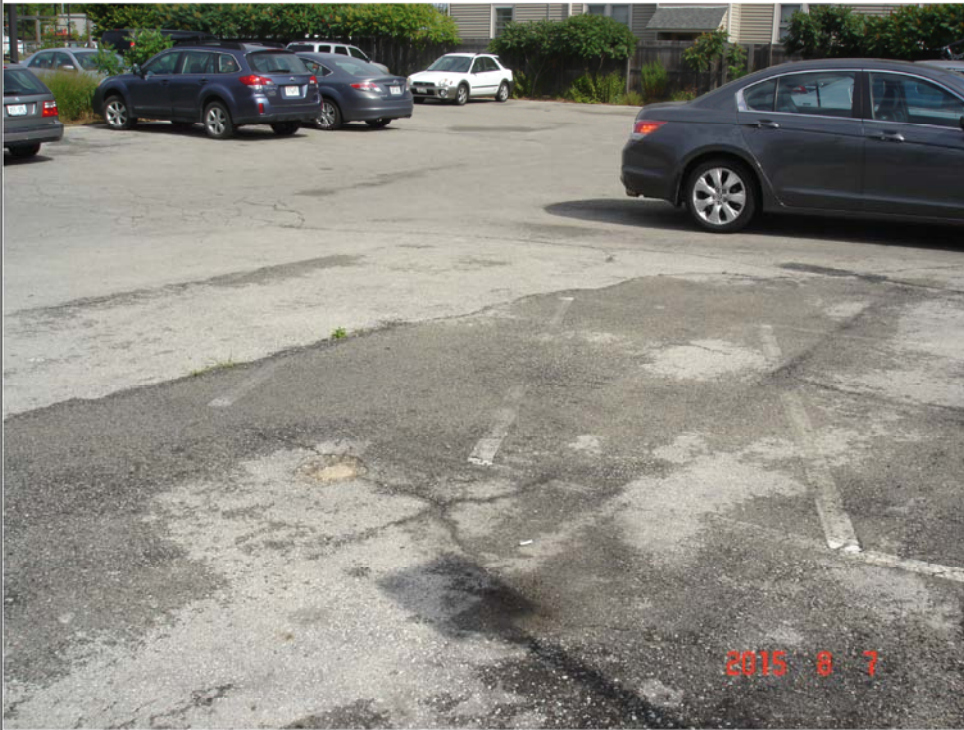
Title: Photo #3. Abandoned monitoring well visible (brownish circle) at the lower left of center of photo.

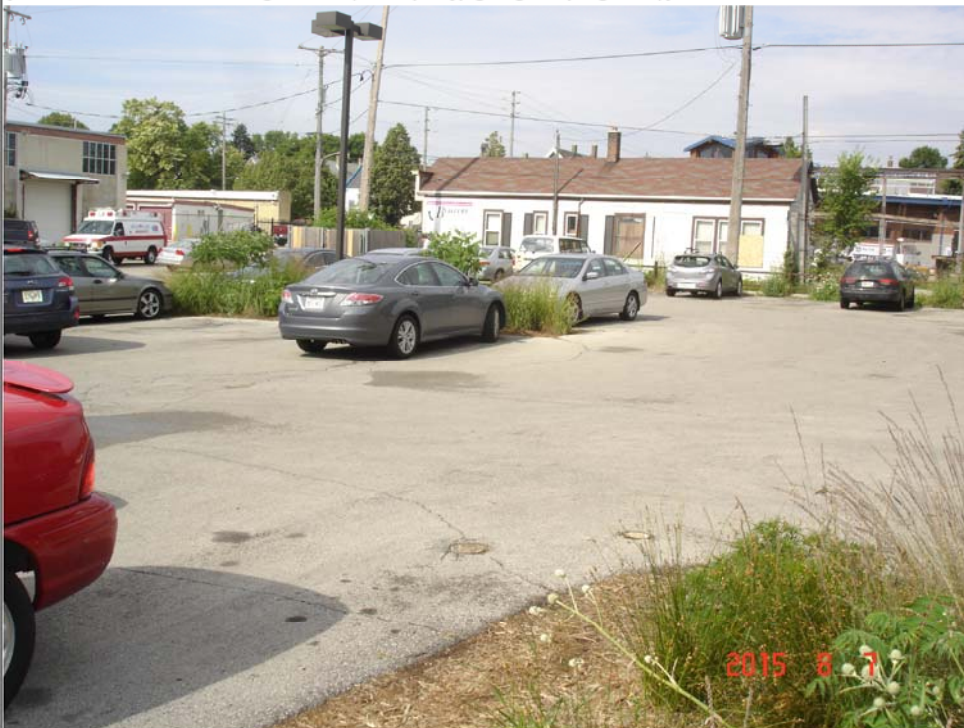
Title: Photo #4. Looking SW from the NE corner of parking lot. Filled former monitoring wells are visible in the lower center of the photo.

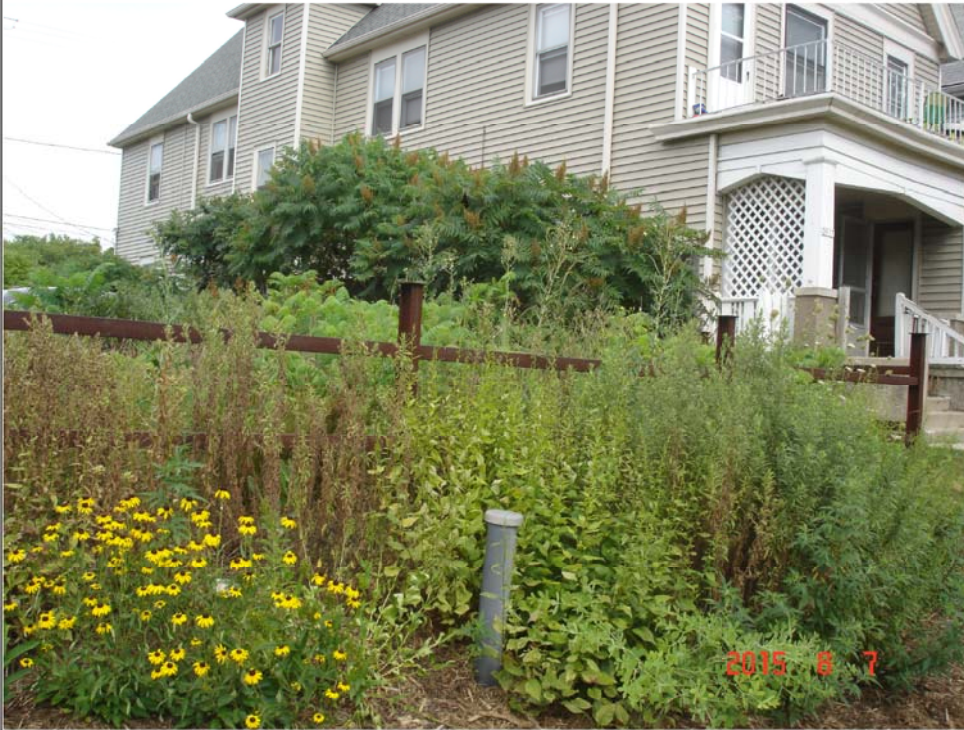
Title: Photo #5. Passive venting (stick-up) pipe near the sidewalk to the east of the parking lot

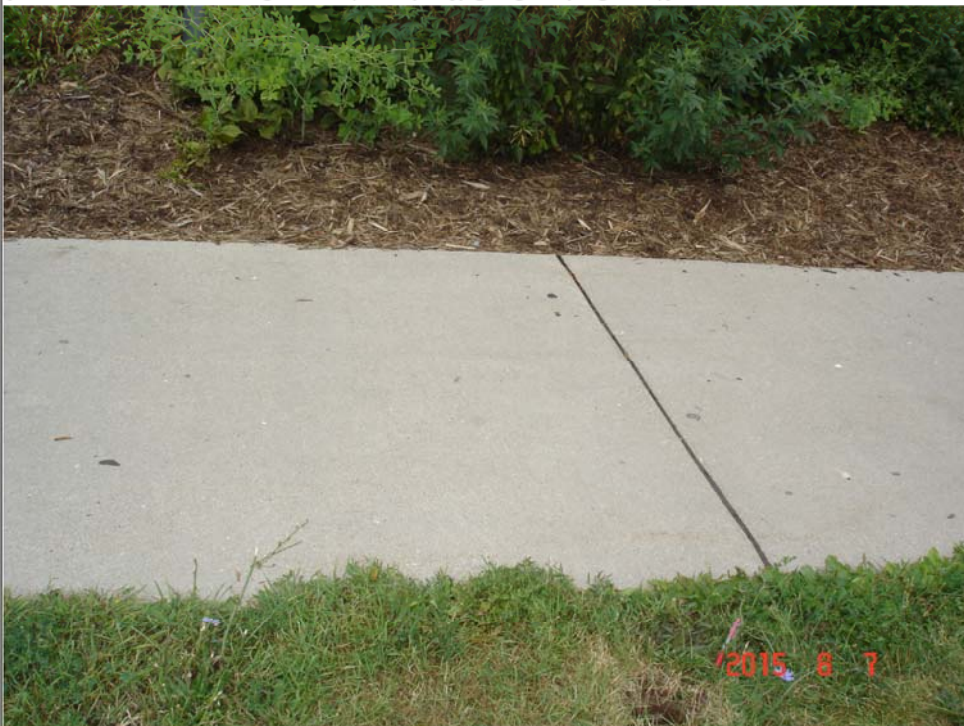
Title: Photo #6. Photo taken just on the other side of the sidewalk from the stick-up venting pipe. There is a freshly-placed hole in the grassy part. Hole is probably for a street sign.

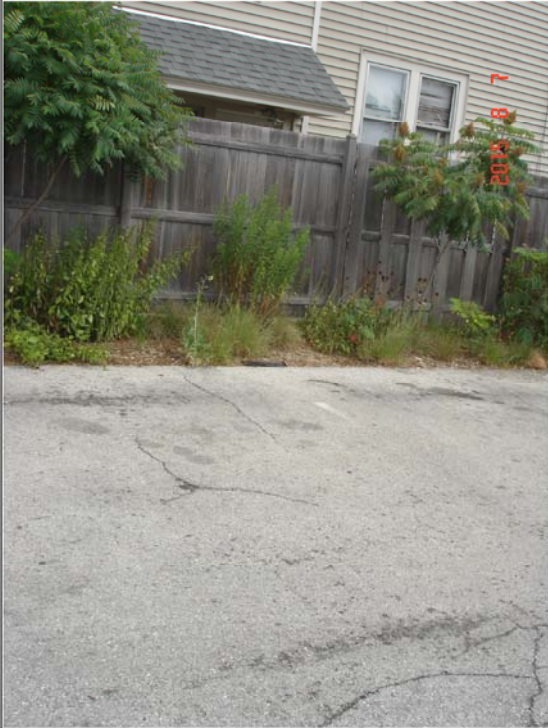
Title: Photo #7. Photo of fence separating the parking lot from the house to the north.

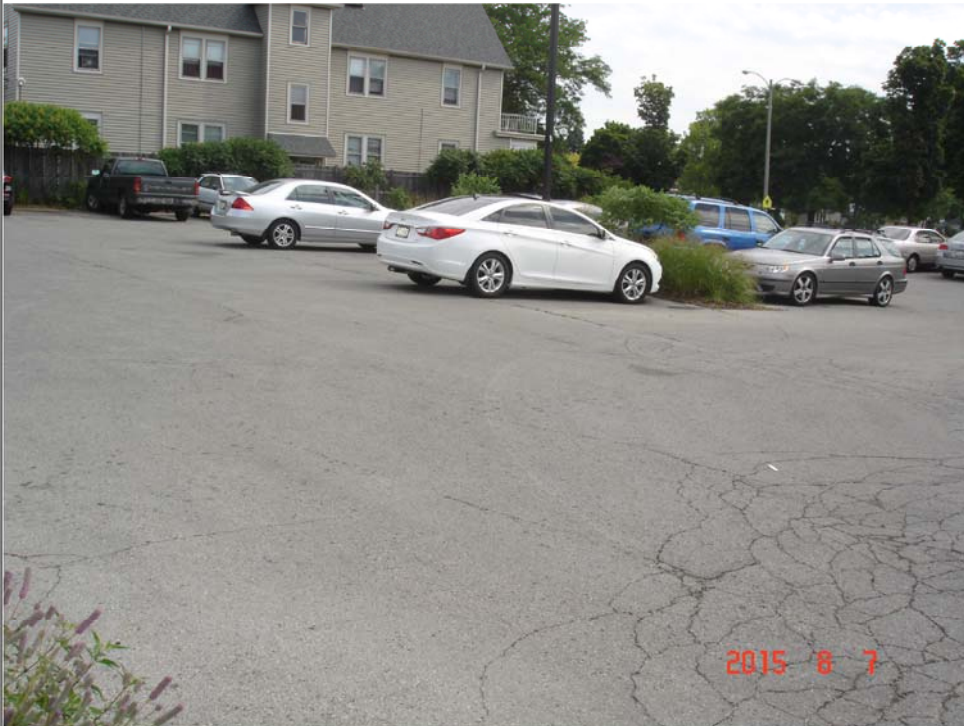
Title: Photo #8. Photo from the SW corner of the lot.

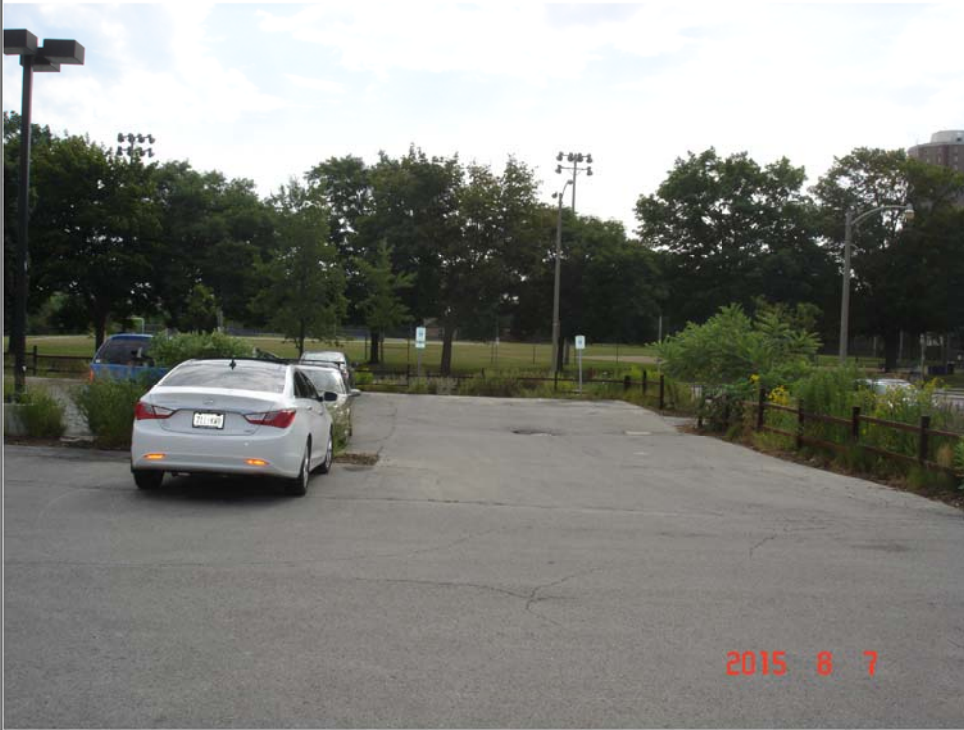
Title: Photo #9 looking E showing the southern portion of the parking lot.

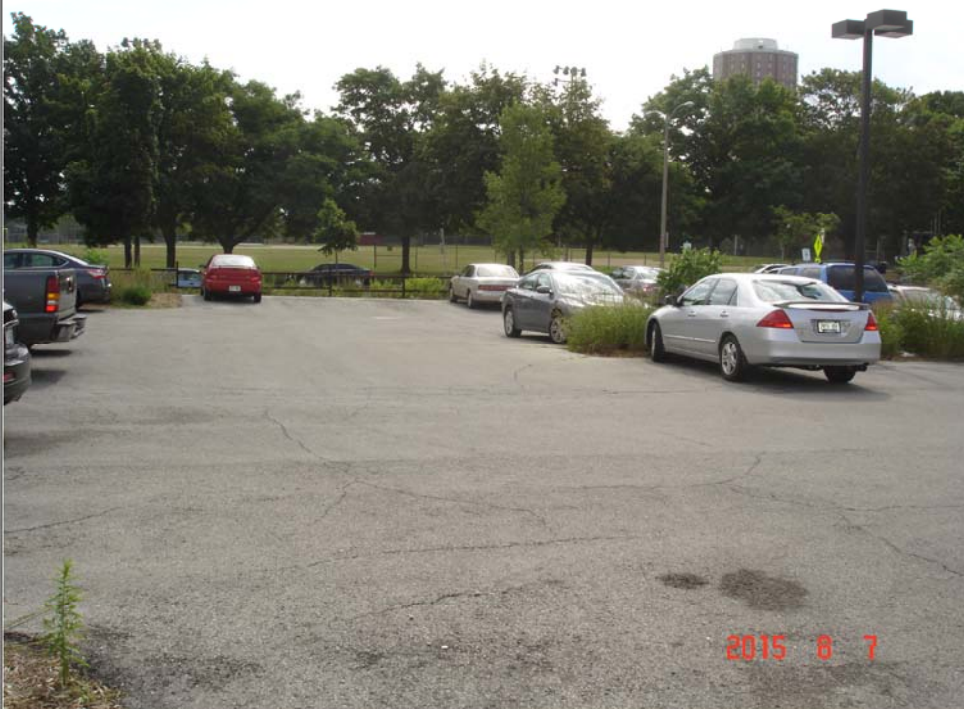
Title: Photo #10 looking E showing the northern portion of the parking lot.
