ANNUAL INSPECTION REPORT

BARRETT LANDFILL

New Berlin, Waukesha County, Wisconsin

January 18, 2018

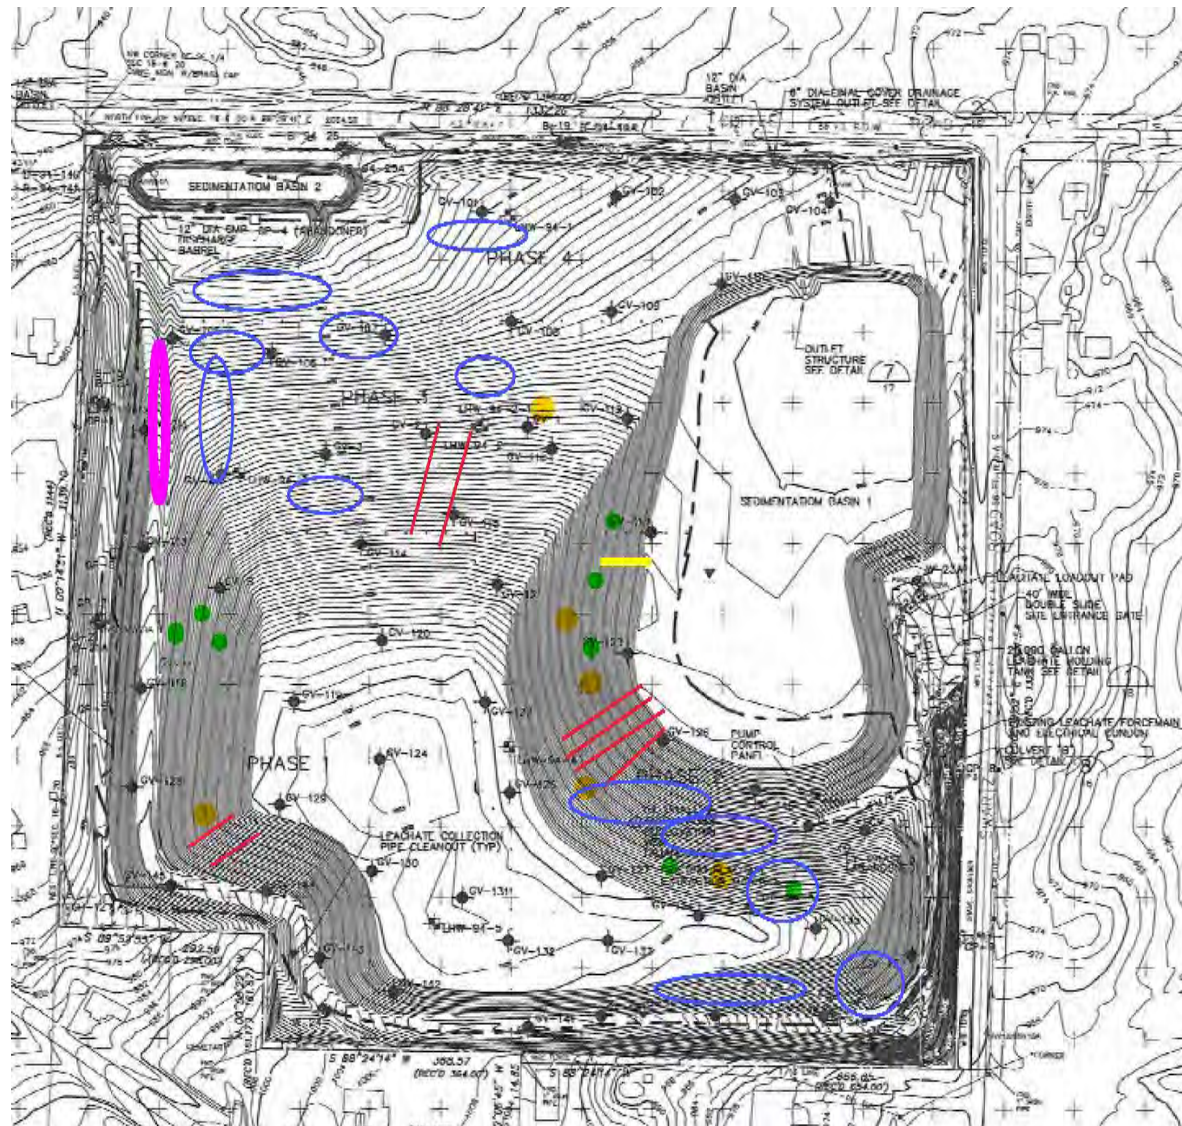
2017 ANNUAL LANDFILL INSPECTION FEATURES – Barrett Landfill, New Berlin, Wisconsin

It was noted during the inspection that small trees and tree stumps (<6 inches in diameter) were located on the cap. Most had appeared to have been recently cut down, while a few remained standing. Locations are noted on the attached figure.

Mulched material from the brush hog was present in the drainage channel on the northwestern portion of the Site. It did not appear to be obstructing any drainage at the time, and it will be monitored in the future. The location of this area location is indicated on the attached figure.

Features are identified on the photo log and attached Figure.

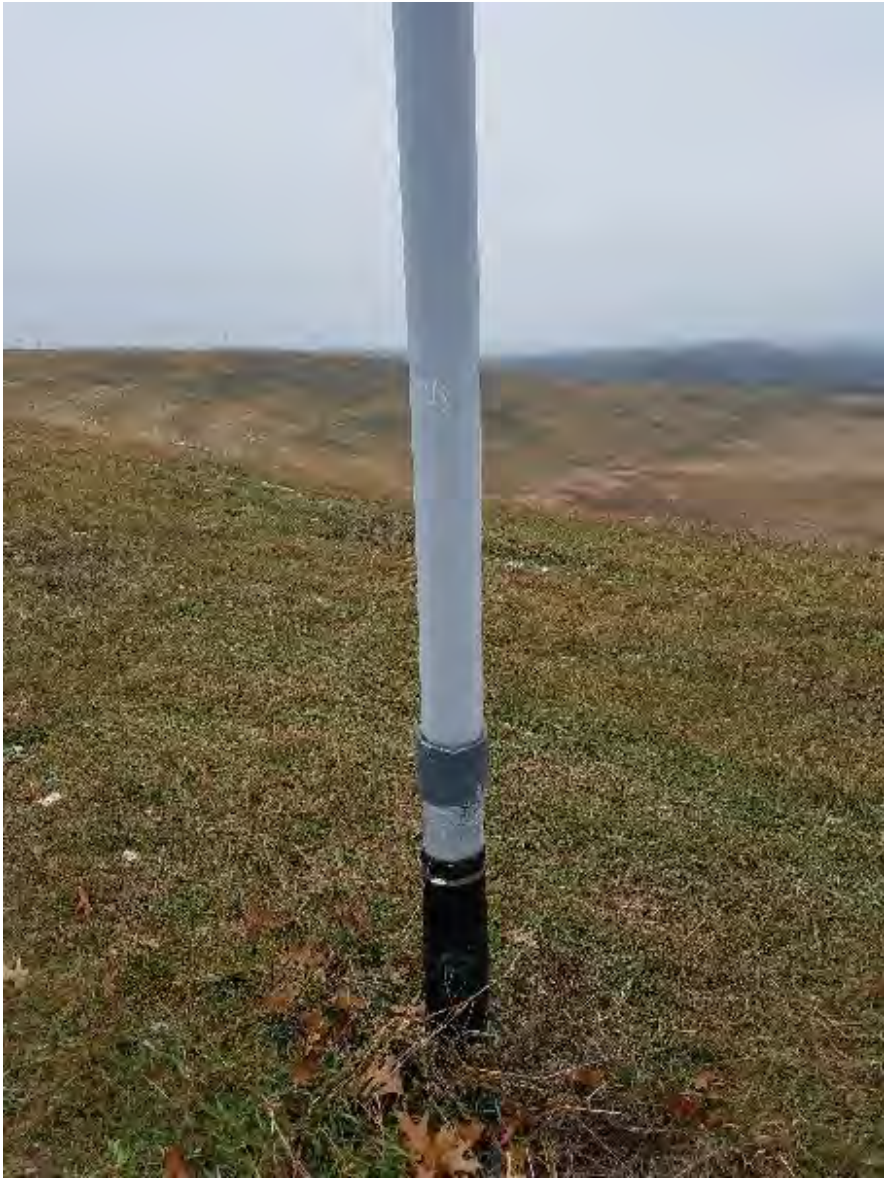
2. GV-2 tilting NE, looking

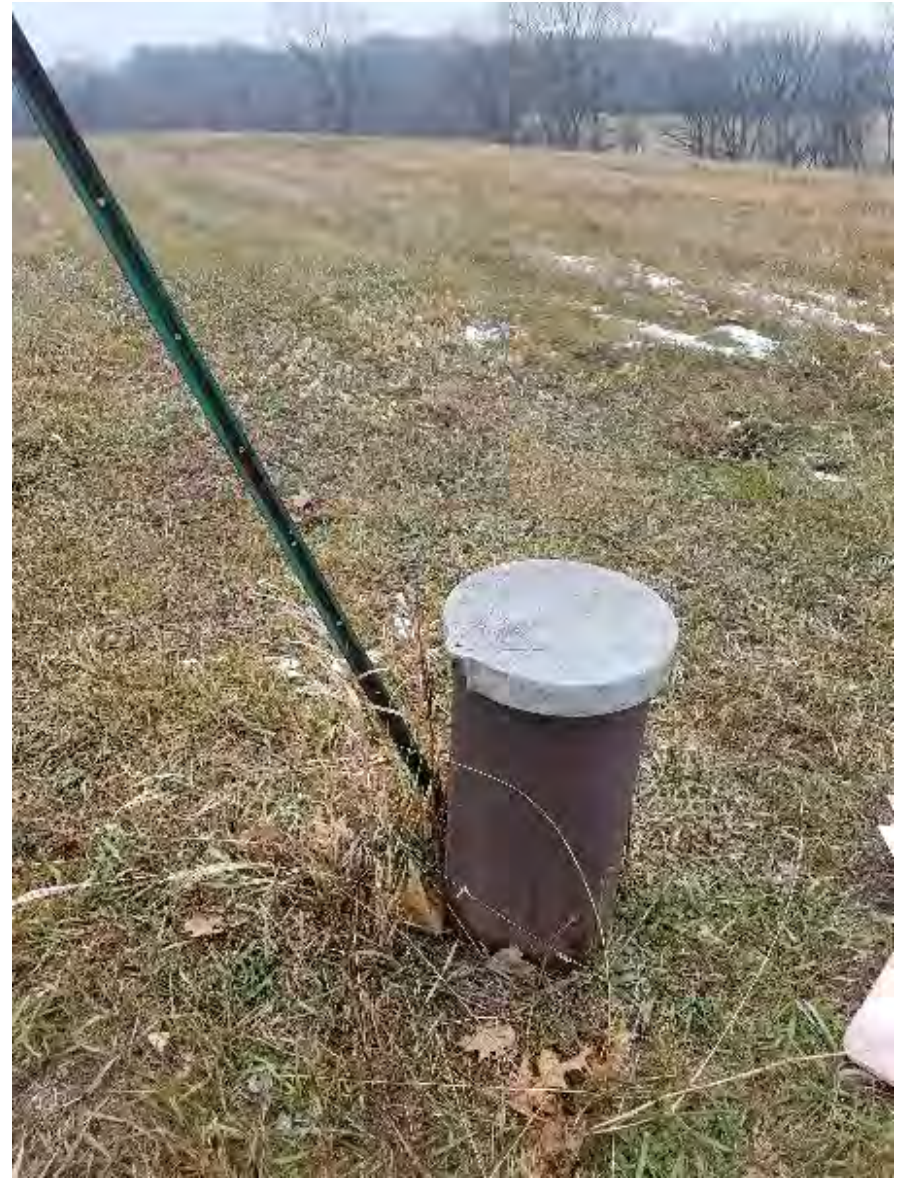
3. GV-3 boot needs repair, looking NW

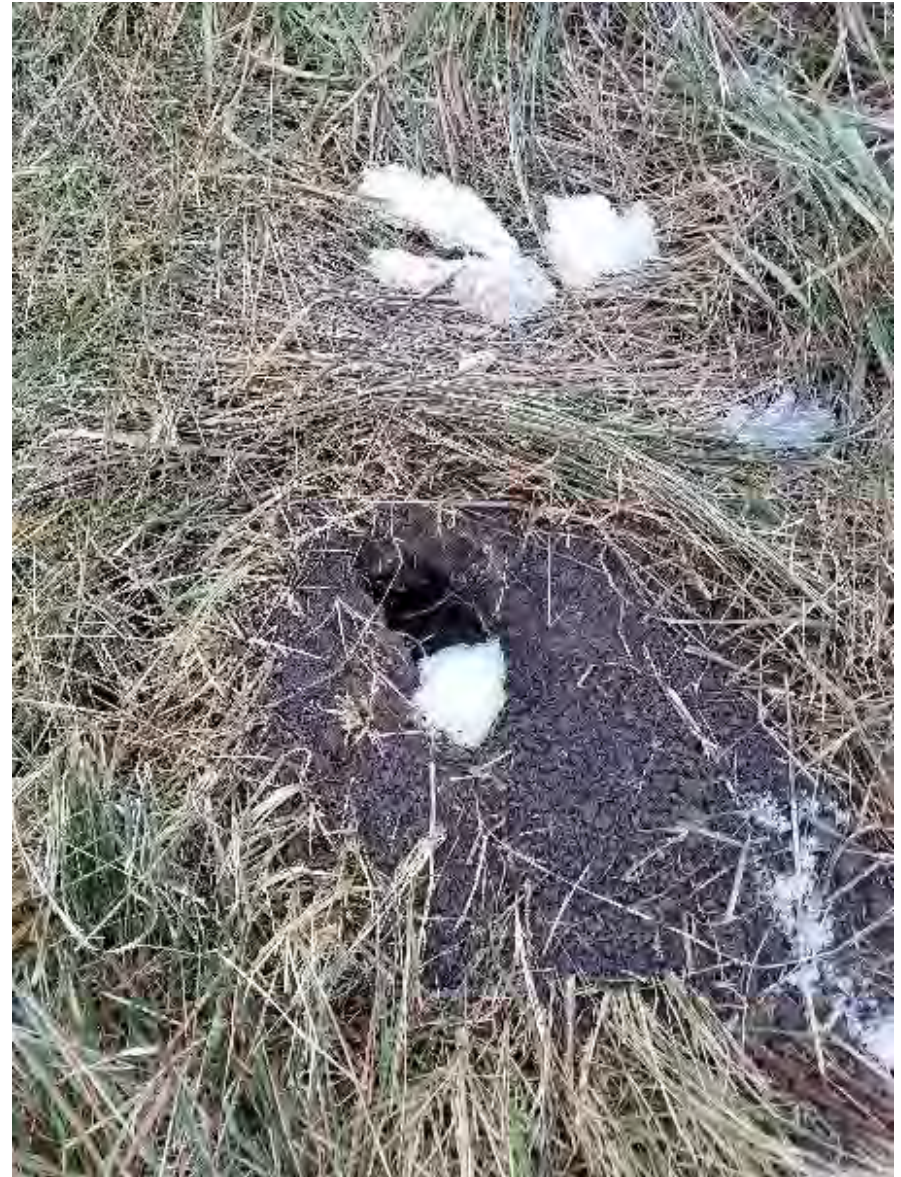
9. Animal burrow, looking SE towards GV-6

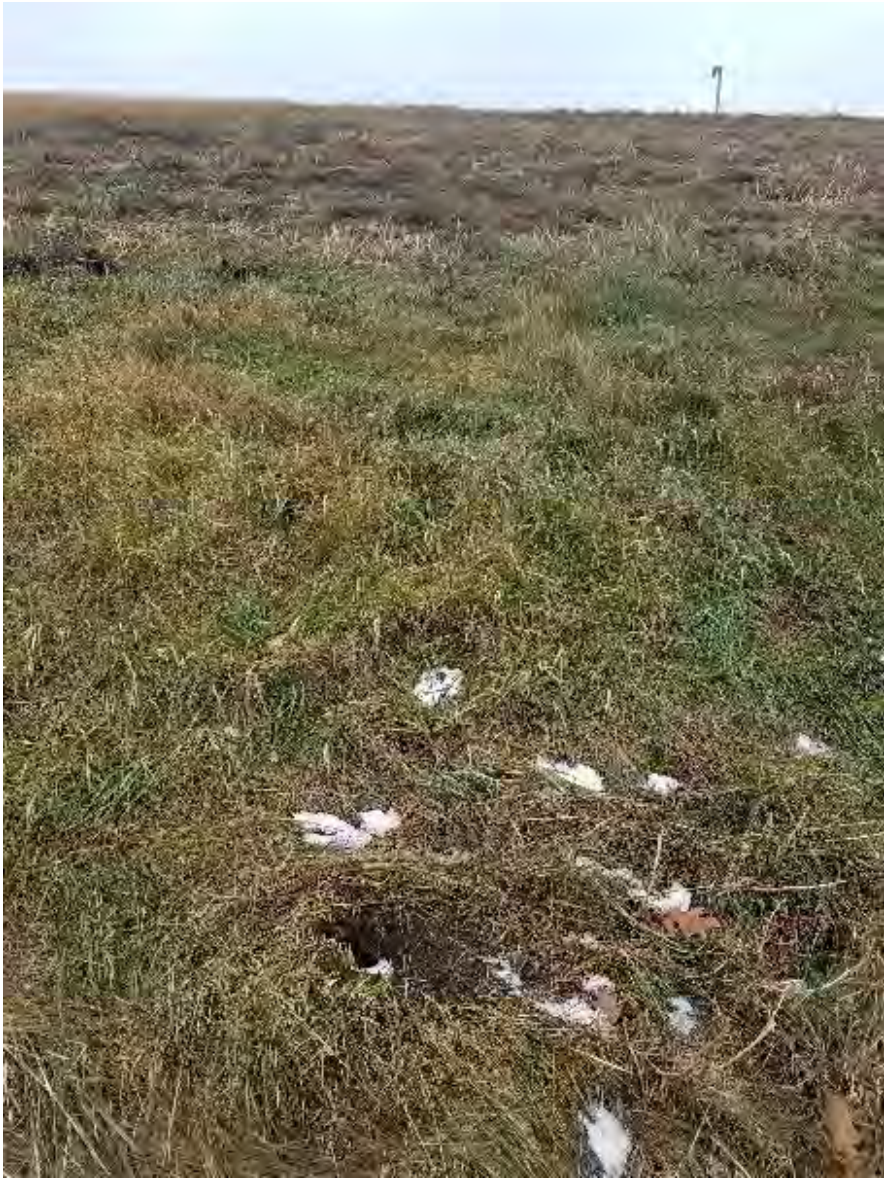
10. Animal Burrow E of GV-7

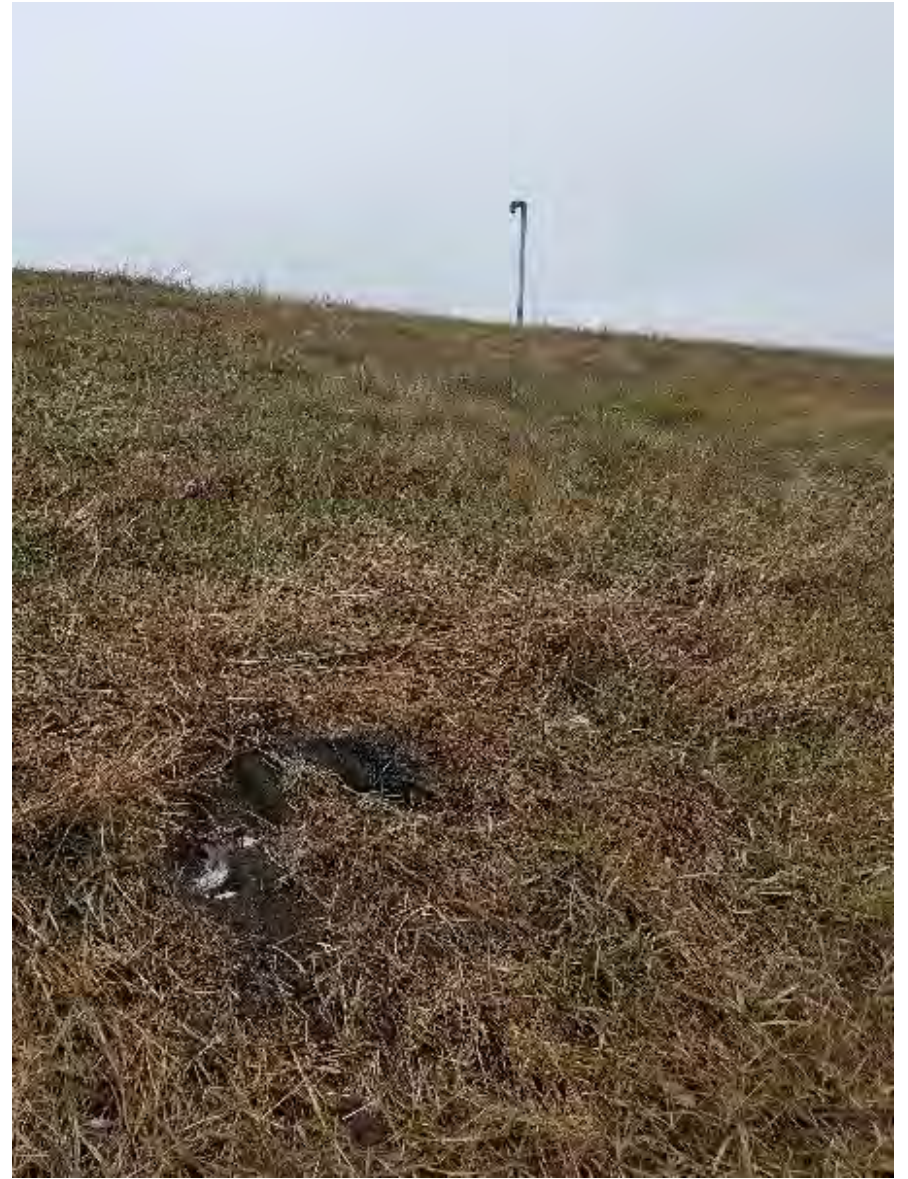
11. Animal Burrow, looking W at GV-7

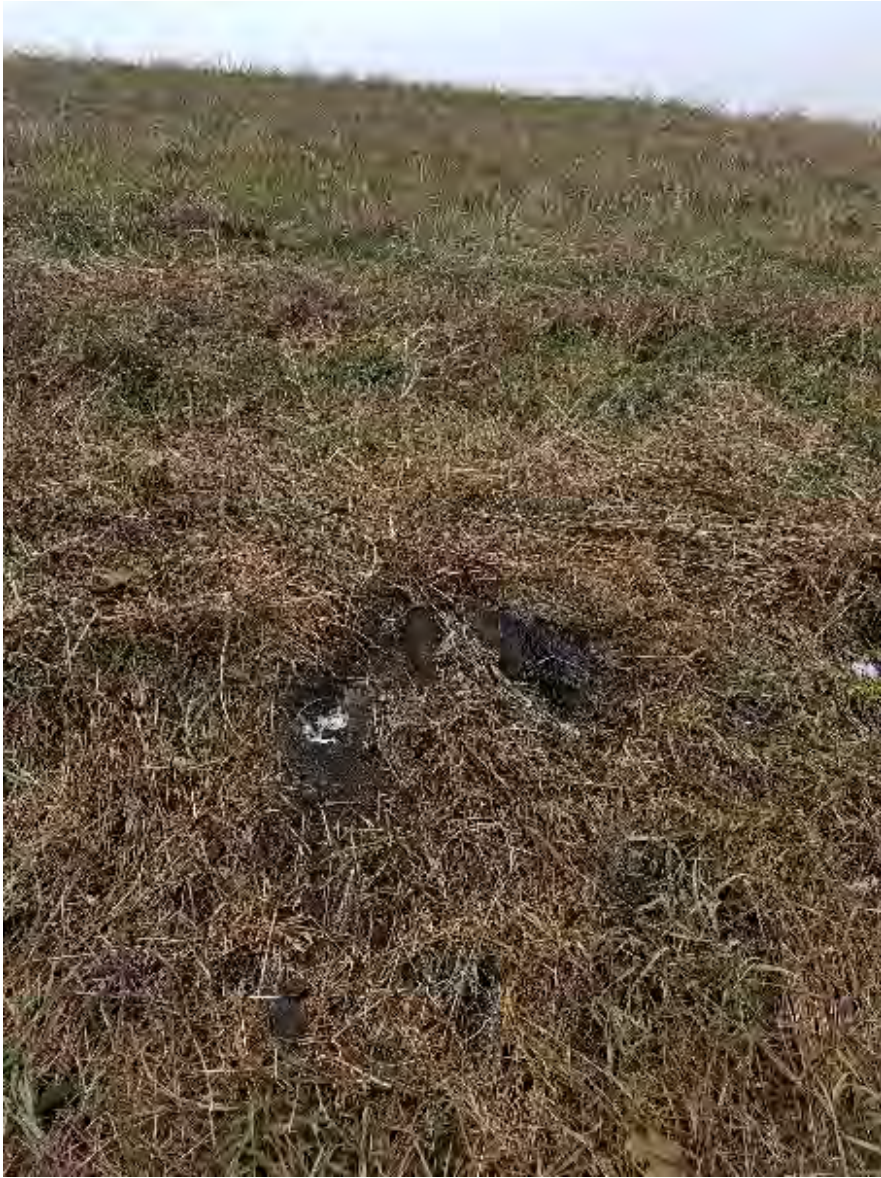
12. Hole and possible damage to liner, looking NW towards GV-8

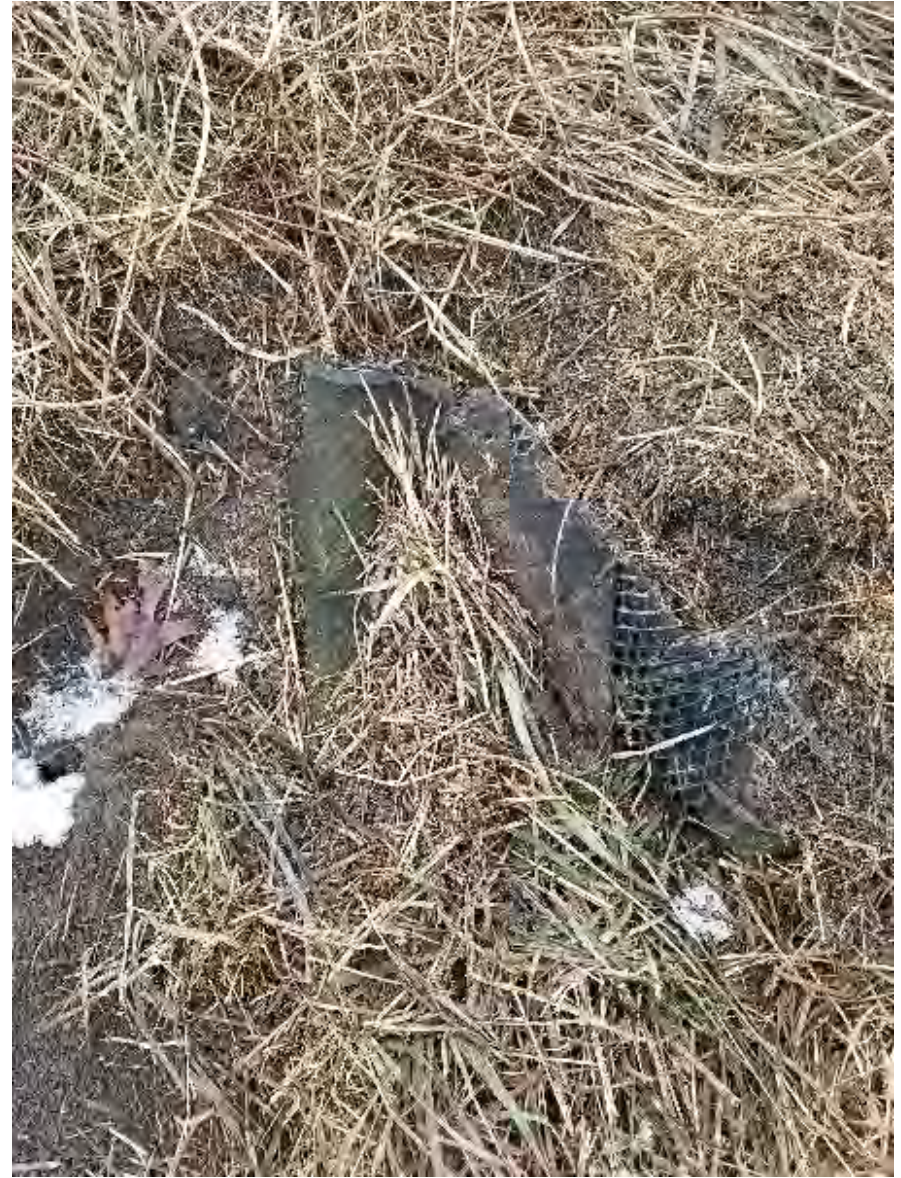
13. Hole and possible damage to liner SE of GV-8, looking W

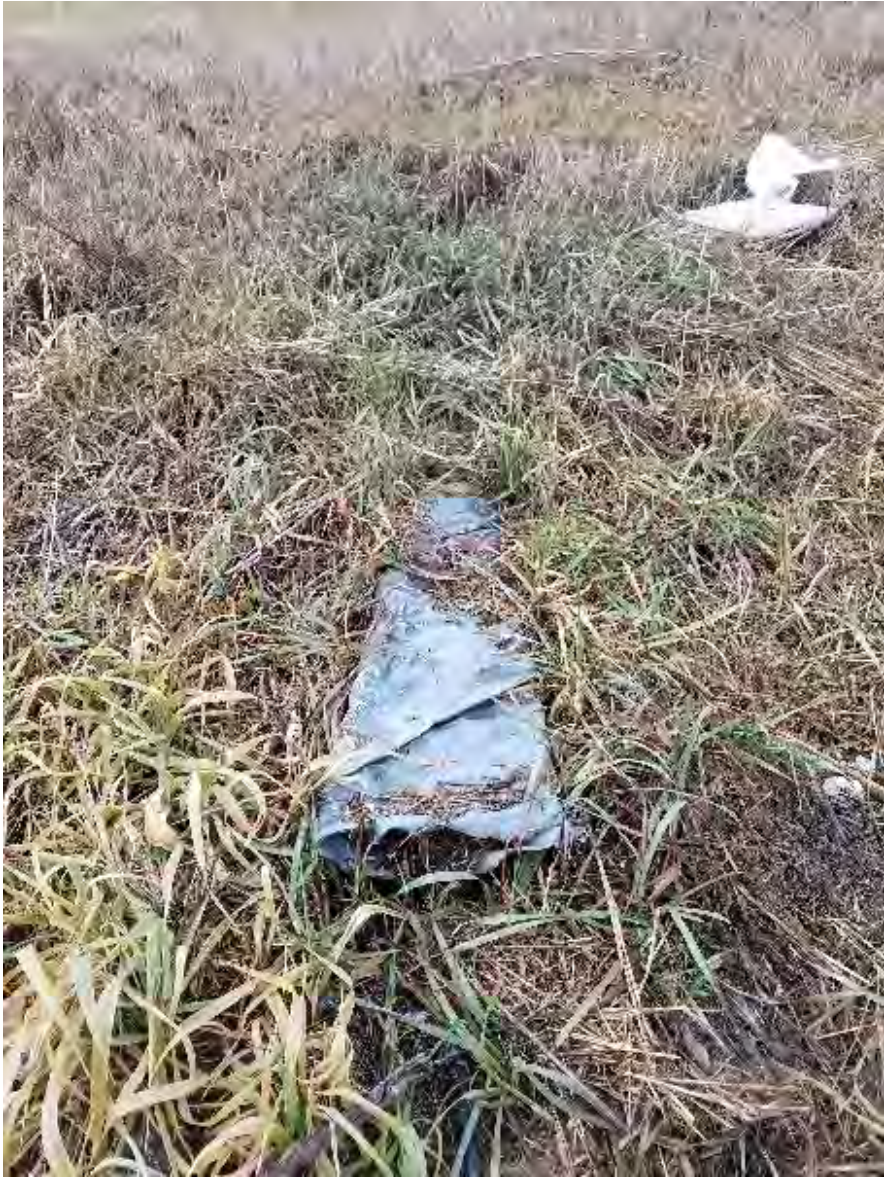
16. Damaged drain pipe

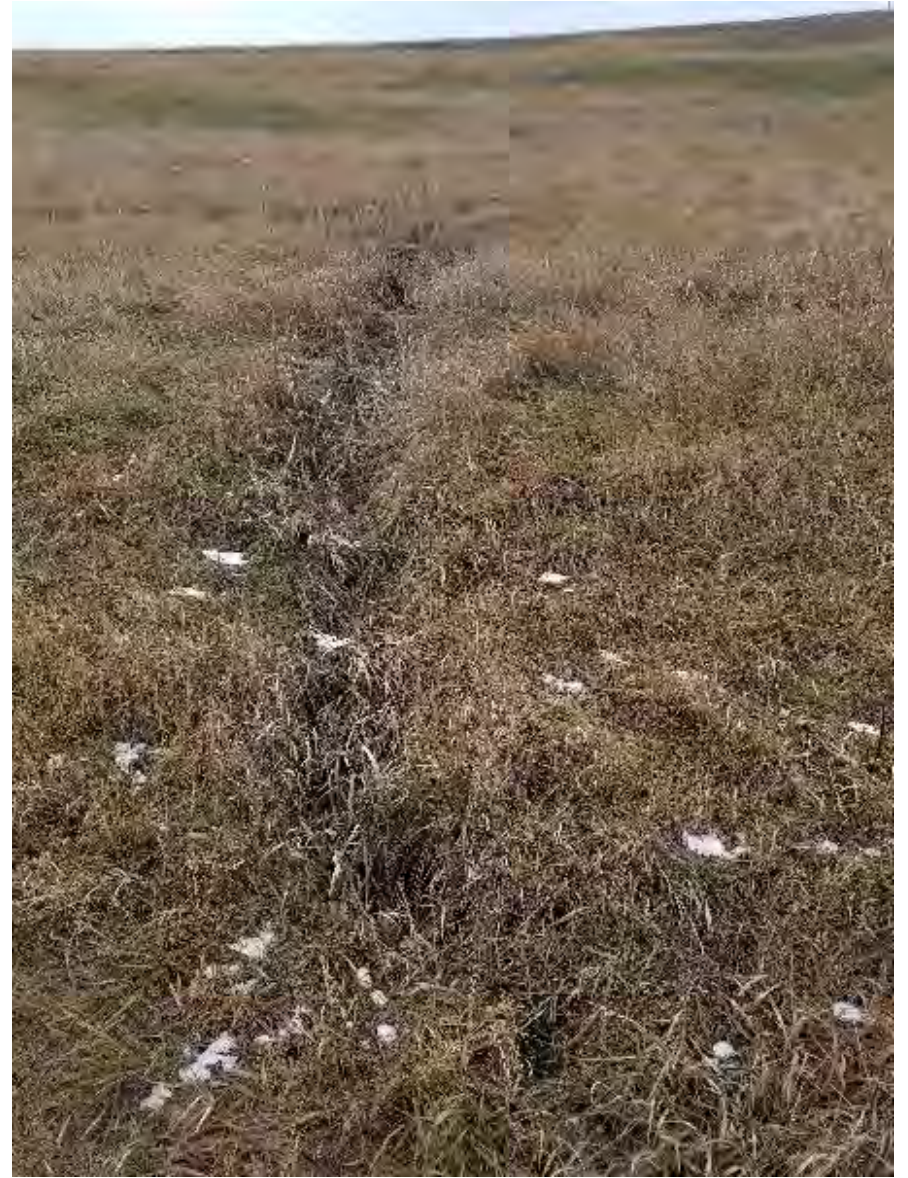
17. Damaged drain pipe, looking NE

11. Drainage layer discharge pipes		X		Drain pipe near GV-26 needs to be repaired/replaced, all others ok
12. Other activities on or adjacent to	X			
13. Additional comments	Some well locks are difficult to open (getting old and rusted) and may need to

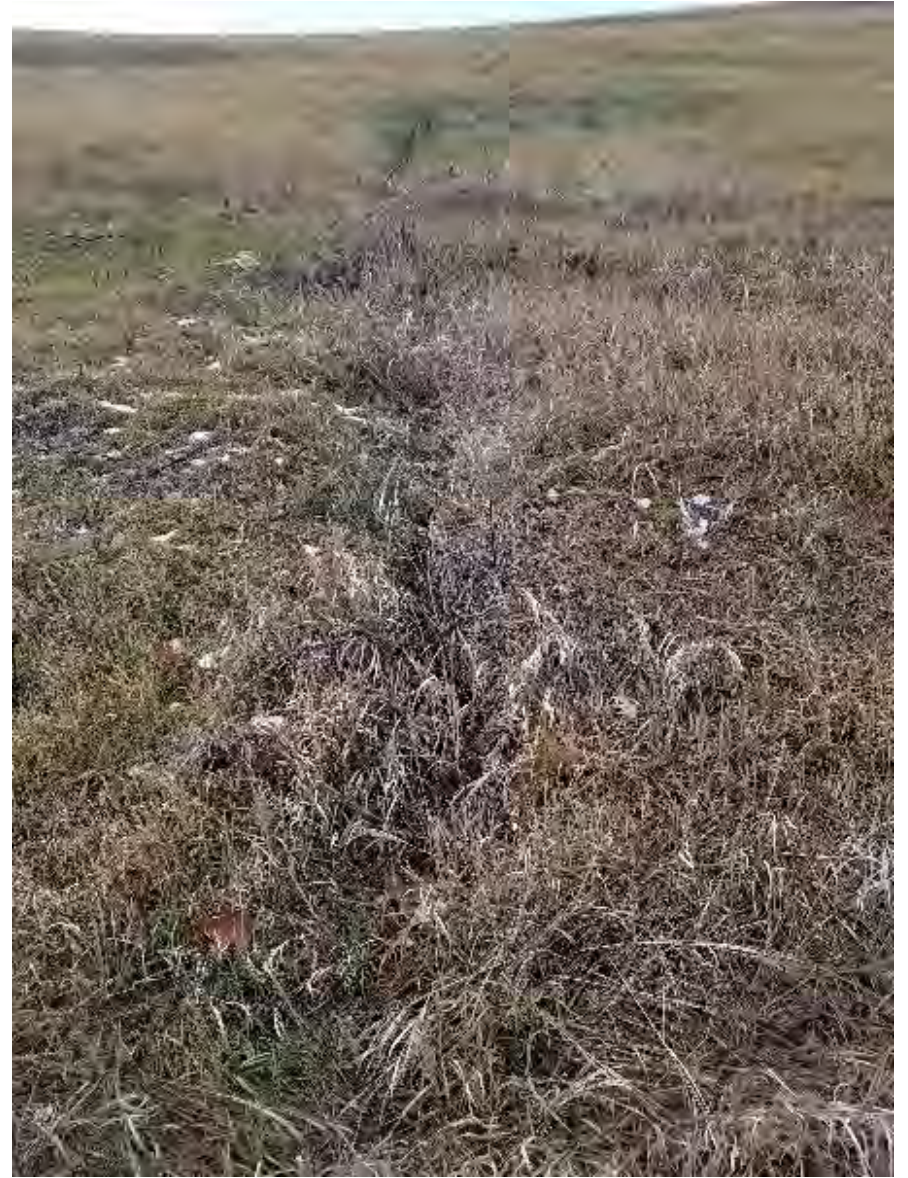
19. Erosion on NE hill face, looking SW towards GV-6

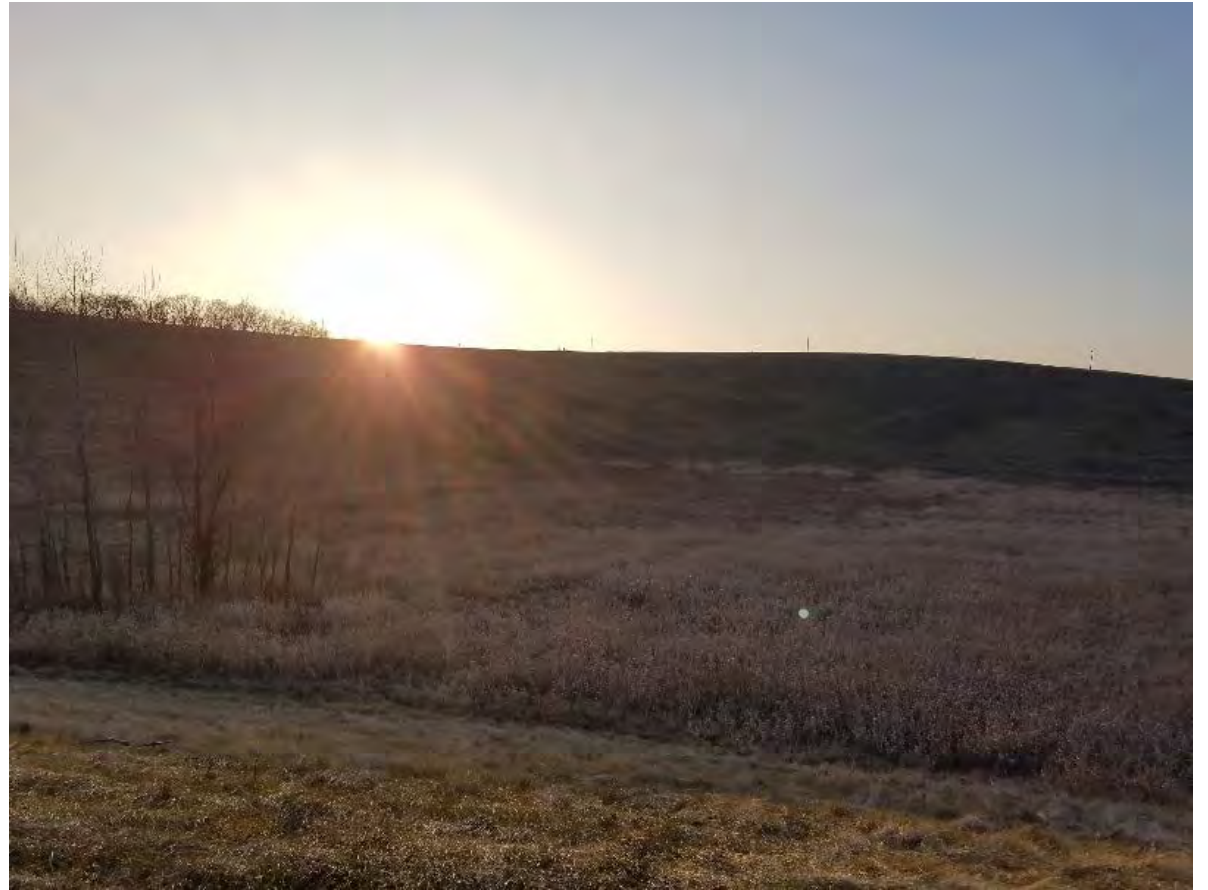
21. Erosion on NE hill face, looking SW towards GV-6

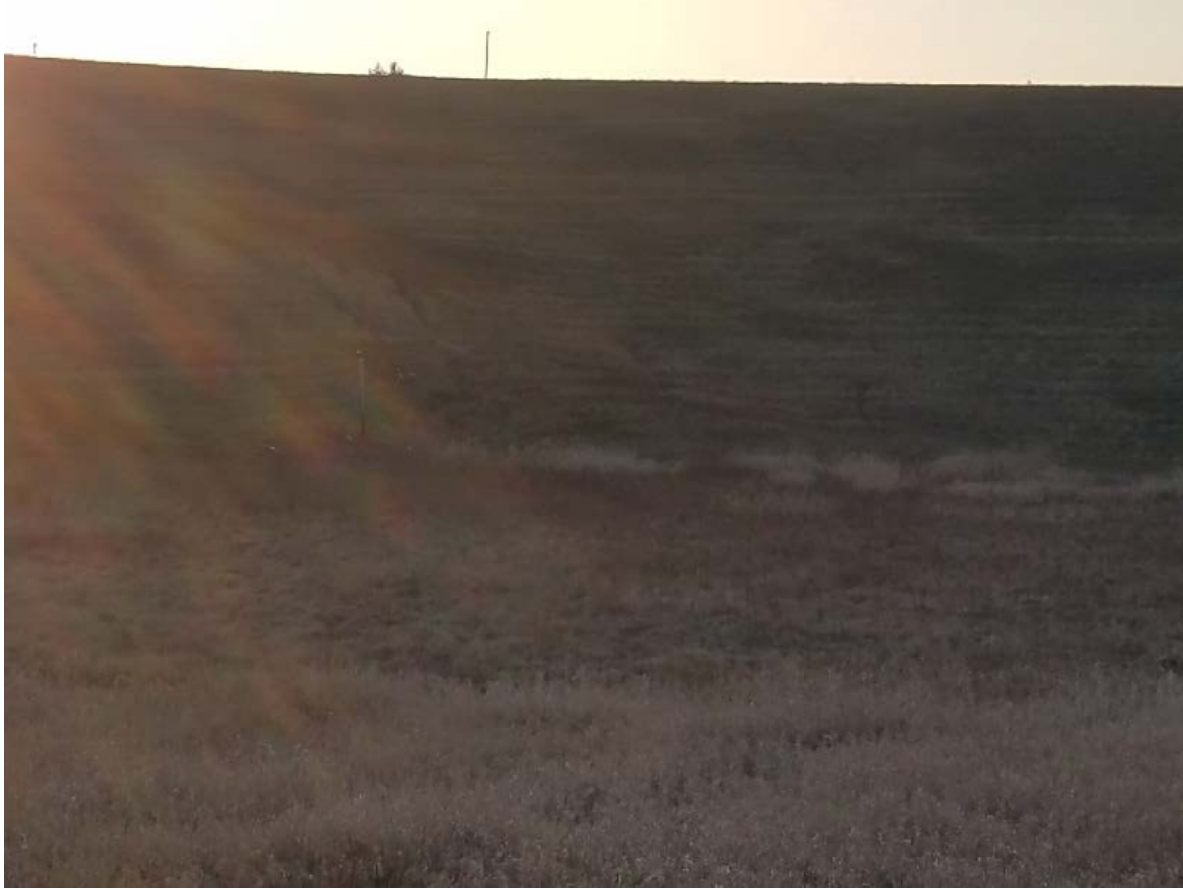
22. NE hill face erosion, looking SW

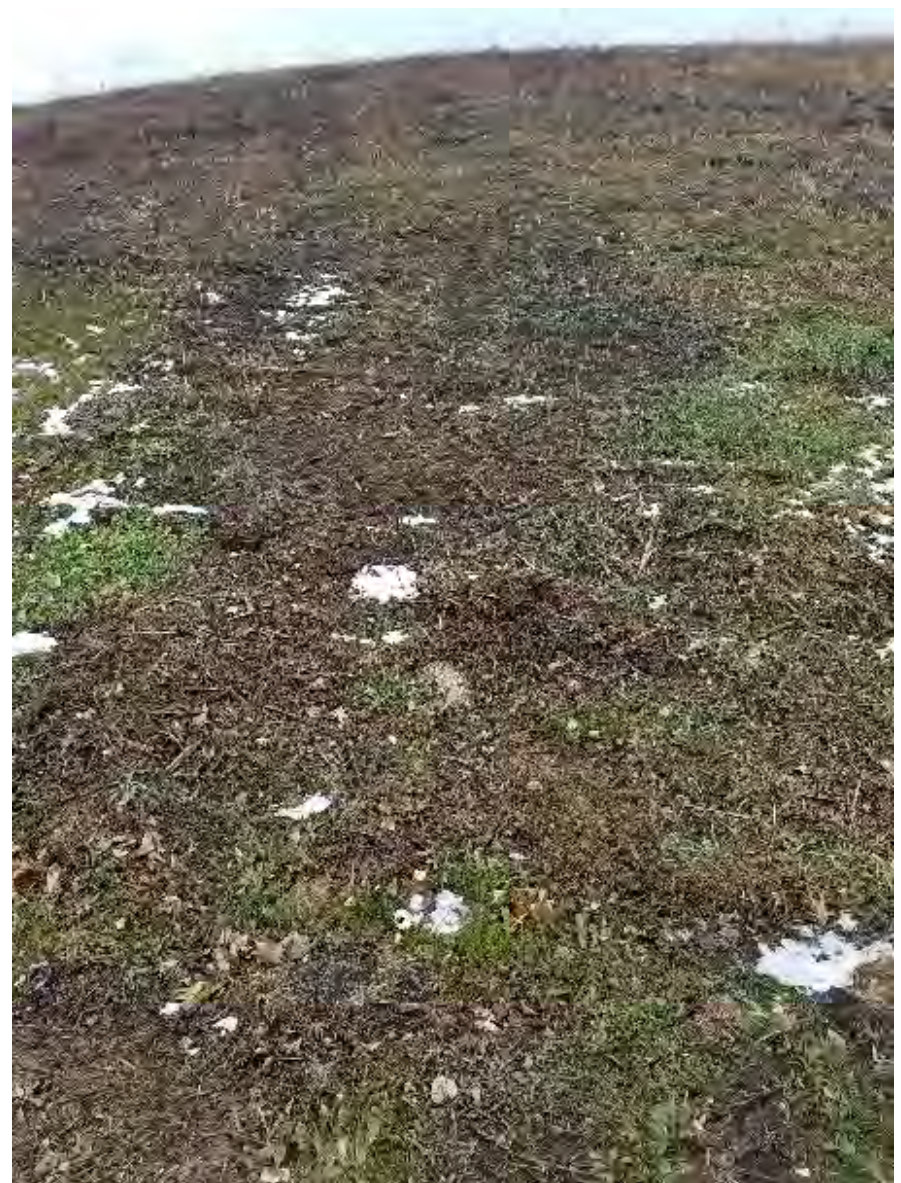
23. NE hill face erosion, looking WSW

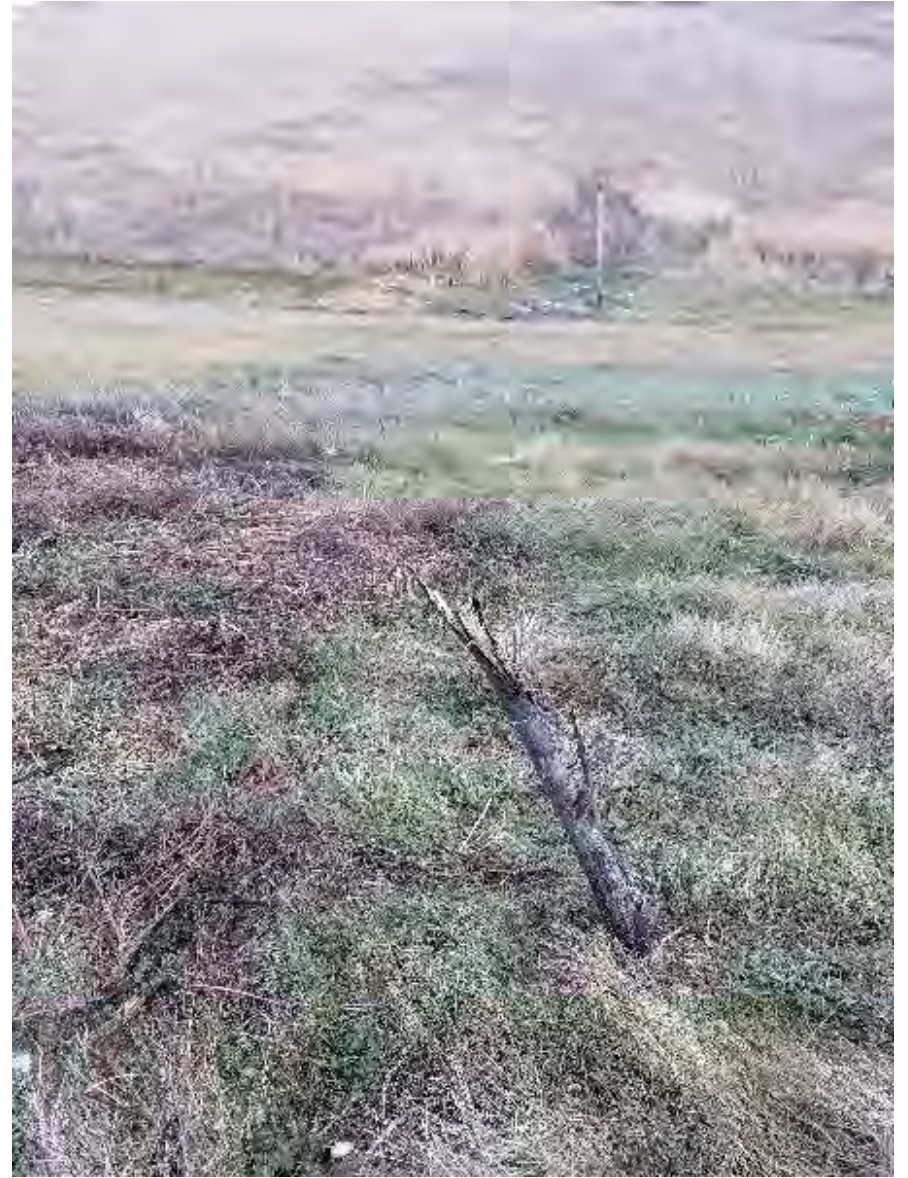
25. Bare spot in vegetation, looking uphill SE towards GV-2

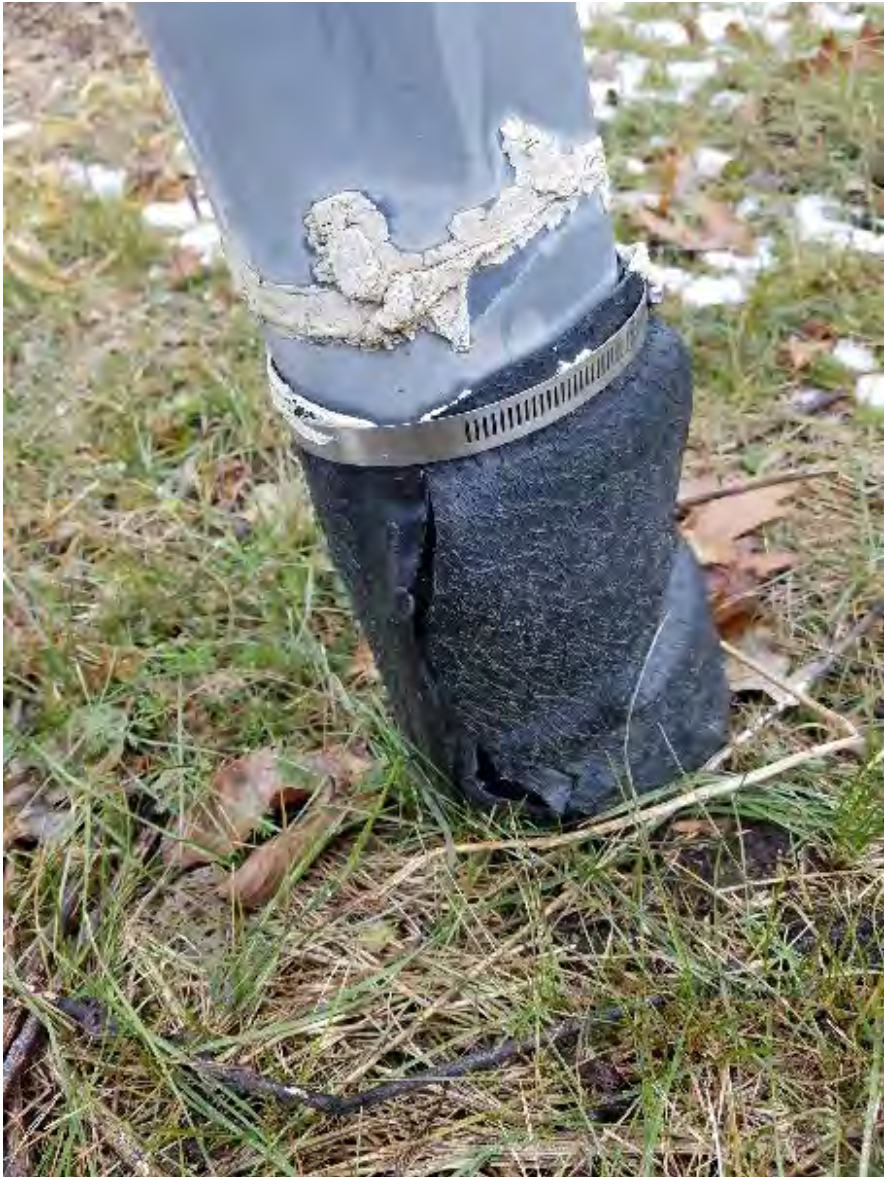
30. Unmarked GV tilting E, looking S at GP-9, towards SE corner of LF

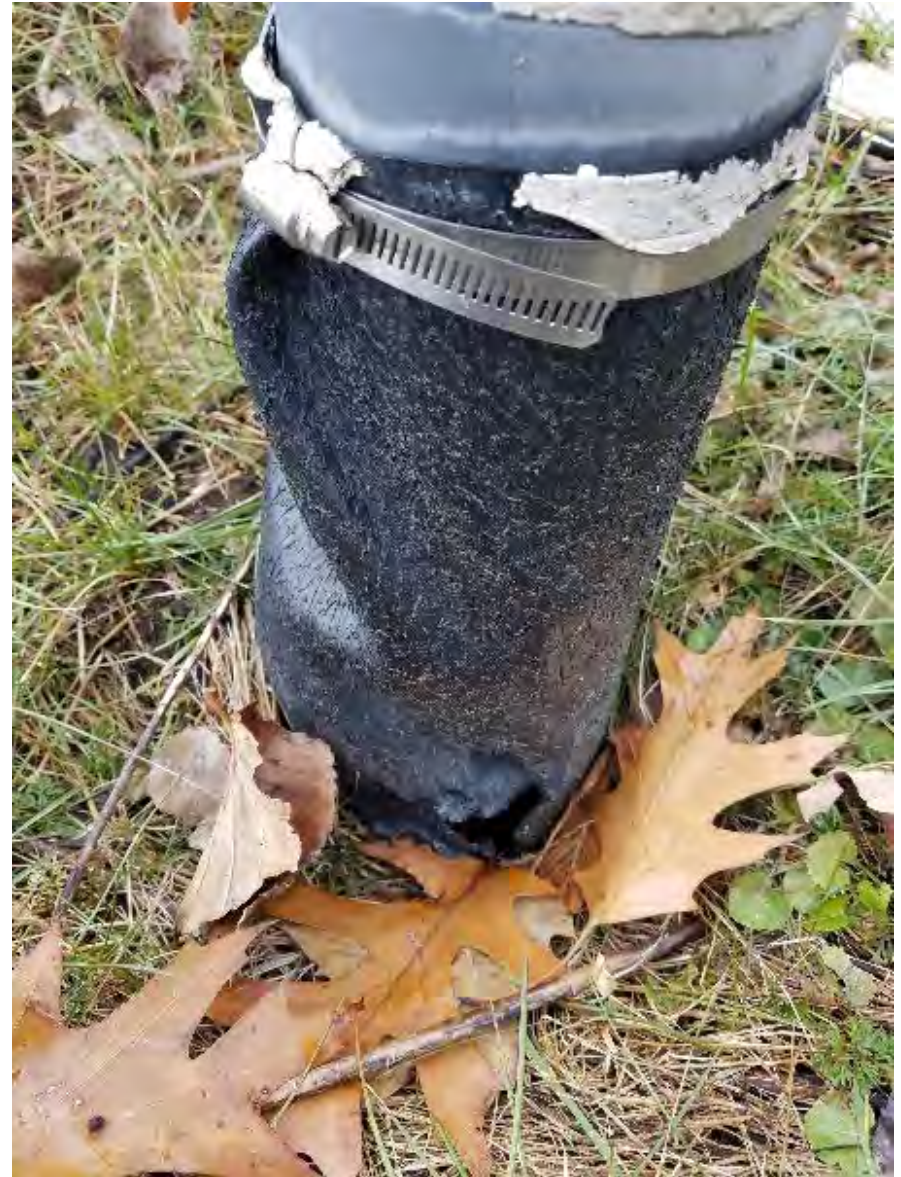
31. Unmarked GV by GP-9 damaged liner

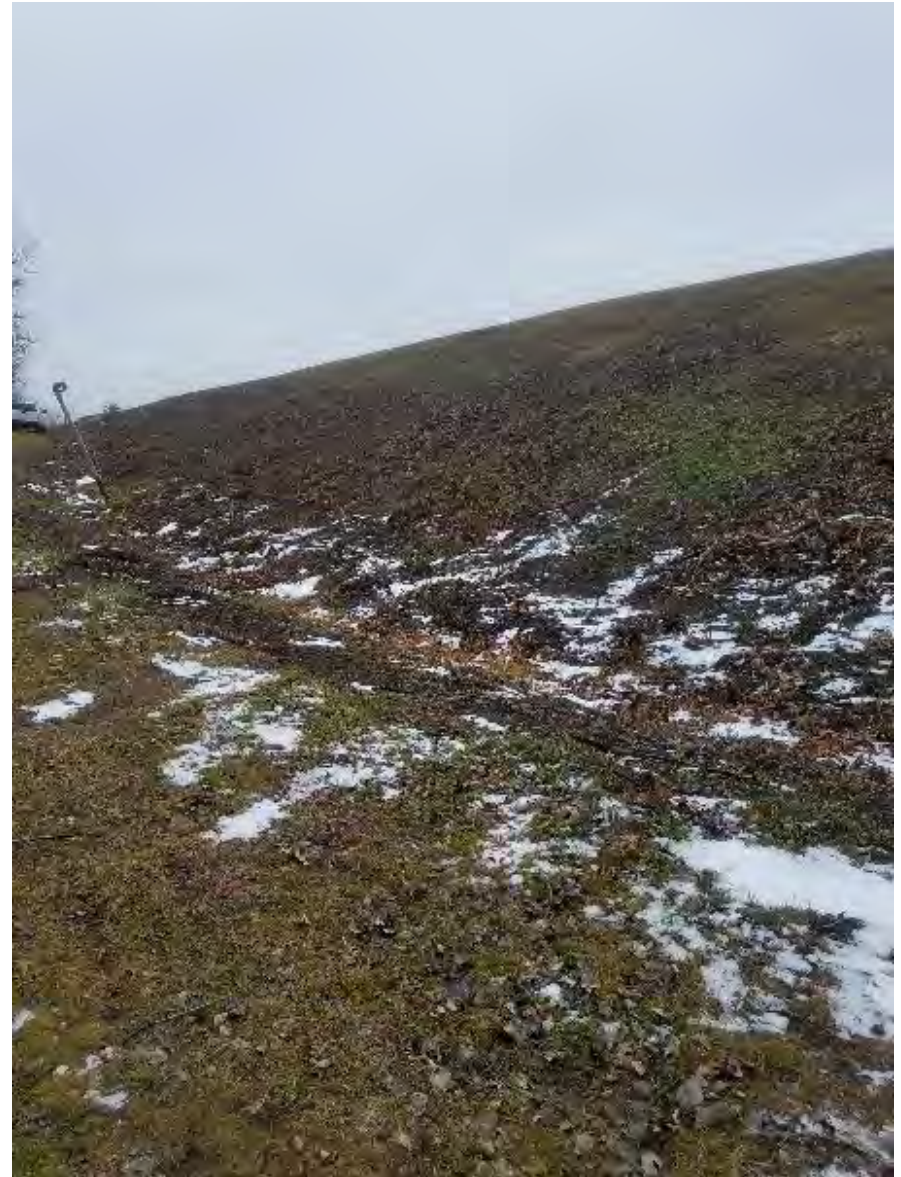
35. SE corner of LF, looking N towards GV-3

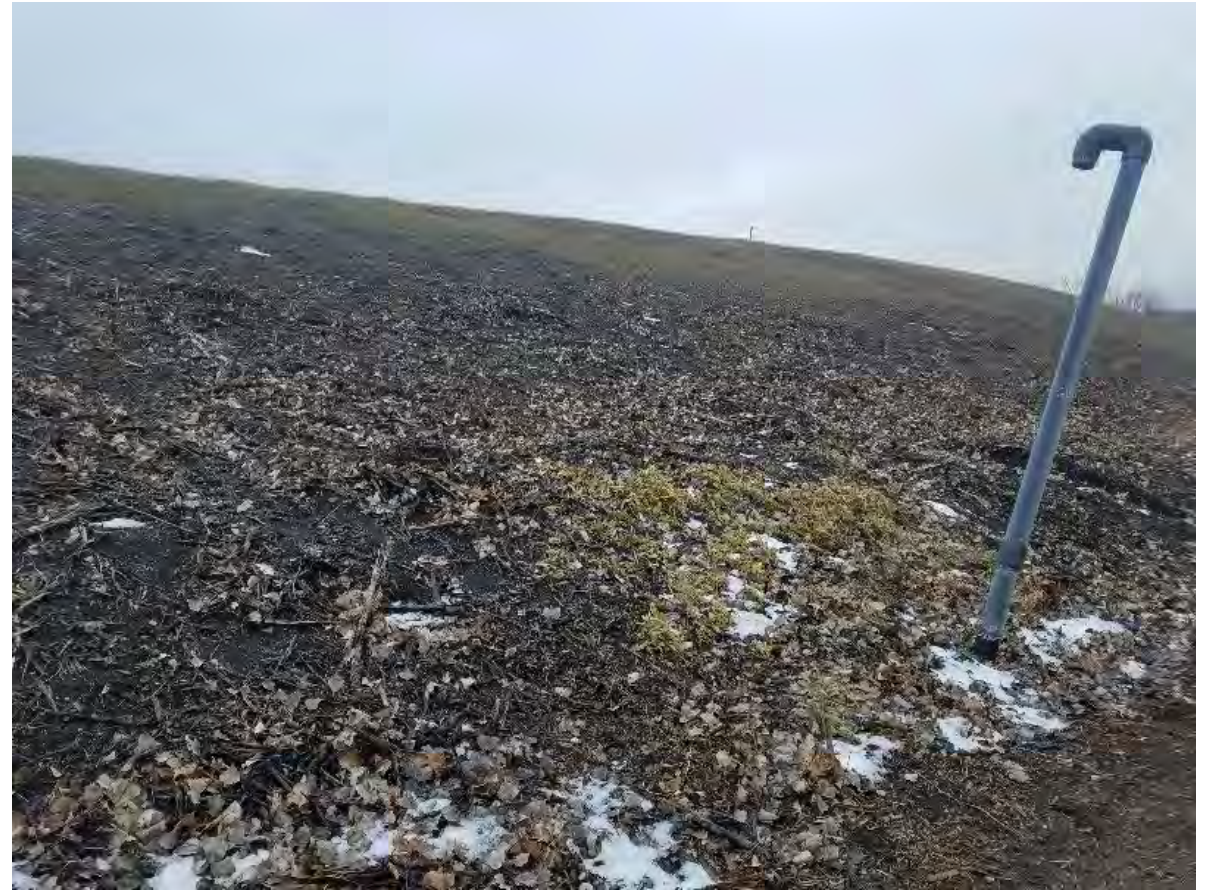
39. GP-10, no caps on individual probes

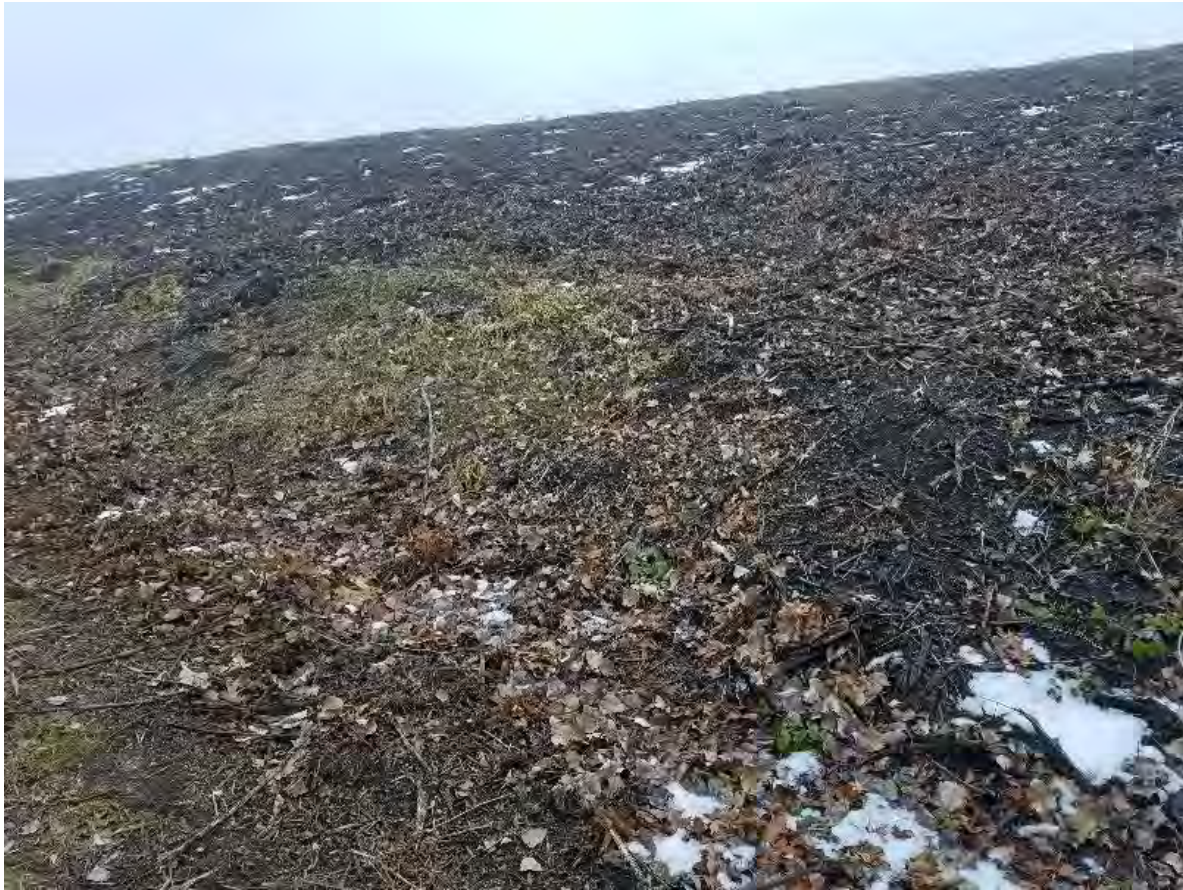
40. GV-49 looking NE, bare spots in vegetation

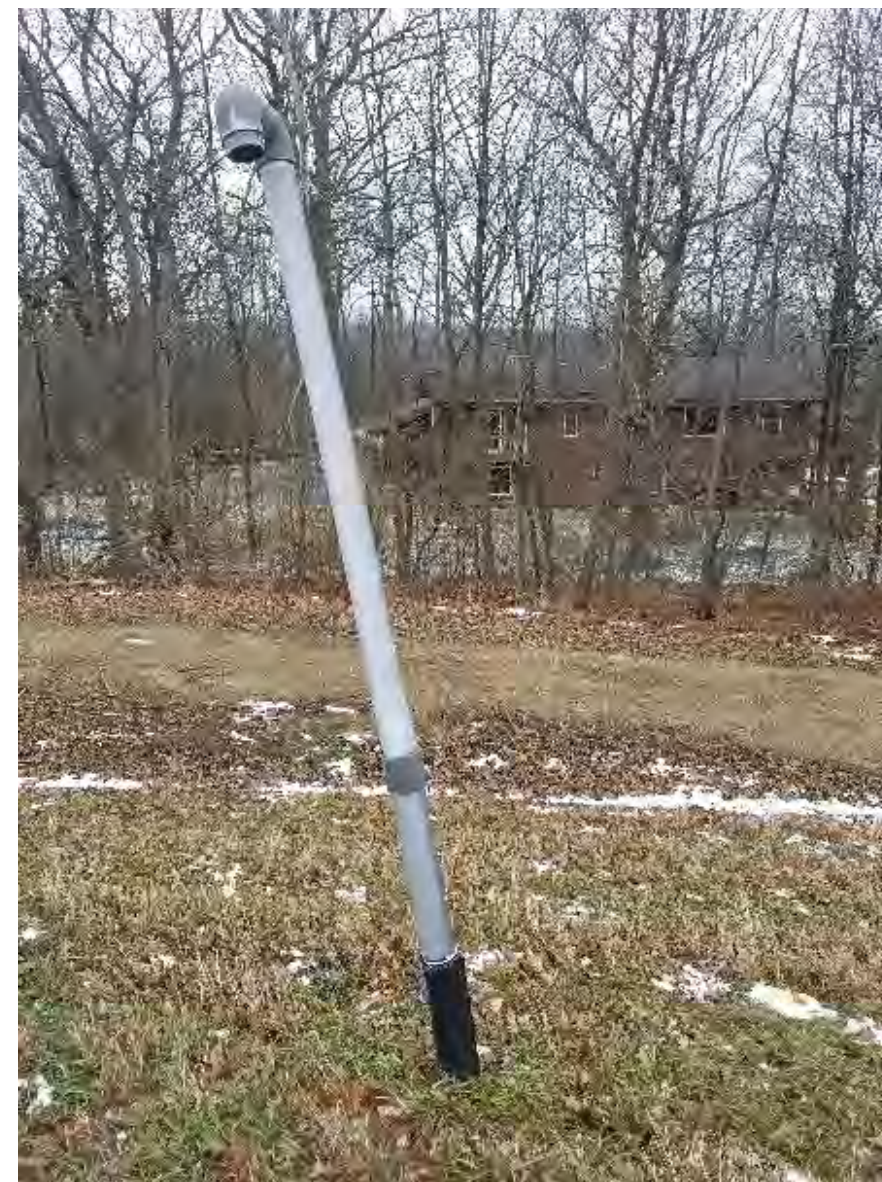
43. B-94-26, no cap
