ANNUAL INSPECTION REPORT

BARRETT LANDFILL

New Berlin, Waukesha County, Wisconsin

January 18, 2018

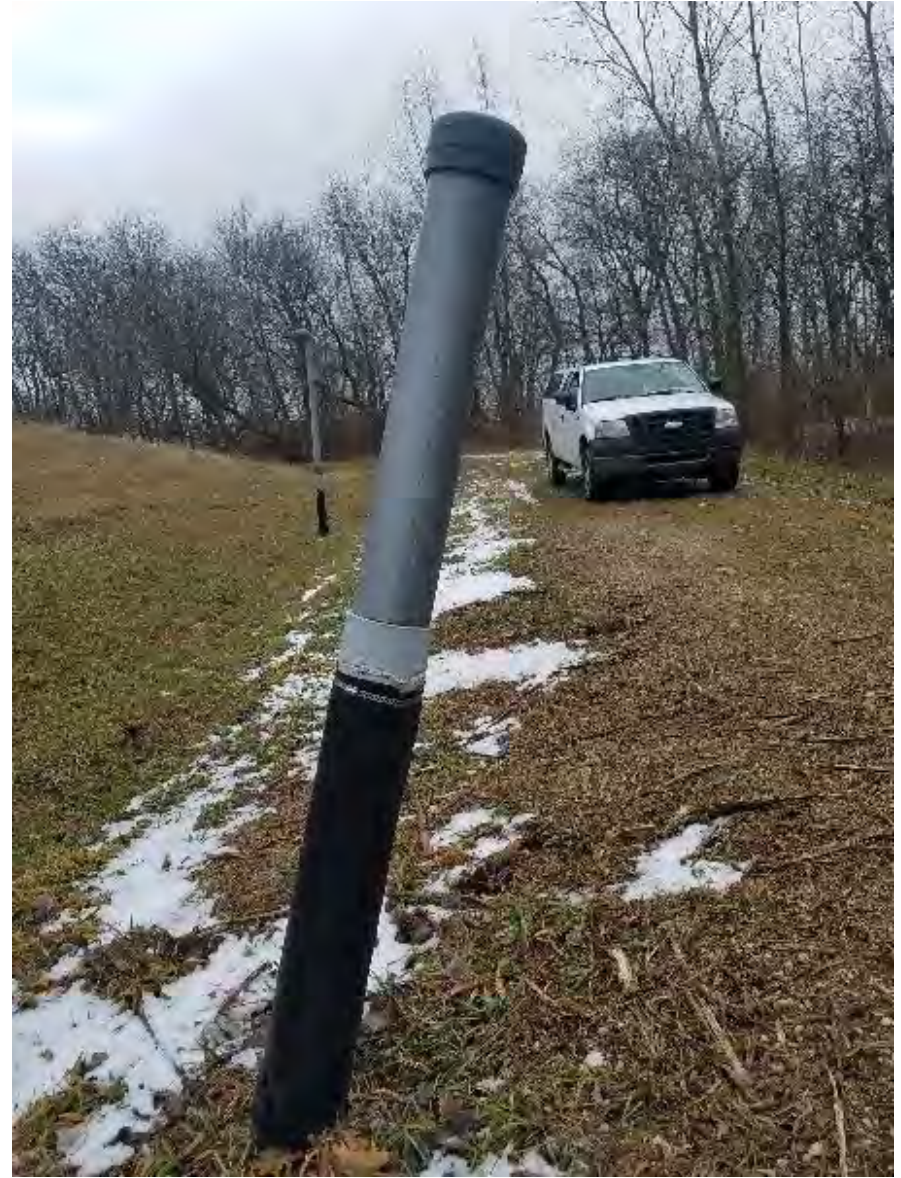
49. W-24, looking NW

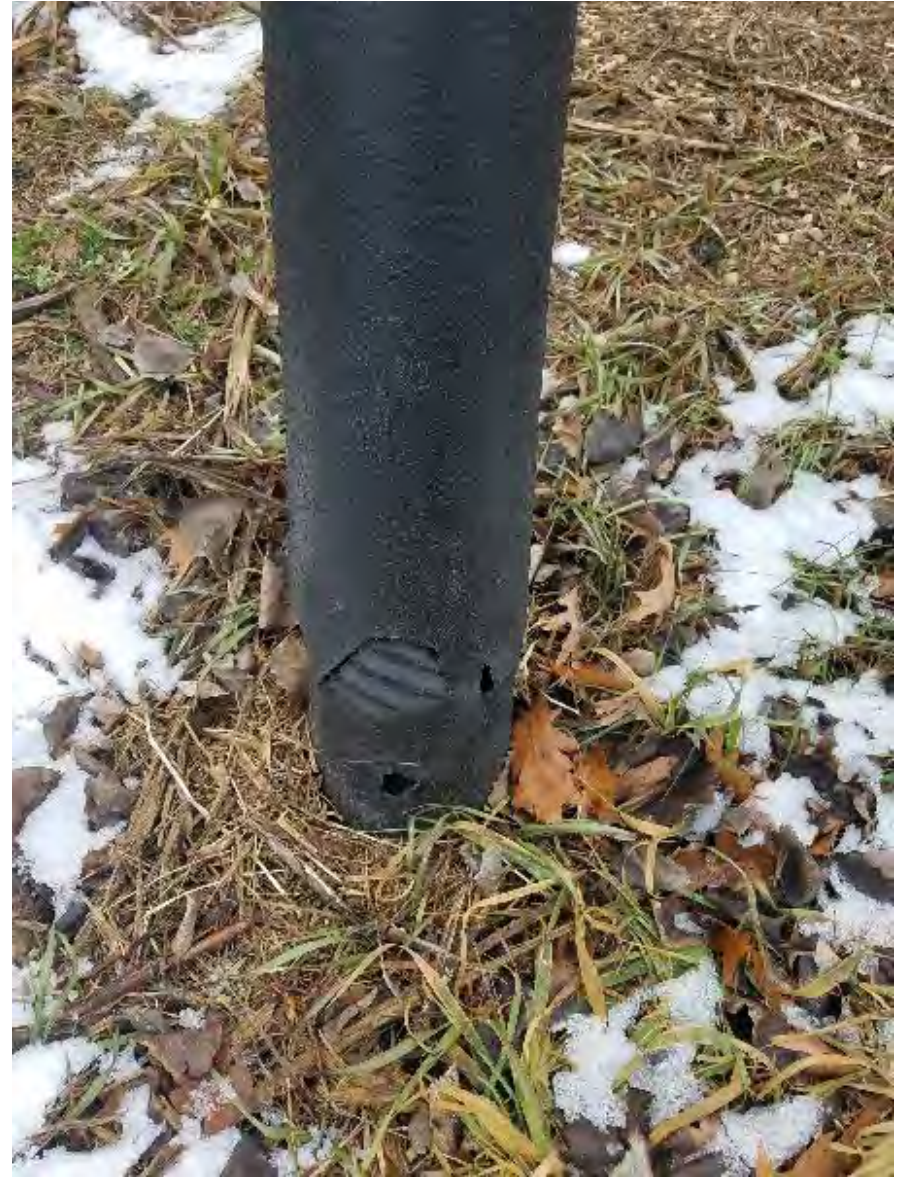
51. Un-numbered LHW by GV-46

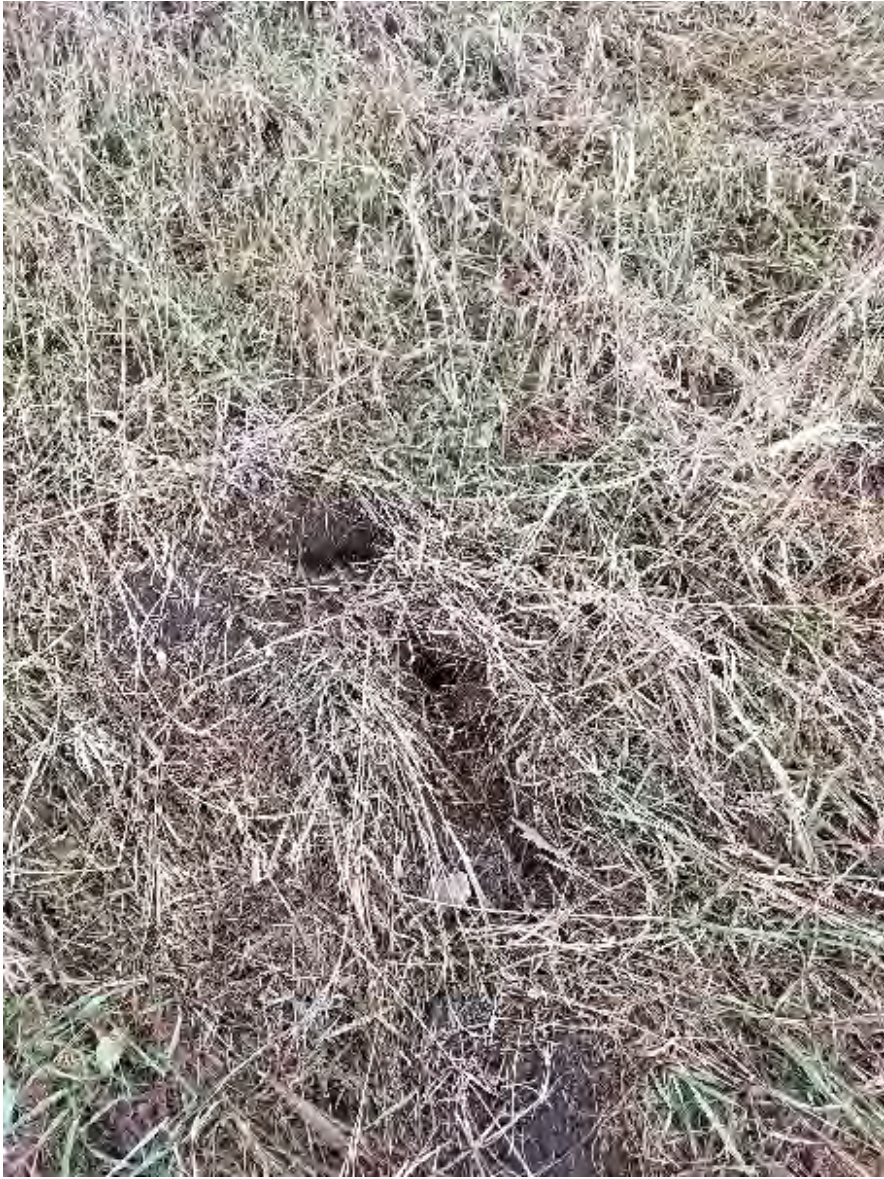
56. Erosion or ruts on SW corner down hill from GV-17 and NE of GV-44

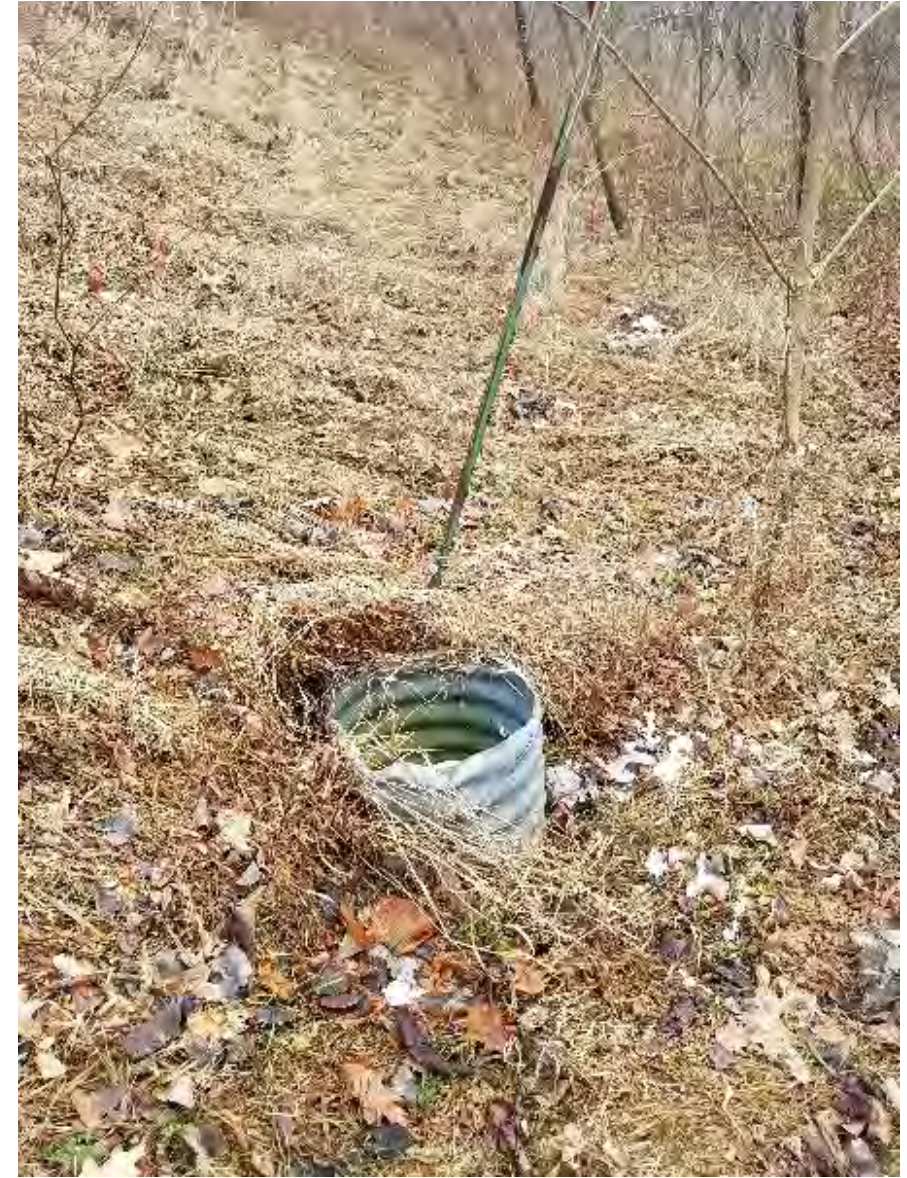
61. B-96-17A, with cap

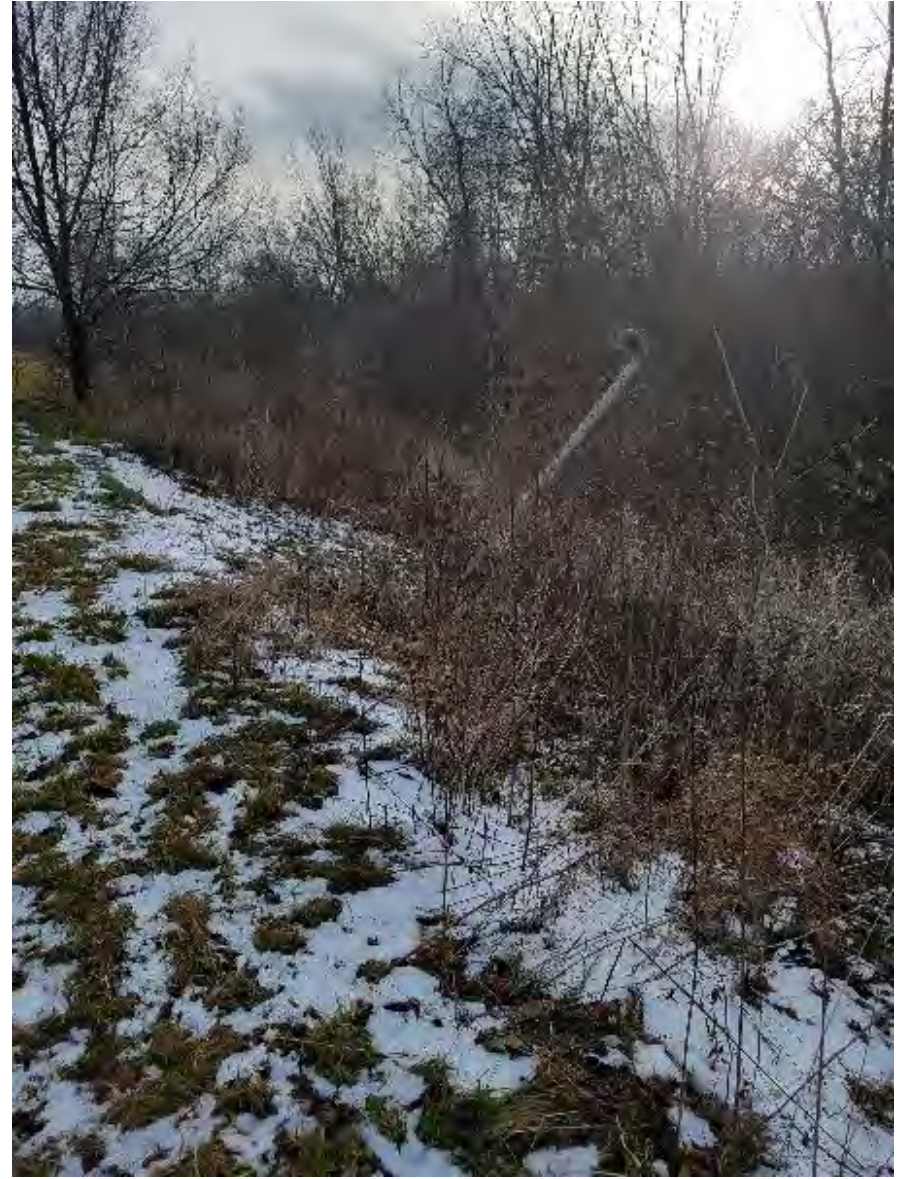
67. GP-6, no caps

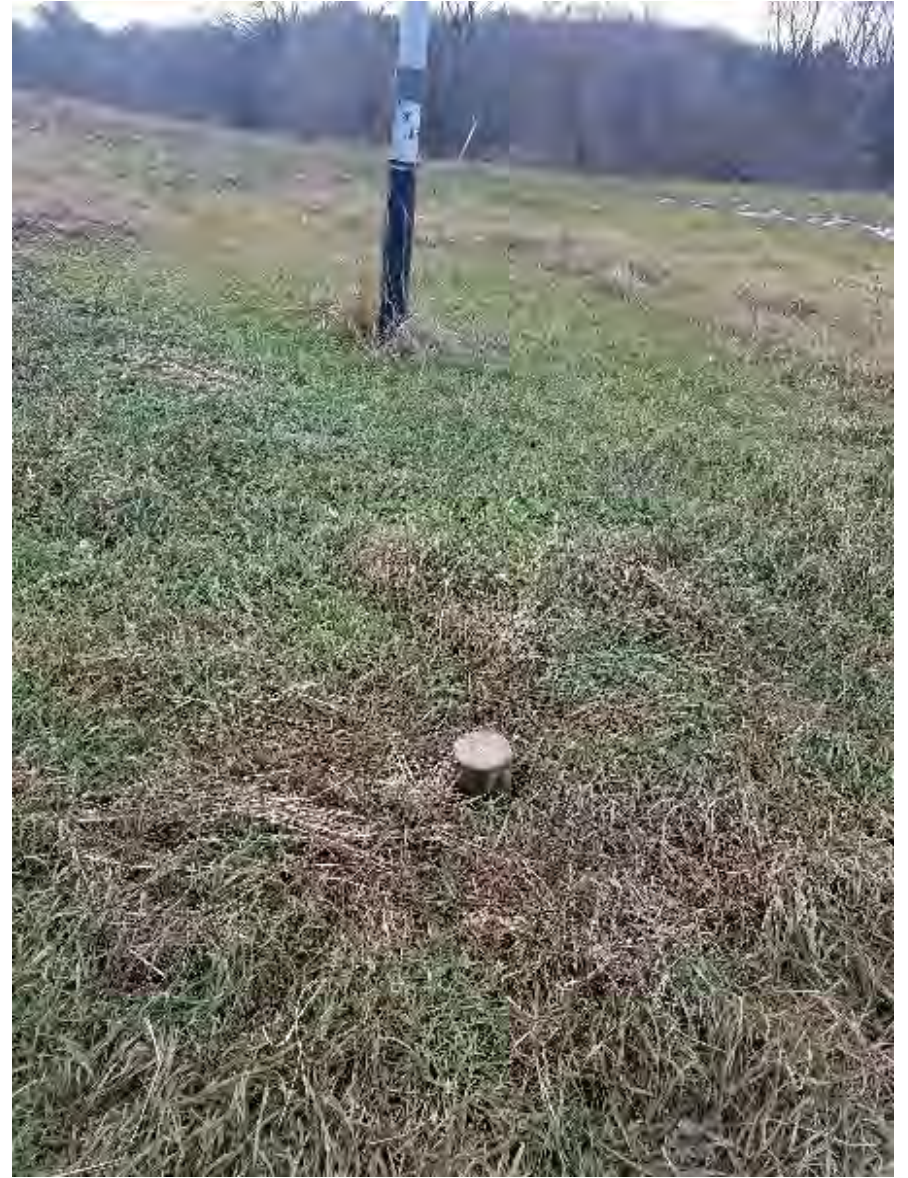
75. Unmarked GV with slight tilt to N, N of GV-39, looking N

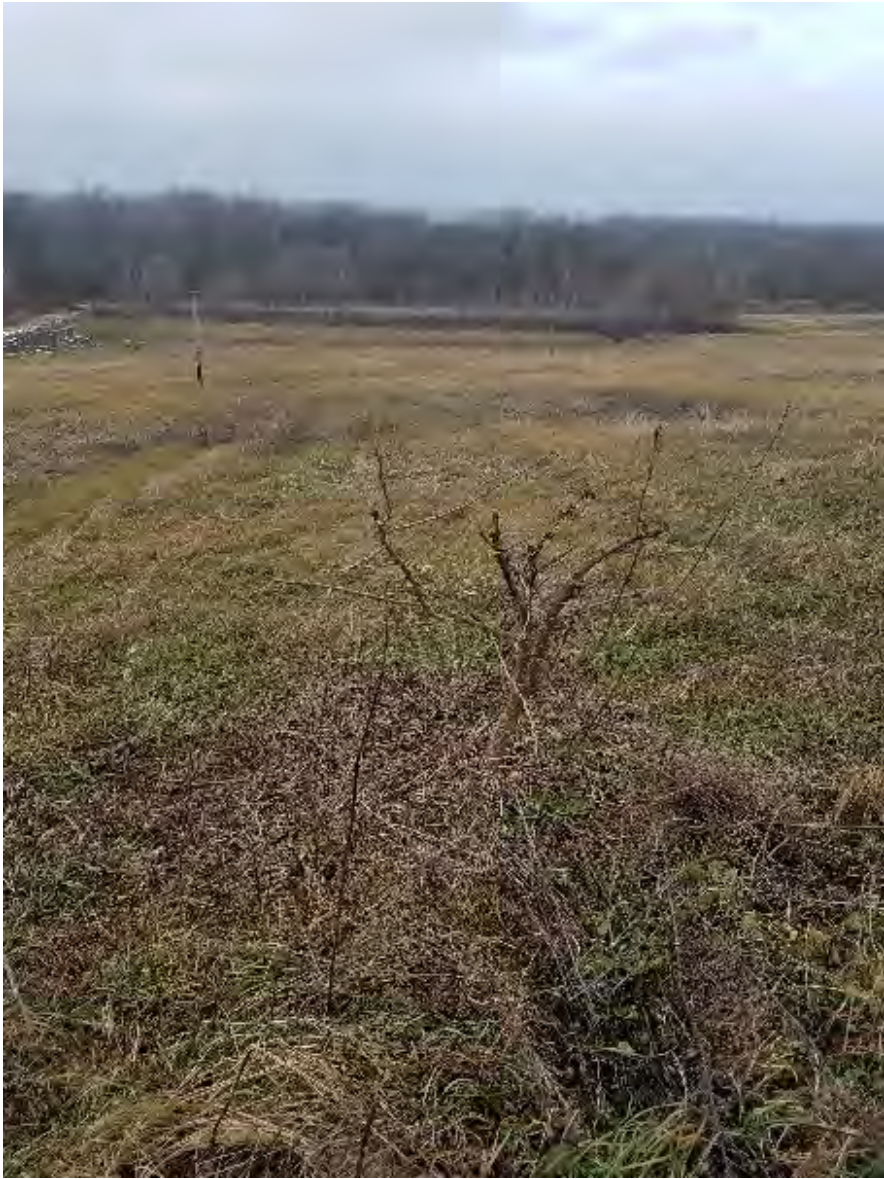
76. Unmarked GV and unmarked LHW, N of GV-39, looking SW

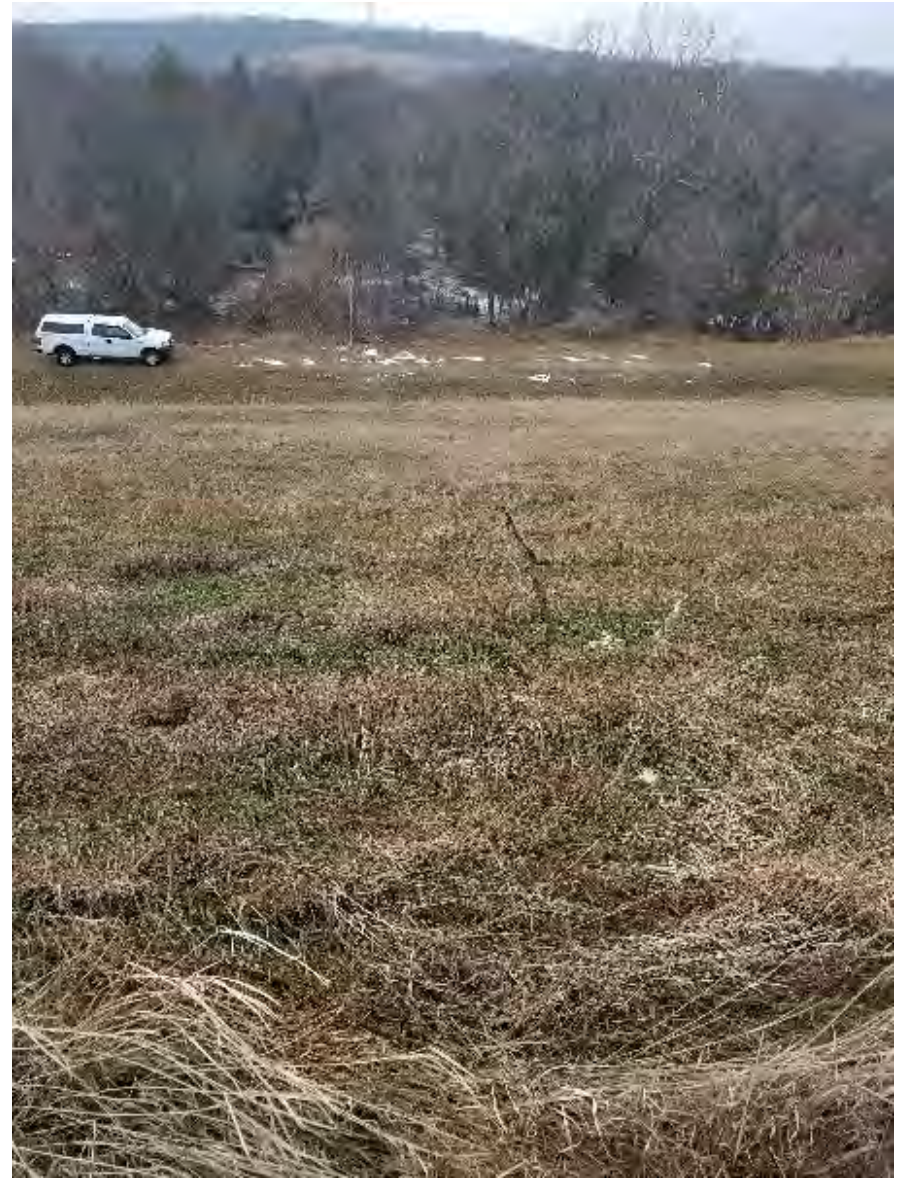
77. Tree stumps at base of unmarked GV that is N of GV-39

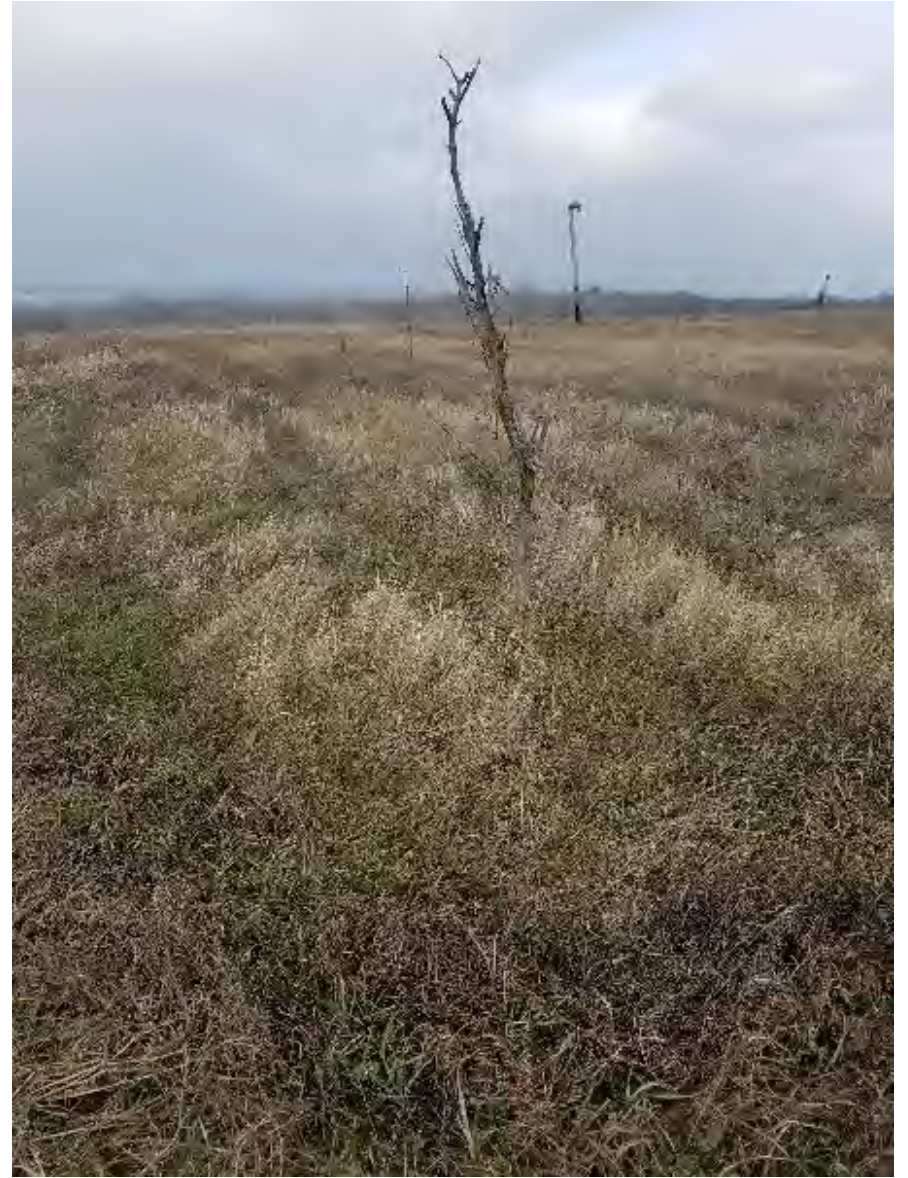
79. Small tree stumps along west hill face, looking W

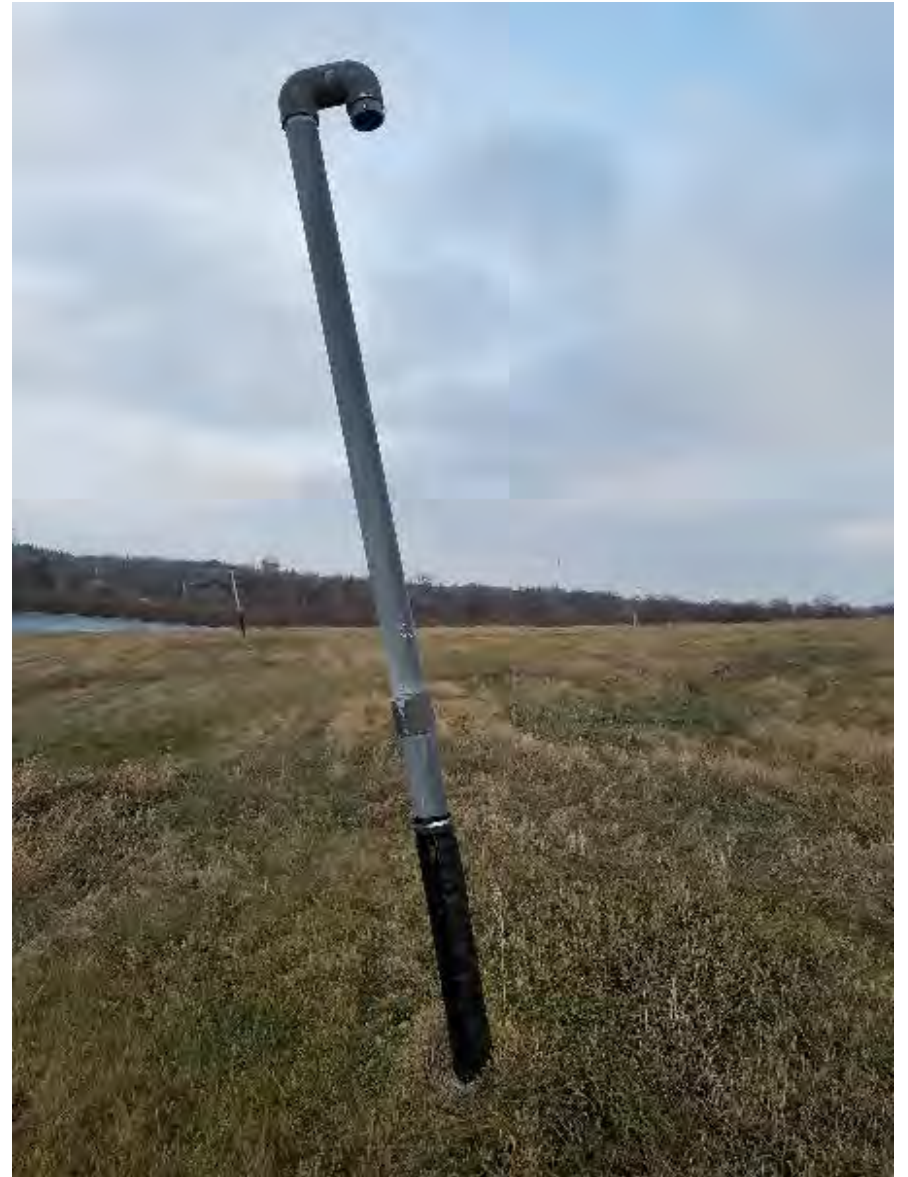
81. GV-14 tilting slightly N, looking E

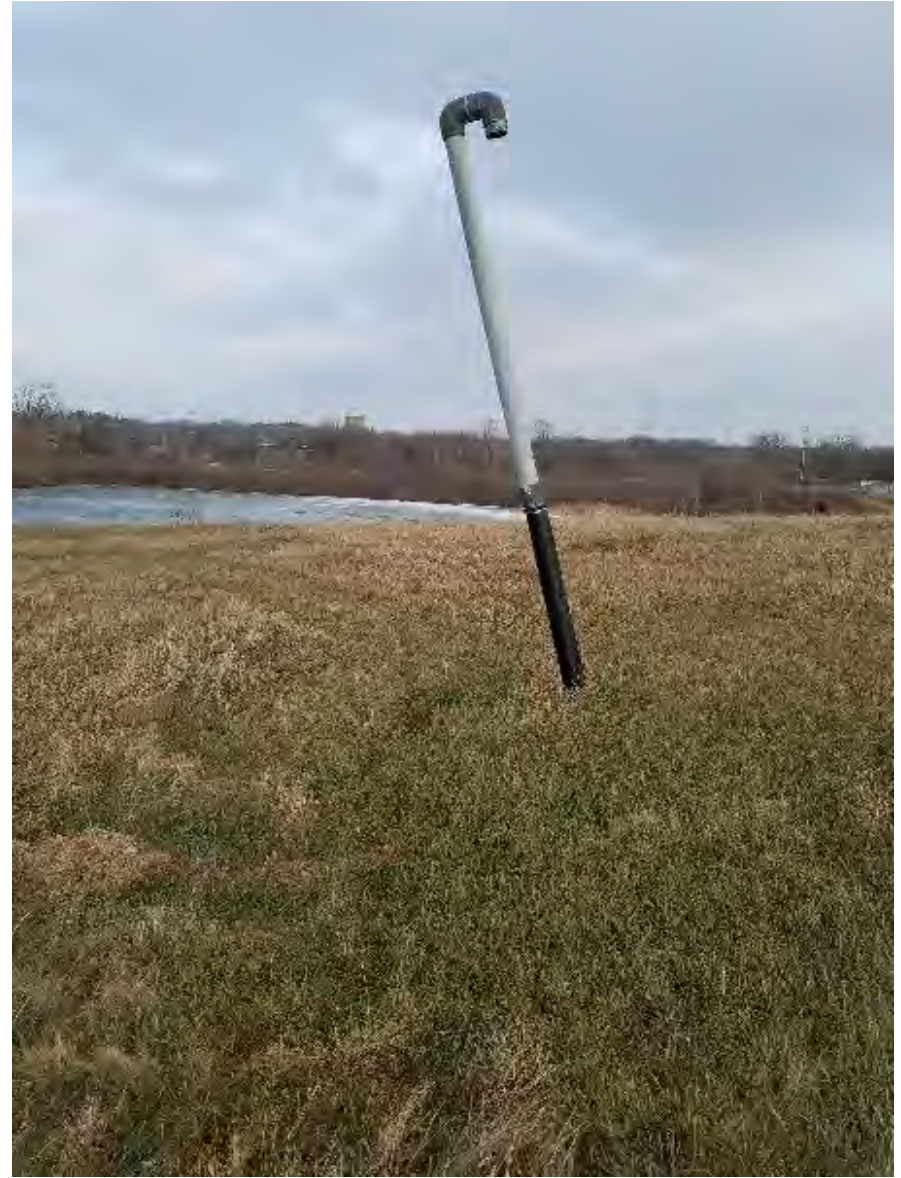
83. Tire on ground by GV-11

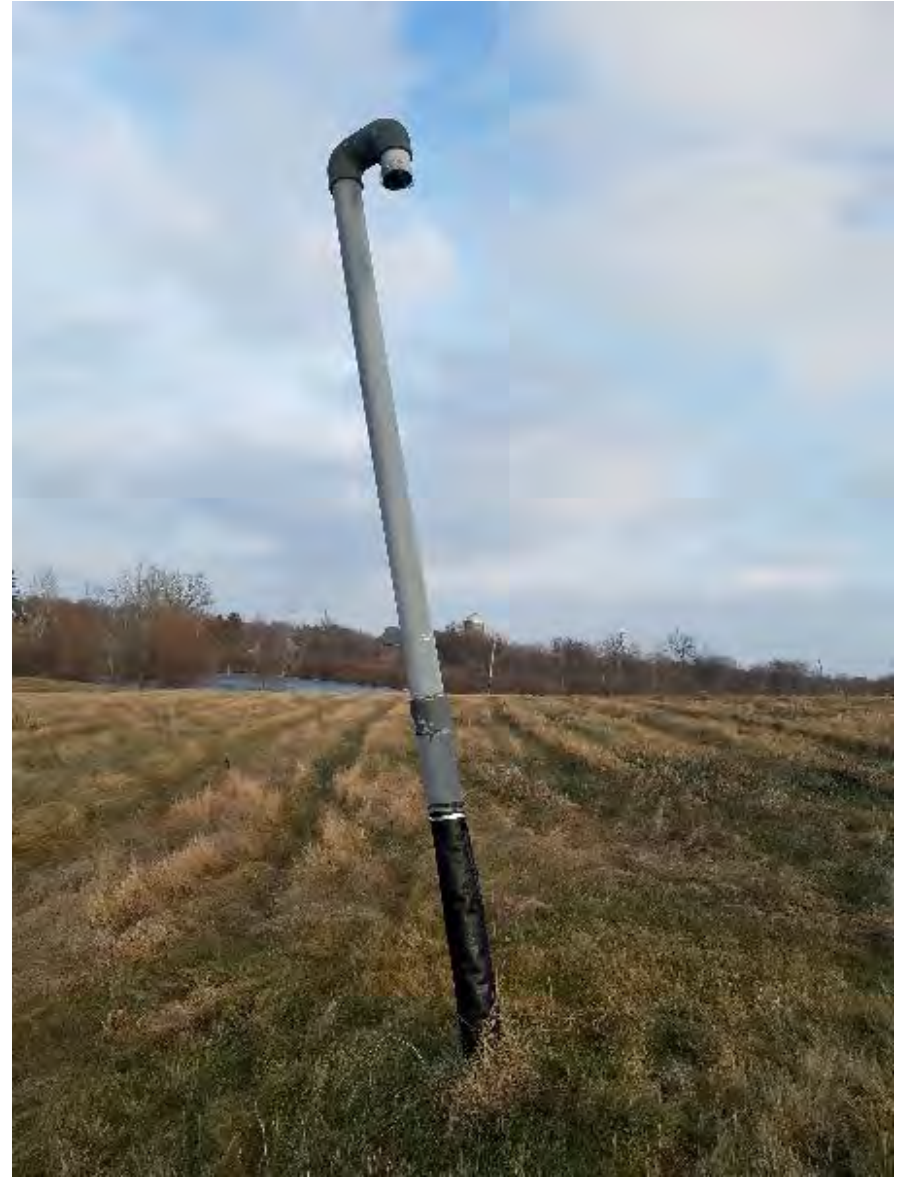
85. GV-27 tilting E, looking N

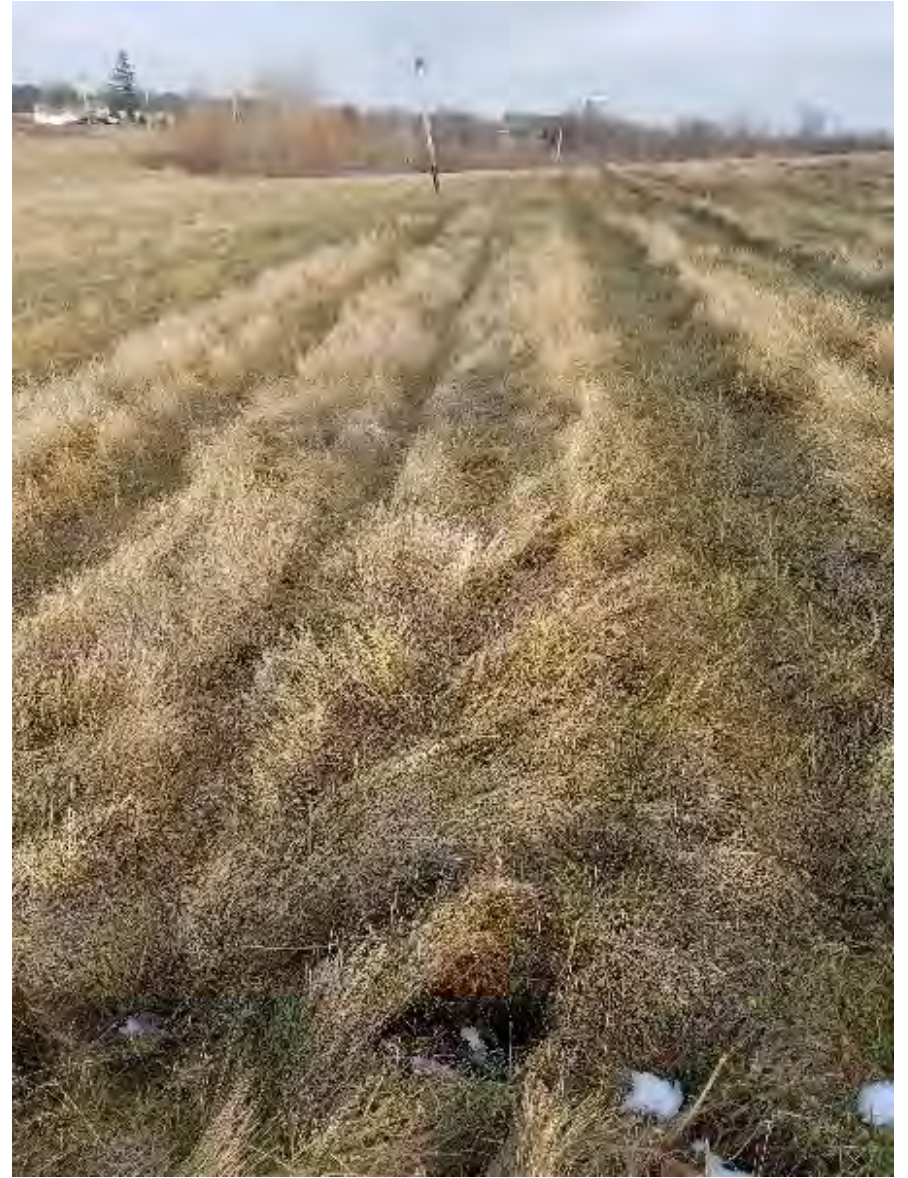
87. Animal burrow W of GV-10

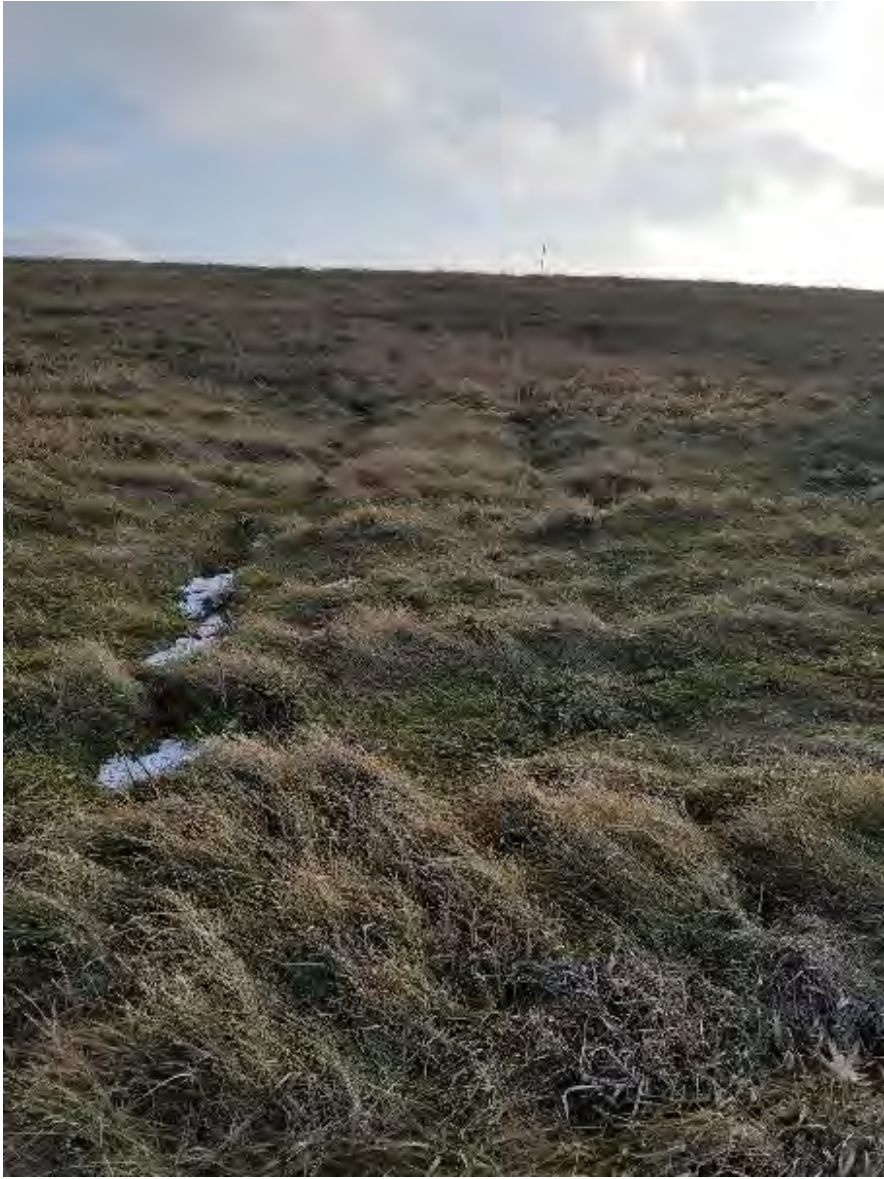
88. Animal burrow by GV-10, looking E at GV-10

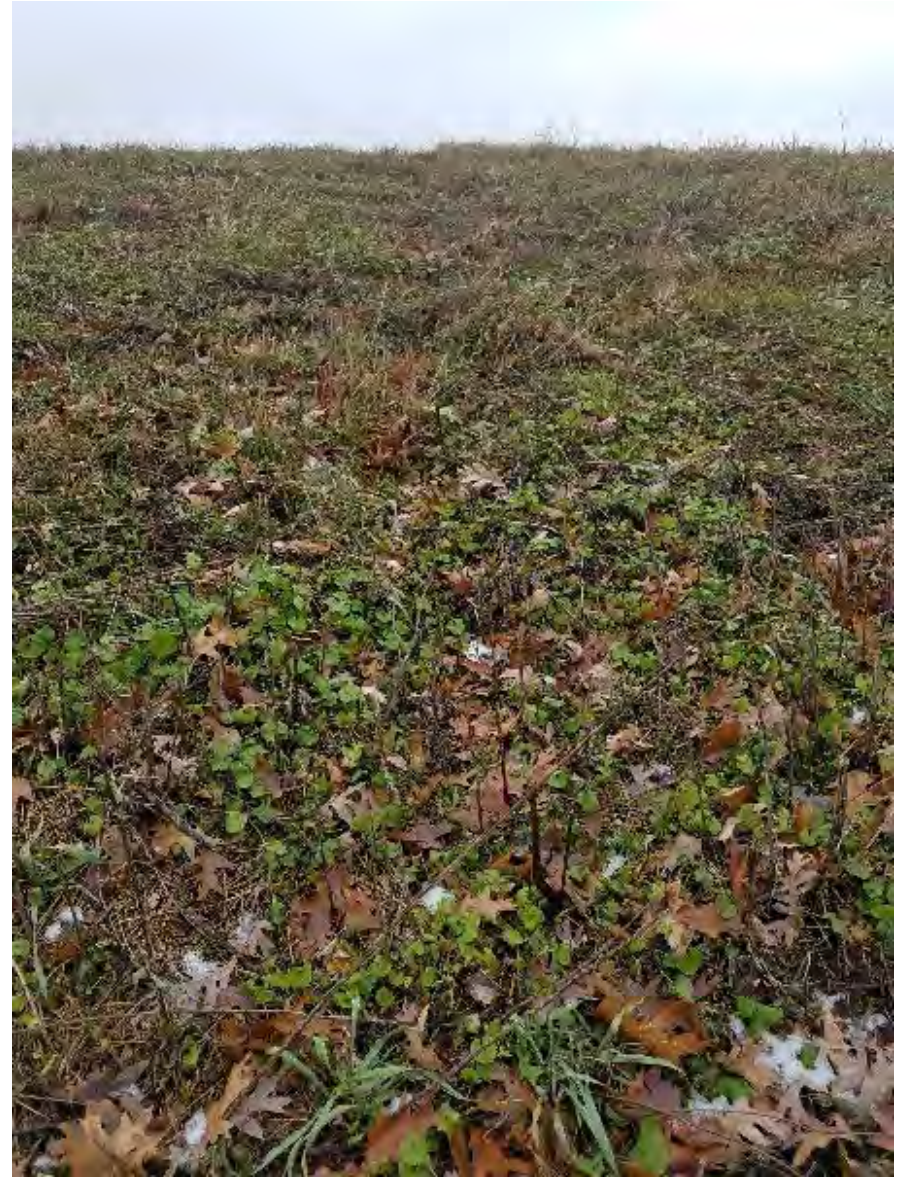
89. Slight erosion or tire tracks on N hill face, looking S uphill towards GV-14

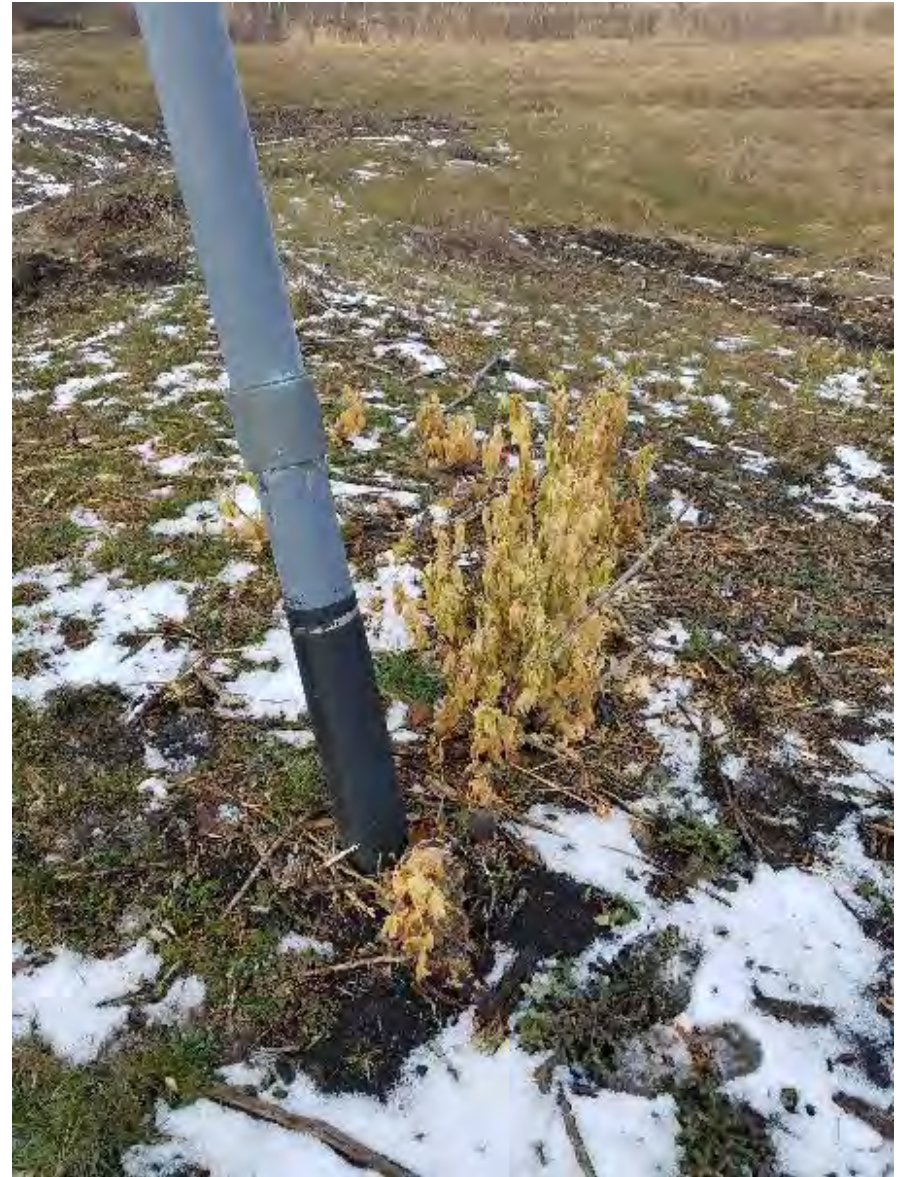
95. Bare spot with a piece of corrugated metal, looking N towards GV-36

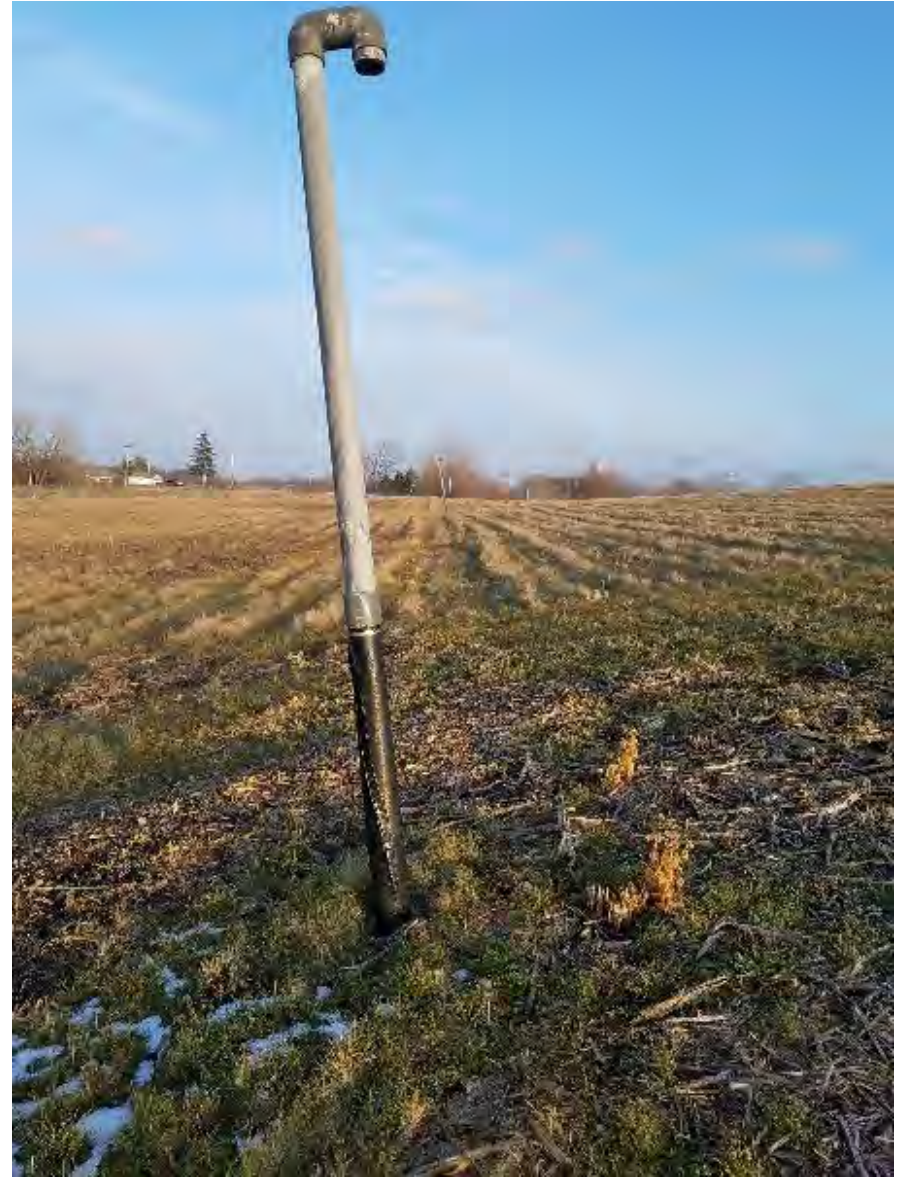
107. B-94-25, with cap

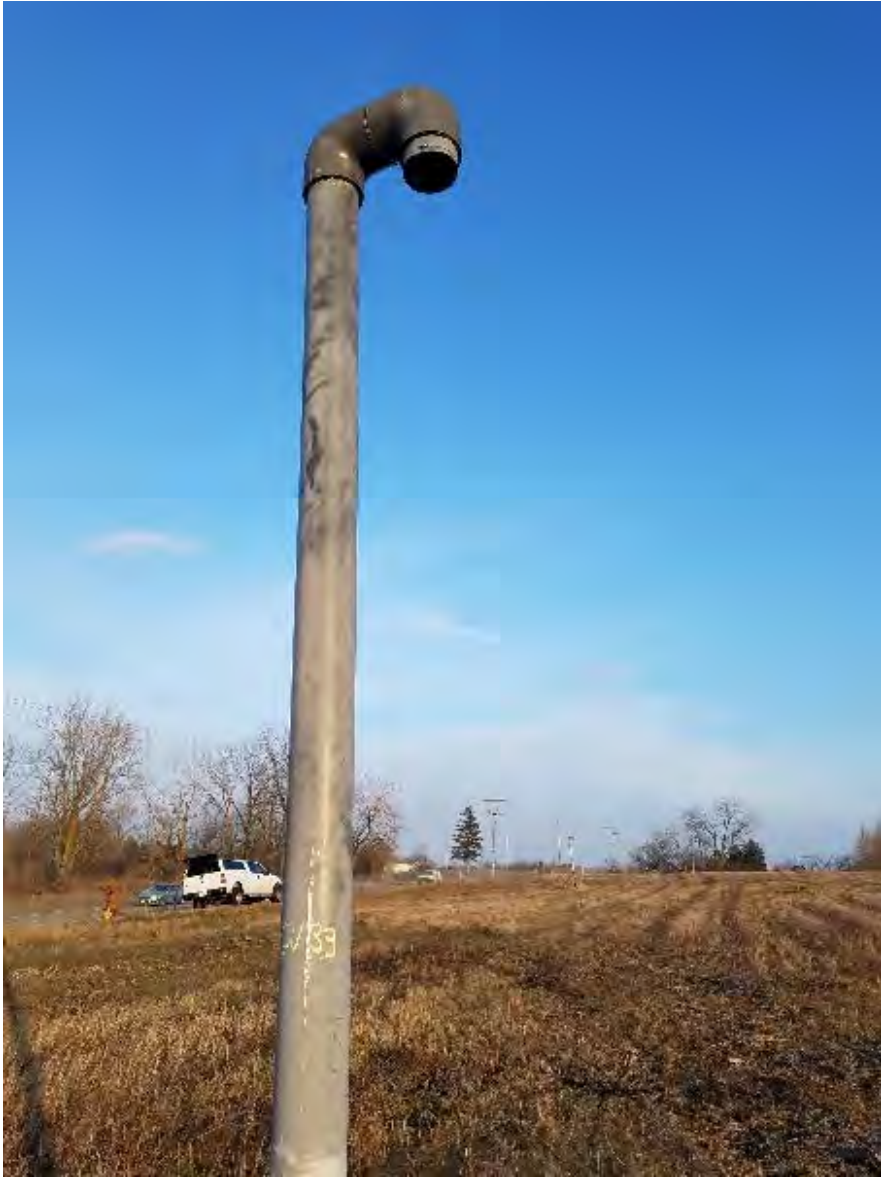
108. GV-35 slightly tilting N, looking E

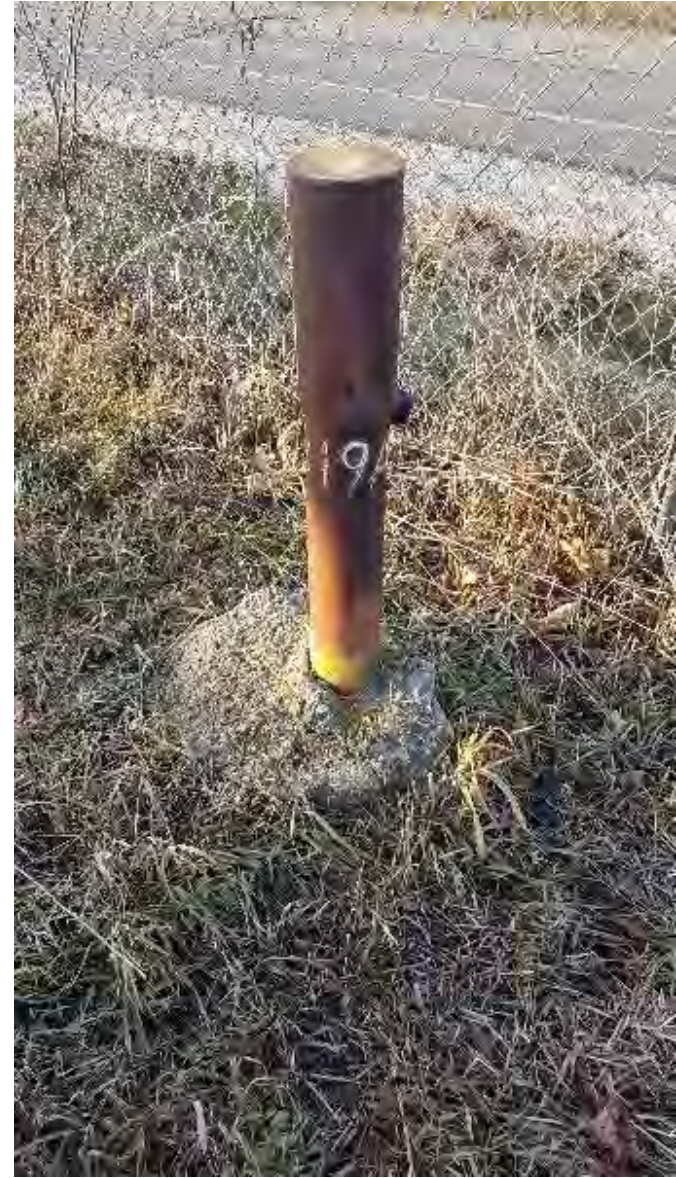
109. GV-33 missing vent screen, looking NE

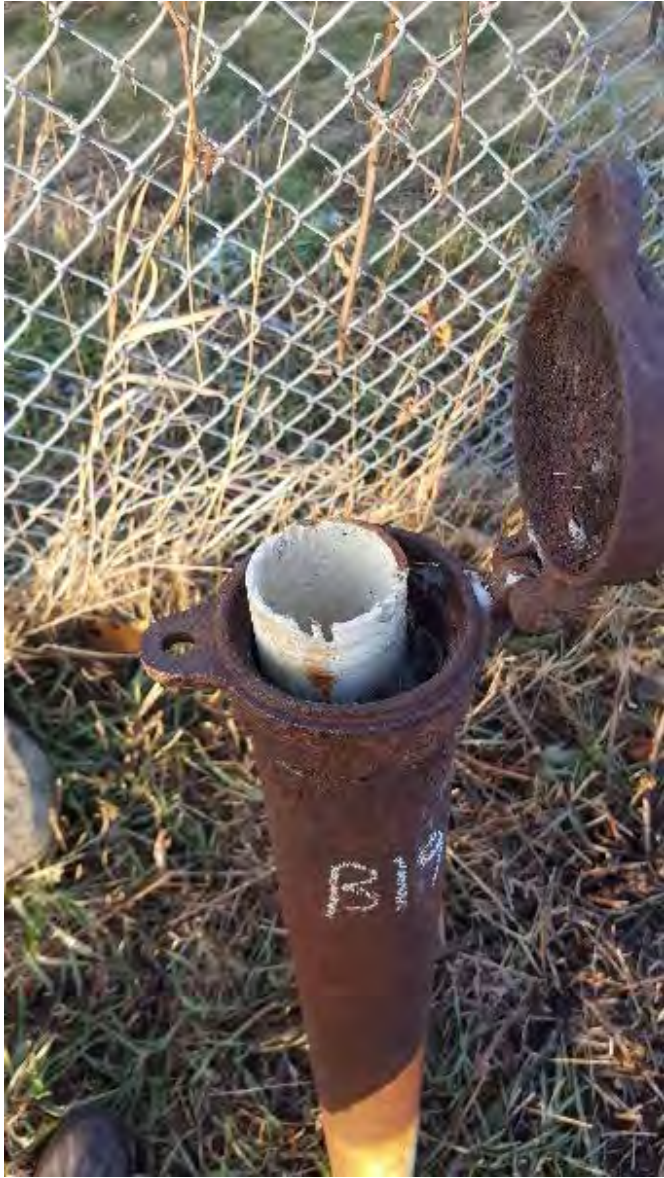
112. B-19, bent towards the N, looking N

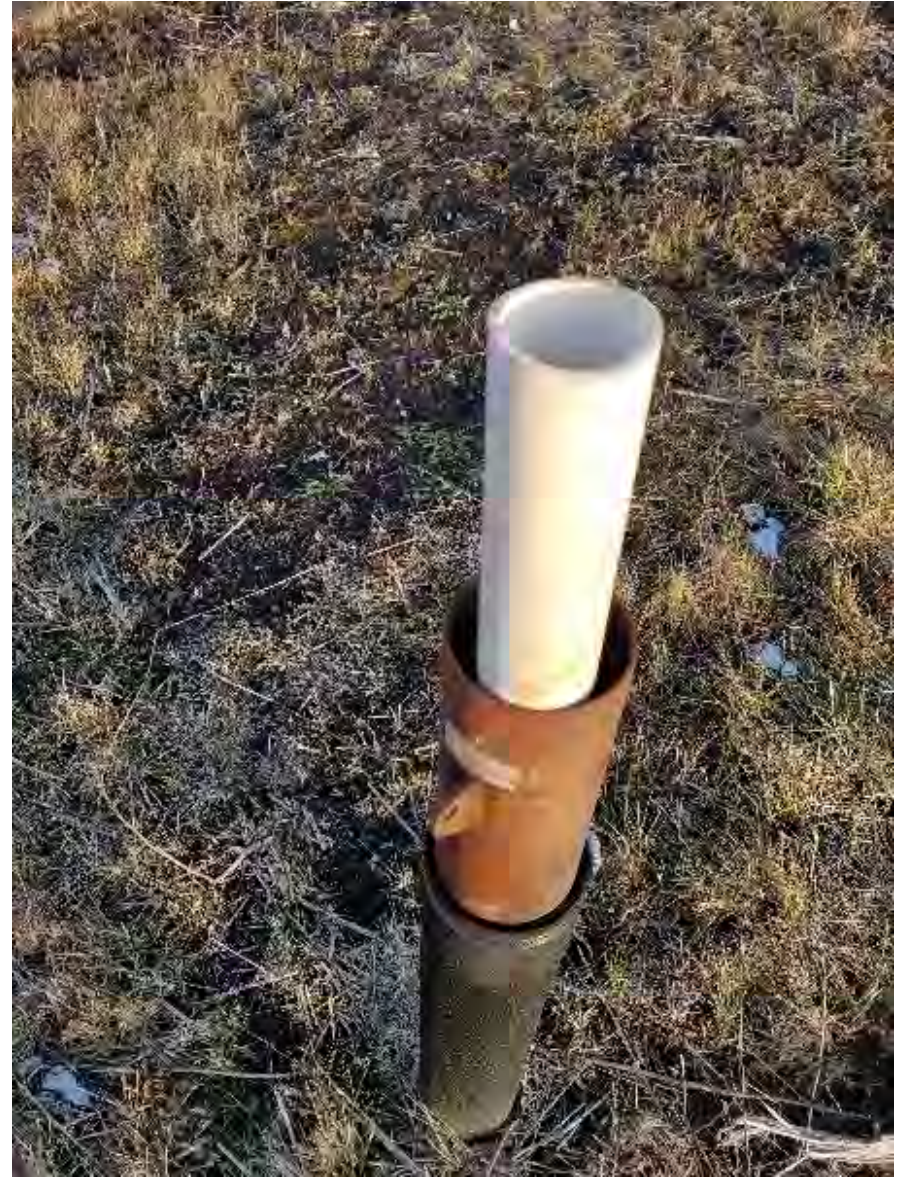
113. B-19, inside well, no cap damage to PVC, looking N

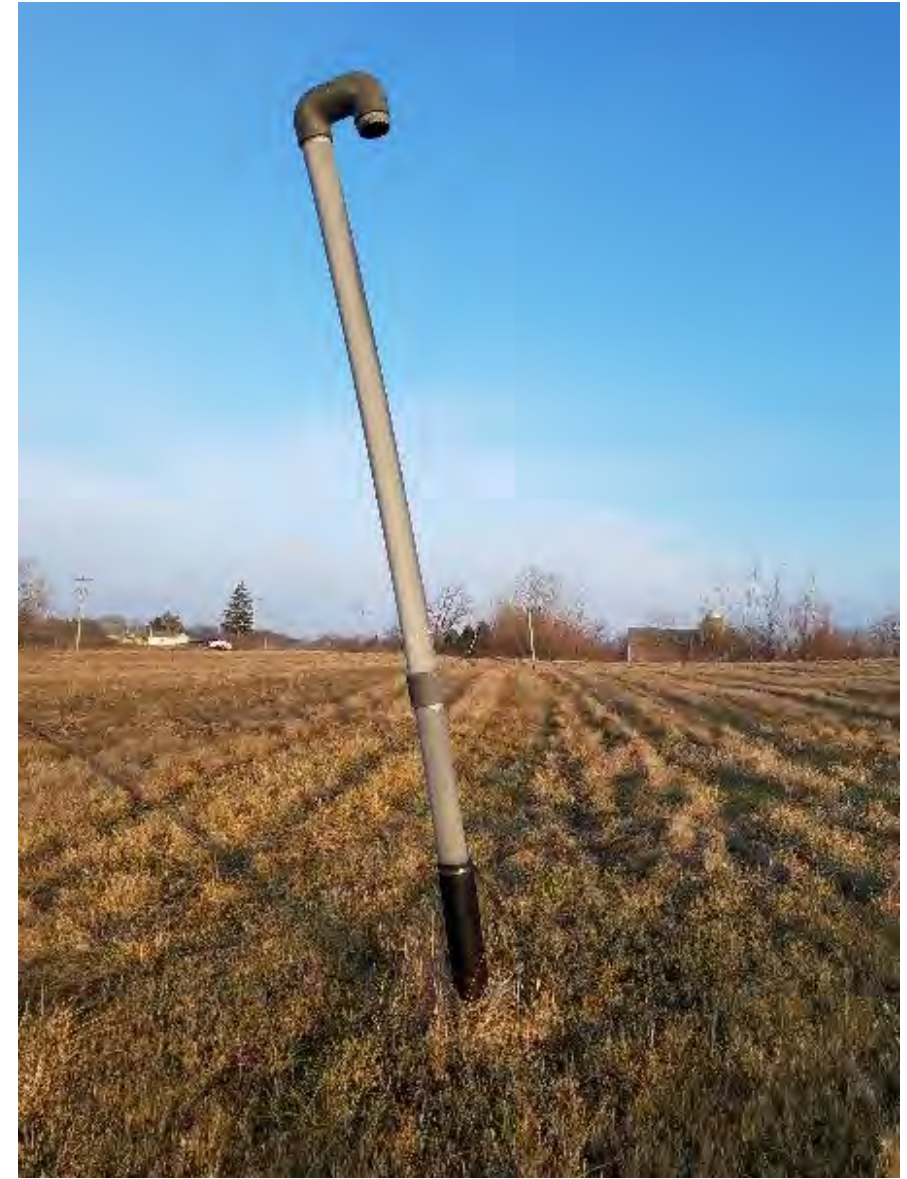
115. Un-numbered LHW E of GV-33, looking W
