ANNUAL INSPECTION REPORT

BARRETT LANDFILL

New Berlin, Waukesha County, Wisconsin

January 18, 2018

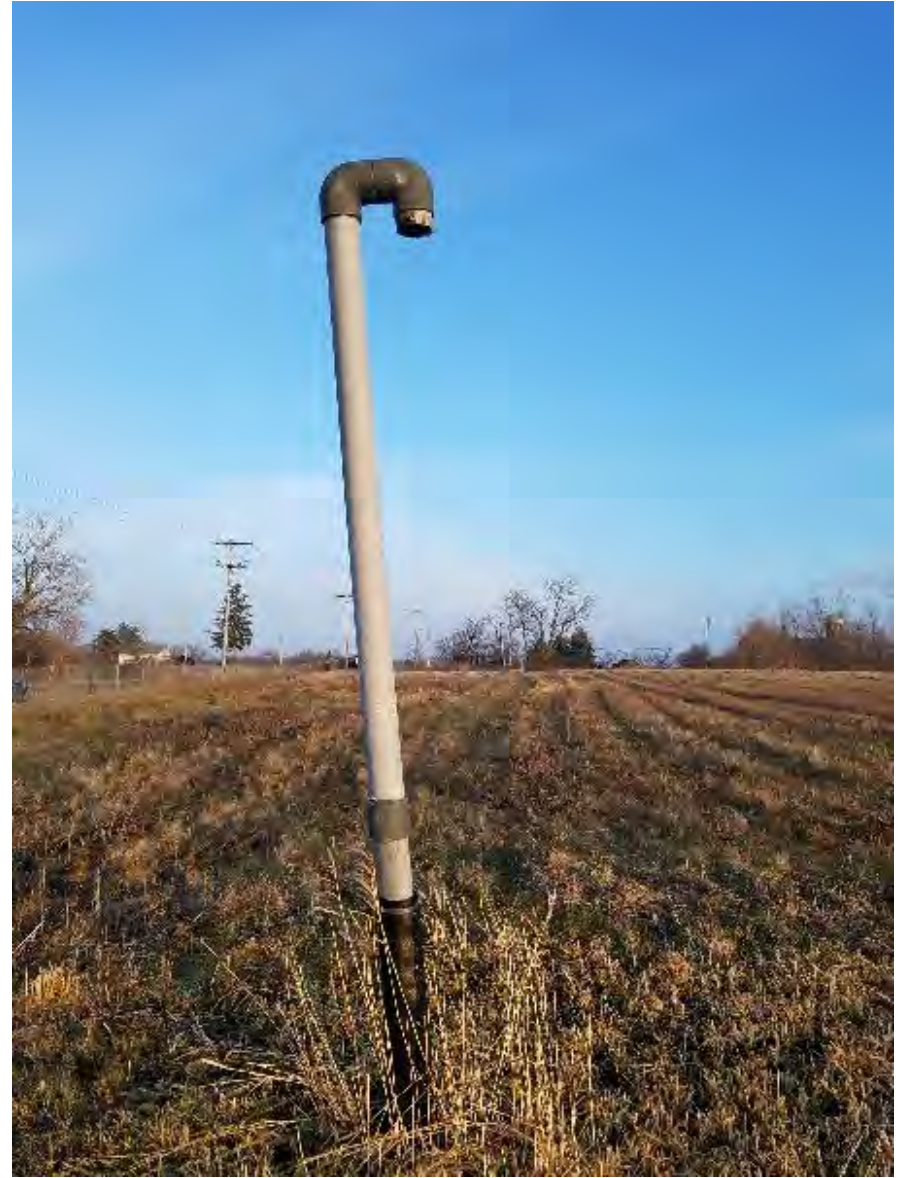
117. GV-32 tilting N to NE, looking E

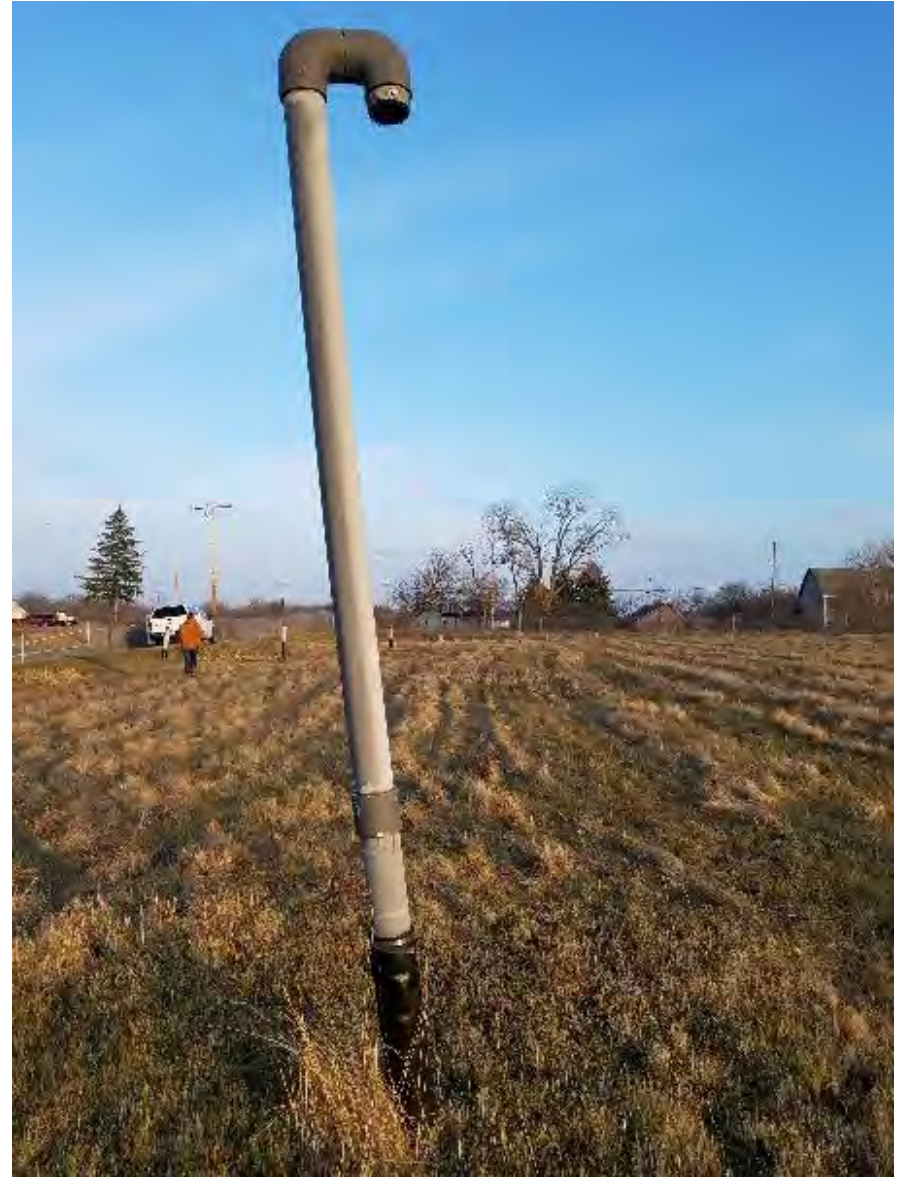
119. GV-30 tilting S, looking E

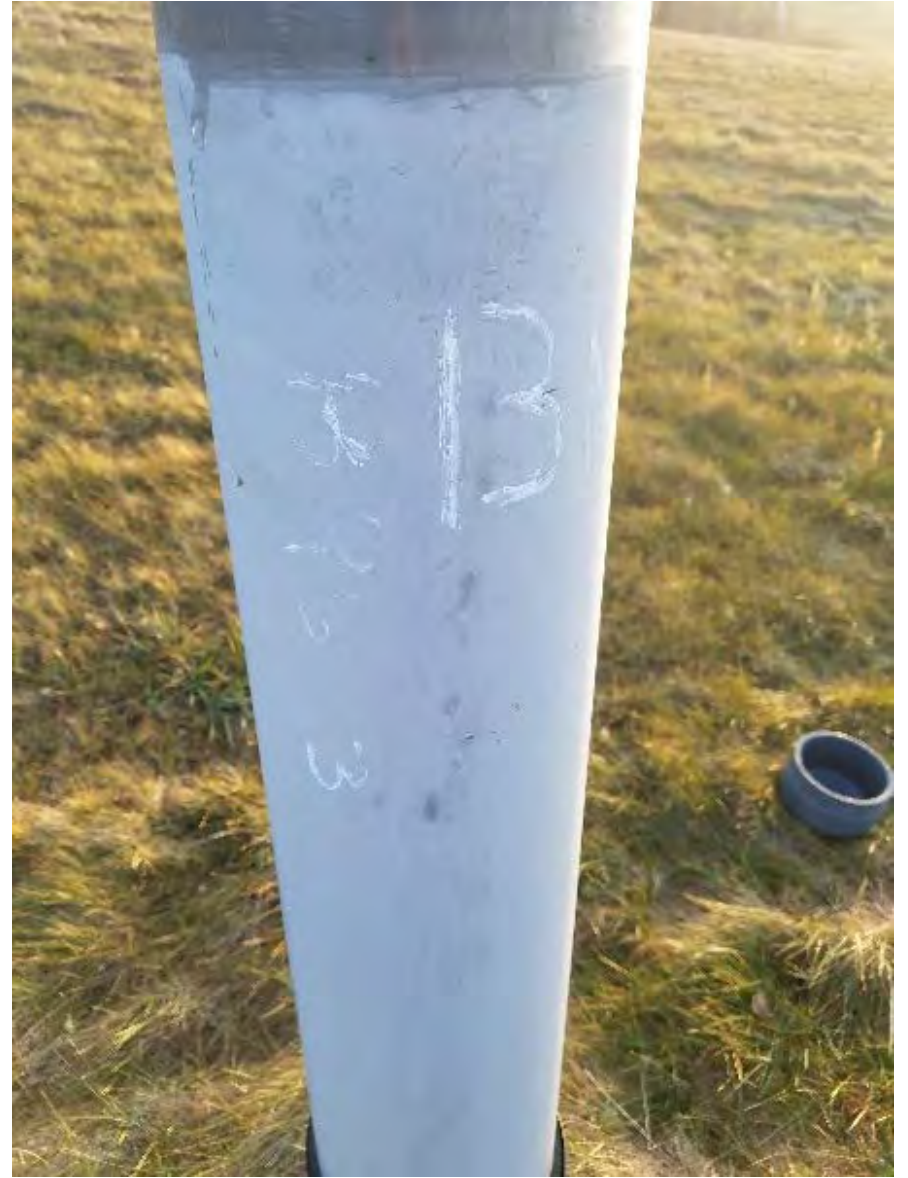
121. GV-28 tilting W, looking N

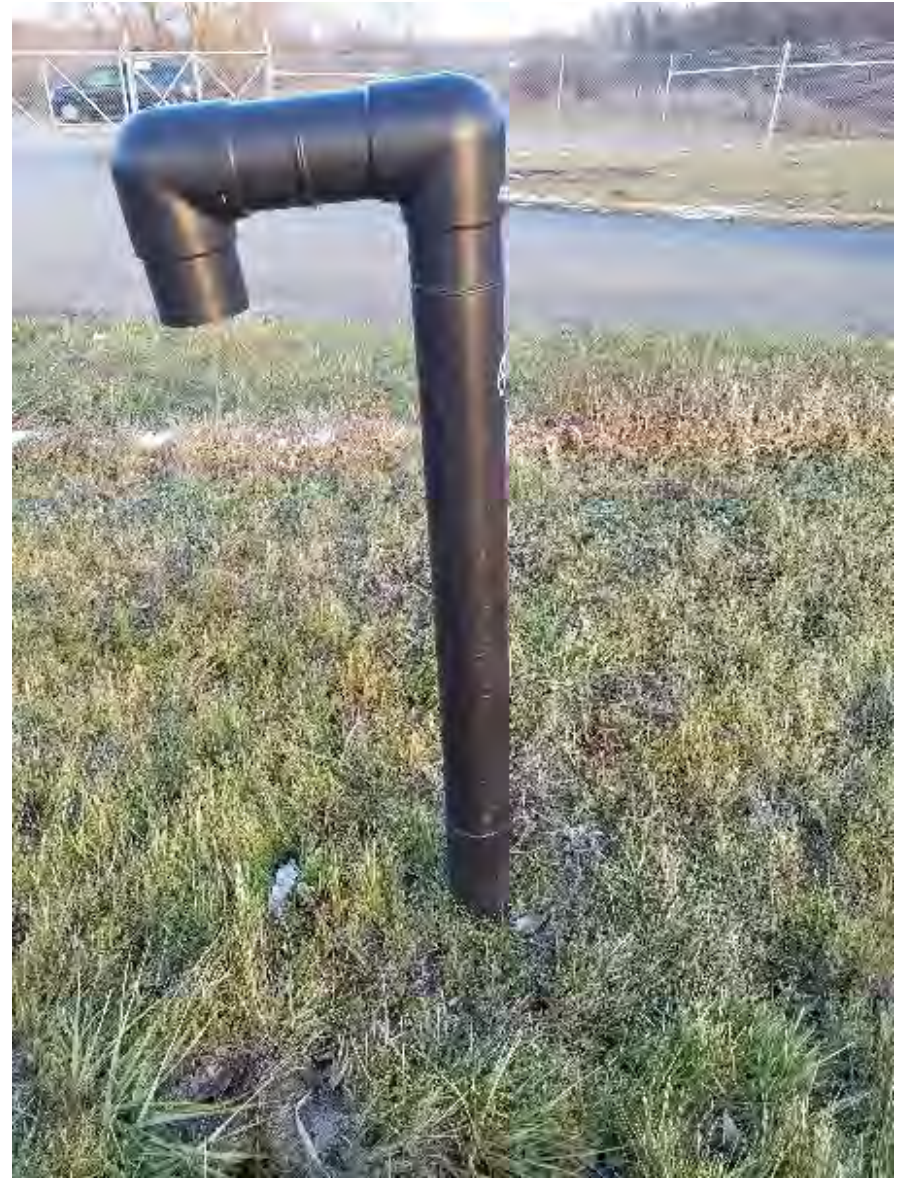
133. Possible LHW or GV, unmarked, looking S along leachate piping

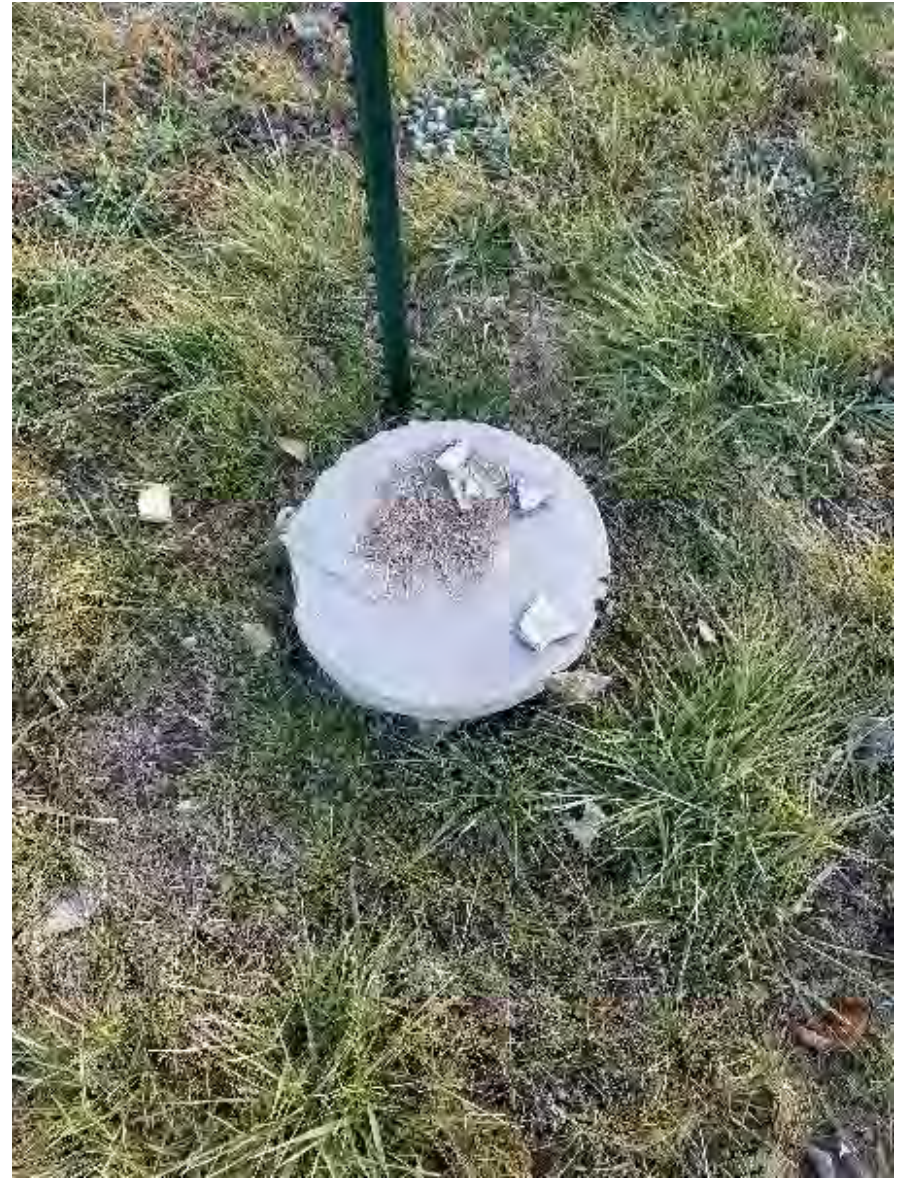
135. GV-1, looking S

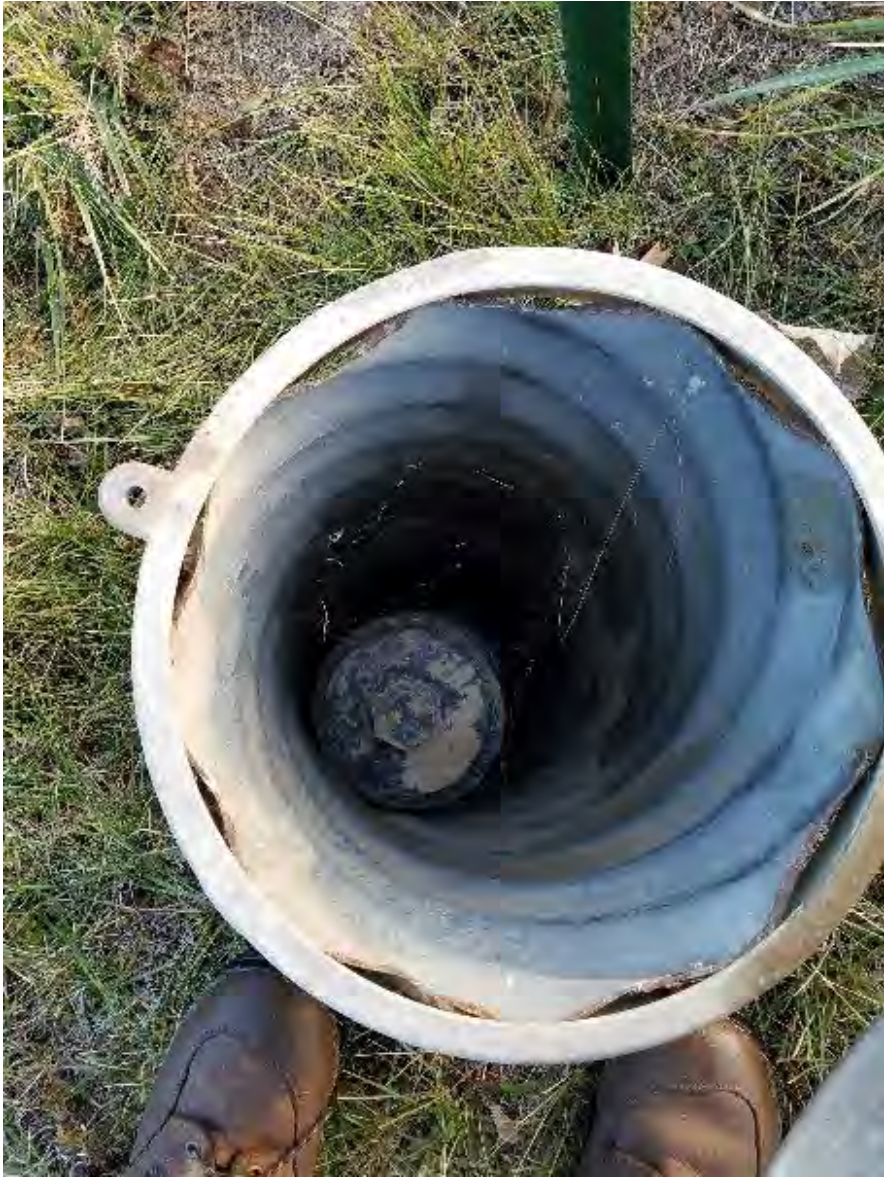
136. Broken cover of southern unmarked possible LHW by leachate piping

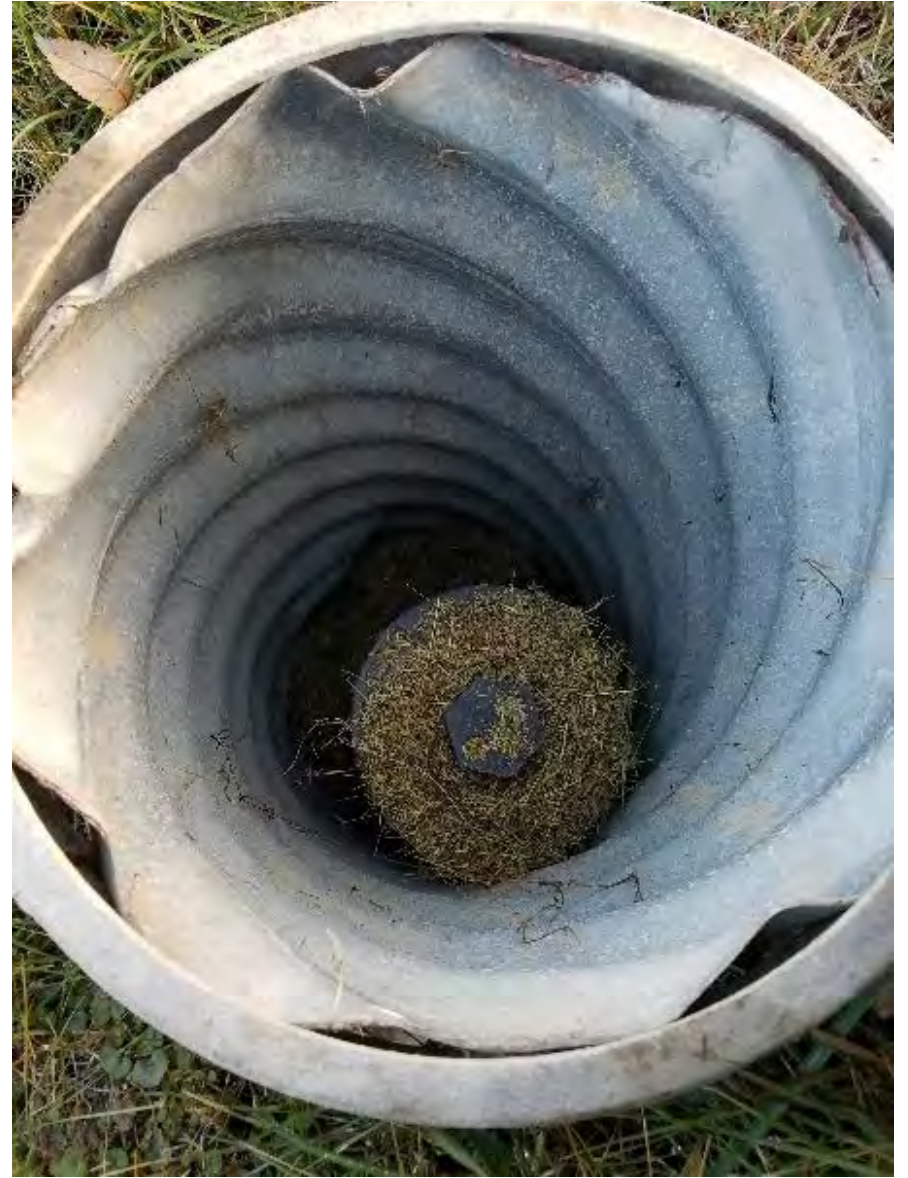
137. Inside unmarked southern LHW by leachate piping

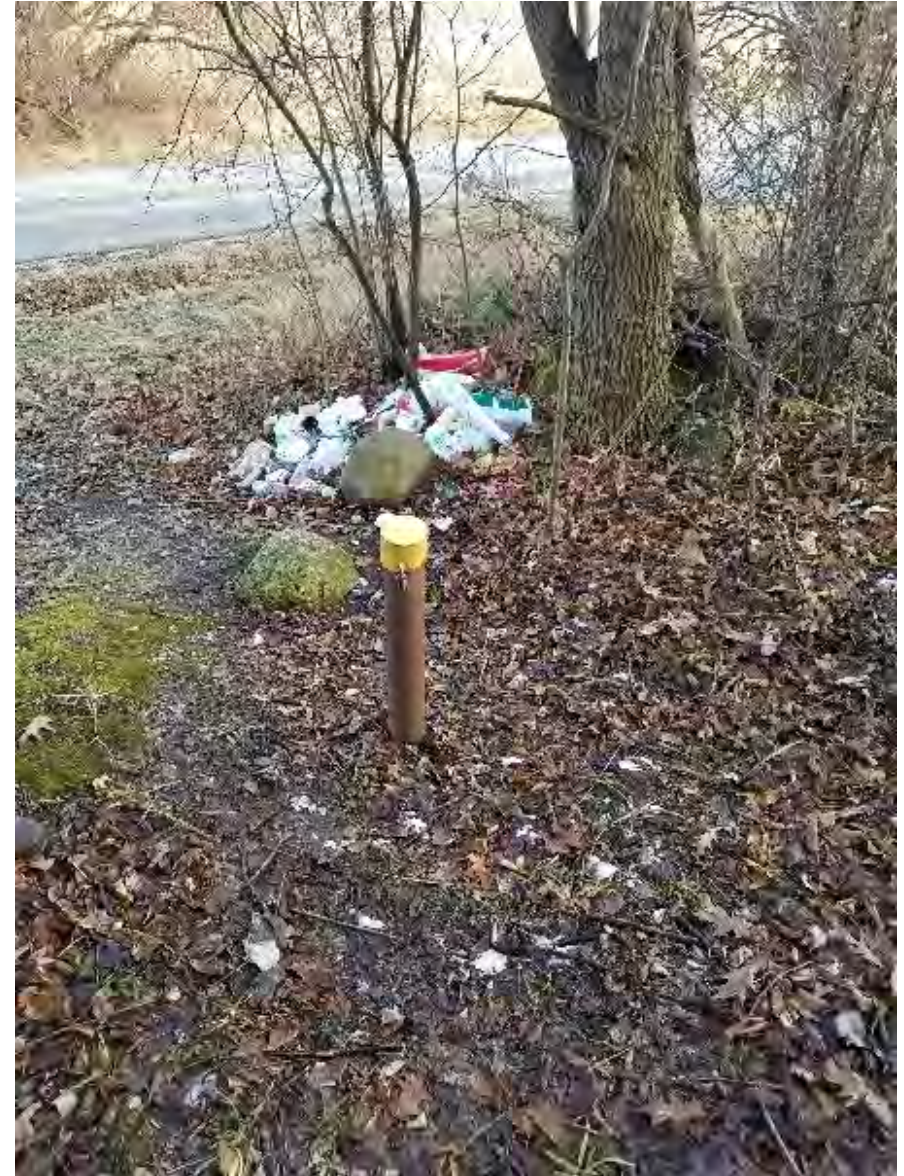
143. B-96-18A inside cap
