MEMO

Subject: Well Repairs and Site Maintenance at the Former Barrett Landfill Property, New Berlin, Wisconsin.

The well repairs and other site maintenance completed by Tetra Tech during the first two weeks of September 2019 is summarized below. Photographs documenting the work are attached.

**Attachment 1
Photograph Documentation Log
Barrett Landfill, WI
License No. 1940**

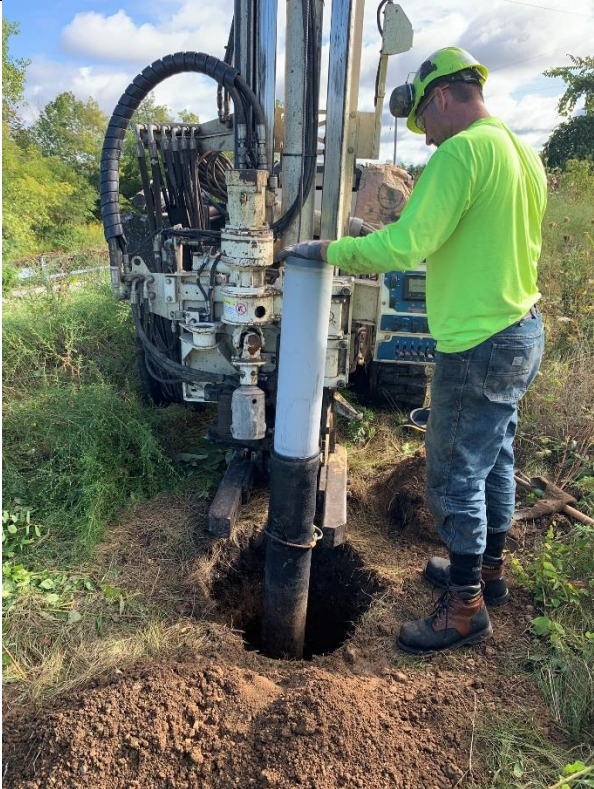
Photo: 2

Description: Removing protective casing and boot liner on B-96-13.	
Date: 9-4-2019

1. The damaged PVC casing of monitoring well B-96-13 was replaced with a new piece of PVC. The grout seal in the annular space was replaced. The original protective casing was reinstalled and adjusted to a workable height. The cap liner was reinstalled (Photos 1 – 8).

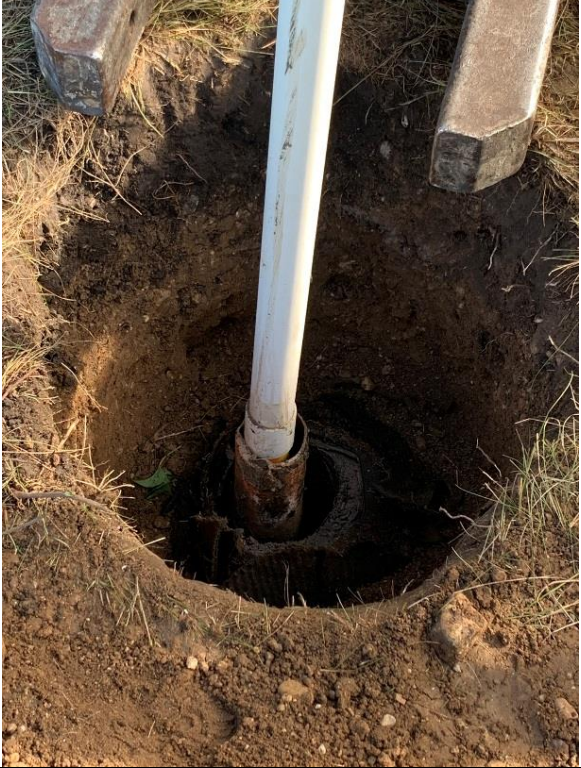
Photo: 3

Description: Additional steel protective casing at two feet below grade on B-96-13.	
Date: 9-4-2019

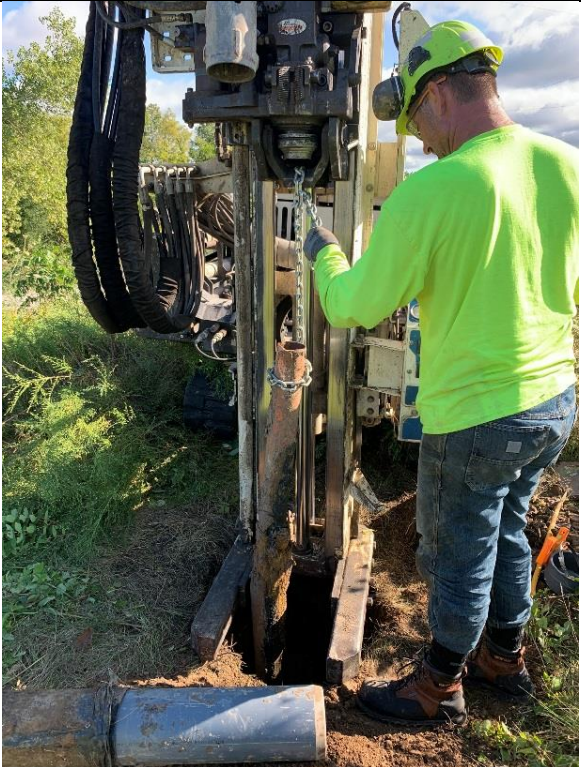
Photo: 4

Description: Removing bent steel casing from B-96-13.	
Date: 9-4-2019

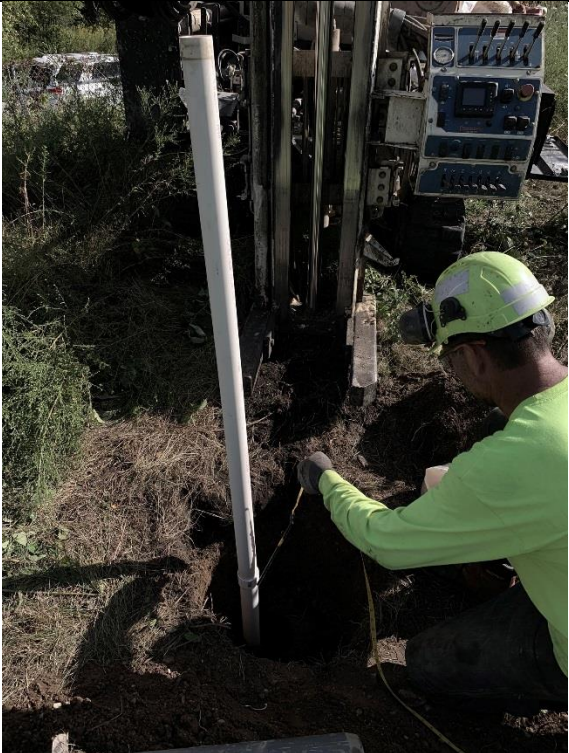
Photo: 5

Description: Bent PVC riser replaced on B-96-13.	
Date: 9-4-2019

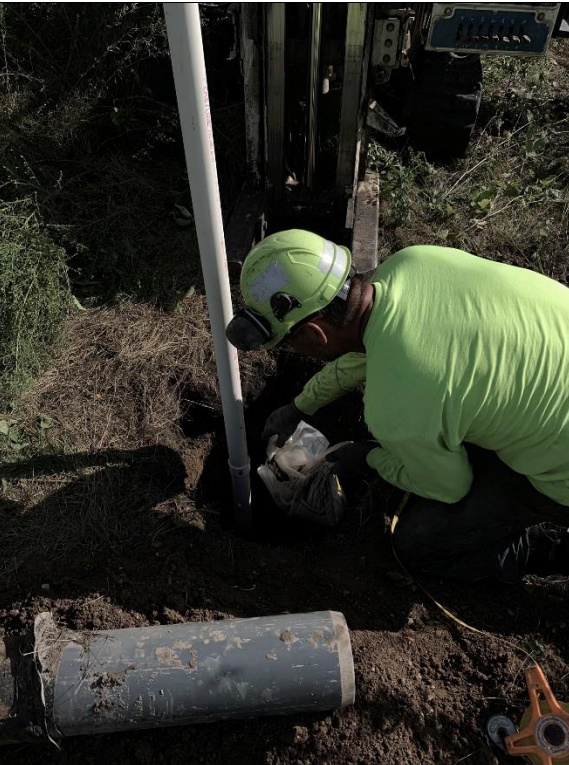
Photo: 6

Description: Material in annular space replaced around B-96-13.	
Date: 9-4-2019

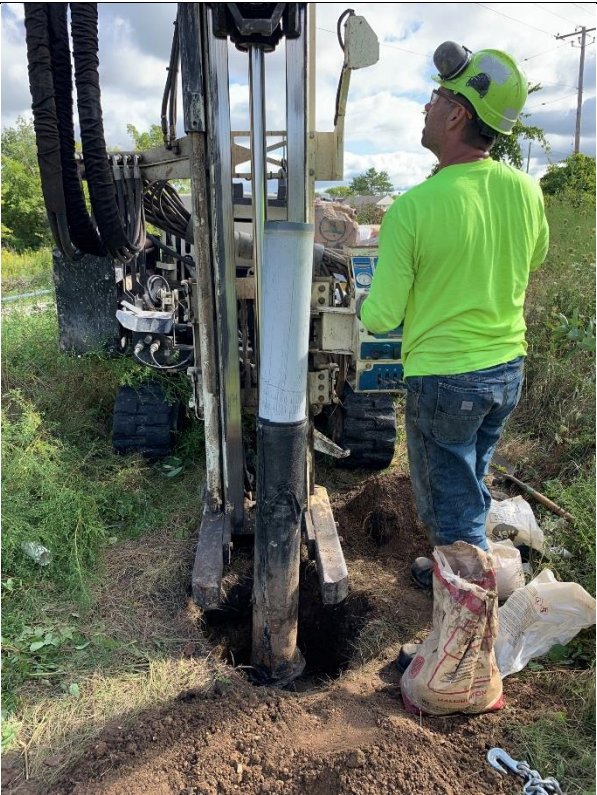
Photo: 7

Description: B-96-13 protective casing and boot liner reinstalled to a workable height.	
Date: 9-4-2019

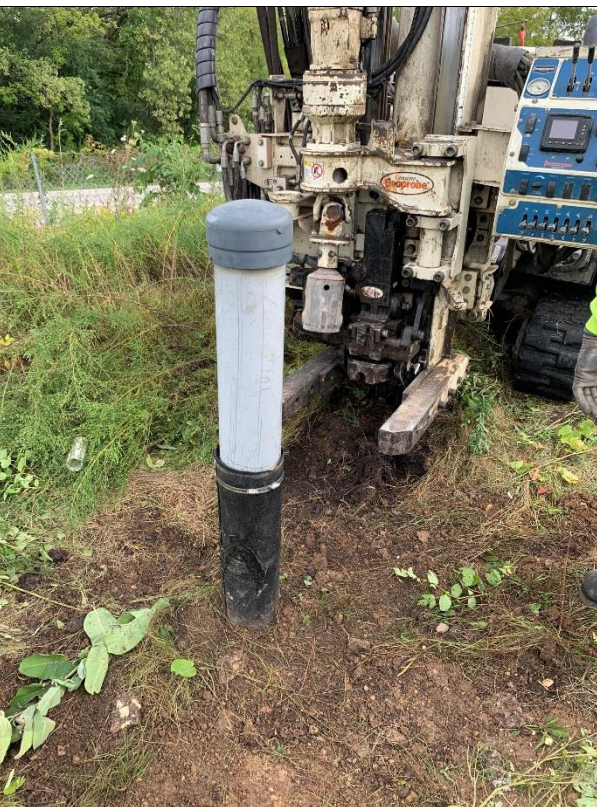
Photo: 8

Description: Completed repair on B-96-13.	
Date: 9-4-2019

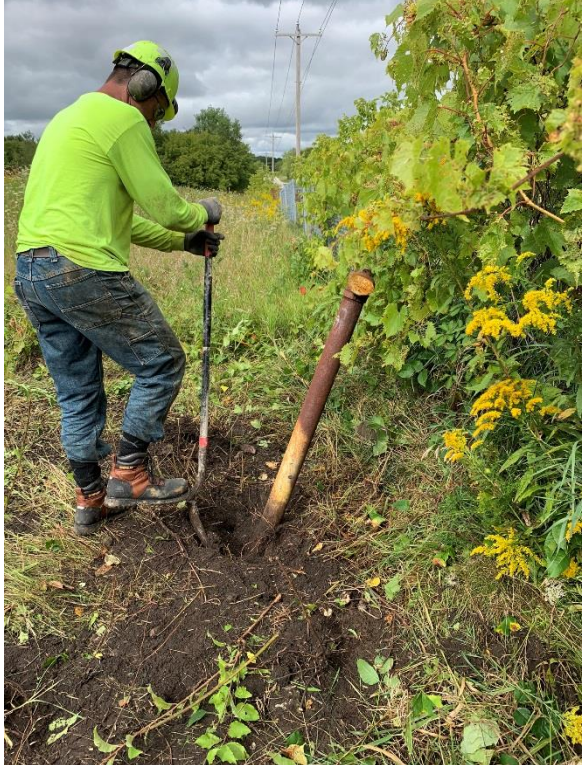
Photo: 11

Description: Starting repair of monitoring well B-19.	
Date: 9-4-2019

4. The damaged PVC casing and steel protective casing of monitoring well B-19 were removed and replaced with new piece of PVC and a new steel protective casing. The annular space grout seal was not disturbed during the repair work so it did not require replacement. (Photos 11 – 15).

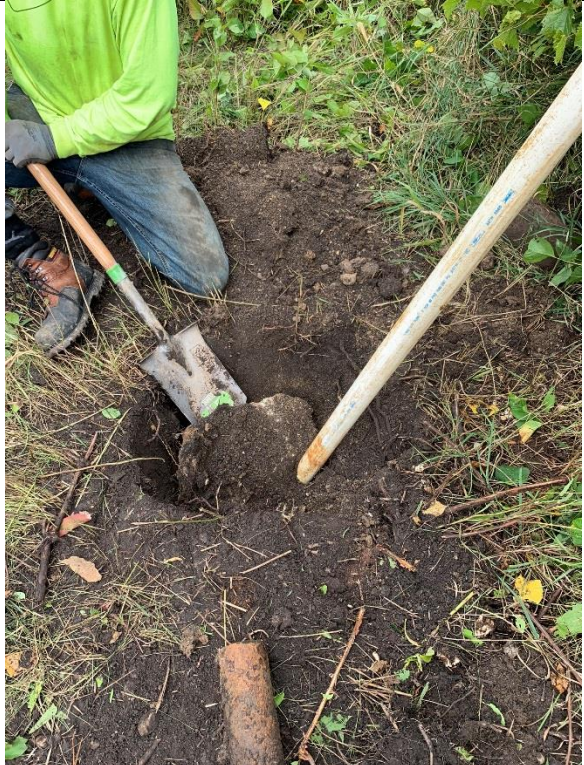
Photo: 12

Description: Large rock shifted into riser causing bend at 1.5 feet below grade of monitoring well B-19.	
Date: 9-4-2019

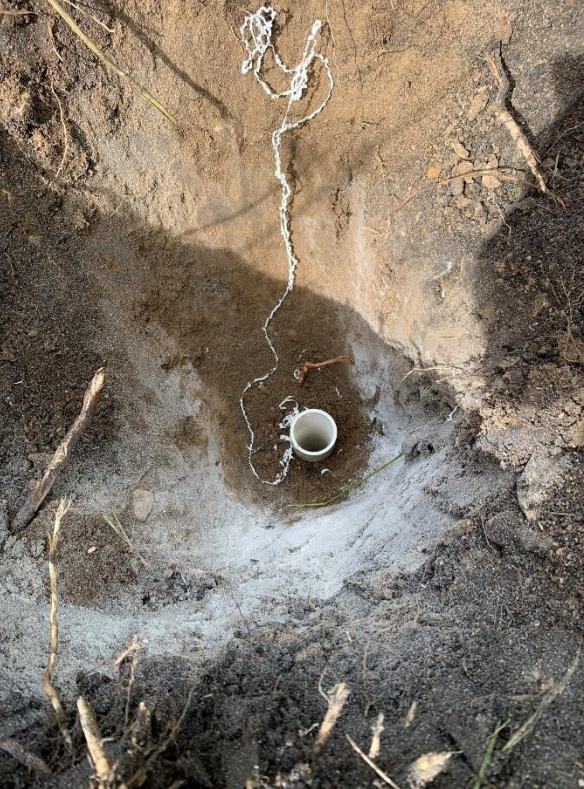
Photo: 14

Description: B-19 riser cut down below bend and replaced with a coupling.	
Date: 9-4-2019

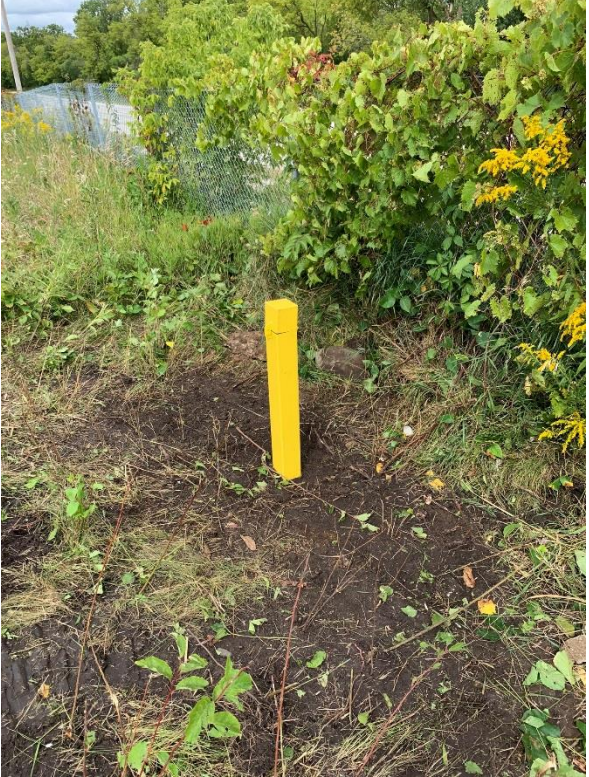
Photo: 15

Description: New protective casing installed around B-19 due to broken lock mechanism on old casing.	
Date: 9-4-2019

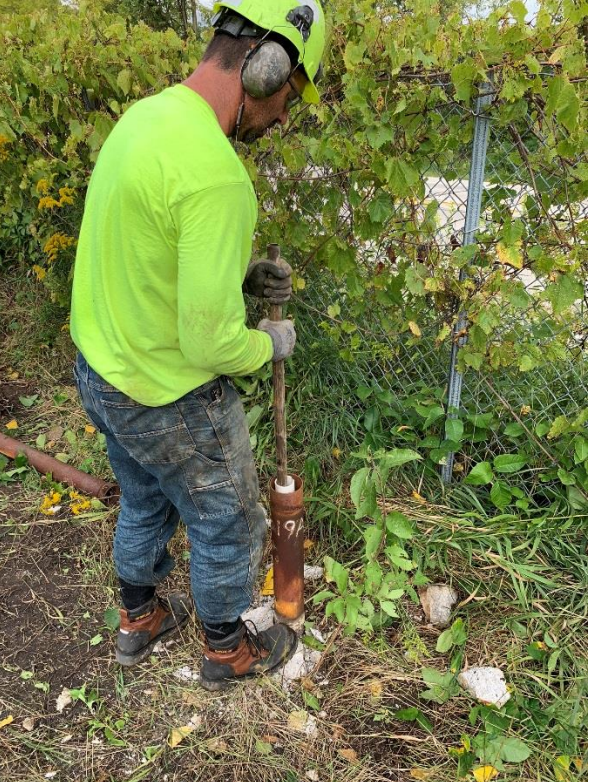
Photo: 16

5. The bend in the PVC casing of monitoring well B-94-19A at a depth of approximately 6.3 feet below grade could not be straightened by inserting drill rods in the casing as described in our July 30, 2019 proposal (Photo 16). Options to consider include the following:

Description: Bend in PVC at 6.3 feet below grade unable to be fixed with drill rods in monitoring well B-94-19A.	
Date: 9-4-2019

- a. Bring in a small backhoe to excavate down to the bend to cut out the bad piece of PVC casing and replace it with a new piece of PVC.
 - b. Abandon the well and install a replacement.

- c. Use the existing monitoring well with the knowledge that the bend in the casing requires the use of force to get the bailer past the bend in the casing.

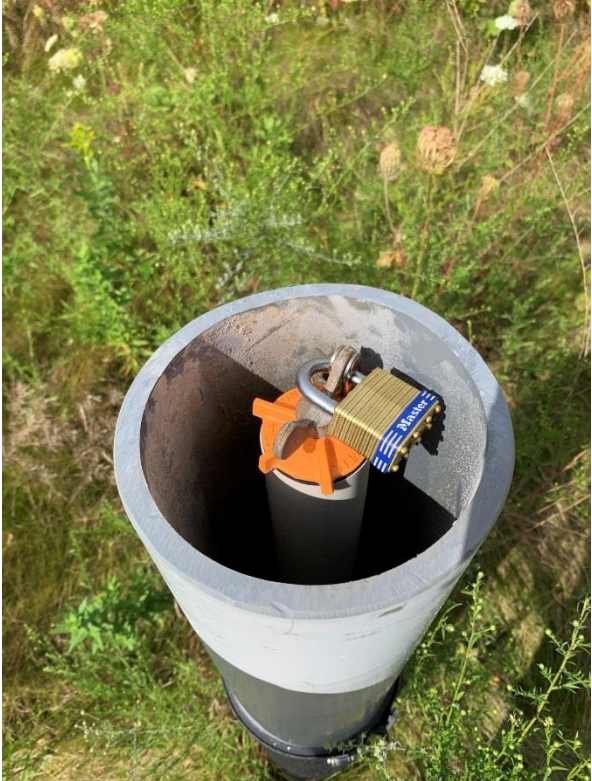
Photo: 17

Description: Lockable well caps installed in monitoring wells where protective casing cannot be locked.	
Date: 9-5-2019

6. New locks and lockable well caps were installed on monitoring wells B-96-13 and B-96-13A (Photo 17).

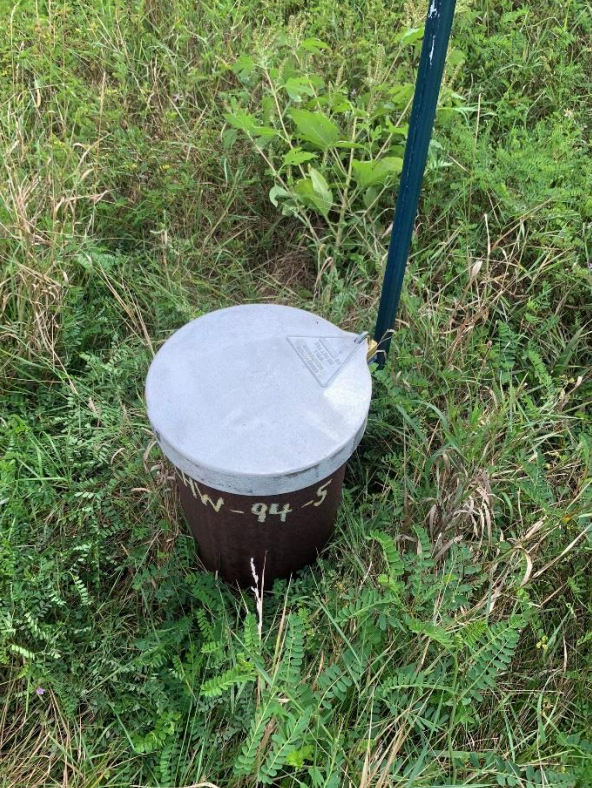
Photo: 18

Description: New aluminum locking well cover installed on LHW-94-5.	
Date: 9-5-2019

7. A new Royer cover was installed on the protective casing of leachate head well LHW-94-5 (Photo 18).
8. New locks were installed on the protective casings of gas probes GP-3, GP-5 and GP-12, leachate head wells LHW-94-1, LWH-94-5 and LHW-94-6, and monitoring wells B-96-13, B-96-13A, B-15, B-96-17, B-96-17A, B-19, B-96-26 W-23 and W-23A (Photo 19).

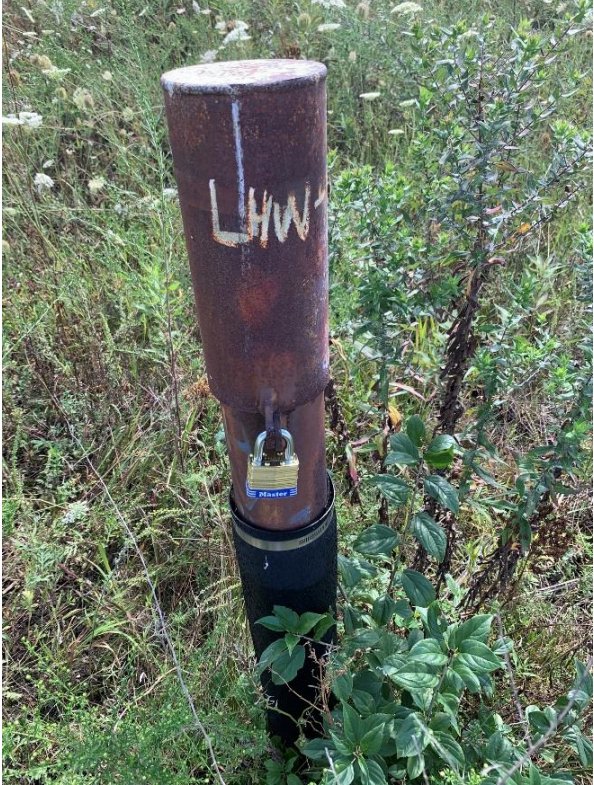
Photo: 19

Description: New locks placed on all gas probes, leachate head wells and monitoring wells that were missing them.	
Date: 9-5-2019

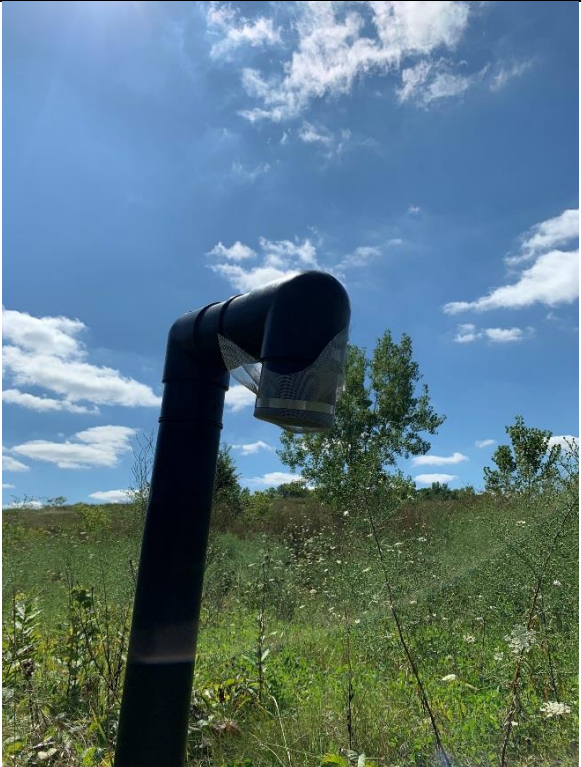
Photo: 20

Description: New gas vent screen installed on GV-100 with aluminum screen	
Date: 9-5-2019

9. New vent screens were installed on gas vents GV-100 and GV-101 (Photos 20 – 23).
10. The holes and tears in the boot liners of gas vents GV-119, GV-124, GV-135, GB-137 and GV-138 were covered with 330x HVAC permanent air-tight seal tape (Photos 24 – 28). The HVAC seal tape was used instead of Fernco couplings as described in our July 30, 2019 proposal as it provided a better seal around the holes and tears than Fernco couplings.

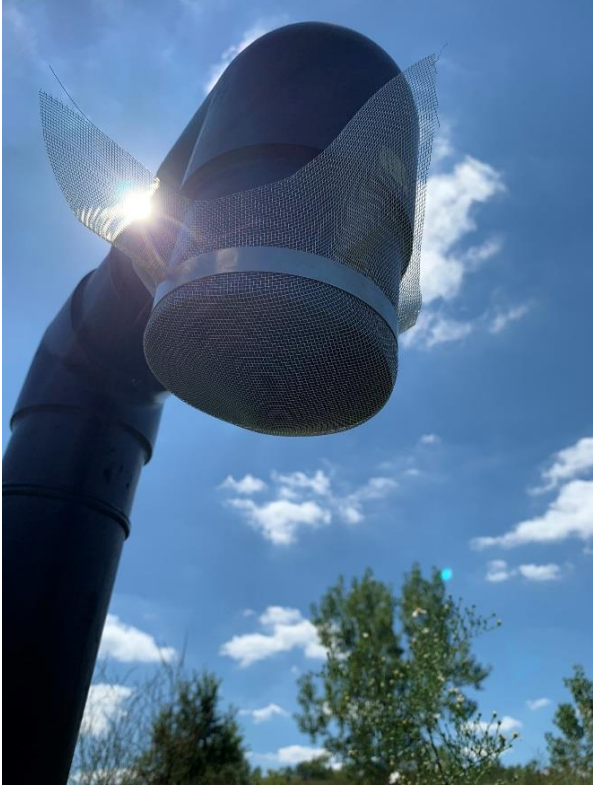
Photo: 21

Description: Close up of new gas vent screen.	
Date: 9-5-2019

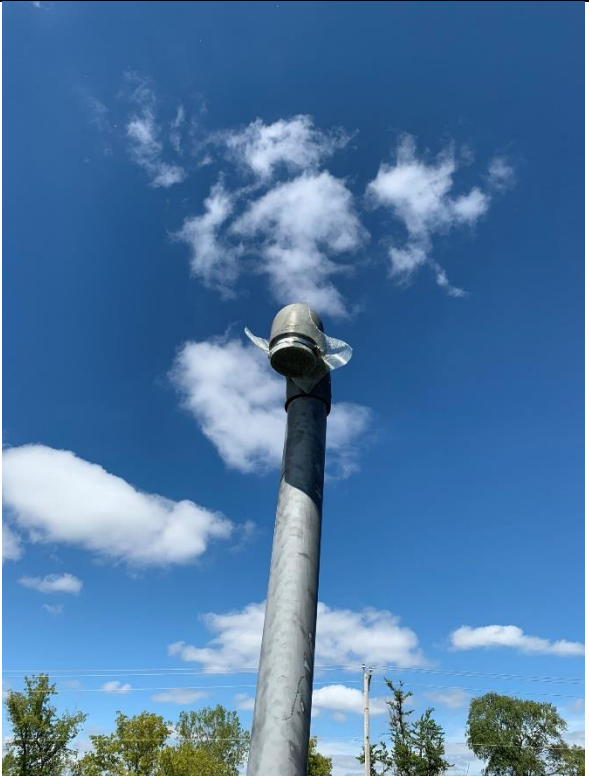
Photo: 22

Description: New gas vent screen installed on GV-101.	
Date: 9-5-2019

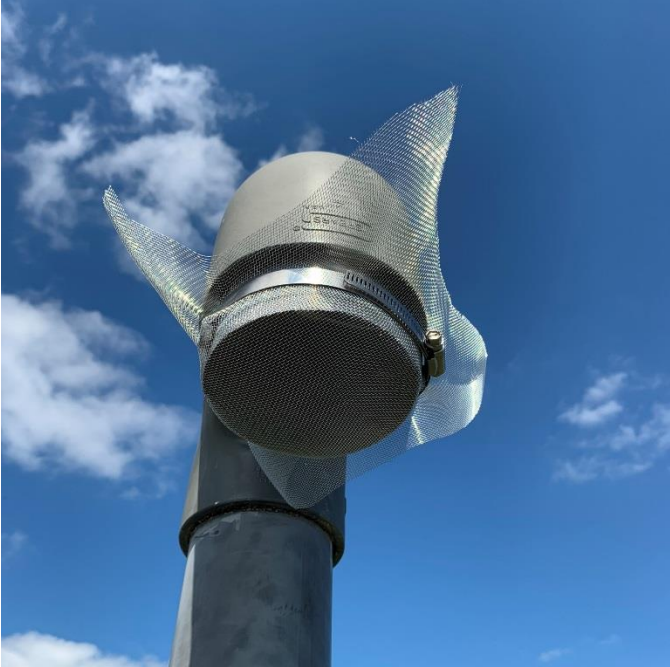
Photo: 23

Description: Close up of new gas vent screen.	
Date: 9-5-2019

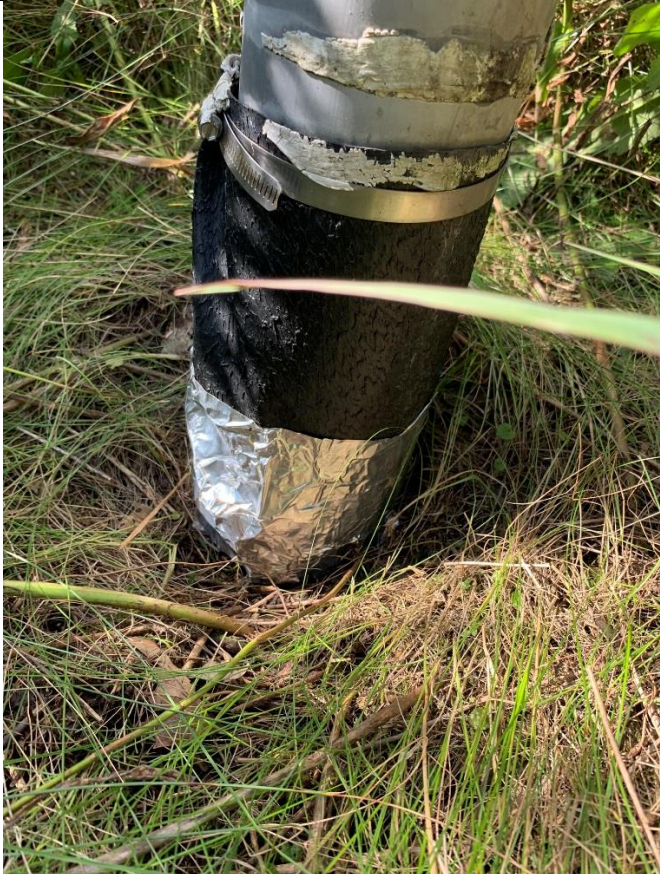
Photo: 24

Description: 330x HVAC permanent air-tight seal tape used to seal holes in boot liners of gas vents GV-119, GV-124, BG-135, GV-137 and GV-138. This photo shows the repaired boot liner around GV-137.	
Date: 9-5-2019

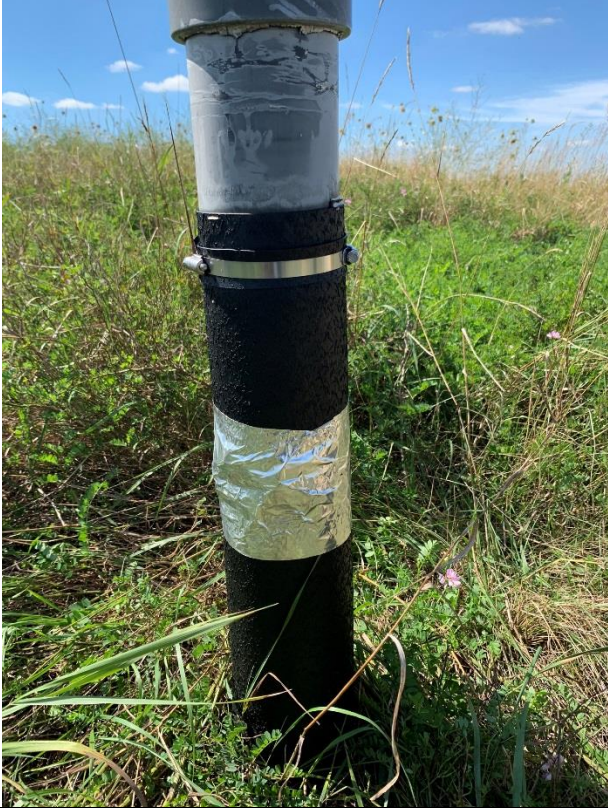
Photo: 25

Description: Seal installed on GV-135.	
Date: 9-5-2019

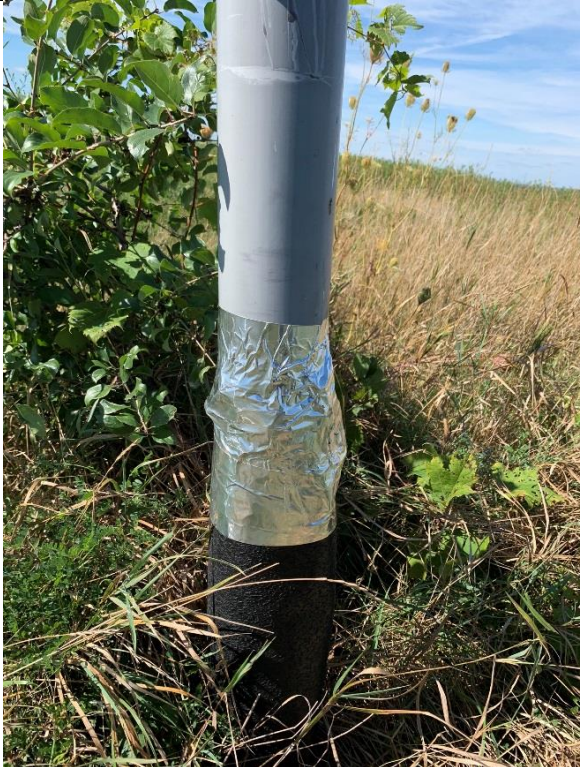
Photo: 28

A vertical photograph showing a grey well casing in a field of tall grass. A clear plastic sealant is applied over a black seal on the casing. The sealant is crinkled and appears to be a thick, clear adhesive or resin. The background shows a blue sky and some green foliage.
Description: Seal installed on GV-124.	
Date: 9-5-2019
