ANNUAL INSPECTION REPORT

# BARRETT LANDFILL

21001 W Coffee Road, New Berlin, Wisconsin 53146 | December 2019

Ashley Wagner, P.G.  
Geologist/Project Manager  
Kapur Inc.

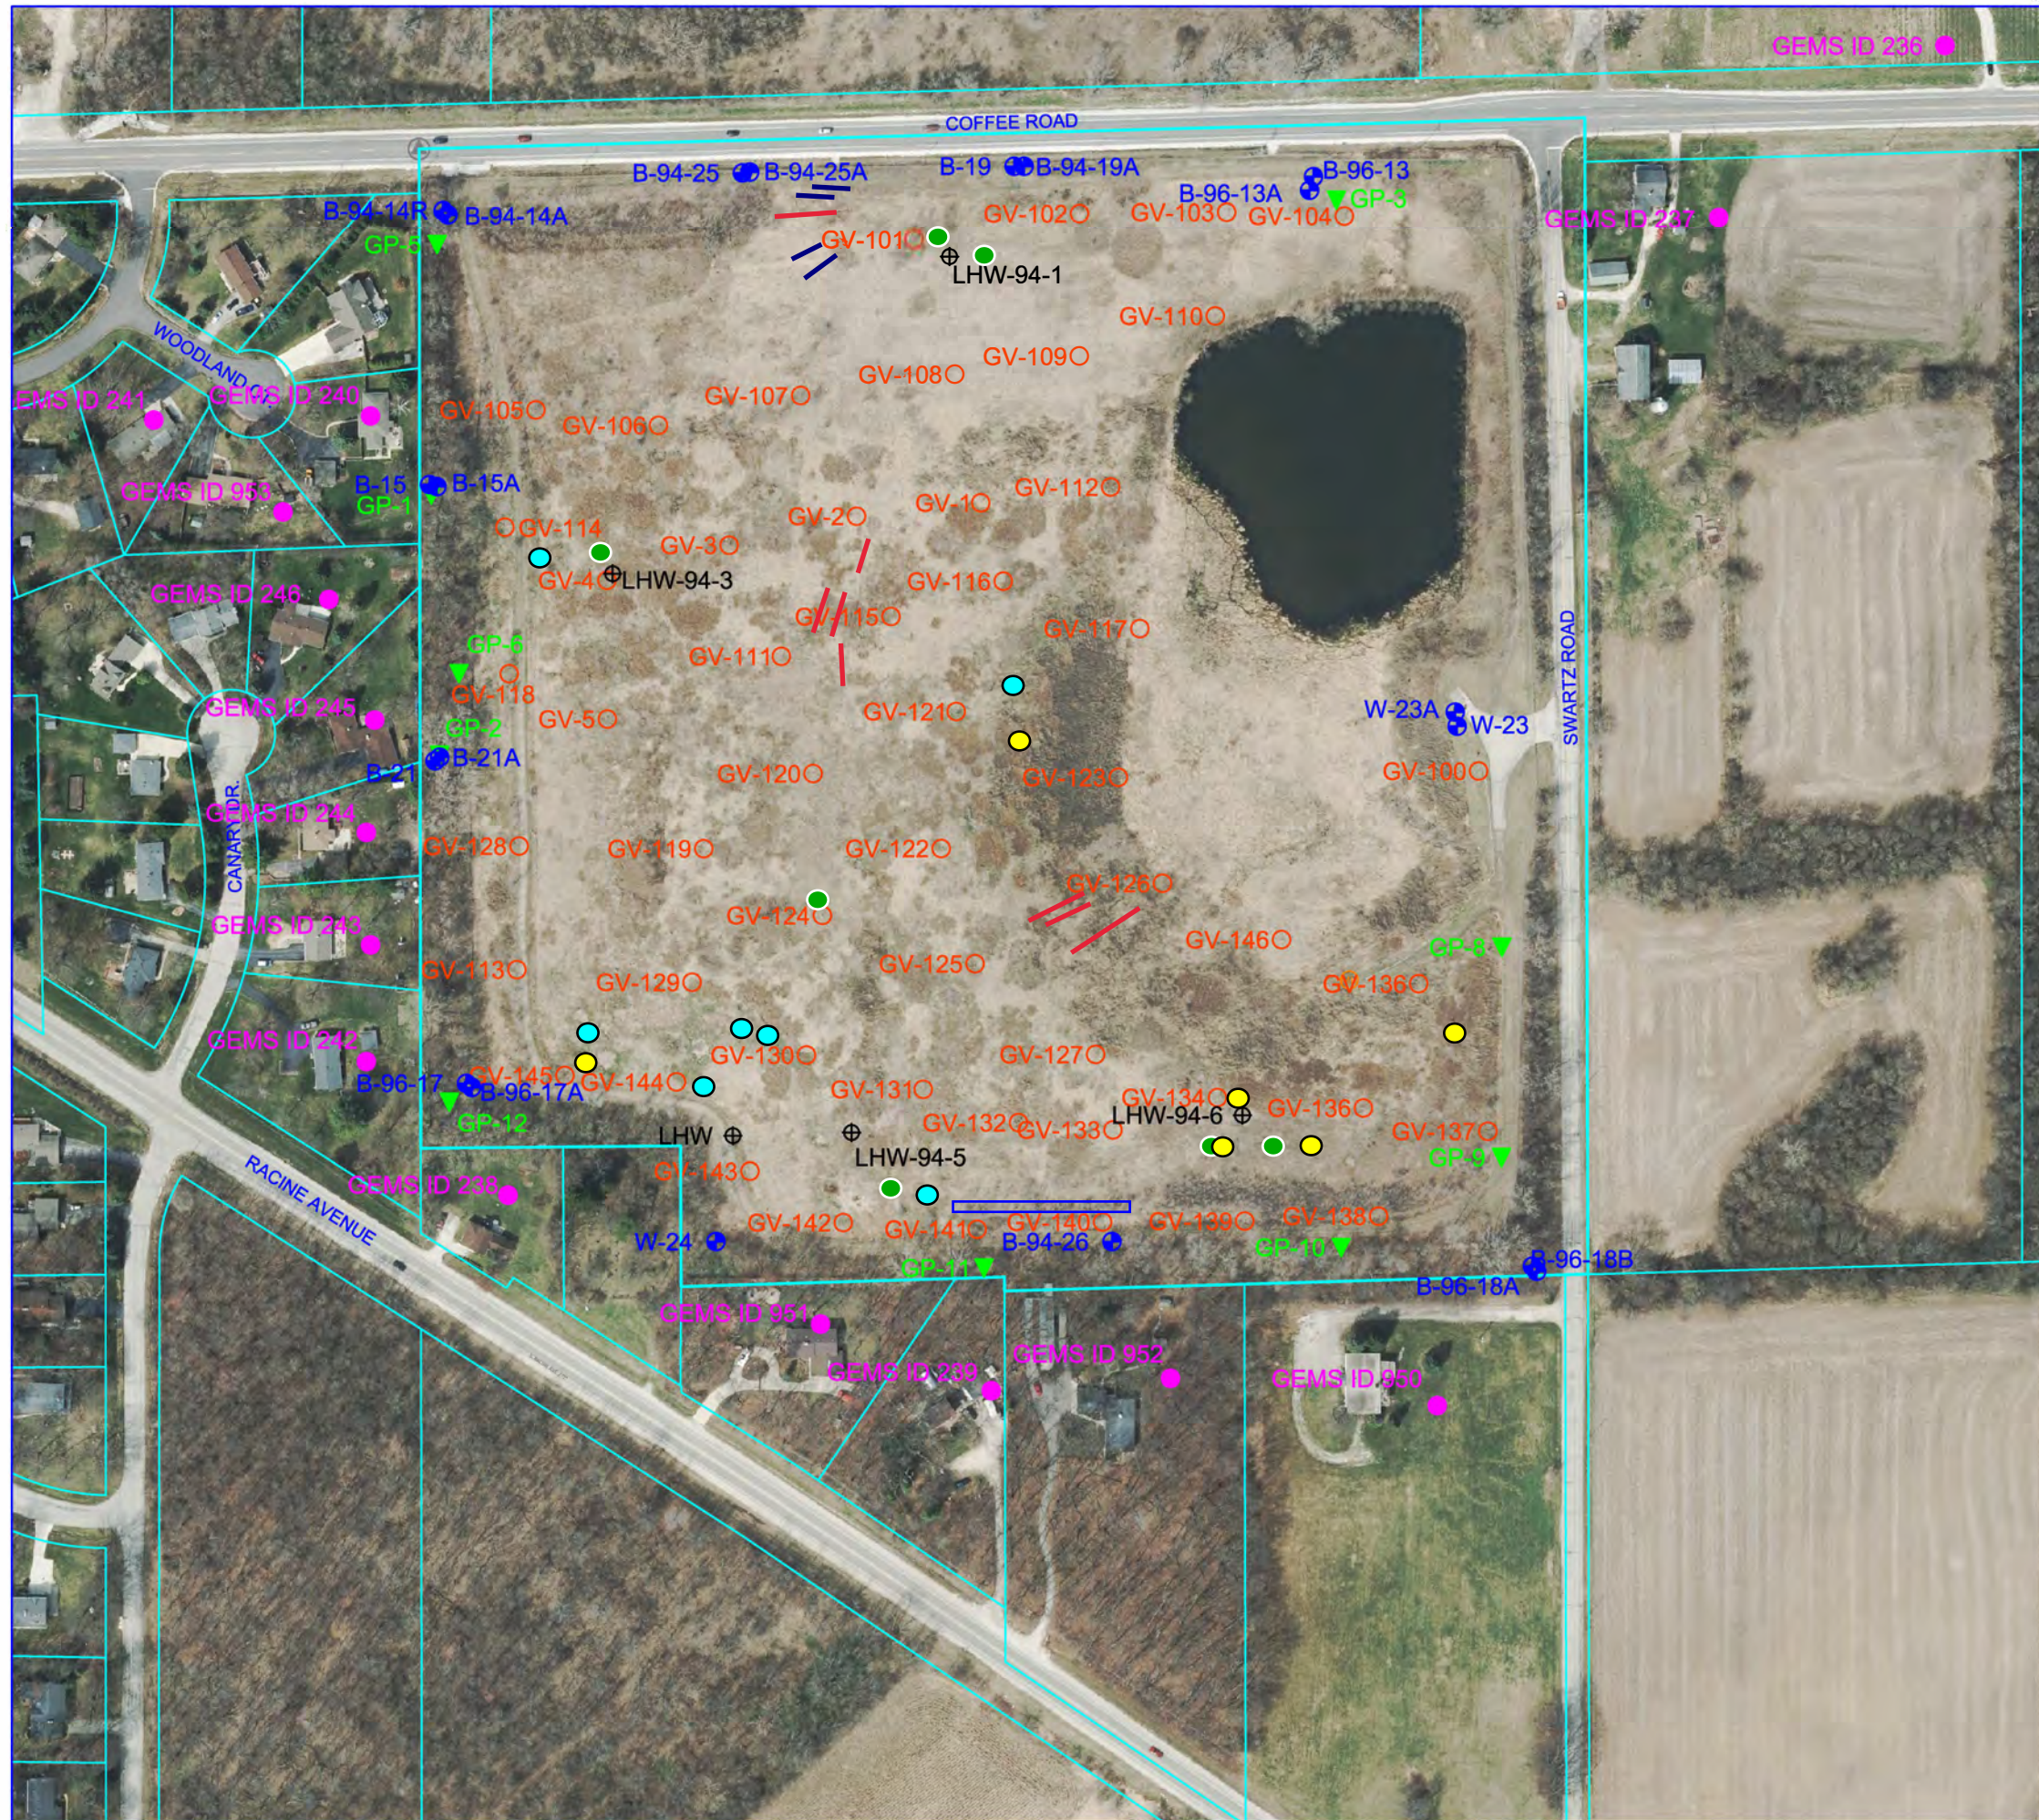
SHEET:  
**NOTABLE FEATURES**

The landfill cover was inspected by field staff on November 5, 2019 for any erosion, burrow holes, slumping, woody vegetation, areas lacking vegetation, and ponding/pooling of liquid (water or leachate). Areas that require future monitoring and/or repairs can be found on Figure 2.

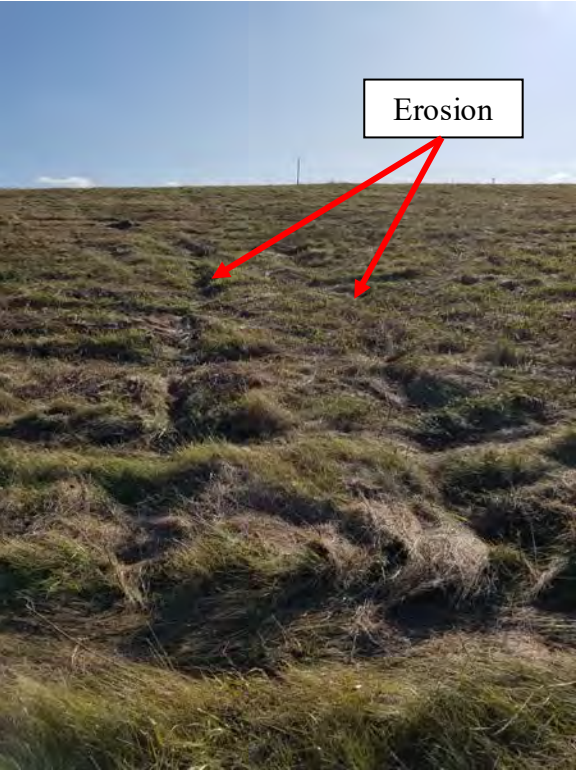
Photo #	Date	
2	11/5/19

Erosion is occurring in a few areas on the cover: near the northwest retention basin (photo 1), on the northern hill face (photo 2), and to the north and south of the newly repaired erosion area (hill face near GV-126) (photos 3-4).

<b>Description</b> Subject Property: Erosion on northern hill face going towards Coffee Road (facing S).

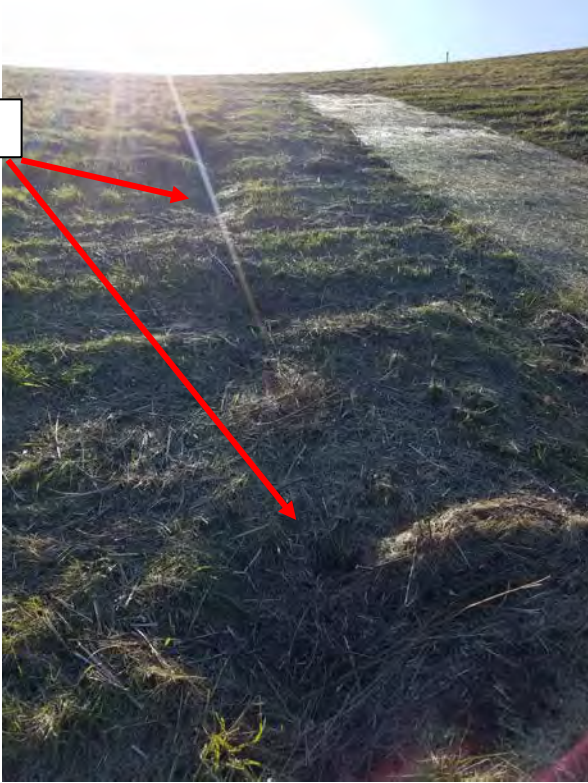
Photo #	Date	
4	11/5/19

<b>Description</b>		
Subject Property:		
Erosion on hill face		
going towards the		
pond (facing SW).

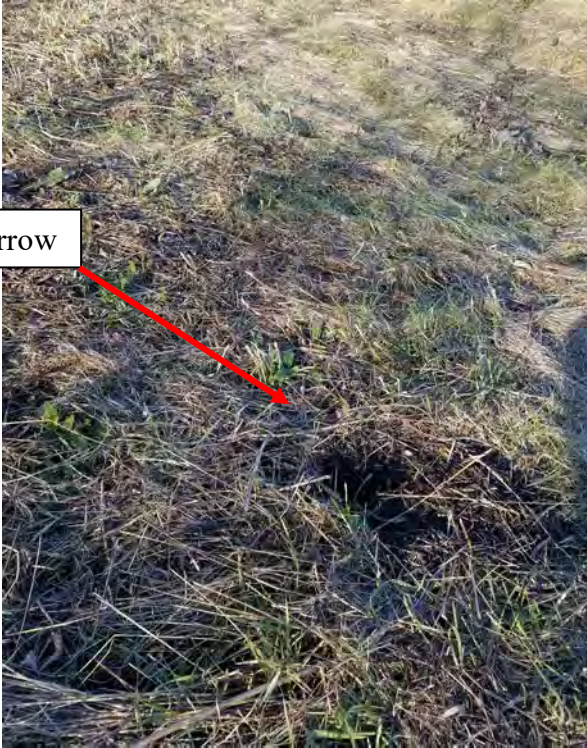
Photo # 5	Date 11/5/19

There were seven (7) animal burrow holes identified during the site inspection; a few examples can be found in photos 5-7. The burrow holes are located in the northwest along the site access road (photo 5), and on the east, southwest (photo 6) and south (photo 7) hill face. All burrow holes were marked with a marking flag so repairs could be made in the future with proper materials.

<p><b>Description</b> Animal burrow along site road, towards the NW portion of the site.</p>

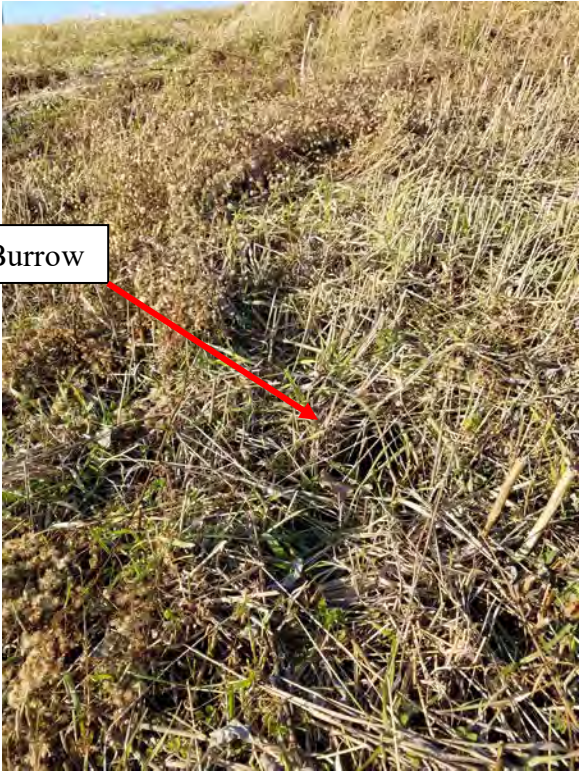
Photo # 6	Date 11/5/19

<p><b>Description</b> Animal burrow on southwest corner (SE of GV-129 and SW of GV-130).</p>

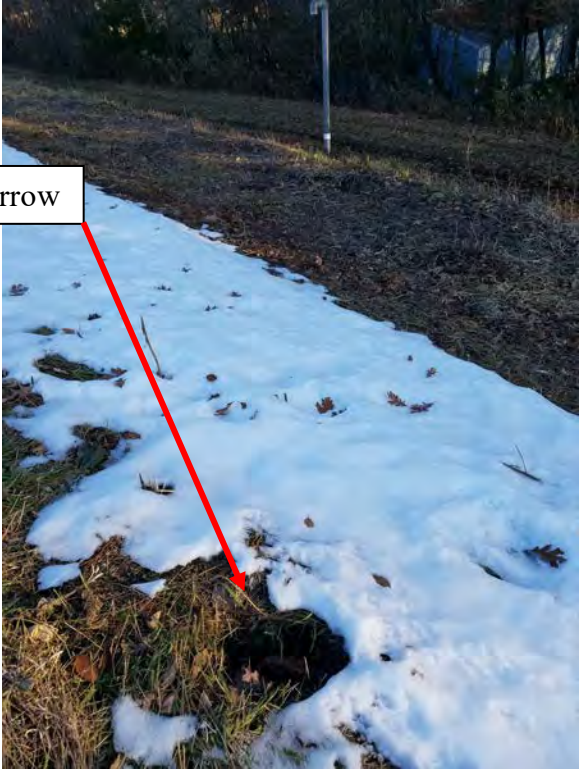
Photo # 7	Date 11/5/19

<p><b>Description</b> Animal burrow on southern hill slope (N of GV-141).</p>

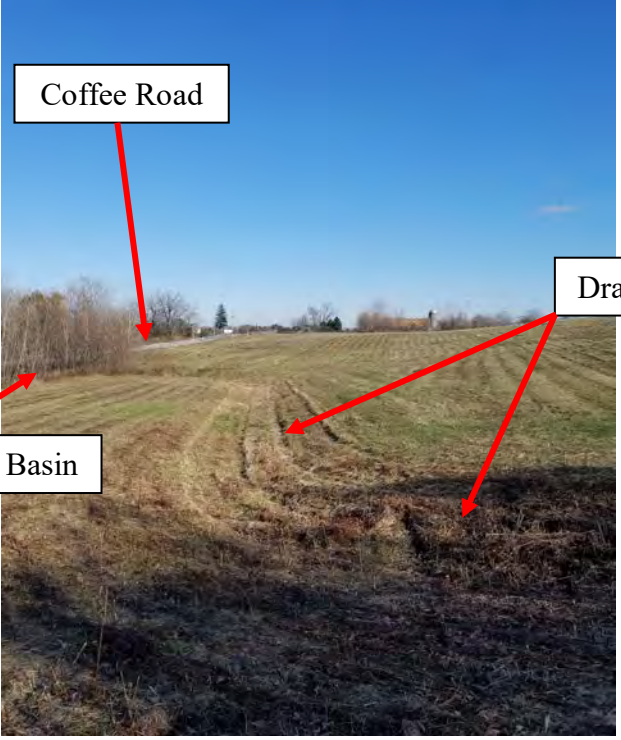
Photo #	Date	
13	11/5/19	
<b>Description</b> Subject Property: Drainage channel free of debris (facing NE).

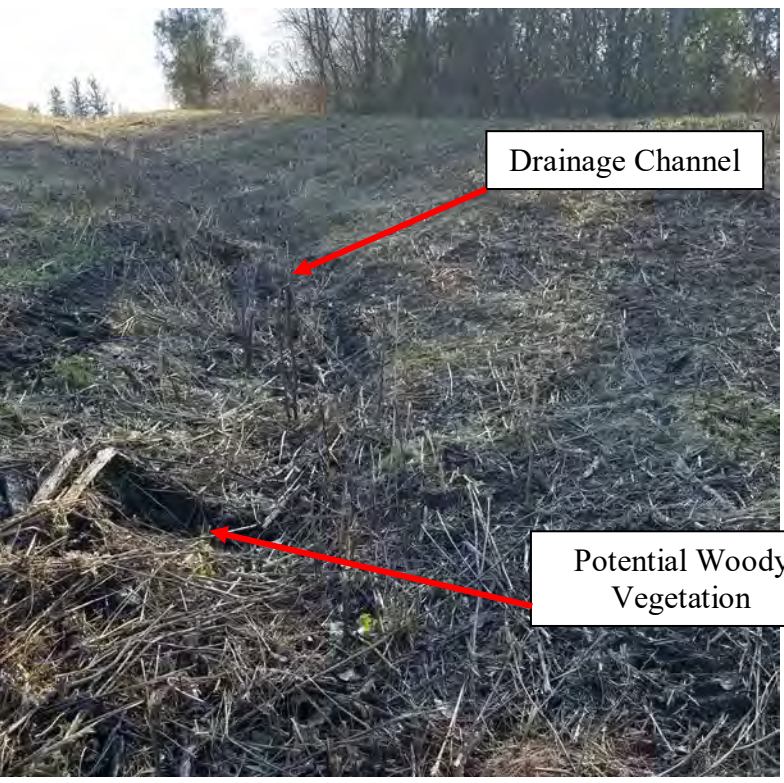
Photo #	Date	
14	11/5/19	
<b>Description</b> Subject Property: Potential woody vegetation growing in drainage channel on western side of property. Monitor in 2020 (facing S).

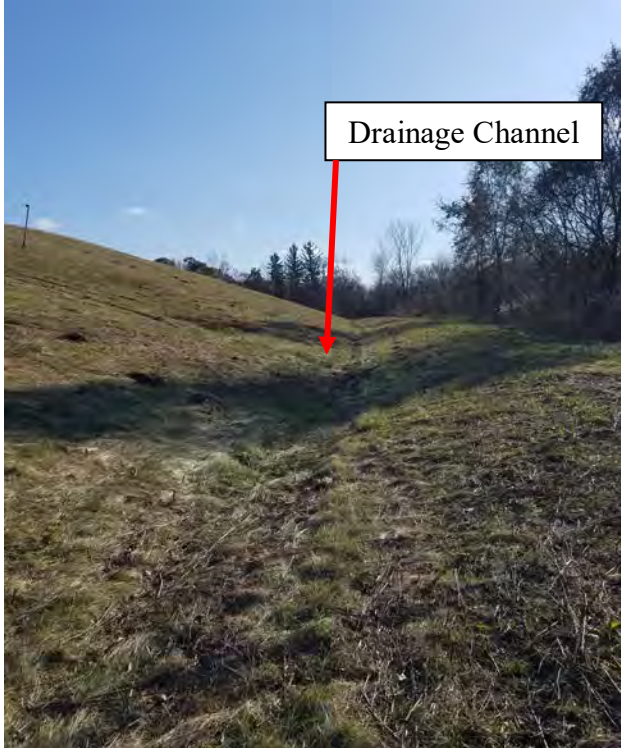
Photo #	Date	
15	11/5/19	
<b>Description</b> Subject Property: Drainage channel free of debris (facing S).

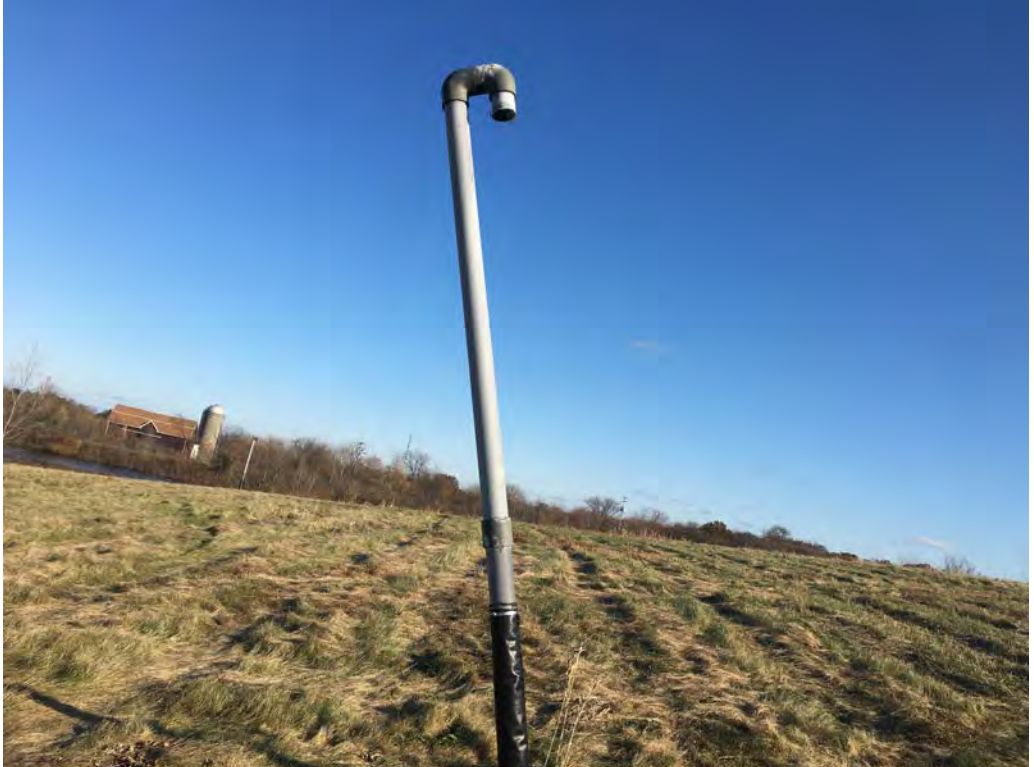
Photo #	Date	
20	11/5/19

<b>Description</b> Subject Property: GV-1 tilting northeast (facing E).

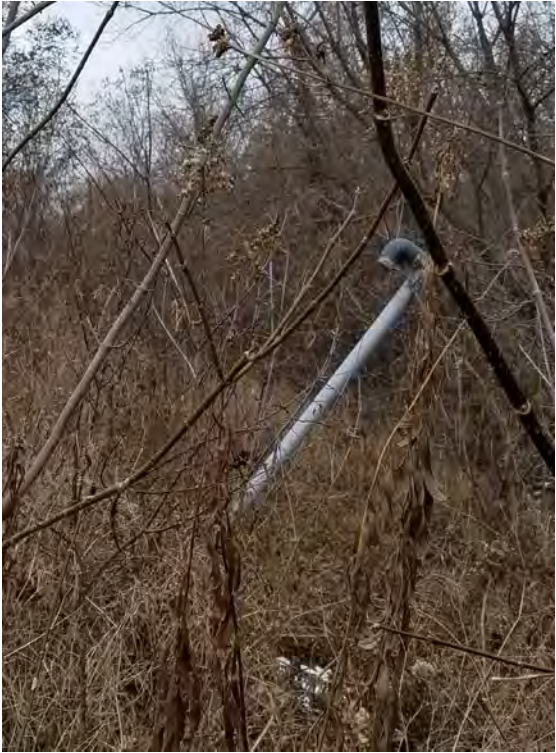
Photo #	Date	
23	11/5/19

<b>Description</b> Subject Property: GV-114 tilting west (facing S).

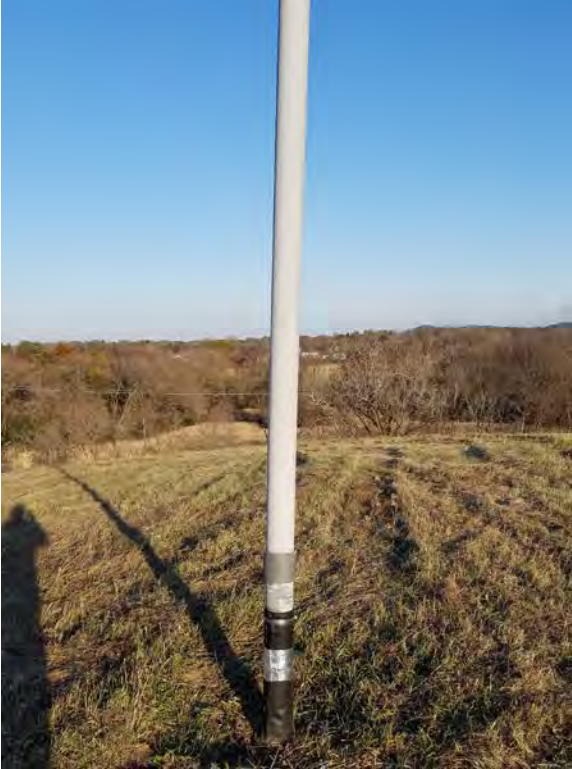
Photo #	Date	
35	11/5/19

<b>Description</b> Subject Property: Repair made to boot of GV-135 (facing E).

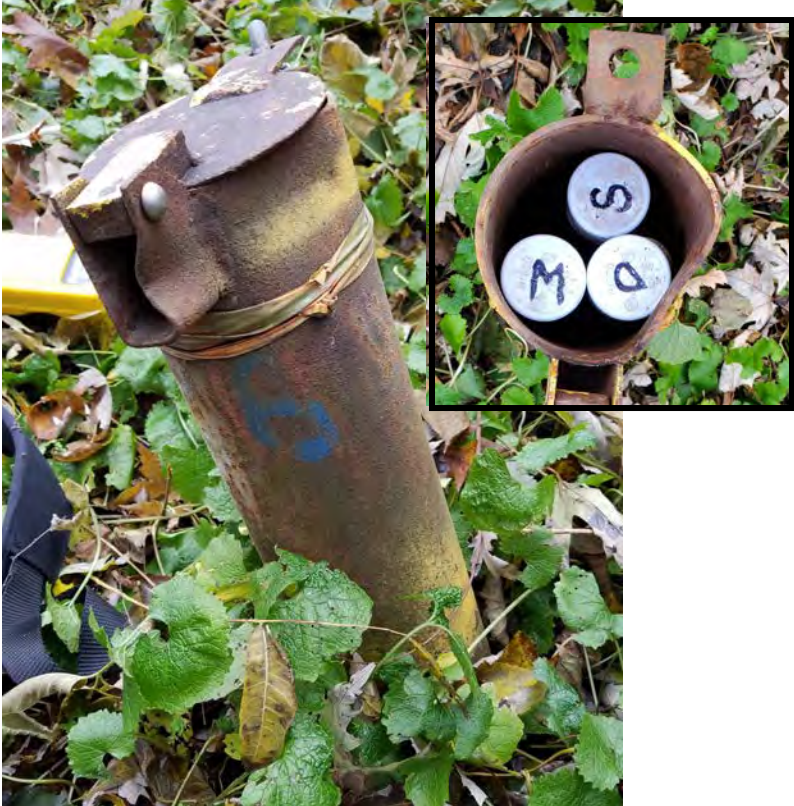
Photo # 46	Date 11/4/19

Due to a small diameter protective casing, gas probes GP-6S, GP-6M and GP-6D's caps are hard to remove (not adequate space for hands, photo 46). A plug style cap should be considered. An example of this plug can be found in Appendix C.

<p><b>Description</b></p> <p>Subject Property: GP-6 needs different well caps, J-Plug style for ease of access.</p>
