ANNUAL INSPECTION REPORT

BARRETT LANDFILL

21001 W Coffee Road, New Berlin, Wisconsin 53146 | April 2022

Ashley Wagner, P.G.
Geologist/Project Manager
Kapur Inc.

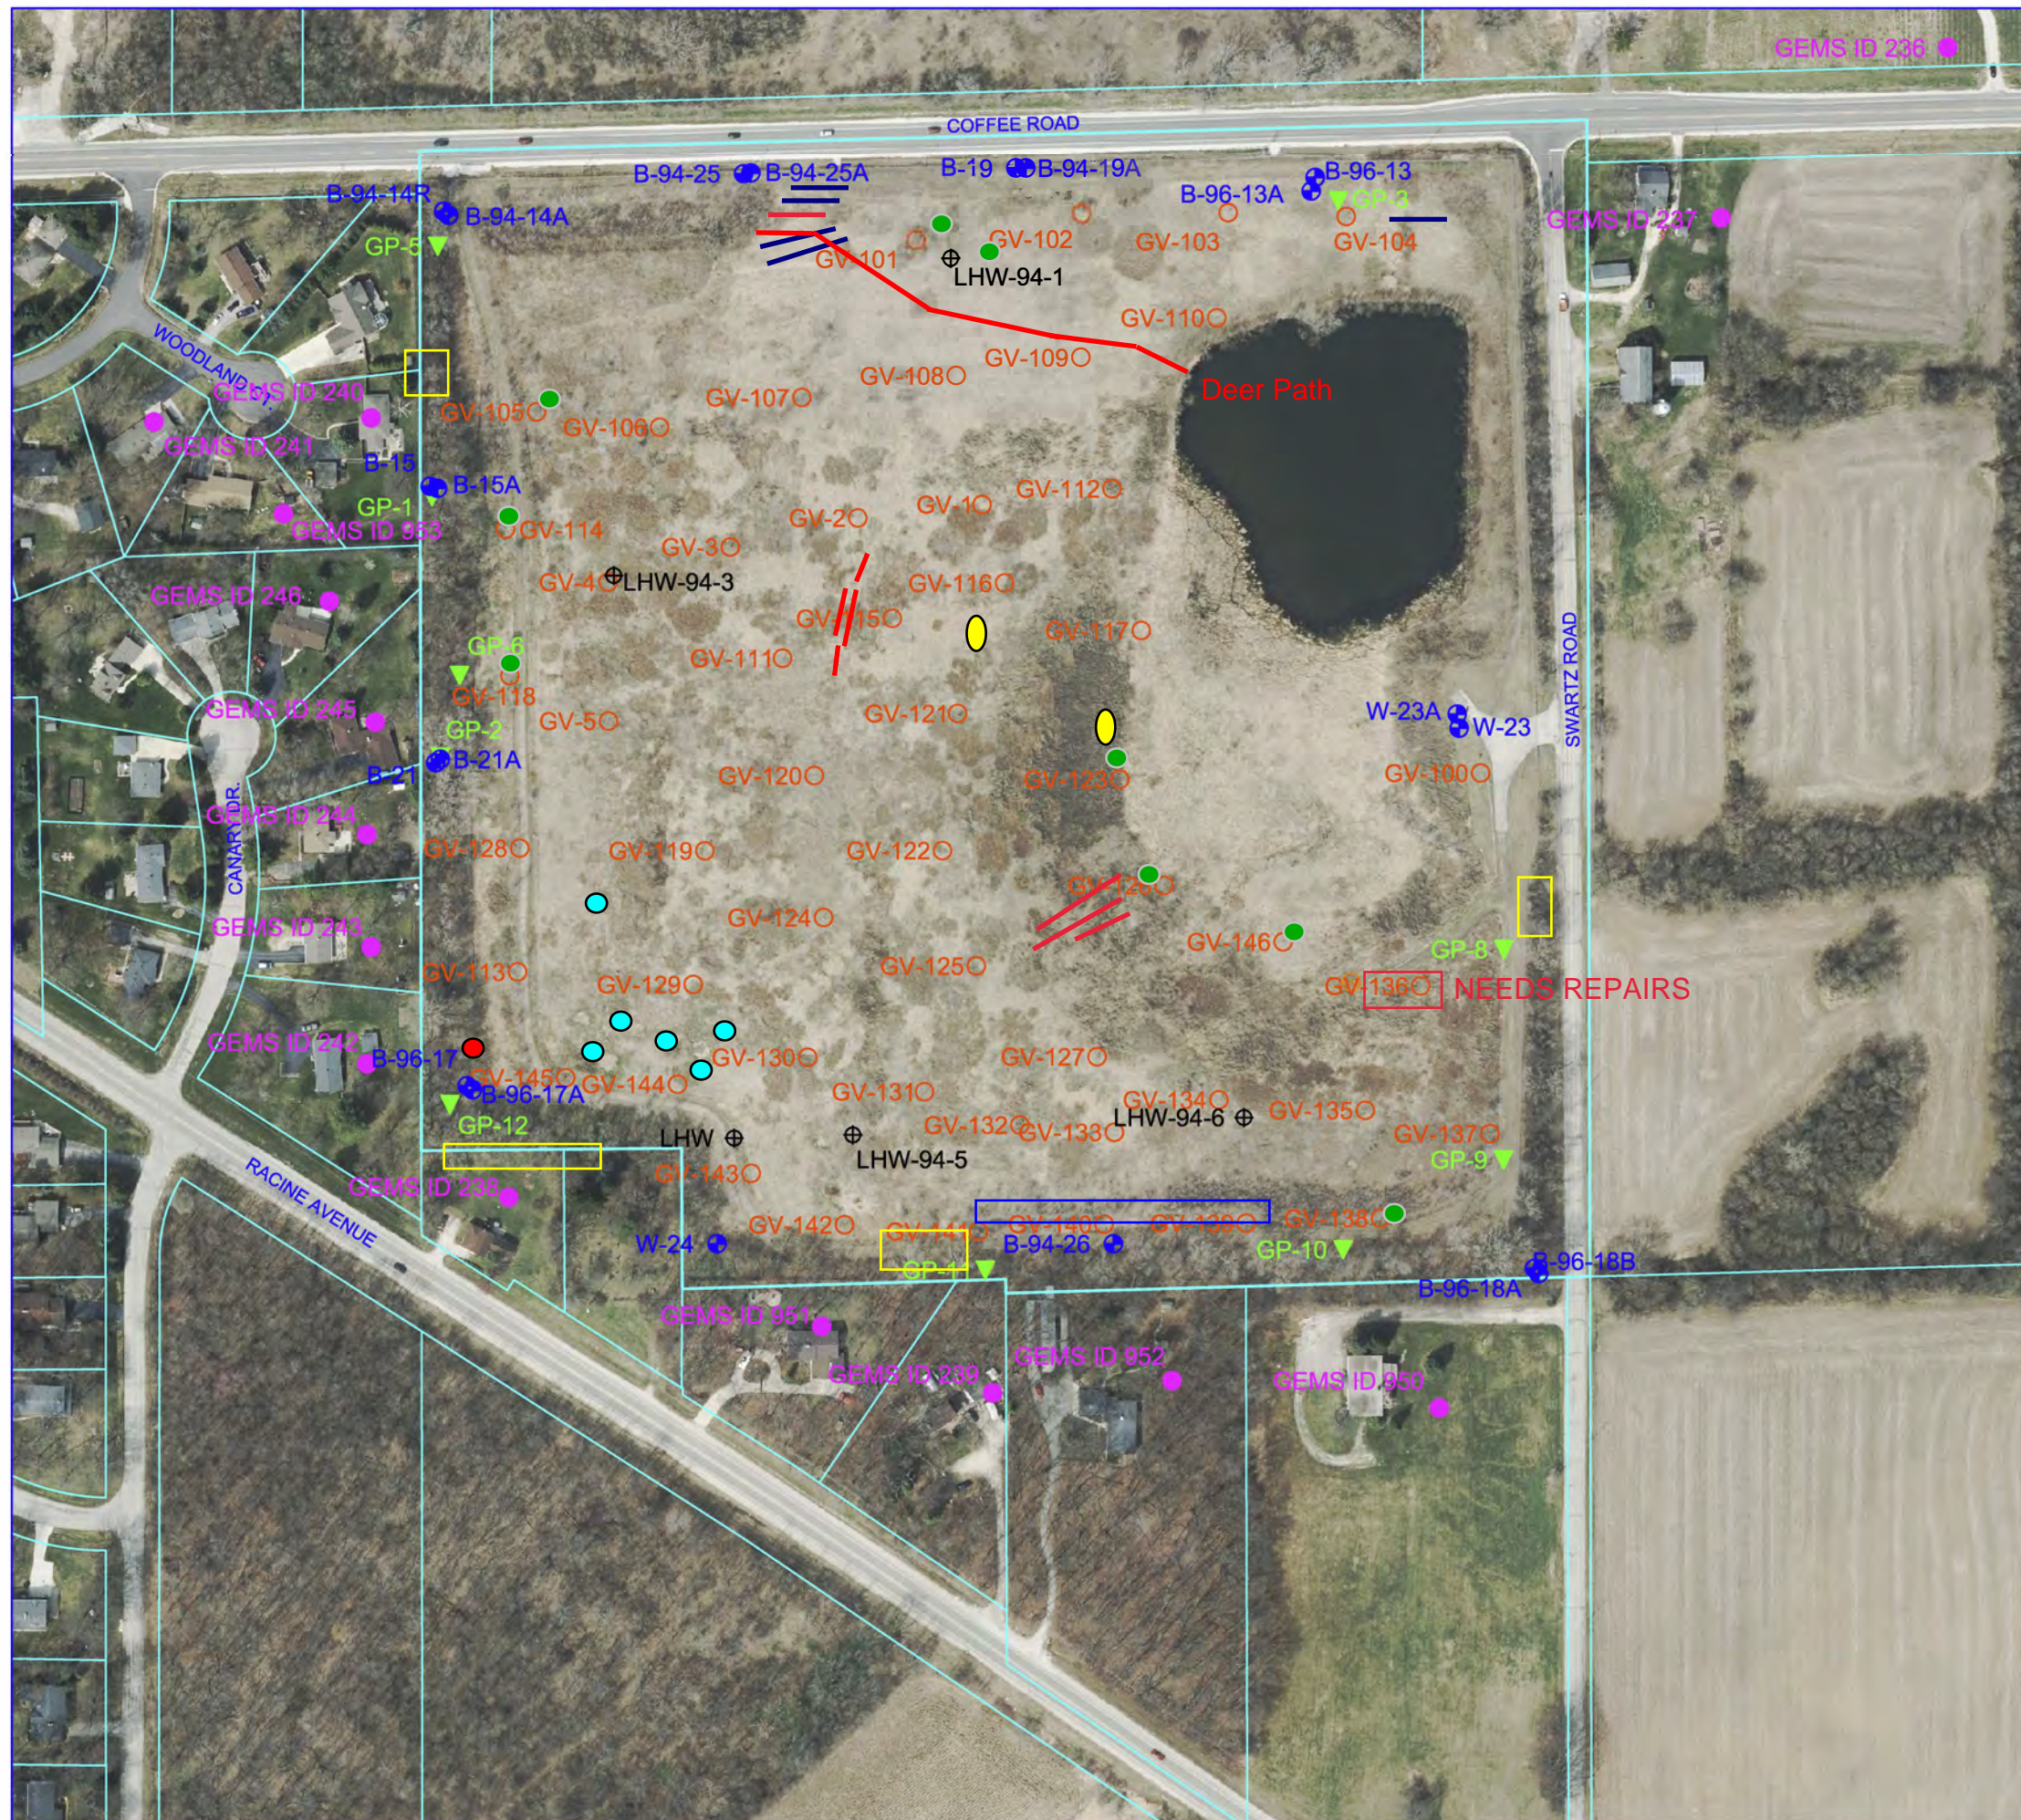
SHEET:
NOTABLE FEATURES
2021 SITE
INSPECTION

The landfill cover was inspected by field staff for any erosion, burrow holes, slumping, woody vegetation, areas lacking vegetation, and ponding/pooling of liquid (water or leachate). Notable features and areas that require future monitoring and/or repairs can be found on Figure 2.

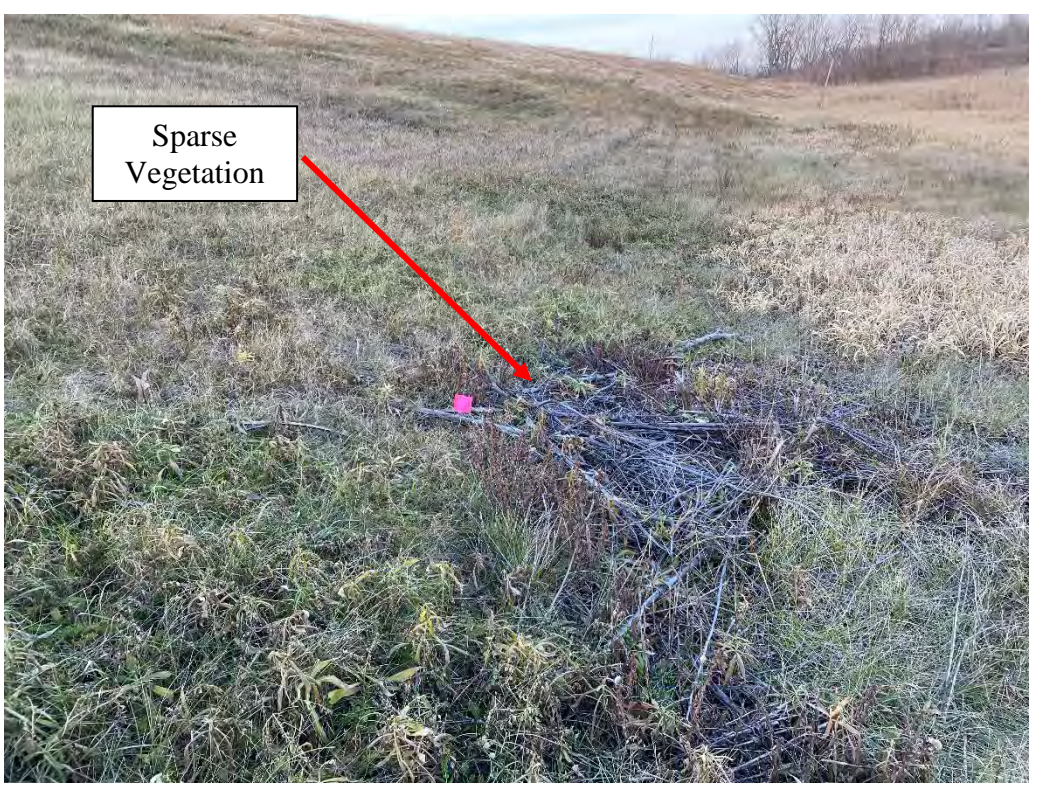
Photo # 1	Date 12/20/21

Areas lacking vegetation or with sparse vegetation were noted throughout the site (photos 1 and 12). These areas were not completely bare and should be monitored in the spring to ensure vegetation has begun to regrow. If vegetation does not appear to be coming back in these areas, grass seed will need to be applied.

Description Subject Property: area of dead/sparse vegetation to be monitored (facing N).		
Photo # 2	Date 12/20/21

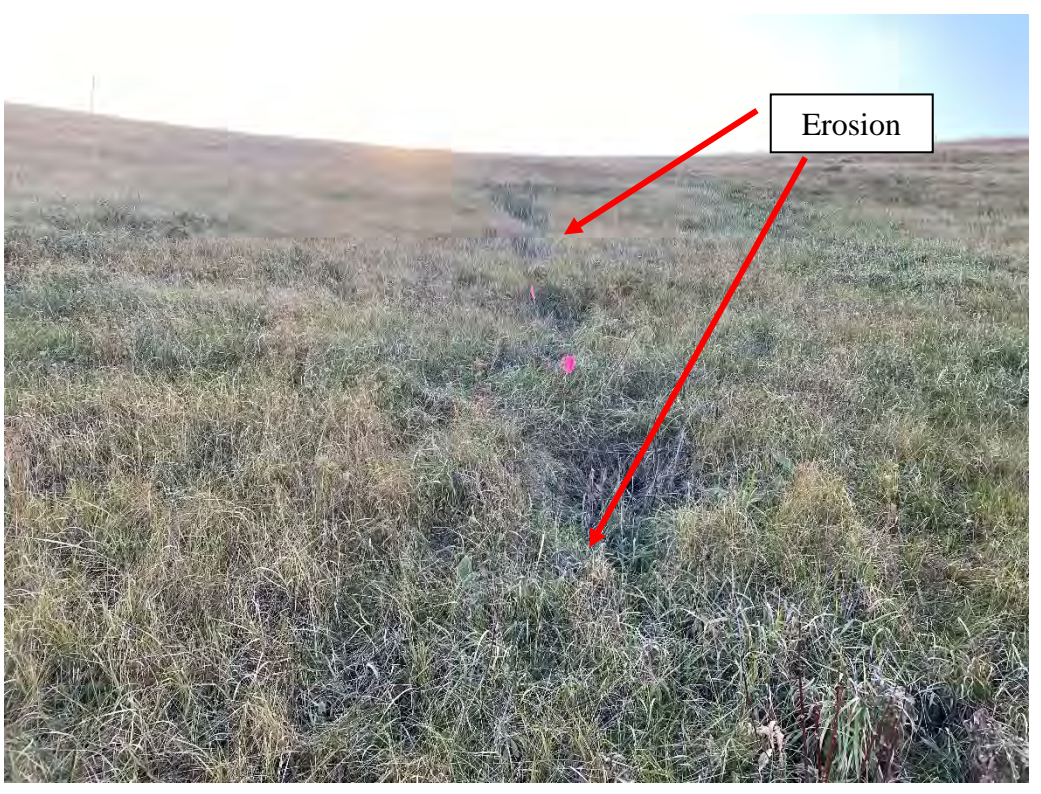
Erosion is occurring in a few areas on the cover: near the northwest retention basin (photo 4-5), on the northern hill face (photo 8), and to the north and south of the newly repaired erosion area (hill face near GV-126) (photos 2-3).

Description Subject Property: Erosion on hill face going towards the pond (facing W).

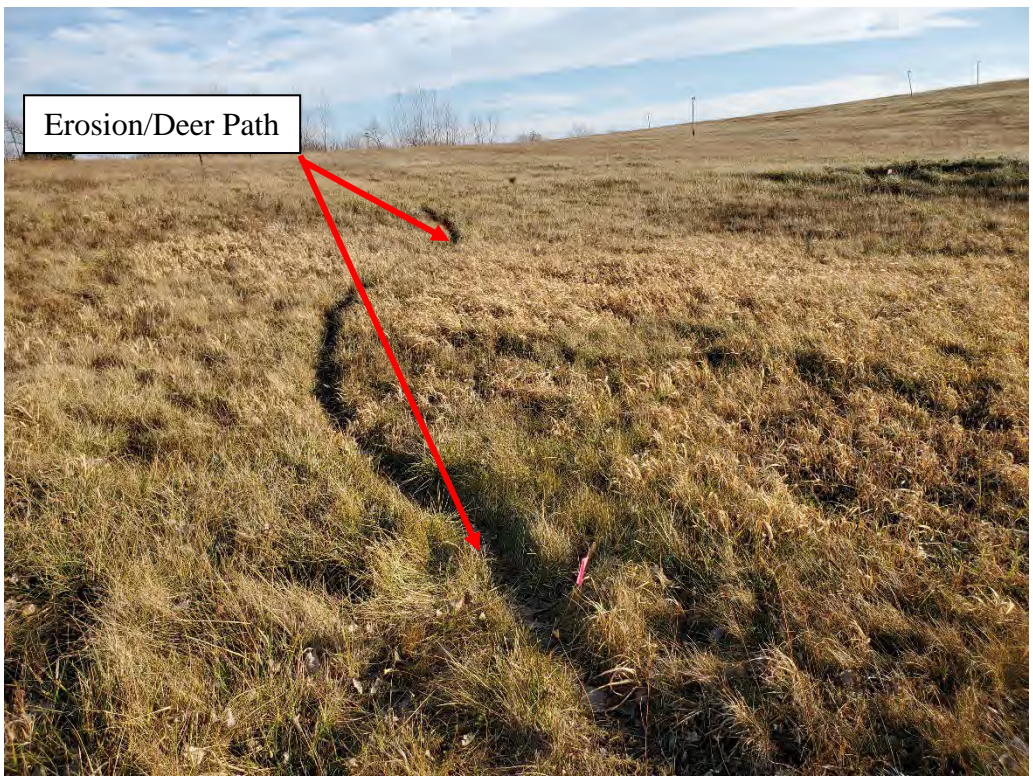
A potential deer path was identified connecting the northwest retention basin to the pond (photos 4-5). While this area may not have been an issue of surface water management, it should be monitored for further damage by deer and/or surface water.

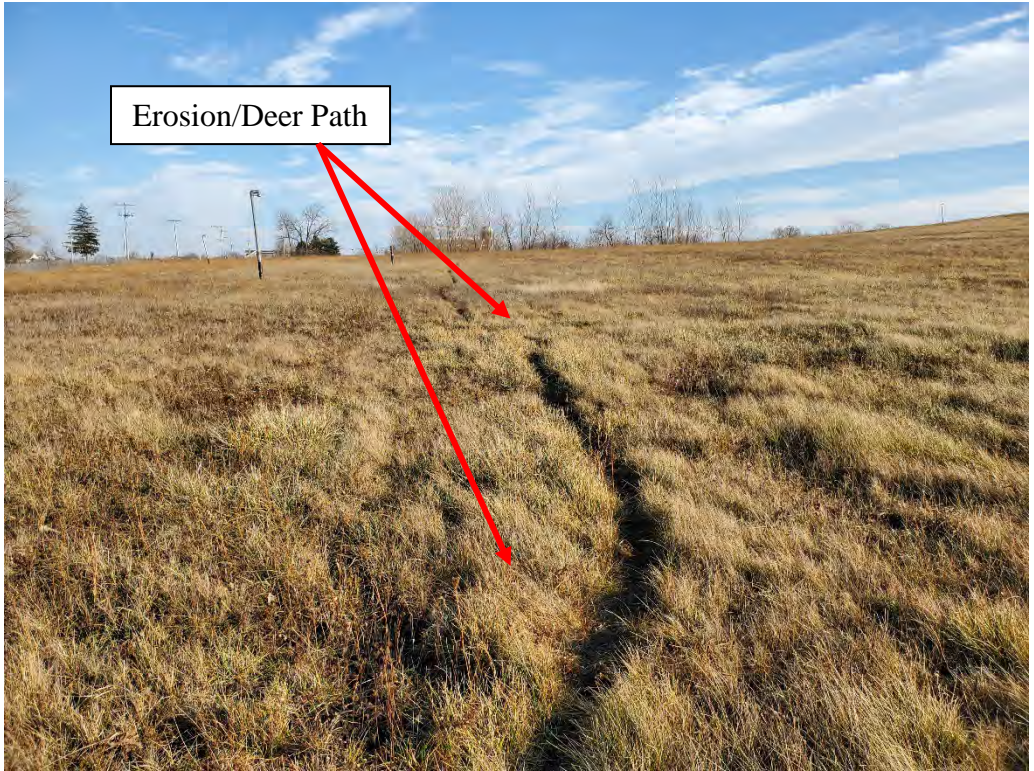
Photo #	Date	
5	12/20/21

Description Subject Property: Erosion/Deer Path from NW Retention Basin to Pond (facing ENE).

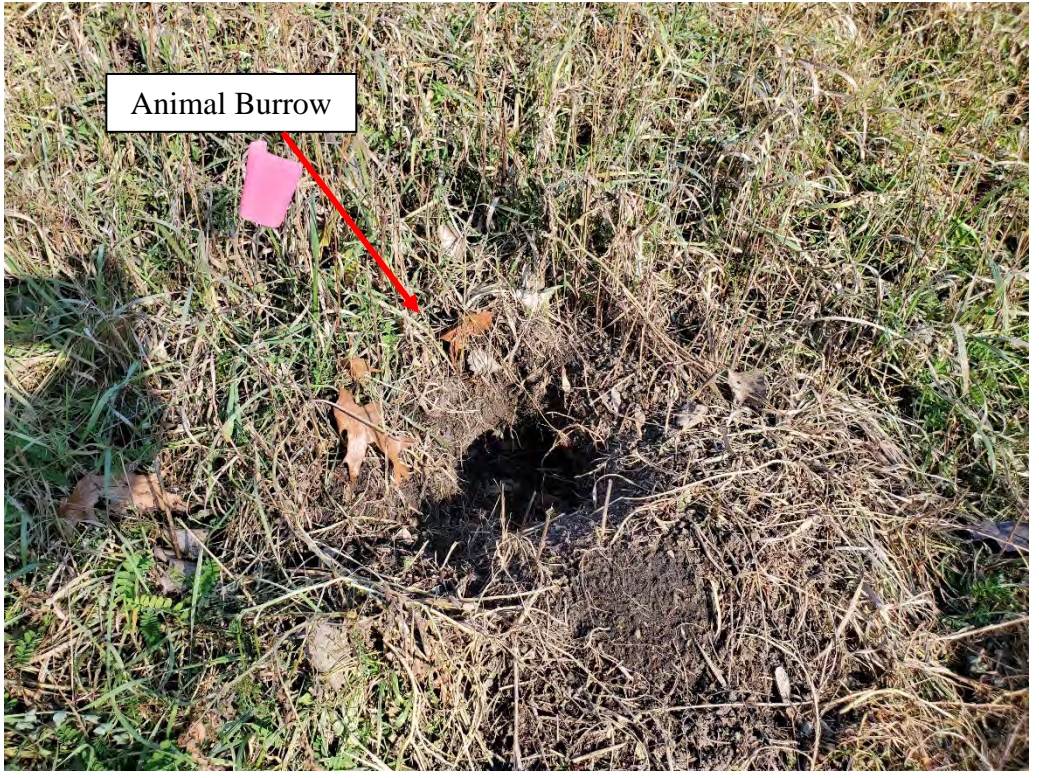
Photo #	Date	
7	12/20/21

There were six (6) animal burrow holes identified during the site inspection; a few examples can be found in photos 6-7, and 9. The burrow holes are located on the center, east, southwest, south (photo 6), northwest and northeast (photo 7) hill face. All burrow holes were marked with a marking flag so repairs could be made in the future with proper materials. *Note: burrow holes documented in 2019/2020 were not repaired (repair proposal had not been approved). The marking flags used to mark the animal burrows were run over by lawn mowing activities. Attempts were made to relocate the animal burrows, however the burrow holes located in the northwest along the site access road, near GV-141 and the east hill face were not relocated.*

A close-up photograph of a hole in the ground, partially obscured by dry grass and twigs. A pink flag is placed to the left of the hole, and a red arrow points from a white box labeled "Animal Burrow" to the hole's entrance. <p data-bbox="586 289 834 344">Animal Burrow</p>
<p data-bbox="175 344 431 485">Description Animal burrow on northern hill slope (N of GV-135).</p>

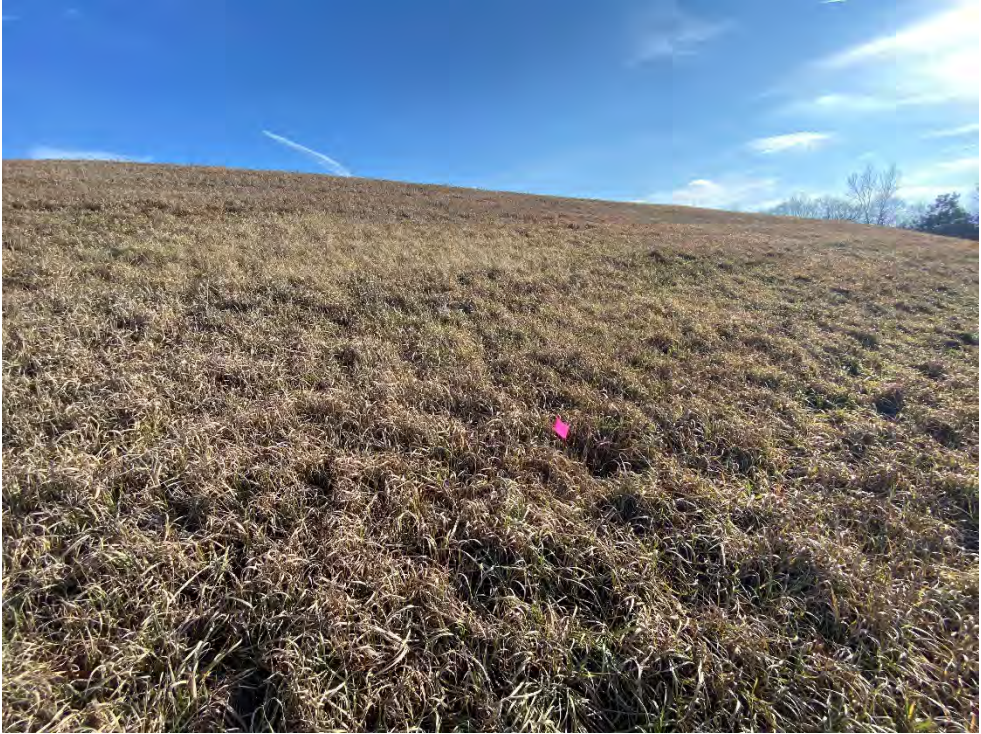
Photo # 9	Date 12/20/21

Description Subject Property: Animal burrow on the southern hill face near GV-141 (facing NE).		
Photo # 10	Date 12/20/21

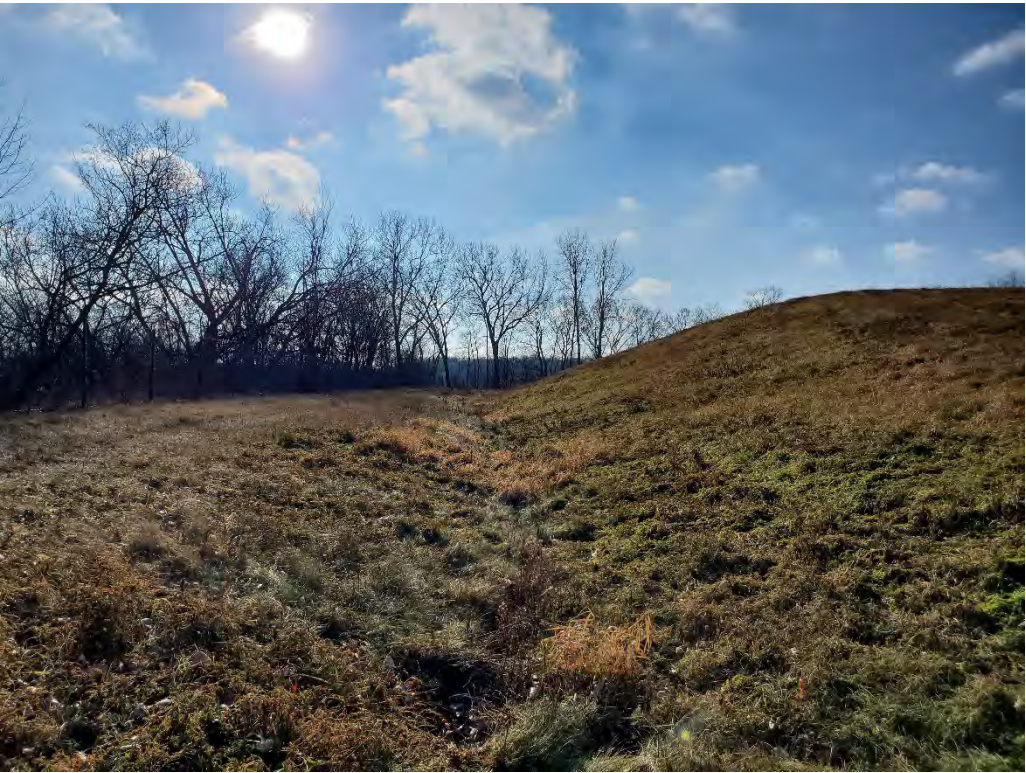
Potential slumping appears to be occurring at the south end of the landfill (photos 10-11). This should be monitored in the future to note any changes. Additional soil may be needed to help stabilize the slopes from further slumping. When comparing the photos from the 2020 inspection, no changes to the slopes are apparent.

Description Subject Property: Possible slumping of the southern hill face near GV-141 (facing W).

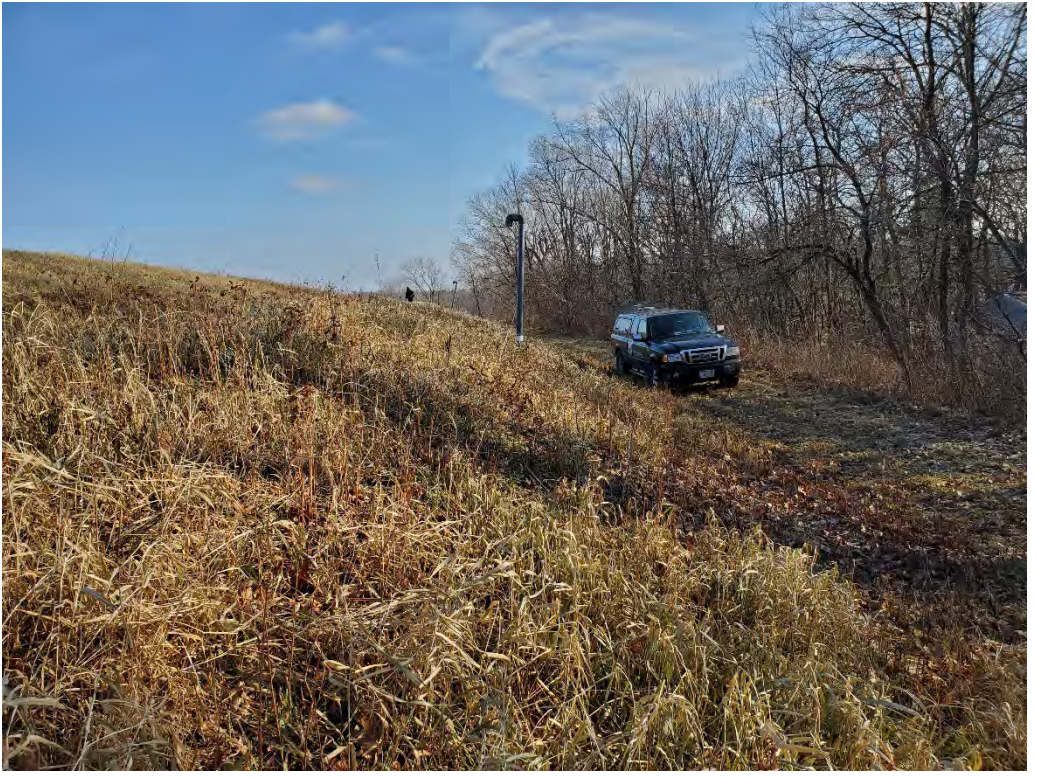
Photo #	Date	
11	12/20/21

<p>Description</p> <p>Subject Property: Possible slumping of the southern hill face (facing E).</p>

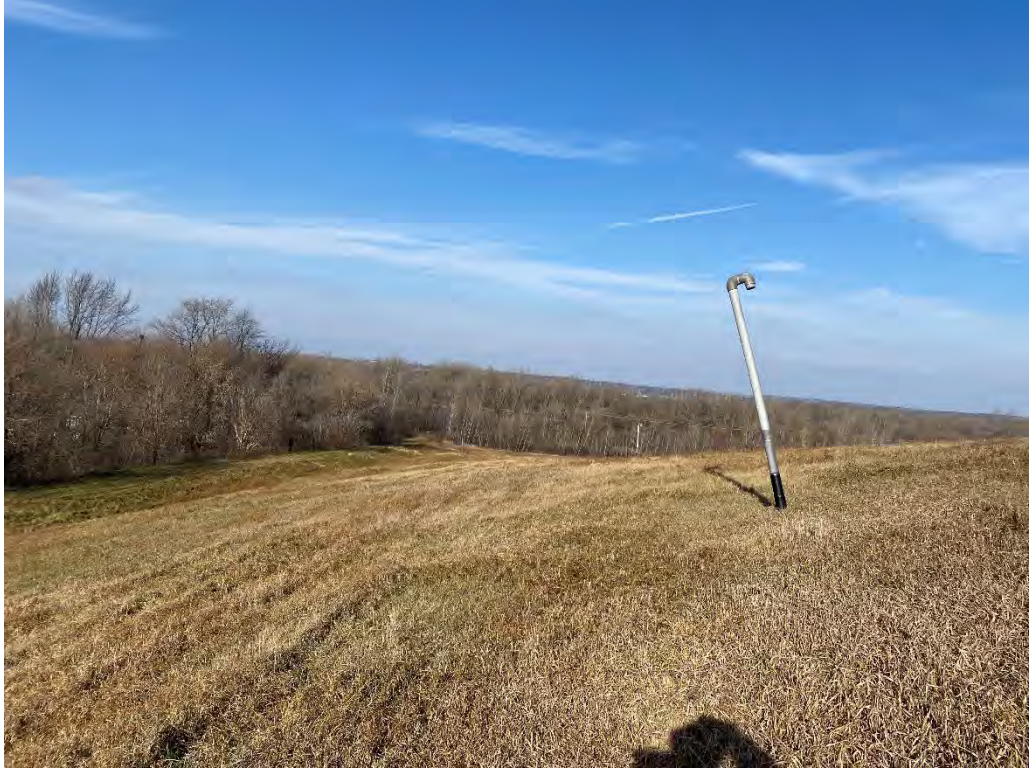
Description Subject Property: GV-3 tilting north (facing N).

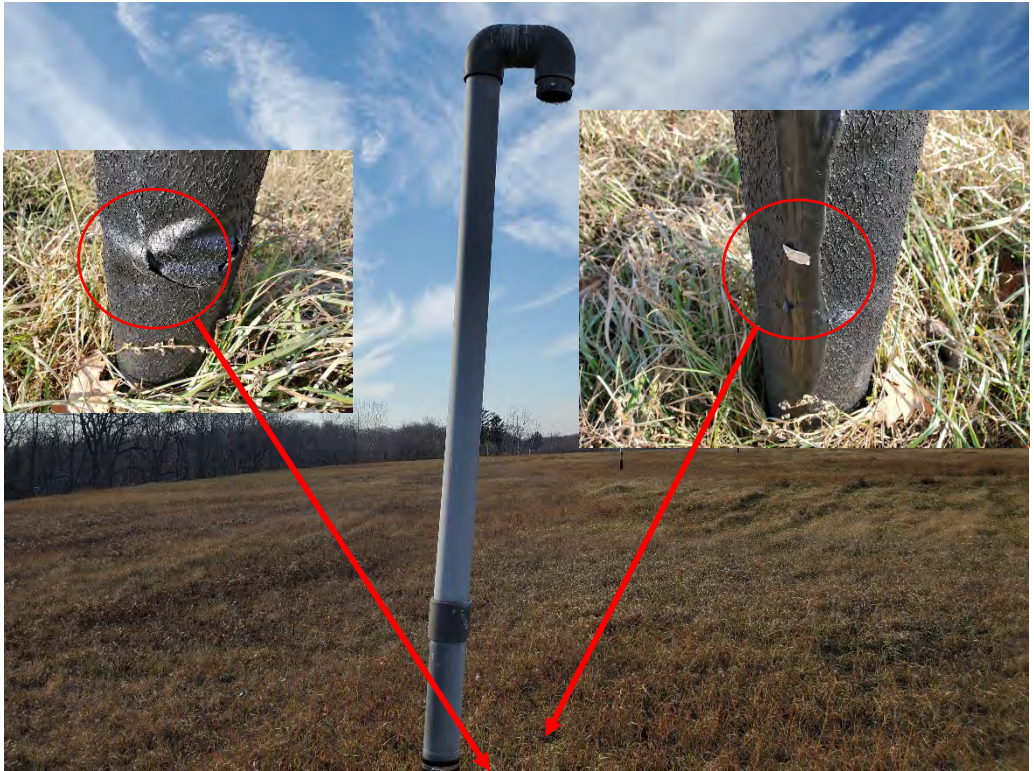
Photo #	Date	
29	12/20/21

Description Subject Property: GV-135 tears in boot (facing W).

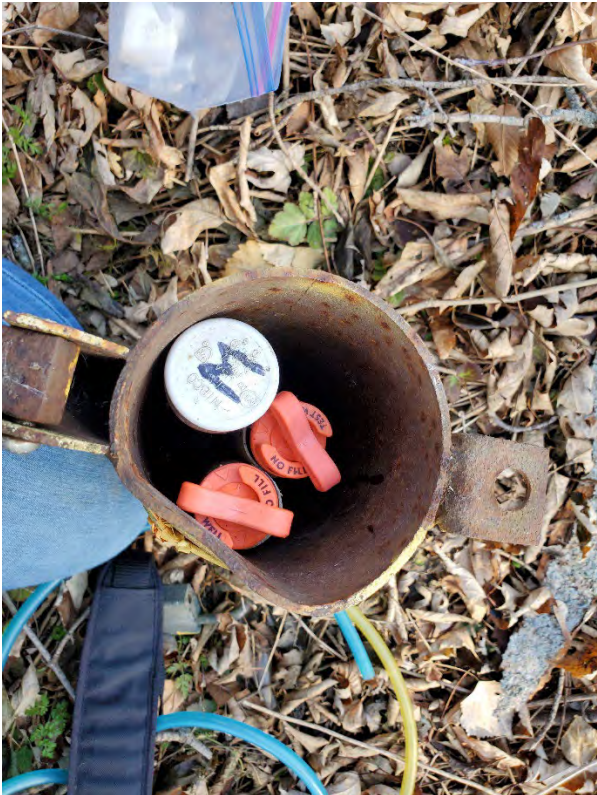
Description		
Subject Property:		
GP-6: dented protective casing makes removing well cap difficult, replace GP-6M cap.
