**RE: Barrett Landfill, City of New Berlin, Waukesha County, Wisconsin, License No. 1940
BRRTS No. 02-68-534609**

This letter summarizes the repairs made and activities conducted at the Barrett Landfill (License No. 1940) located at 21001 W Coffee Road, New Berlin, Wisconsin (Site).

Attachment A – Photo Log

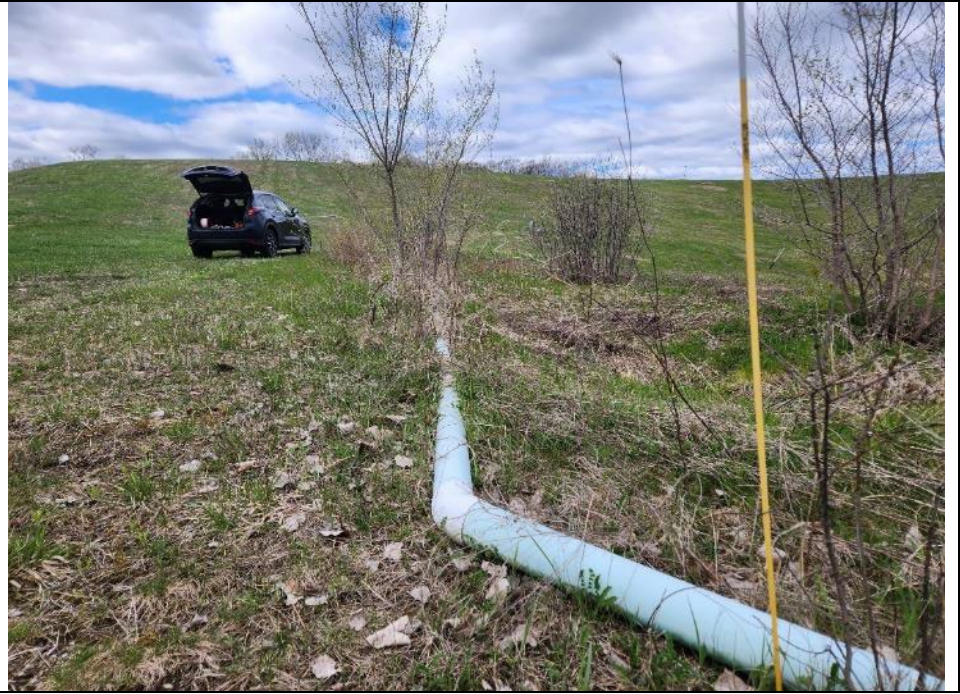
Photo No.	Date
1	5/2/23
Direction Photo Taken	
Southwest	
Description	
Woody vegetation along leachate line.

On June 5, 2023, Cedar picked up repair supplies, including the replacement hose, and returned to the Site to begin repairs and site maintenance. All woody vegetation along the leachate lines were cut down and the grass trimmed and mowed on both sides of the leachate lines so a thorough inspection could be completed. The areas previously treated for poison ivy were also cut so additional treatment could be completed. The cracked flexible hose was replaced with the new flexible hose. Cedar used approximately 2.5 cubic feet of all-purpose stone and 3 cubic feet of organic topsoil to raise the ground in the area that was eroding. The broken

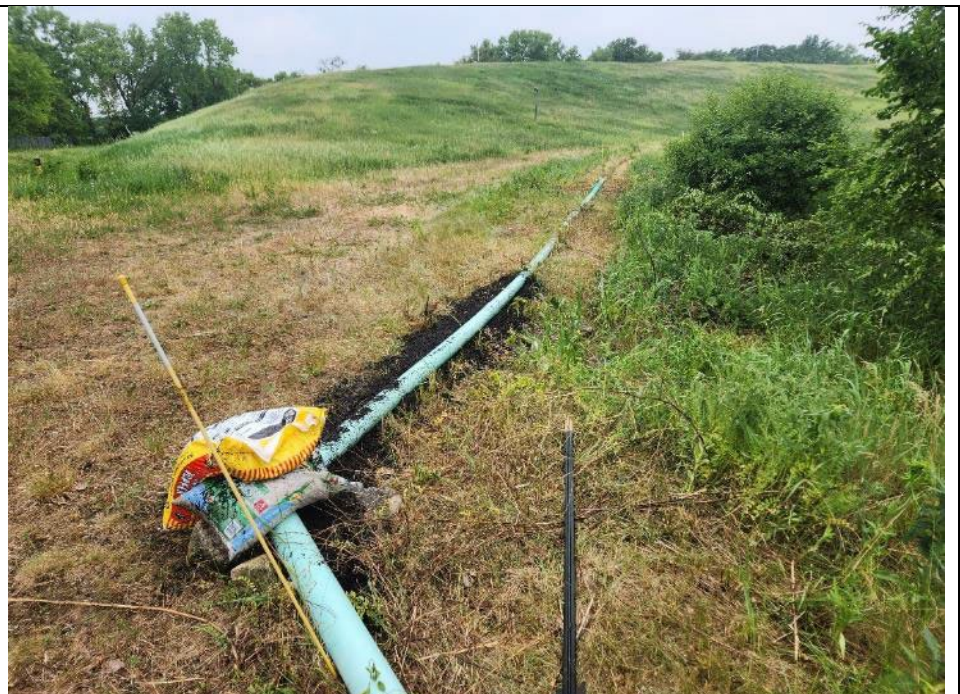
Photo No.	Date
2	6/6/23
Direction Photo Taken	
Southwest	
Description	
Eroding ground repaired with gravel and topsoil. Bags of gravel and topsoil on end to add if it settles and hold corner in place while repairs cure.

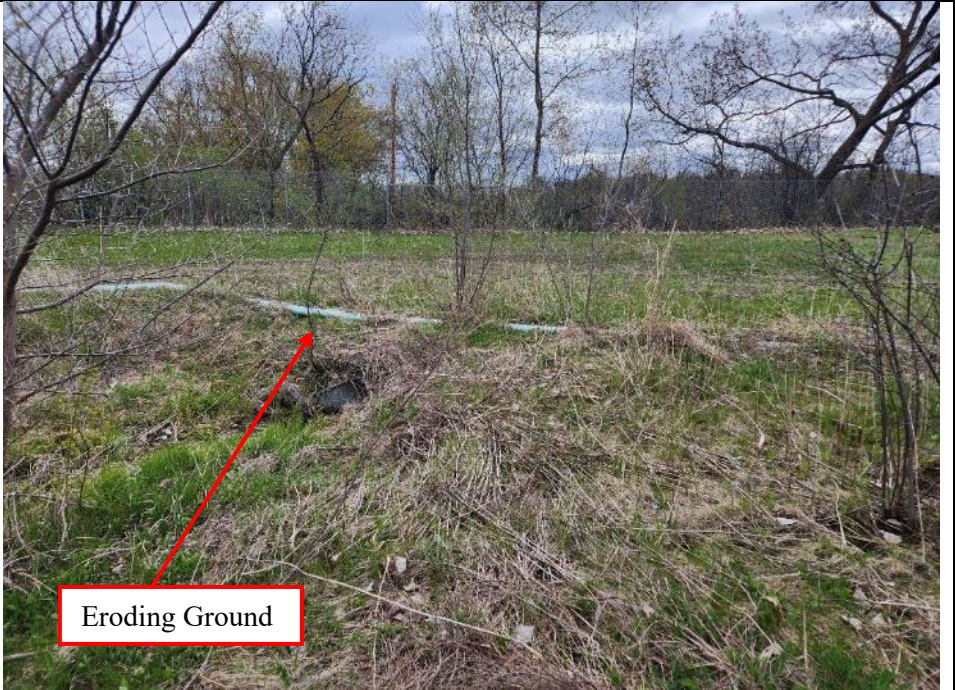
3	5/2/23	
Direction Photo Taken		
Southeast		
Description		
Eroding ground over culvert.

Cedar recommends that the poison ivy continues to be treated as needed, as was observed growing throughout the Site and in areas where staff and contractors work frequently. Cedar recommends that during the annual cap inspection, that the ground repairs above the culvert be inspected, and if needed, the bag of all-purpose stone and organic topsoil be spread in the area to keep the ground as level as possible. Cedar will have MJM Pumping check the repaired connection when they are at the Site, to help eliminate the release of leachate to the ground when no one is present at the Site.

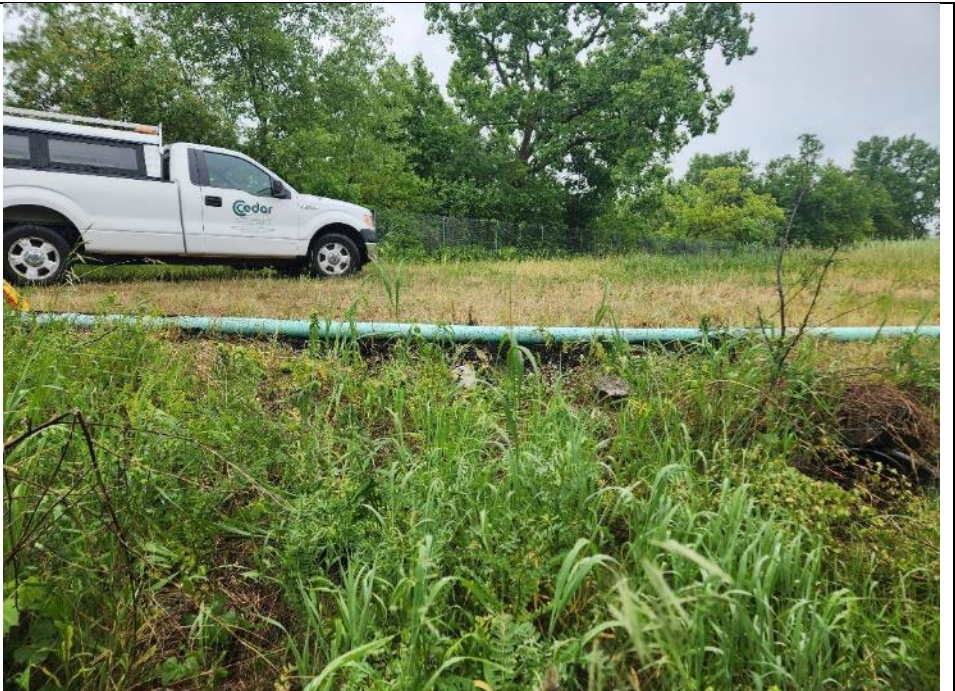
4	6/6/23	
Direction Photo Taken		
Southeast		
Description		
Eroding ground repaired with gravel and topsoil.

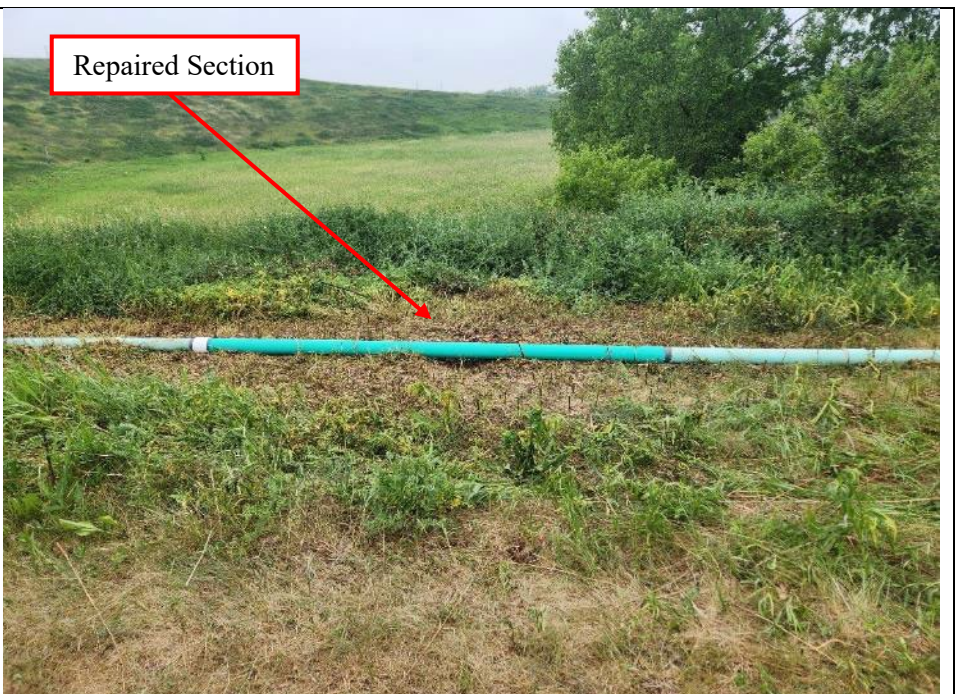
Photo No.	Date	 
5	5/2/23	
Direction Photo Taken		
Northwest		
Description		
Broken connection of PVC.

6	6/6/23	
Direction Photo Taken		
Northwest		
Description		
Repaired section of PVC.

On June 6, 2023, an approximate 10-foot section surrounding the break in the leachate lines was cut out, and a new piece of 4" by 10-foot section of bell-end sewer pipe was connected to the existing leachate line with a coupling and the use of industrial grade PVC cleaner, primer, and glue. The glue was allowed to dry for one (1) hour before turning the system on. A bag of all-purpose stone, organic topsoil, and some riprap found at the Site was placed at the turn of the PVC to ensure that it didn't move when the system turned on. Once turned on, there were no signs of leaks. The holding tank was filled, and the pump was turned off.

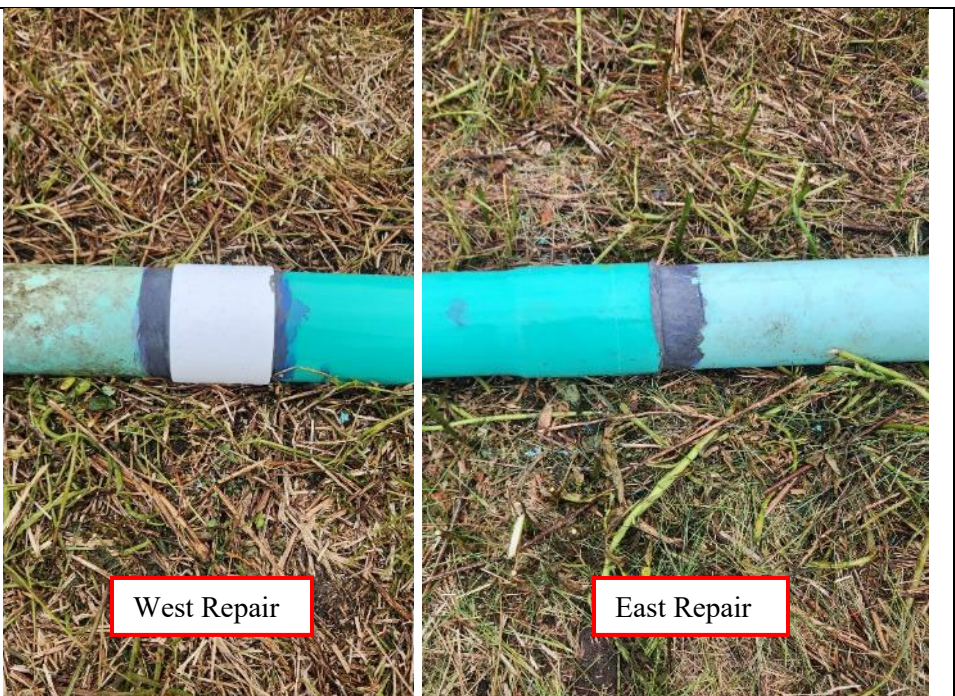
Photo No.	Date	 
7	5/2/23	
Direction Photo Taken		
Northwest		
Description		
Broken connection of PVC.

8	6/6/23	
Direction Photo Taken		
Northwest		
Description		
Repaired section of PVC.		
		<div style="border: 1px solid red; padding: 2px; display: inline-block;">West Repair</div>
		<div style="border: 1px solid red; padding: 2px; display: inline-block;">East Repair</div>

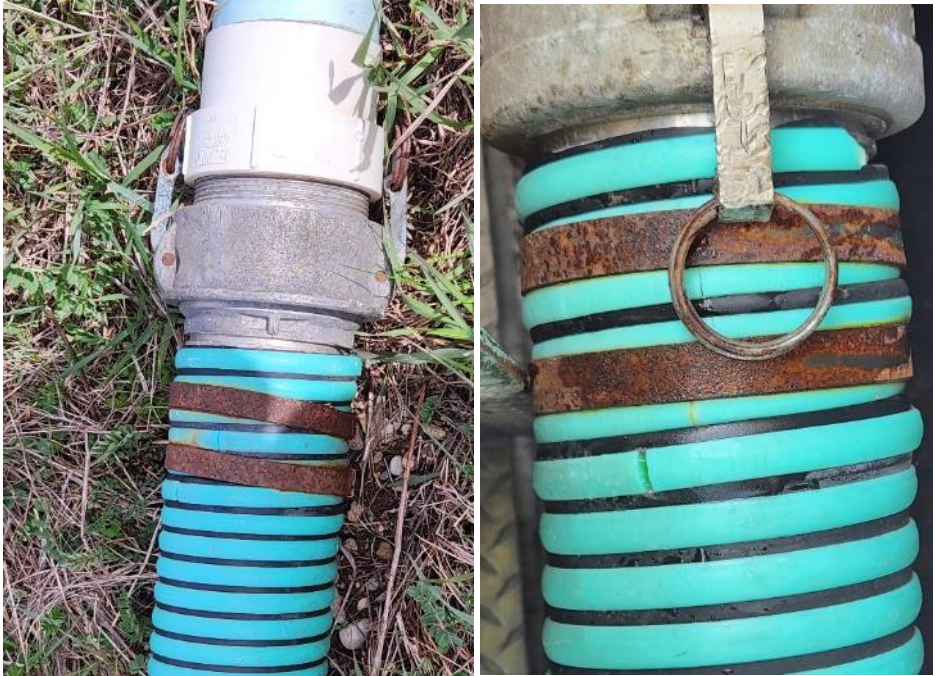
9	5/2/23	
Direction Photo Taken		
NA		
Description		
Cracked flexible hose near lift station.

A replacement flexible hose was ordered from Milwaukee Rubber Products in Menomonee Falls. The replacement hose was a 300 EPDM all-weather suction/discharge (4" diameter, 27 feet long, original Kanaflex Hose), with CF Aluminum male and female camlock fittings.

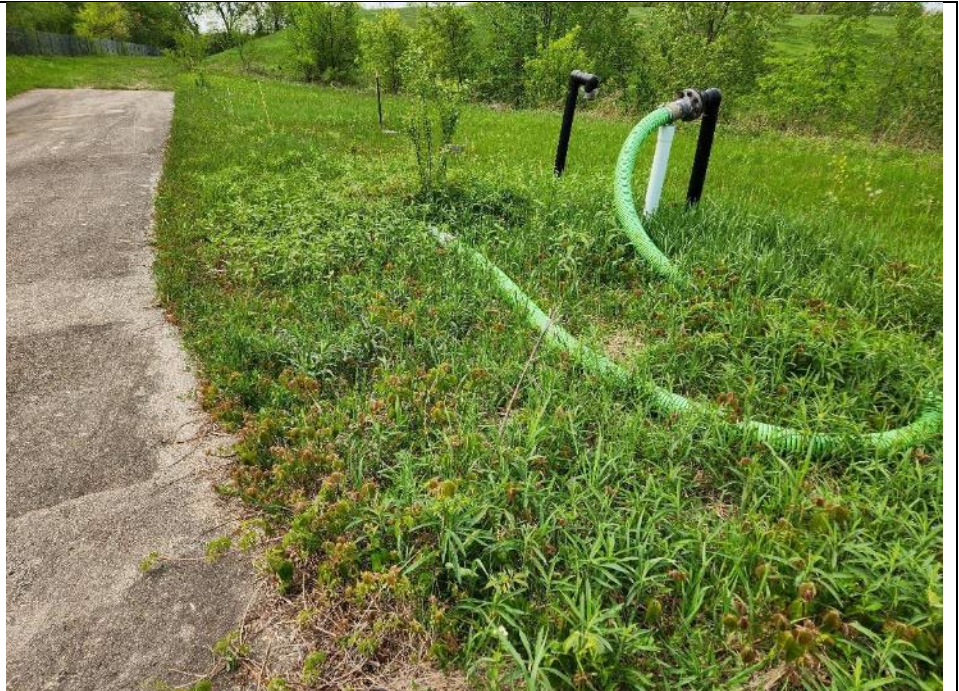
Photo No.	Date
11	5/18/23
Direction Photo Taken	
South	
Description	
Growing poison ivy before treatment.

Before repairs could be completed, the Site had to be sprayed to kill the growing poison ivy in the work area. Poison ivy was treated on May 22 and June 2, 2023. Bonide Brush Killer BK-32 was used, according to instructions, to treat the poison ivy. This product worked well in killing the poison ivy, without killing all the vegetation that was sprayed.

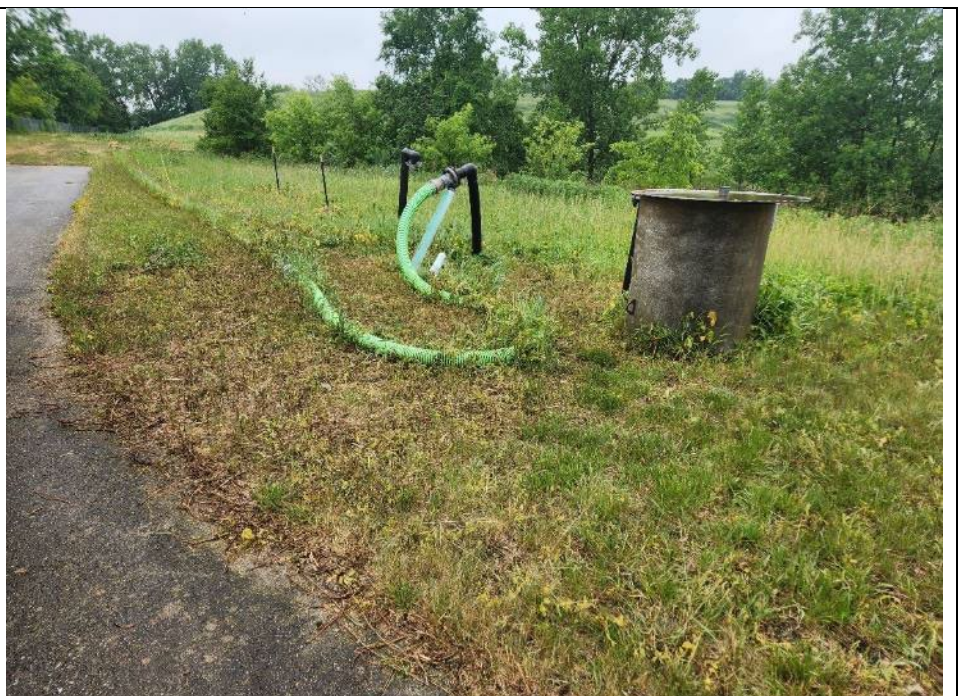
Photo No.	Date
12	6/6/23
Direction Photo Taken	
South	
Description	
Area where significant poison ivy was previously. Ground treated 3 times and mowed.

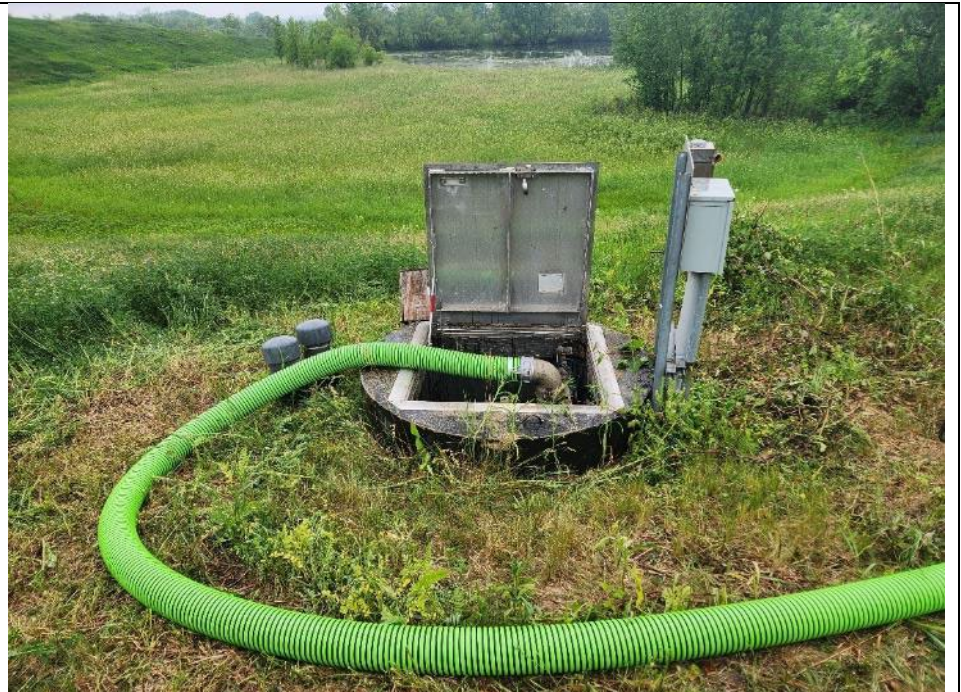
Photo No.	Date
13	6/6/23
Direction Photo Taken	
North	
Description	
New flexible hose, woody vegetation cut down, grass mowed to be able to check for any other cracks or leaks.

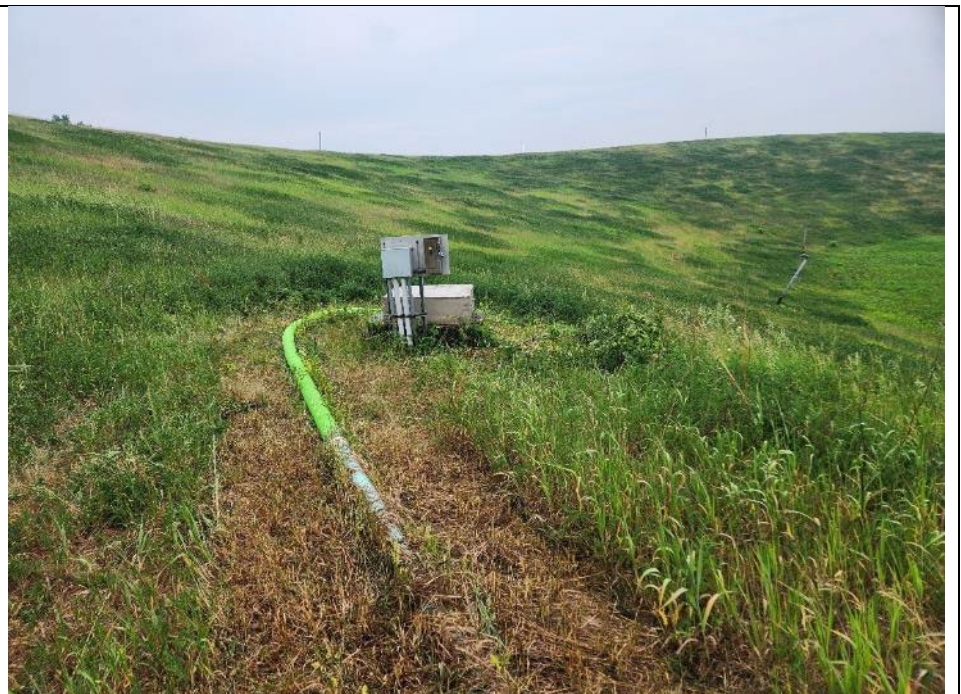
Photo No.	Date
14	6/6/23
Direction Photo Taken	
West	
Description	
Woody vegetation cut down, grass mowed to be able to check for any other cracks or leaks.

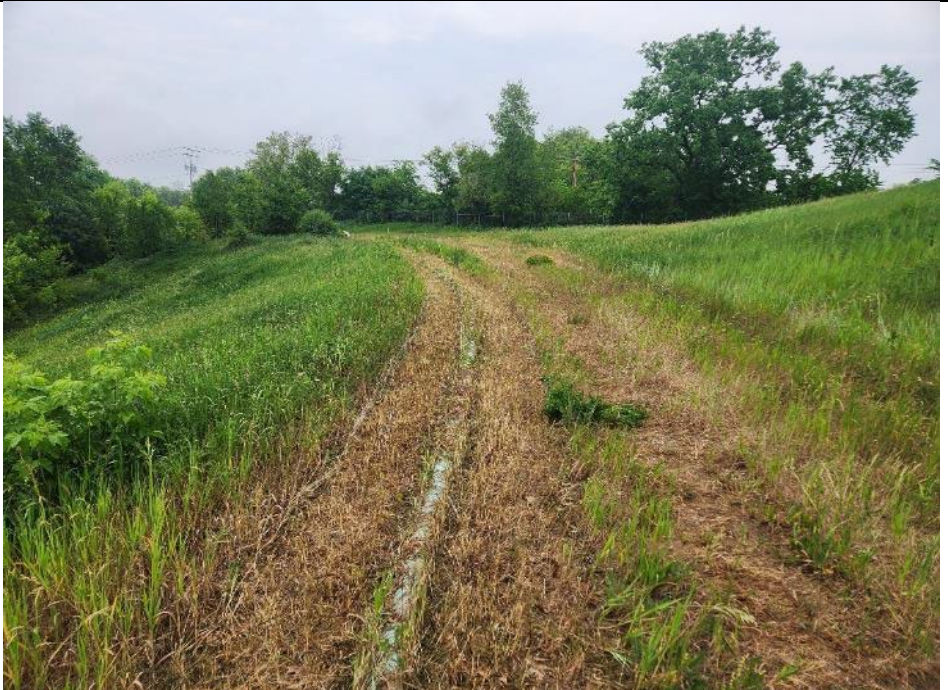
15	6/6/23	
Direction Photo Taken		
Northeast		
Description		
<p>Woody vegetation cut down, grass mowed to be able to check for any other cracks or leaks.</p>

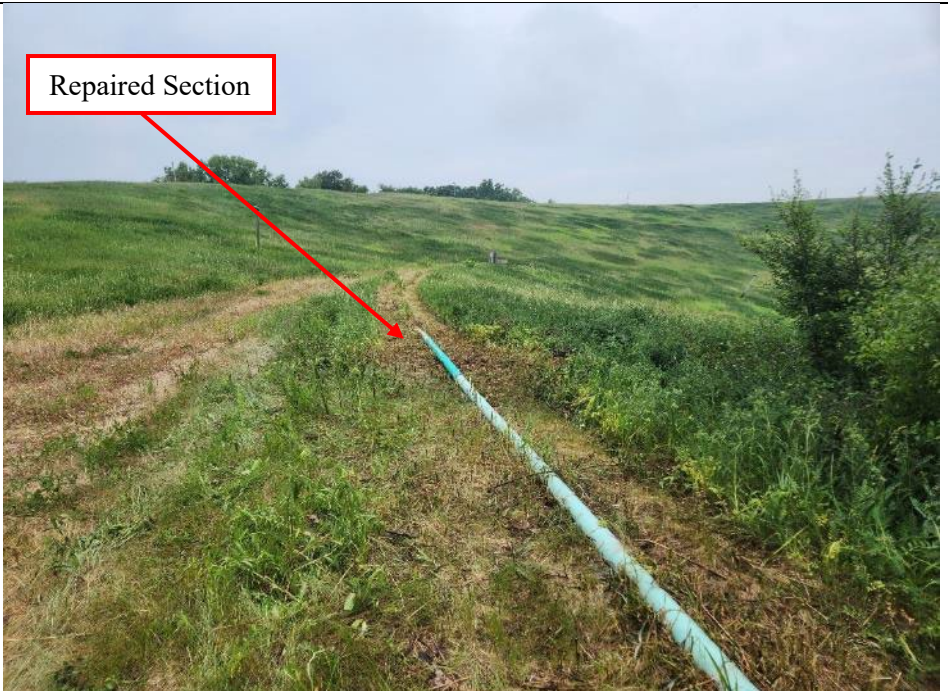
16	6/6/23	
Direction Photo Taken		
Southwest		
Description		
<p>Woody vegetation cut down, grass mowed to be able to check for any other cracks or leaks. Repaired section in place.</p>

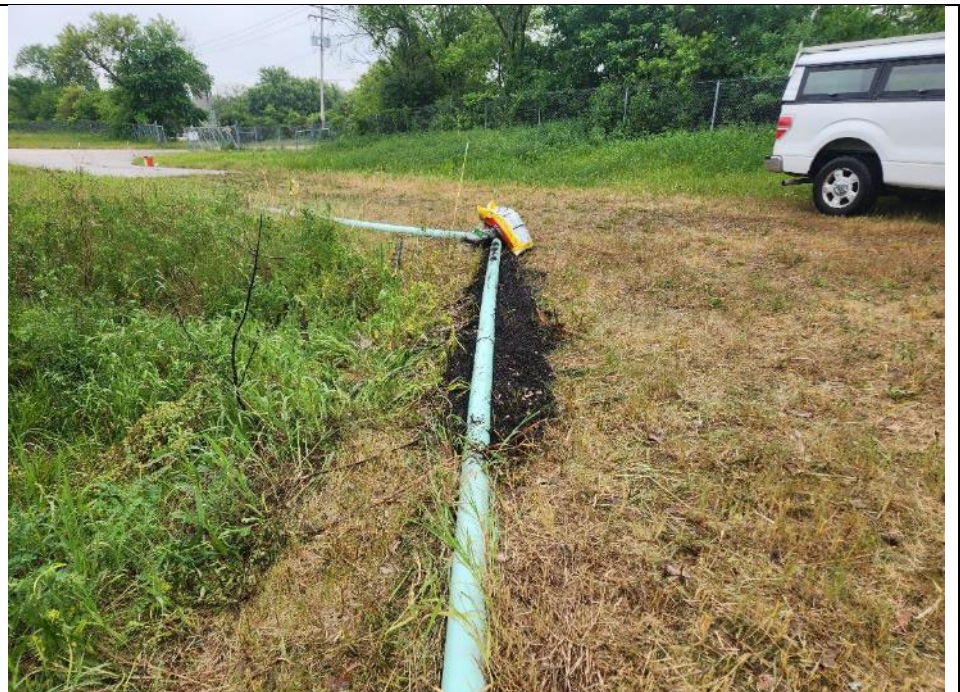
Photo No.	Date
17	6/6/23
Direction Photo Taken	
Northeast	
Description	
Ground repairs to

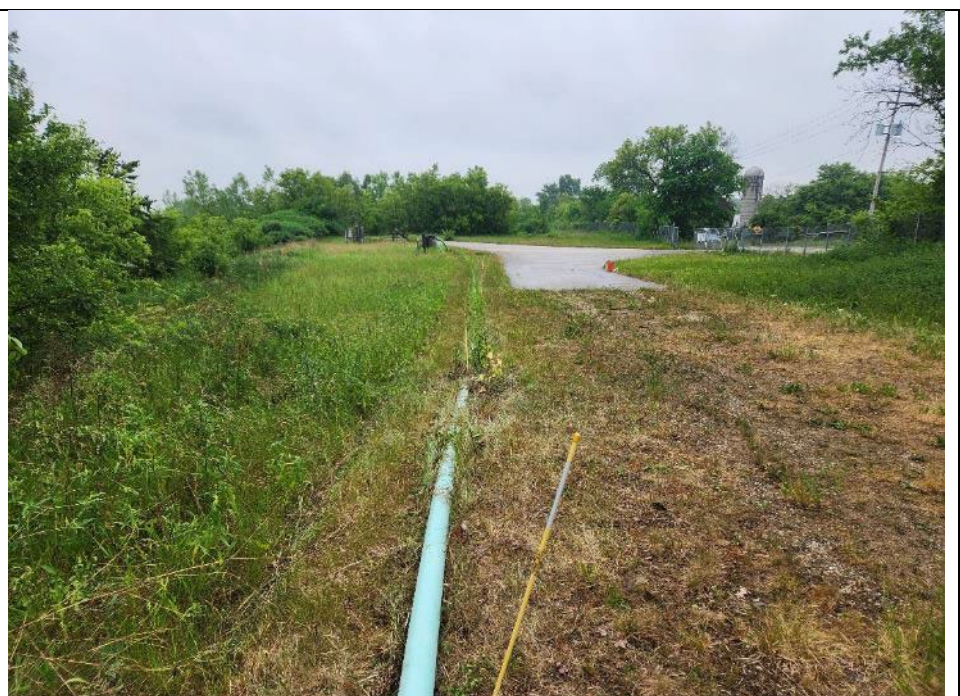
Photo No.	Date
18	6/6/23
Direction Photo Taken	
North	
Description	
Poison ivy treated, woody vegetation cut down, grass mowed to be able to check for any other cracks or leaks.

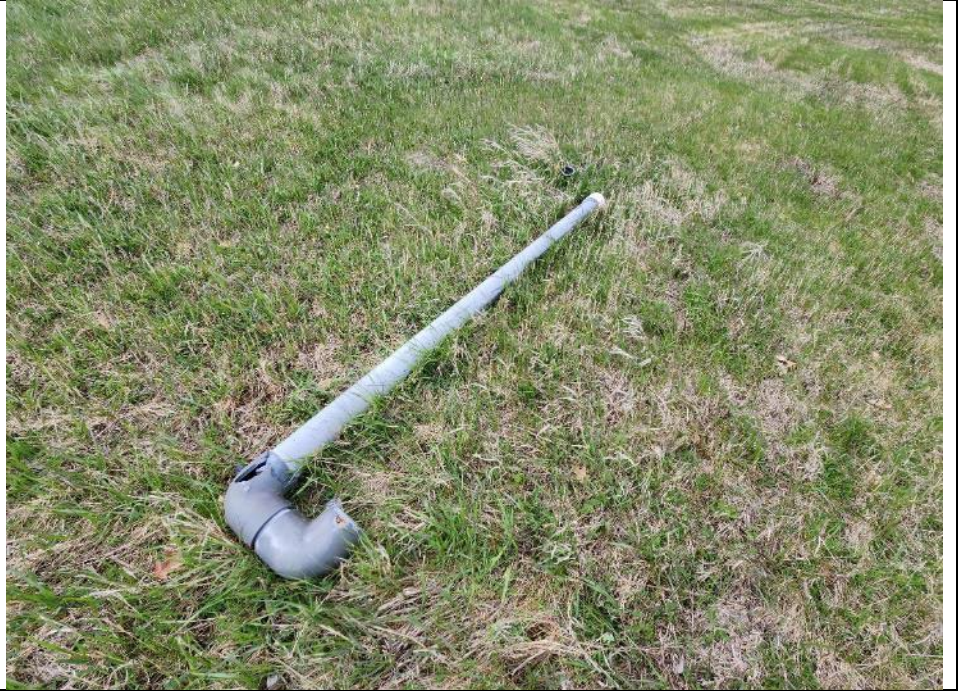
Gas vent, GV-136, was observed to be laying on the ground. This gas vent was hit by a lawn mower in 2021 and was repaired by the mowing contractor at that time. Cedar used the industrial grade PVC cleaner, primer, and glue to reattach the vent to the coupling at the ground surface. A wooden stake was used to brace one side of the gas vent, and an additional wooden stake was tapped into the ground (approximately 3 inches) and used rope to help secure the gas vent while the glue dried.

Photo No.	Date
21	5/2/23
Direction Photo Taken	
Southeast	
Description	
GV-136 broken at ground level (from lawn mower in 2021, previous repair did not hold).

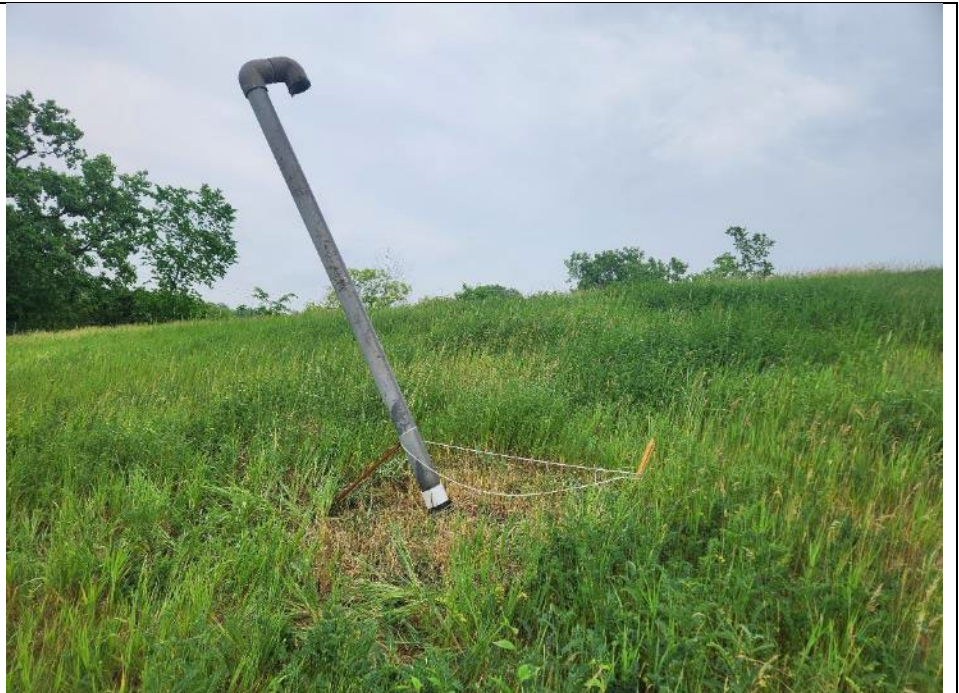
Photo No.	Date
22	6/6/23
Direction Photo Taken	
Southeast	
Description	
GV-136 repaired, using stakes and rope to help hold up gas vent while PVC glue dries
