BRRTS ID No. 02-68-539238

Review Date: 07/12/2016

Site Name: One Hour Martinizing

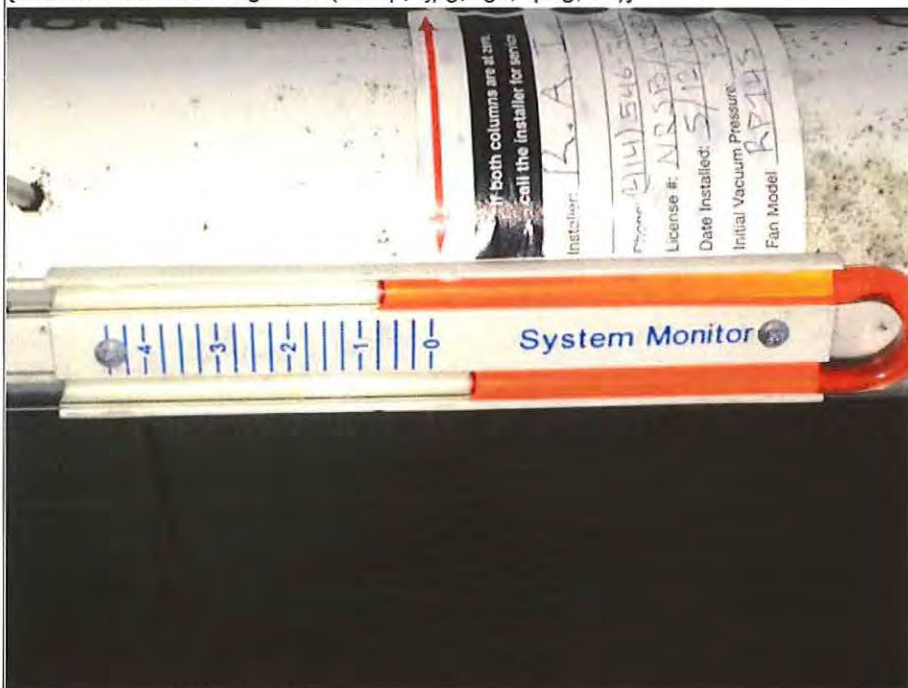
Title: Manometer

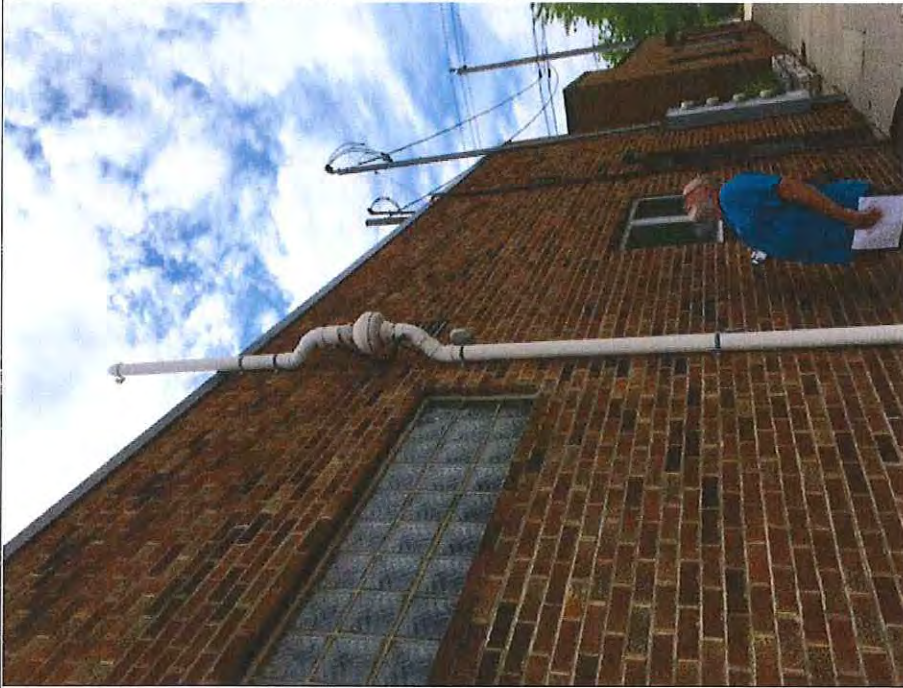
Title: SSDS fan and vent discharge.

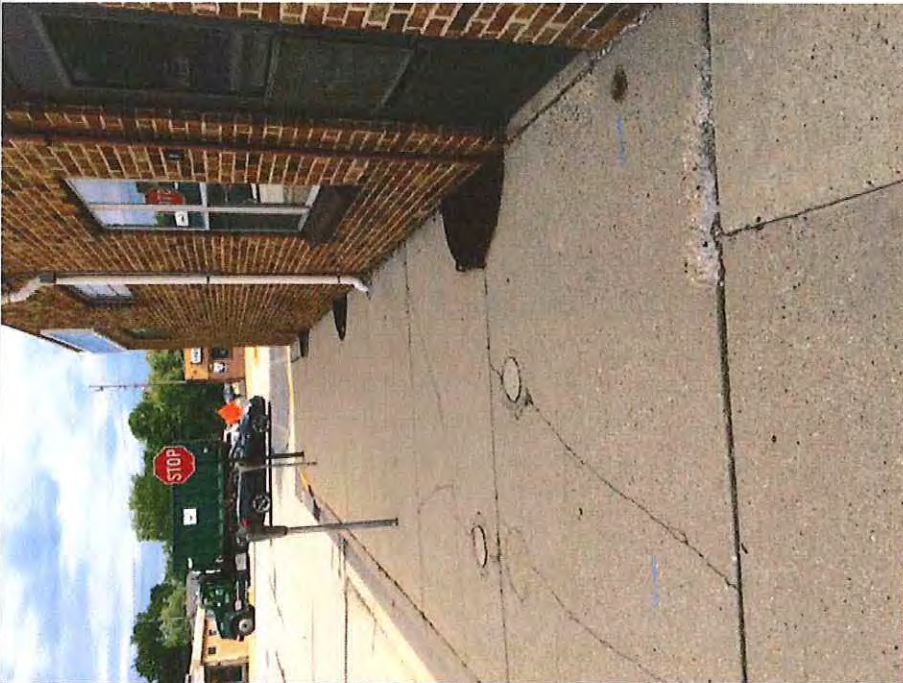
Title: Looking north - sidewalk part of required cap.

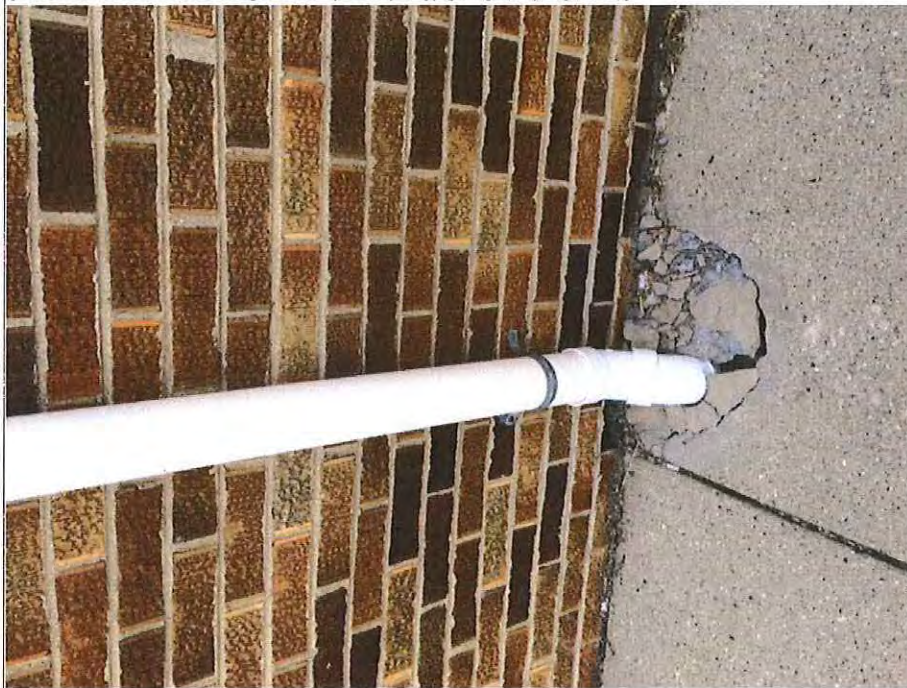
Title: Vent pipe exit from building - repair needed.

Property is currently vacant and for sale. Vent pipe exit at sidewalk needs to be recaulked. RP indicates this work will be conducted in the near future. Documentation of repair should be submitted to DNR along with previous manometer inspection readings. Annual inspection has been completed, RP made aware of annual and quarterly inspection requirements and annual submittal of inspection/maintenance report. July has now been established as the date for annual reporting.

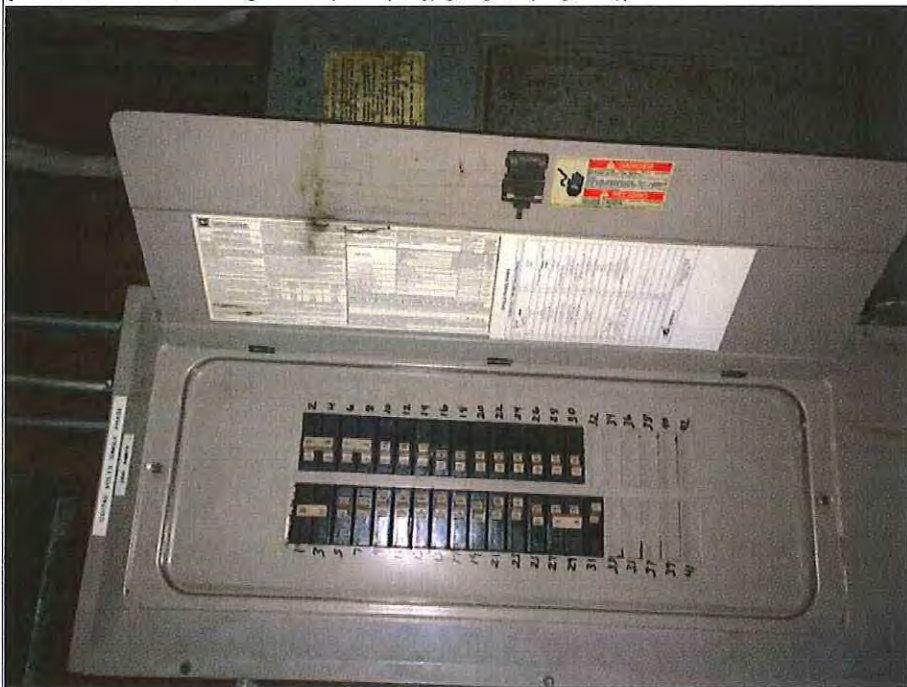
Title: Circuit breaker box - vapor mitigation system breaker location labeled
