Subject: Well Abandonment Documentation

BRRTS #: 02-41-542923- Launderama

5130 South 108th Street, Hales Corners, Wisconsin

SITE PHOTOGRAPHS

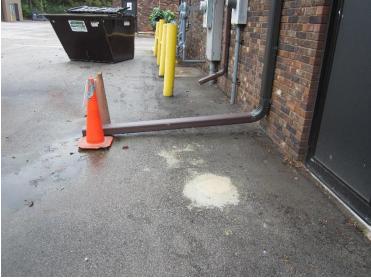
Upon locating the two (2) well covers, the covers were removed and interior area observed. Based on observations, it appeared the wells had been previously filled with bentonite and the bentonite had risen to the surface and completely filled the well flush mount.

3. View of MW-1 with concrete.

Subsequent to the initial inspection which confirmed the wells had been previously abandoned, the well covers were removed, a portion of the bentonite filling the inner shroud of the flush mounts was removed and the resultant void was filled with concrete.

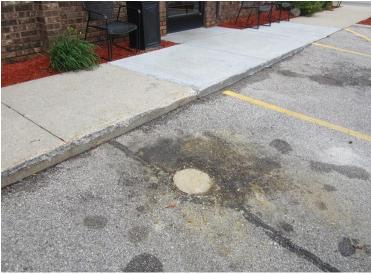
6. View of MW-4 with concrete.
