# SEYMOUR ENVIRONMENTAL SERVICES, INC.

March 10, 2006

**Re: Investigation Update  
Former Highway Cleaners  
1509 Elm Street - Boscobel, Wisconsin**

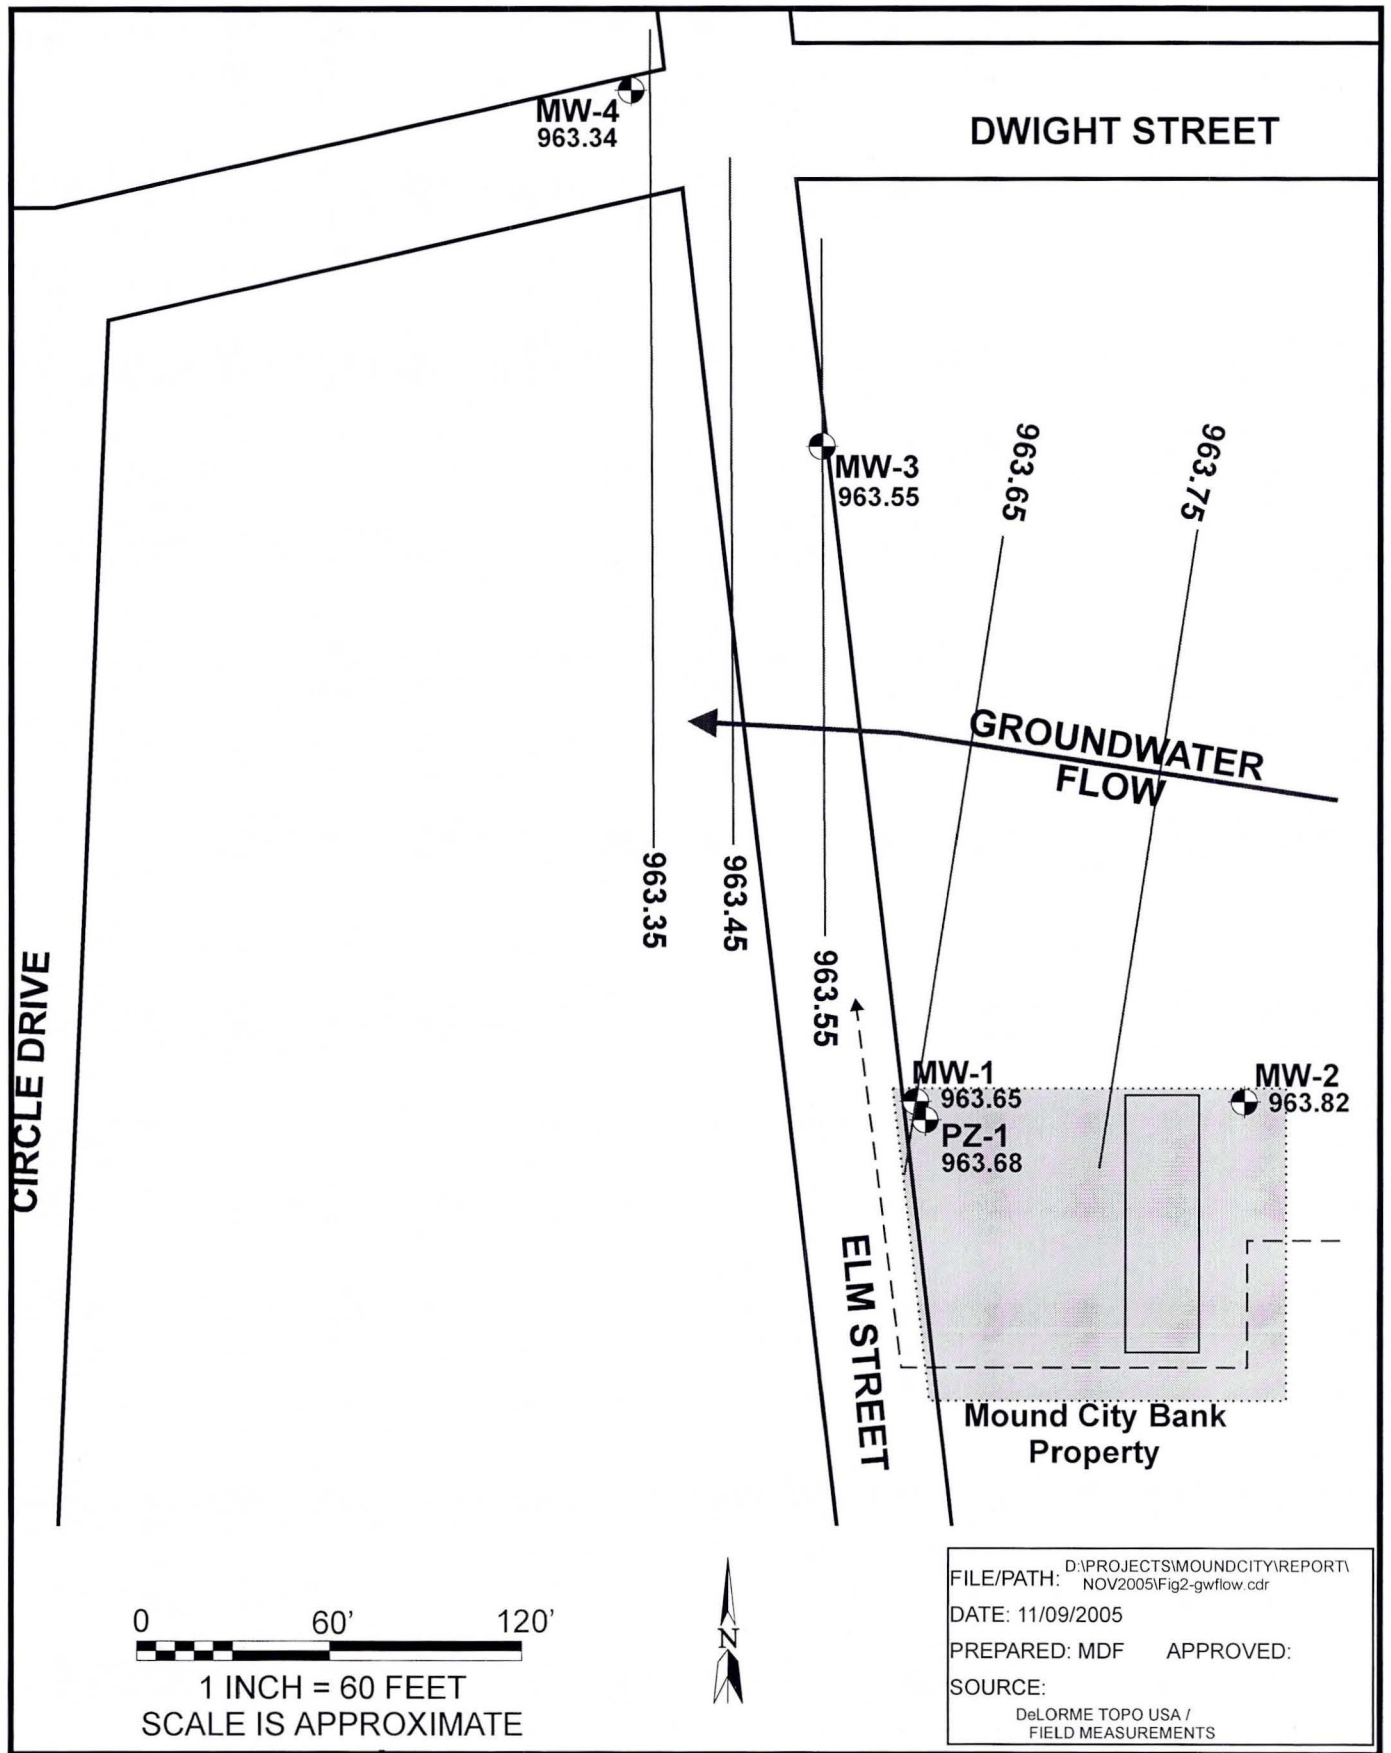
Groundwater Flow (October 2005)  
 Mound City Bank Property  
 1509 Elm Street  
 Boscobel, Wisconsin

On October 19, 2005 and February 25, 2006 water level data and groundwater samples were collected from the monitoring wells. Additionally, the well locations and top of casing elevations were surveyed during October 2005. The groundwater elevation data from the water-table monitoring wells was contoured to construct groundwater flow maps (Figure 1/1A). The data indicate that shallow groundwater flow is toward the west northwest; the horizontal gradient is approximately 0.0018 ft/ft. The vertical hydraulic gradient was calculated at the MW-1/PZ-1 well nest. The vertical gradient was slightly upward (0.00046 to 0.00138 ft/ft). Well construction details and groundwater level data are summarized in Table 1.

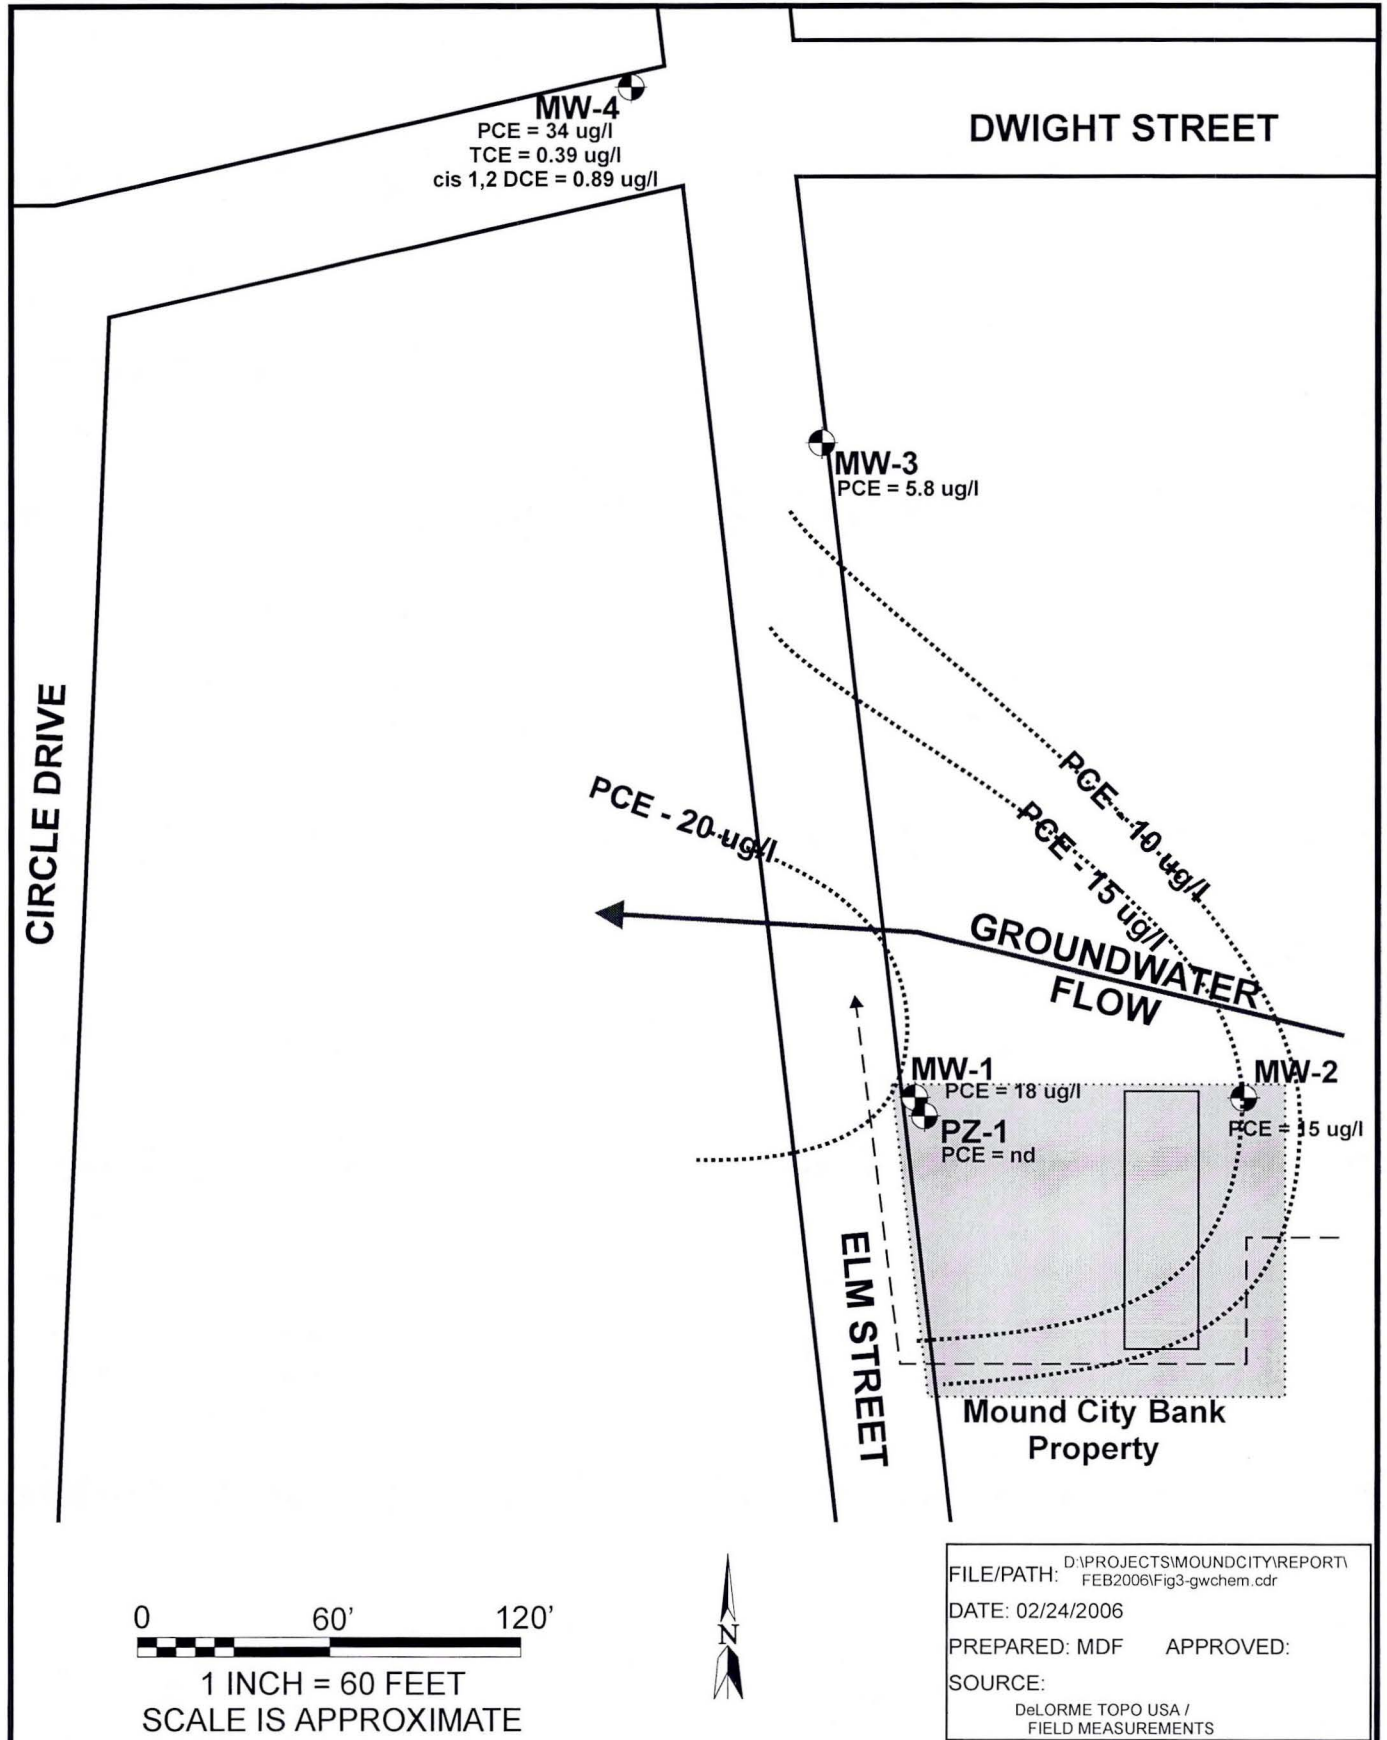
Contaminants in Groundwater (January 2006)  
Mound City Bank Property  
1509 Elm Street  
Boscobel, Wisconsin

During both monitoring events groundwater samples were collected from the monitoring wells and analyzed for volatile organic compounds (VOCs). No VOCs were detected in the groundwater from the piezometer. Groundwater from all of the water-table monitoring wells contained PCE at levels which exceed the NR140 enforcement standard (ES). In the most upgradient well (MW-2) the PCE concentration was 10 to 15 ug/l. At the well located at the downgradient edge of the subject parcel

(MW-1) the PCE level was 18 to 25 ug/l. The PCE concentration at the well located north of the site along the east edge of Elm Street (MW-3) was 5.8 to 13 ug/l. No VOCs other than PCE were detected in these wells. At the most downgradient well (MW-4) PCE was measured at 34 and 210 ug/l; the higher level of PCE was present in the groundwater sample collected in October 2005. Additionally, trichloroethene and cis 1,2 dichloroethene were detected in the groundwater from MW-4. These compounds are metabolites of PCE. Results of the groundwater analyses are summarized in Table 2. A map showing the distribution of contaminants in groundwater during the January 2006 sampling is attached (Figure 2).

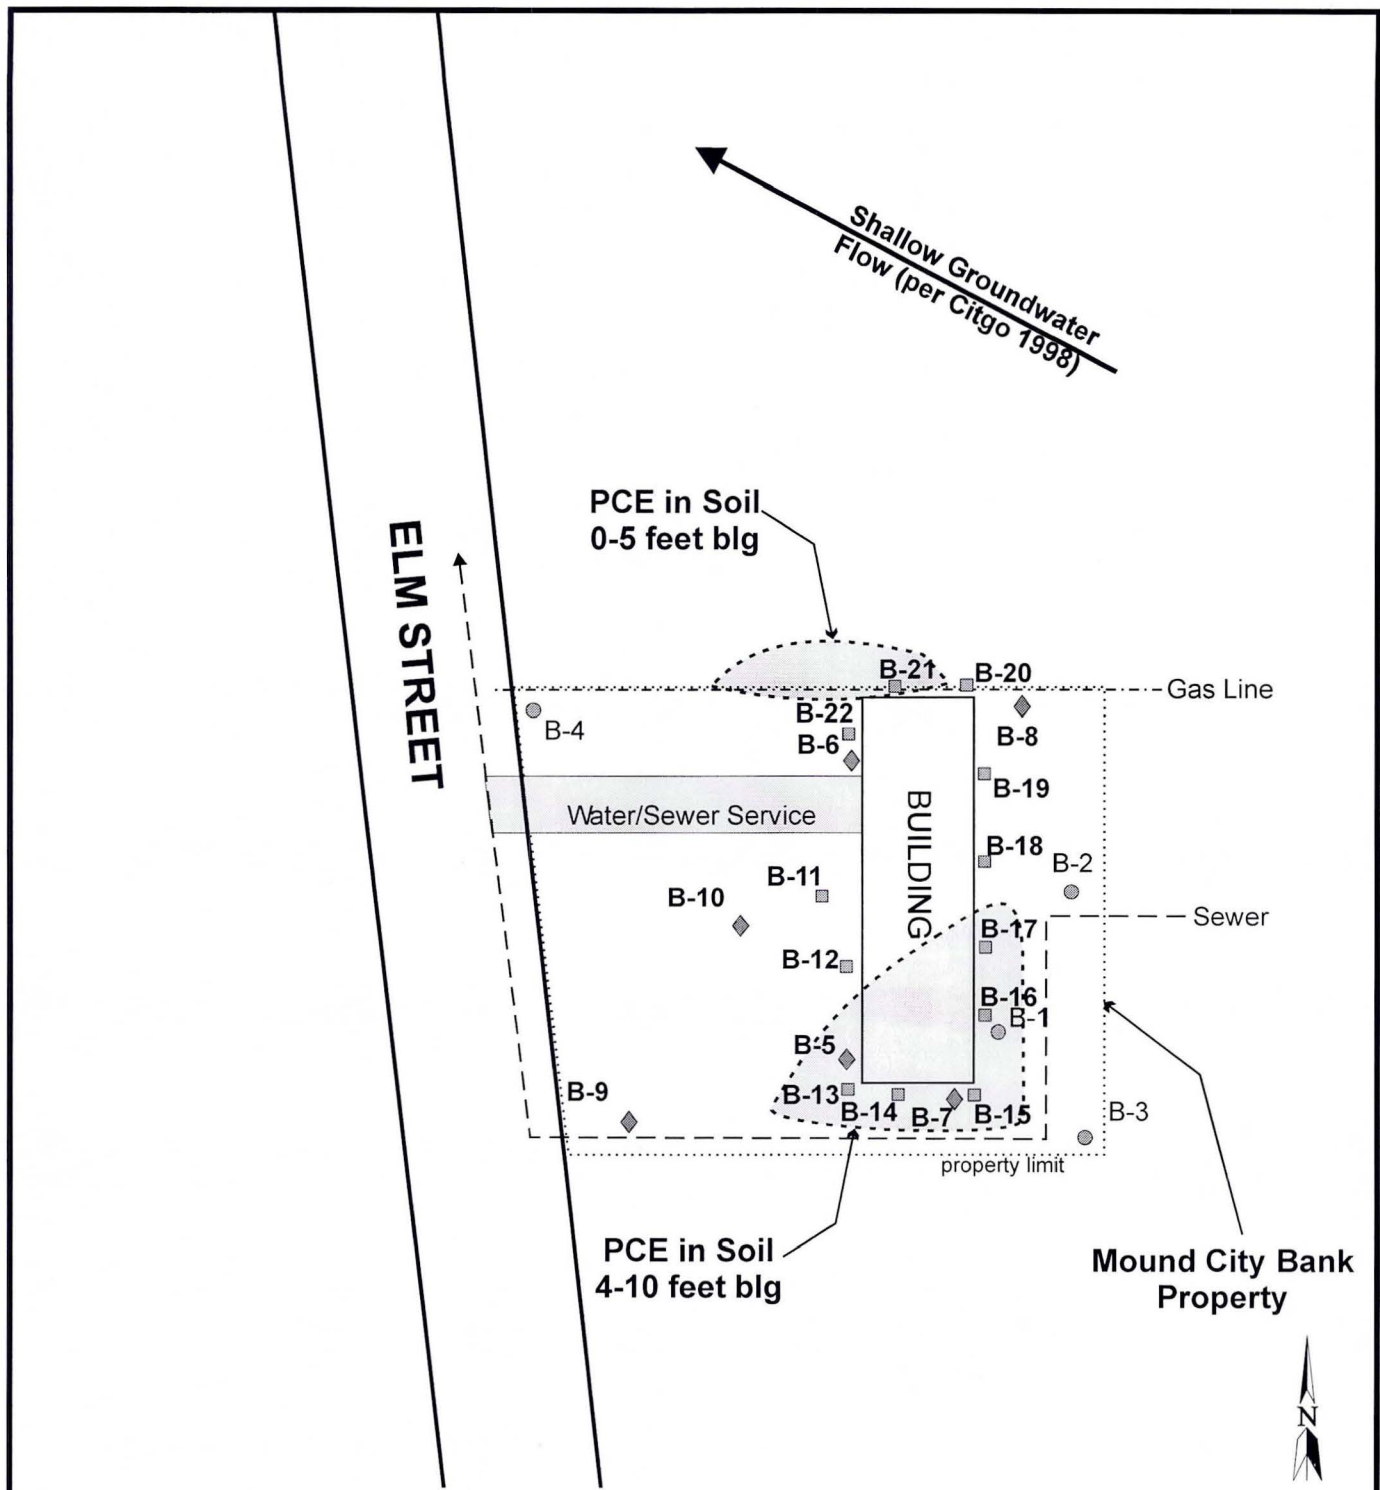
Extent of PCE-Impacted Soil  
Mound City Bank Property  
1509 Elm Street  
Boscobel, Wisconsin

Soil sampling was conducted previously at the site. Analysis of the soil samples confirmed that two VOCs are present in soil on the subject parcel, tetrachloroethene (PCE), and methylene chloride. PCE was present in soil at concentrations ranging from 37 to 5500 ug/kg. The PCE-impacted soil was generally located around the southern end of the building. A small area of soil containing PCE was identified at the north edge of the pavement near the west side of the building. The distribution of the PCE seems to indicate that, at least in part, the PCE originated from a surface spill since the concentrations of the dry cleaning compounds are higher in the shallow soils. The most severe soil contamination is present near the south end of the building where contamination has been confirmed from 4 to 10 feet below grade. Sampling shows that the soil contamination does not extend to the groundwater table (30 ft blg) in this area. No soils from depths between 10 to 30 feet have been analyzed from this area. Methylene chloride was detected in soil at concentrations between 200 and 600 ug/kg. The methylene chloride generally was present in the same areas as the PCE. However, the methylene chloride was only detected in samples collected at 8 to 10 feet below grade. A map showing the PCE distribution in soil is included as Figure 3.
