**Remediation & Redevelopment  
 Continuing Obligation Review**

**BRRTS ID No. 02-41-543523**

Site Name: Jomblee Inc.

BRRTS Site Name Jomblee, Inc. Activity Number 02-41-543523

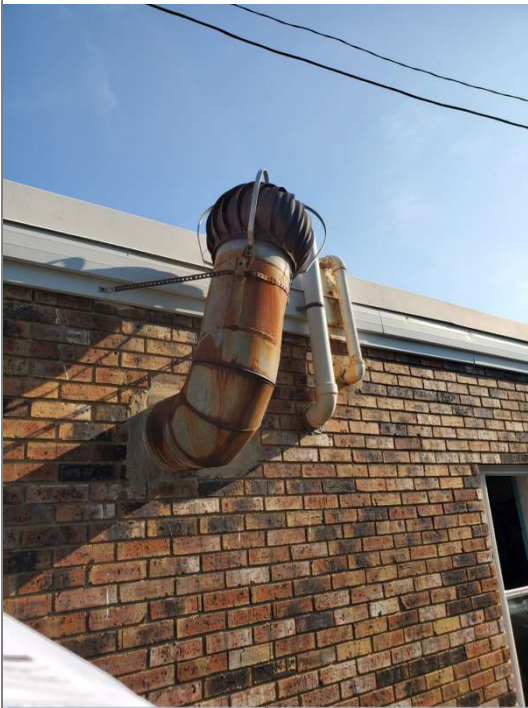
Title: VMS Exhaust Stack, (White PVC) Rear of Building

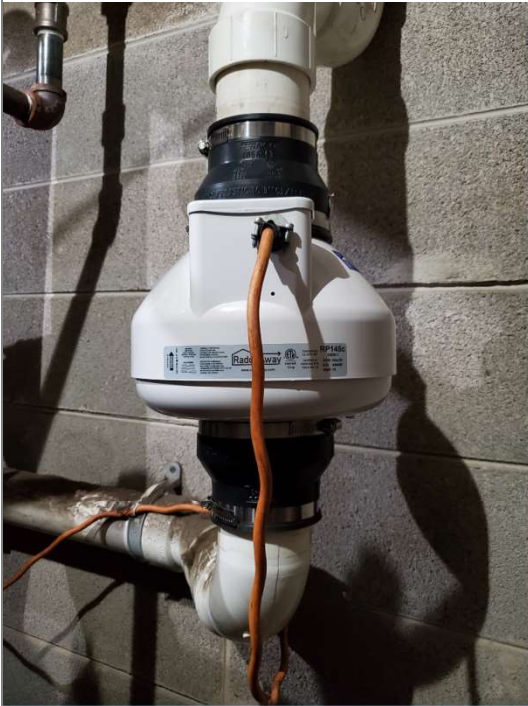
Title: Blower Fan

**Notes:** System blower is located in boiler room, while not technically a conditioned space it is okay.

Given PCE is no longer used, we would recommend that the fan be move outside, especially if the  
Site use changes. The fan is plugged into an outlet over six feet away and we would recommend  
changing that to hard wired with a dedicated switch.

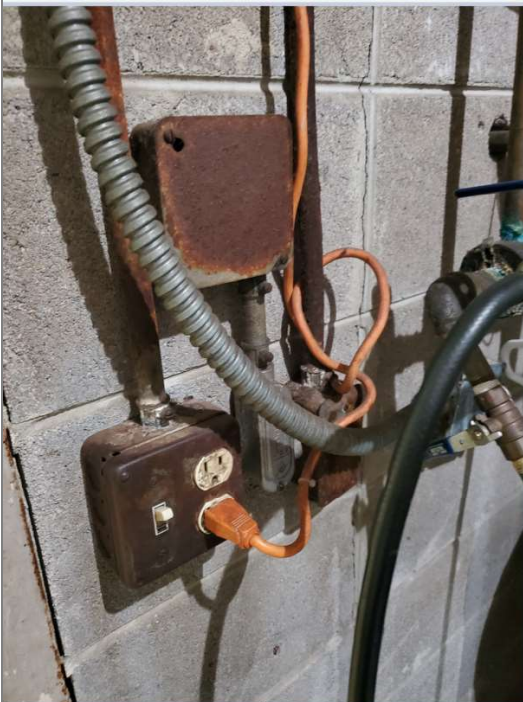
Title: Blower Fan Plug In

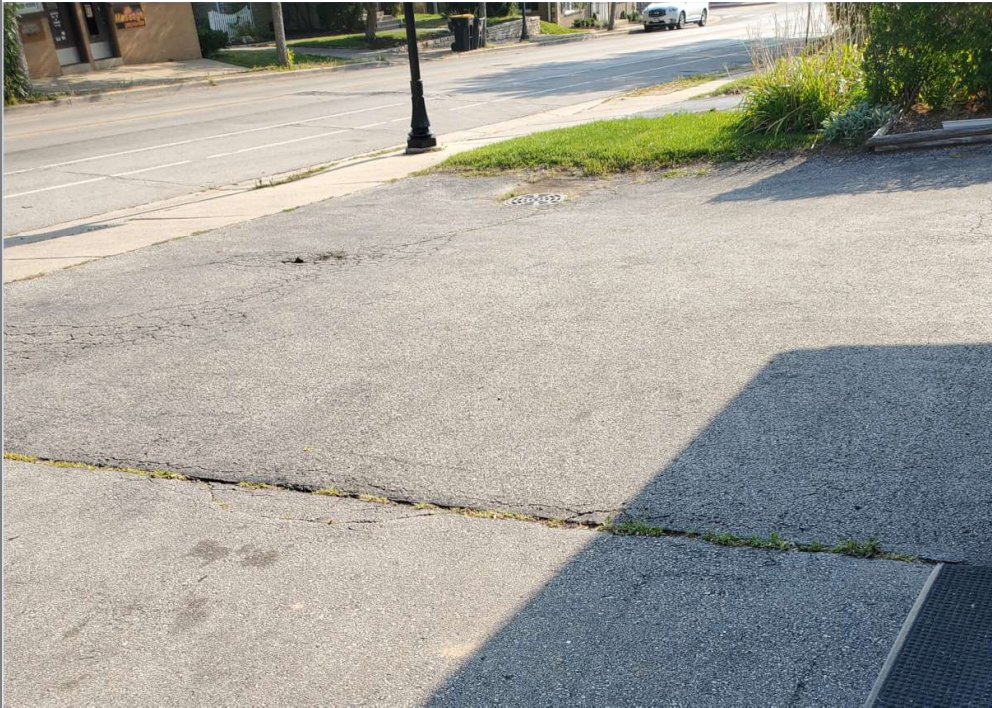
Keith said that they use a sealant on the pavement every year and it was about in the same shape now as it was when the case was closed. He has been there 37 years. I gave him two copies of the GIS package, which includes the maintenance form and plan.

Title: Front Pavement Looking Northeast

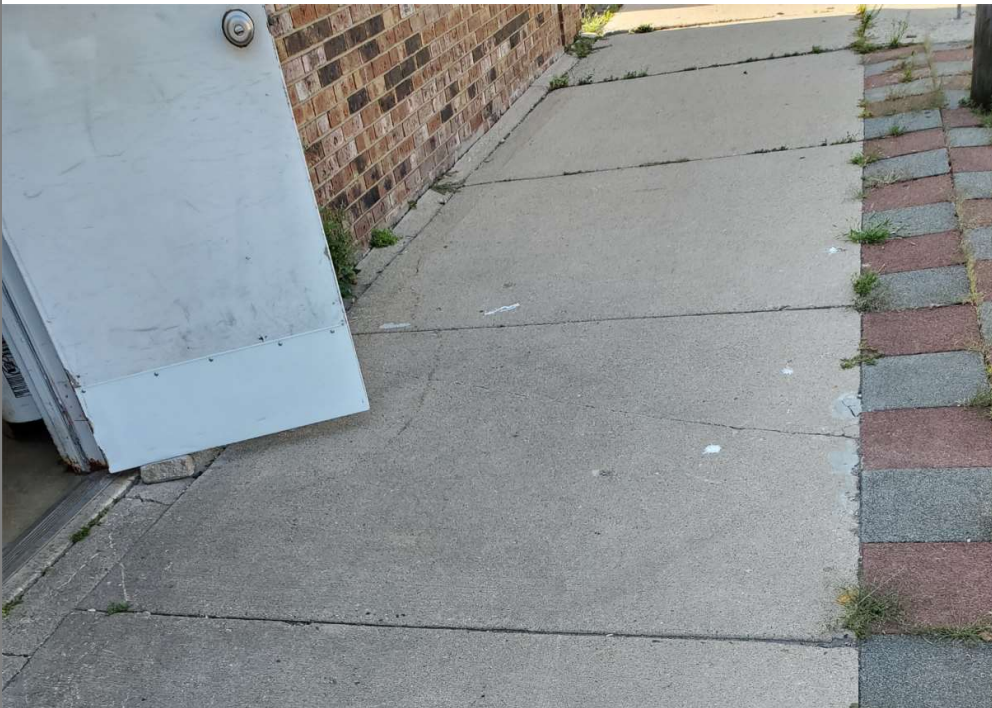
Title: Front Pavement Looking Northwest

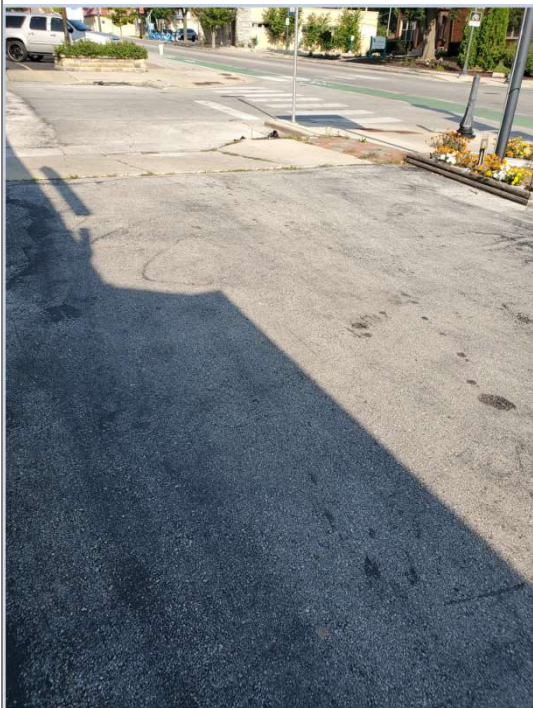
Title: Front Pavement Looking Northwest

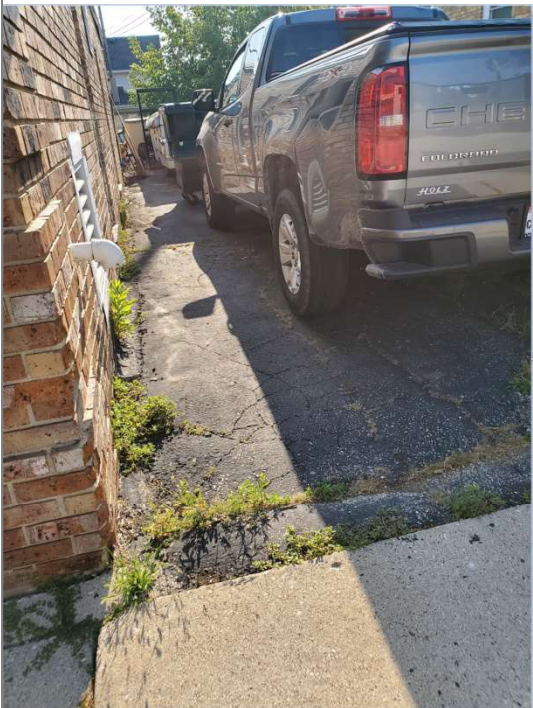
Title: Rear Pavement Looking East

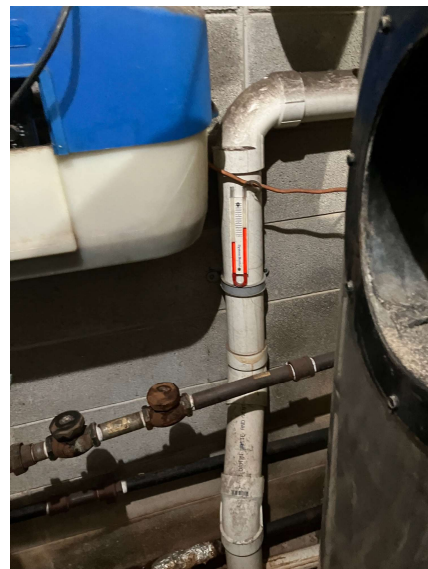
A pressure monitor is present, operating, and is accessible.  Y  N (active systems only, e.g., U-Tube manometer, cylinder, or gauge.) Pressure Reading: 0.9 inch h2o

Description: U-tube

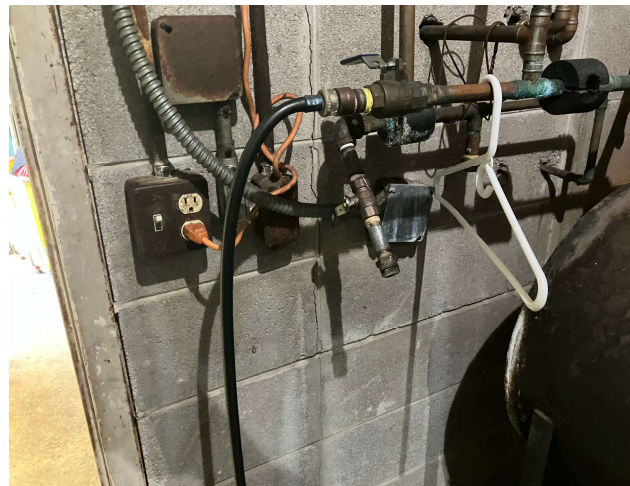
Description: Power cord

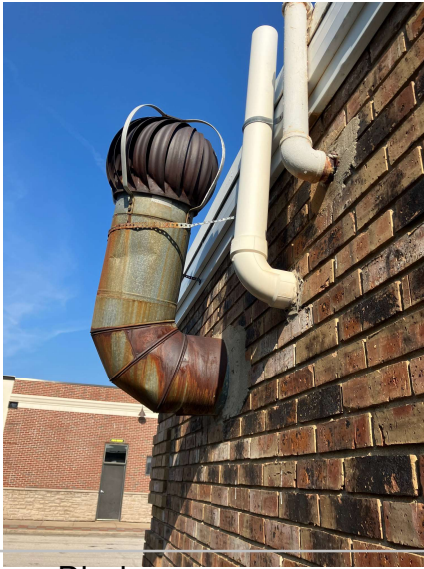
Description: Discharge
