Supplemental Checklist for Vapor Mitigation Continuing Obligations

BRRTS Site Name Jomblee, Inc. Activity Number 02-41-543523

System Address(es) 7027 W North Ave, Wauwatosa Current Site Use(s): Dry Cleaner

Inspected By: R. Hoverman/ J. Feeney Date 2023/08/23

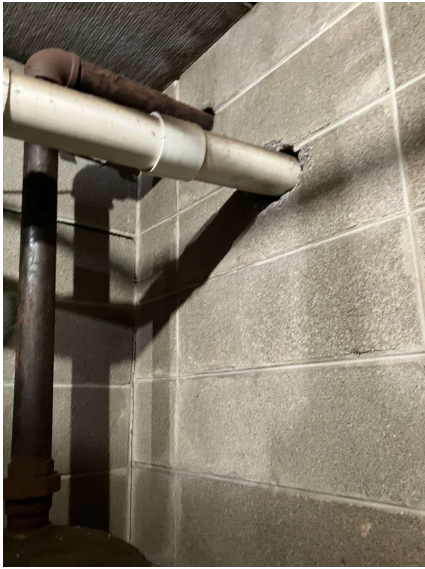
Description: Exit to exterior

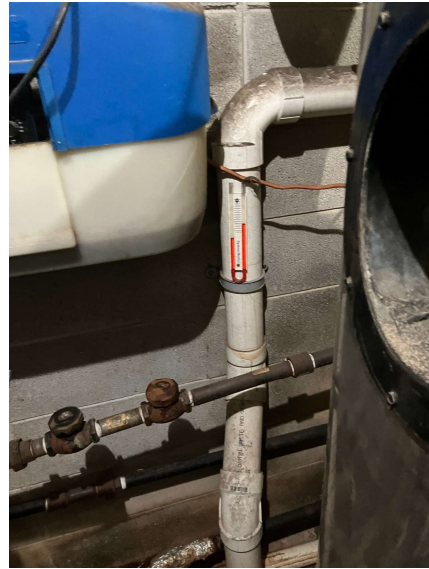
A pressure monitor is present, operating, and is accessible. Y N (active systems only, e.g., U-Tube manometer, cylinder, or gauge.) Pressure Reading: 0.9 inch h2o

Description: U-tube

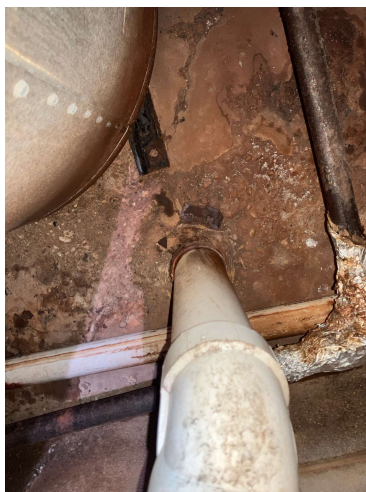
Description: Extraction point

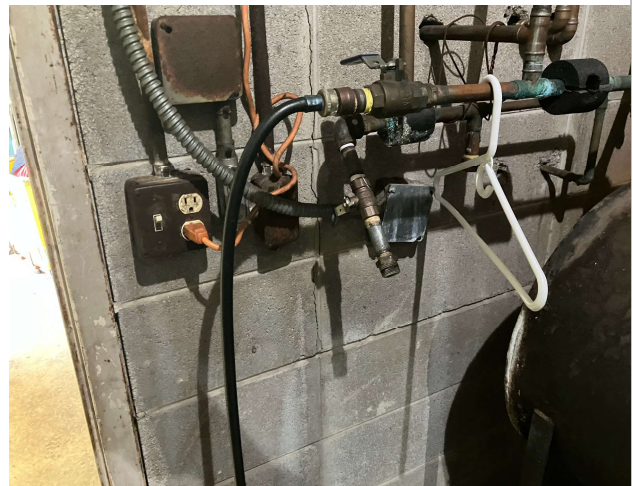
Given PCE is no longer used, we would recommend that the fan be move outside, especially if the
Site use changes. The fan is plugged into an outlet over six feet away and we would recommend
changing that to hard wired with a dedicated switch.

Description: Power cord

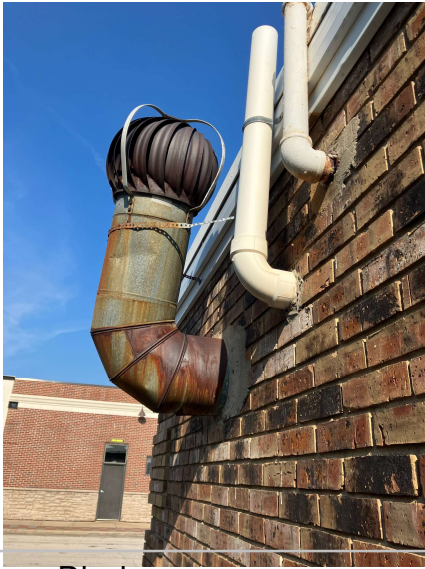
Description: Discharge
