Annual Inspection Report – 2015 Barrier Cap Maintenance Plan
Skana Aluminum Co., 2009 Mirro Drive, Manitowoc, WI 54220
VPLE # 06-36-556282
WI DNR Environmental Repair Activity # 02-36-544601
Facility ID # 436106110

INSPECTION LOG

SKANA ALUMINUM COMPANY
2009 Mirro Drive
Manitowoc, Wisconsin 54221

VLPE #06-36-556282
WI DNR Environmental Repair Activity # 02-36-544601/02-36-550138
Facility ID# 436106110

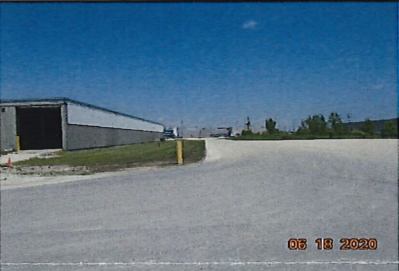
Item No
#1 - East side of 5C Facility

General Area				Condition of Surface		New or Old Condition (location)
Interior/Exterior	Location Marked w/Paint Yes / No	Good	Need Repair	Describe Condition (crack/void/settling, ...)		
Exterior	No	Y	N	Pavement East of 5C - Asphalt		Old
Pavement was replaced in Sept. of 2012 - 100 Cu.yds. Soil from under old roadway was profiled and disposed of.						
Describe Location: East of 5 C Facility						
Recommended Repair: None required at this time.						
Date Repair was Conducted : N/A			Name Documenting Repair Completed: Steve Jacques

Condition At Time of Inspection	Repair Conducted (If needed)
Some approximately 1/2" wide cracks observed, but no potholes

No repairs needed

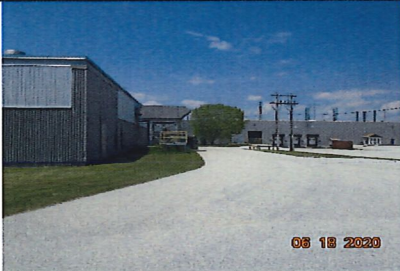
Item No
2 North side of 5C Facility

General Area				Condition of Surface		New or Old Condition (location)
Interior/Exterior	Location Marked w/Paint Yes / No	Good	Need Repair	Describe Condition (crack/void/settling, ...)		
Exterior	No	Y	N	Pavement North of 5C - Asphalt		Old
Pavement good - No repairs needed						
Describe Location: North of 5C Facility						
Recommended Repair: None required at this time.						
Date Repair was Conducted : N/A			Name Documenting Repair Completed: Steve Jacques

Condition At Time of Inspection	Repair Conducted (If needed)
Several approximately 1/2" wide cracks observed but no potholes

No repairs needed

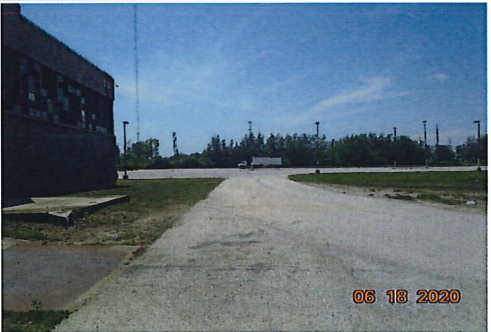
Item No
#3 - South West side of 5C Facility

General Area				Condition of Surface		New or Old Condition (location)
Interior/Exterior	Location Marked w/Paint Yes / No	Good	Need Repair	Describe Condition (crack/void/settling, ...)		
Exterior	No	Y	N	Pavement South West of 5C - Asphalt		Old
South side pavement replaced Oct. 2015 By N.E. Asphalt - Asphalt ground off & relaid -No soil removed - only minor grading.						
Describe Location: South West of 5C Facility						
Recommended Repair: None required at this time.						
Date Repair was Conducted : Oct. 2015			Name Documenting Repair Completed: Steve Jacques

Condition At Time of Inspection	Repair Conducted (If needed)
Some approximately 1/2" wide cracks observed in various areas of target area, but no potholes

No repairs needed
