Annual Inspection Report – 2015 Barrier Cap Maintenance Plan  
Skana Aluminum Co., 2009 Mirro Drive, Manitowoc, WI 54220  
VPLE # 06-36-556282  
WI DNR Environmental Repair Activity # 02-36-544601  
Facility ID # 436106110

Skana Aluminum has performed the required annual Barrier Cap Maintenance Plan inspection of the areas surrounding the 5C section facility and inside of the 5C section of the facility and is posting the results in the attached "Exhibit B".

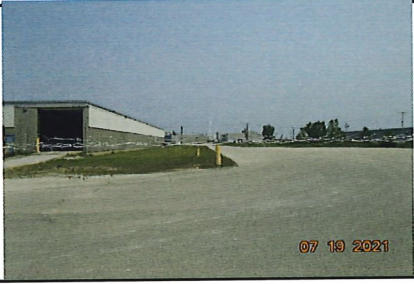
Item No  
#1 - East side of 5C Facility

Condition At Time of Inspection	Repair Conducted (if needed)
Only one 3' x 3' diameter pothole was found near the northwest corner of the parking lot

General Area				Condition of Surface	New or Old Condition (location)
Interior/Exterior	Location Marked w/Paint Yes / No	Good	Need Repair	Describe Condition (crack/void/settling, ...)	
Exterior	No	Y	N	<b>Pavement East of 5C - Asphalt</b> Pavement was replaced in Sept. of 2012 - 100 Cu.yds. Soil from under old roadway was profiled and disposed of. Will hold off on repairs since there is only one small pothole at this time.	Old
Describe Location: East of 5C Facility					
Recommended Repair: None required at this time.					
Date Repair was Conducted: N/A			Name Documenting Repair Completed: Steve Jacques

No repairs needed

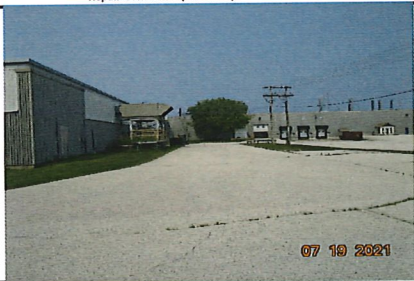
Item No  
# 2 North side of 5C Facility

Condition At Time of Inspection	Repair Conducted (if needed)
Numerous approximately 1/2" wide cracks observed but no potholes

General Area				Condition of Surface	New or Old Condition (location)
Interior/Exterior	Location Marked w/Paint Yes / No	Good	Need Repair	Describe Condition (crack/void/settling, ...)	
Exterior	No	Y	N	<b>Pavement North of 5C - Asphalt</b> Pavement good - No repairs needed	Old
Describe Location: North of 5C Facility					
Recommended Repair: None required at this time.					
Date Repair was Conducted: N/A			Name Documenting Repair Completed: Steve Jacques

No repairs needed

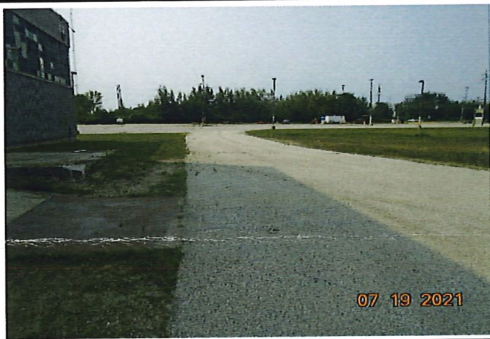
Item No  
#3 - South West side of 5C Facility

Condition At Time of Inspection	Repair Conducted (if needed)
The same approximately 1/2" wide cracks observed in various areas of target area, but no potholes. Some cracks were down the middle, some across the driveway

General Area				Condition of Surface	New or Old Condition (location)
Interior/Exterior	Location Marked w/Paint Yes / No	Good	Need Repair	Describe Condition (crack/void/settling, ...)	
Exterior	No	Y	N	<b>Pavement South West of 5C - Asphalt</b> South side pavement replaced Oct. 2015 By N.E. Asphalt - Asphalt ground off & relaid -No soil removed - only minor grading. Pavement in good condition other than the 1/2" cracks	Old
Describe Location: South West of 5C Facility					
Recommended Repair: None required at this time.					
Date last repair was conducted: Oct. 2015			Name Documenting Repair Completed: Steve Jacques

No repairs needed
