July 18, 2022

Annual Inspection Report – 2015 Barrier Cap Maintenance Plan
Skana Aluminum Co., 2009 Mirro Drive, Manitowoc, WI 54220
VPLE # 06-36-556282
WI DNR Environmental Repair Activity # 02-36-544601
Facility ID # 436106110

INSPECTION LOG

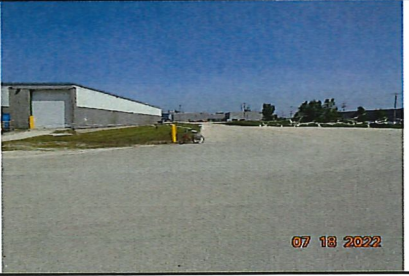
General Area		Condition of Surface		New or Old Condition (location)
Interior/Exterior	Location Marked w/Paint Yes / No	Good	Need Repair	
Exterior	No	Y	N	Pavement East of 5C - Asphalt Old Pavement was replaced in Sept. of 2012 - 100 Cu.yds. Soil from under old roadway was profiled and disposed of. 1/4" cracks observed down center of access road. Overall pavement good-no repairs needed
Describe Location: East of 5 C Facility				
Recommended Repair: None required at this time.				
Date Repair was Conducted: N/A		Name Documenting Repair Completed: Steve Jacques

Condition At Time of Inspection	Repair Conducted (if needed)
<p>Item No <u>#1 - East side of 5C Facility</u> No repairs needed If subcontractor used for repairs (attach Invoice) WI DNR Approval Required (attach Approval Letter)</p>	<p>Cracks in asphalt observed, none greater than 1/4". Cracks following down center of access road</p>

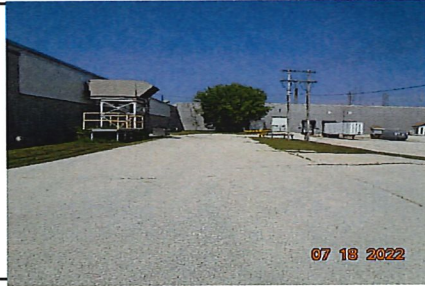
General Area		Condition of Surface		New or Old Condition (location)
Interior/Exterior	Location Marked w/Paint Yes / No	Good	Need Repair	
Exterior	No	Y	N	Pavement North of 5C - Asphalt Old Other than the 1/4" - 1/2" cracks, Pavement good - No repairs needed
Describe Location: North of 5C Facility				
Recommended Repair: None required at this time.				
Date Repair was Conducted: N/A		Name Documenting Repair Completed: Steve Jacques

<p>07 18 2022</p>
<p>Item No <u>#2 North side of 5C Facility</u> No repairs needed If subcontractor used for repairs (attach Invoice) WI DNR Approval Required (attach Approval Letter)</p>	<p>Numerous approximately 1/4" - 1/2" wide cracks observed but no potholes</p>

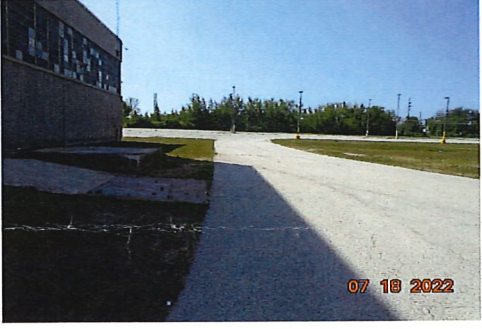
General Area		Condition of Surface		New or Old Condition (location)
Interior/Exterior	Location Marked w/Paint Yes / No	Good	Need Repair	
Exterior	No	Y	N	Pavement South West of 5C - Asphalt Old South side pavement replaced Oct. 2015 By N.E. Asphalt - Asphalt ground off & relaid -No soil removed - only minor grading. Pavement in good condition
Describe Location: South West of 5C Facility				
Recommended Repair: None required at this time.				
Date last repair was conducted: Oct. 2015		Name Documenting Repair Completed: Steve Jacques

<p>07 18 2022</p>
<p>Item No <u>#3 - South West side of 5C Facility</u> No repairs needed If subcontractor used for repairs (attach Invoice) WI DNR Approval Required (attach Approval Letter)</p>	<p>Some cracks approximately 1/2" wide, but no potholes.</p>
