Annual Inspection Report – 2023 Barrier Cap Maintenance Plan
Skana Aluminum Co., 2009 Mirro Drive, Manitowoc, WI 54220
VPLE # 06-36-556282
WI DNR Environmental Repair Activity # 02-36-544601
Facility ID # 436106110

INSPECTION LOG

Barrier INSPECTION and MAINTENANCE LOG Item No. # 1

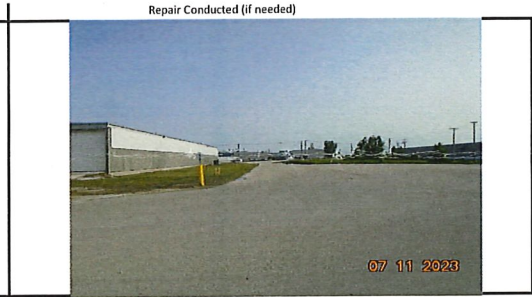
Item No
#1 - East side of 5C Facility
Repairs will be needed

General Area			Condition of Surface		New or Old Condition (location)
Interior/Exterior	Location Marked w/Paint Yes / No	Good	Need Repair	Describe Condition (crack/void/settling, ...)	
Exterior	No	N	Y	Pavement North of 5C - Asphalt	Old
Some cracks will need to be sealed					
Describe Location: North of 5C Facility					
Recommended Repair: Call asphalt company for estimate					
Date Repair was Conducted: N/A			Name Documenting Repair Completed: Steve Jacques

Cracks in asphalt observed, some greater than 1/4" that will need to be sealed. Pot holes found that will need to be filled in.

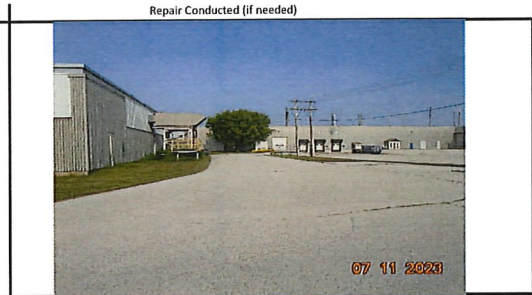
Item No
2 North side of 5C Facility
Repairs will be needed

Numerous cracks have grown bigger and will now need to be sealed up

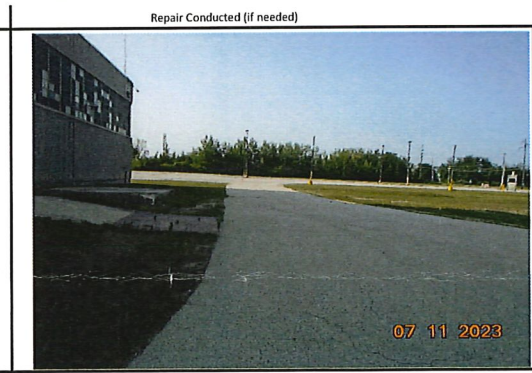
Item No
#3 - South West side of 5C Facility
Repairs will be needed

General Area			Condition of Surface		New or Old Condition (location)
Interior/Exterior	Location Marked w/Paint Yes / No	Good	Need Repair	Describe Condition (crack/void/settling, ...)	
Exterior	No	N	Y	Pavement South West of 5C - Asphalt	Old
South side pavement replaced Oct. 2015 By N.E. Asphalt - Asphalt ground off & relaid - No soil removed - only minor grading. Some cracks need to be sealed					
Describe Location: South West of 5C Facility					
Recommended Repair: Call asphalt company for estimate					
Date last repair was conducted: Oct, 2015			Name Documenting Repair Completed: Steve Jacques

Some cracks have grown and will now need to be sealed up
