To: Nic Sparacio  
City of Manitowoc, WI

From: Philip J. Caswell, P.E.  
Stantec – St. Paul, MN

Date: July 25, 2016

**Reference: Mirro Buildings Structural Condition Assessment**

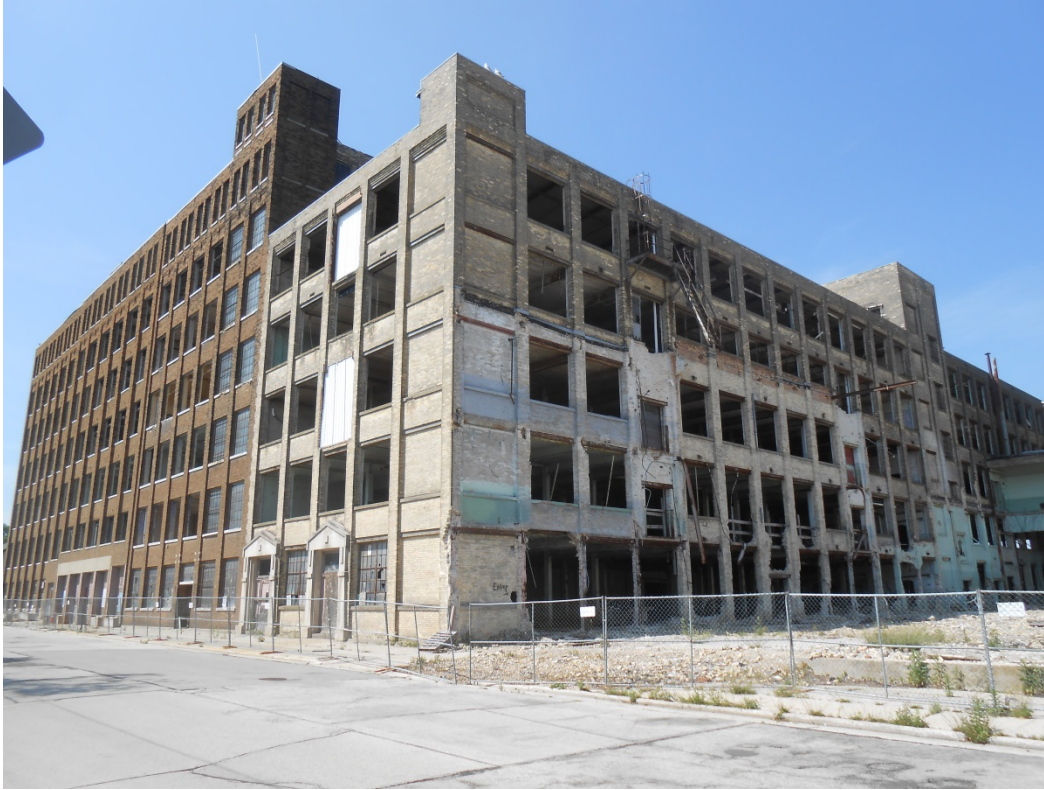
The building situated at the south end of the site is older, and is constructed of steel beams and columns, with laminated 2x timber floors, spanning (1-way) between beams. The majority of the south building is 7 stories in height, with the northern 3-bay portion stopping at 5 stories. See Photo No. 1, attached. The roofs are essentially flat, sloping slightly to internal roof drains.

**Photo No. 1 – View of South Building**

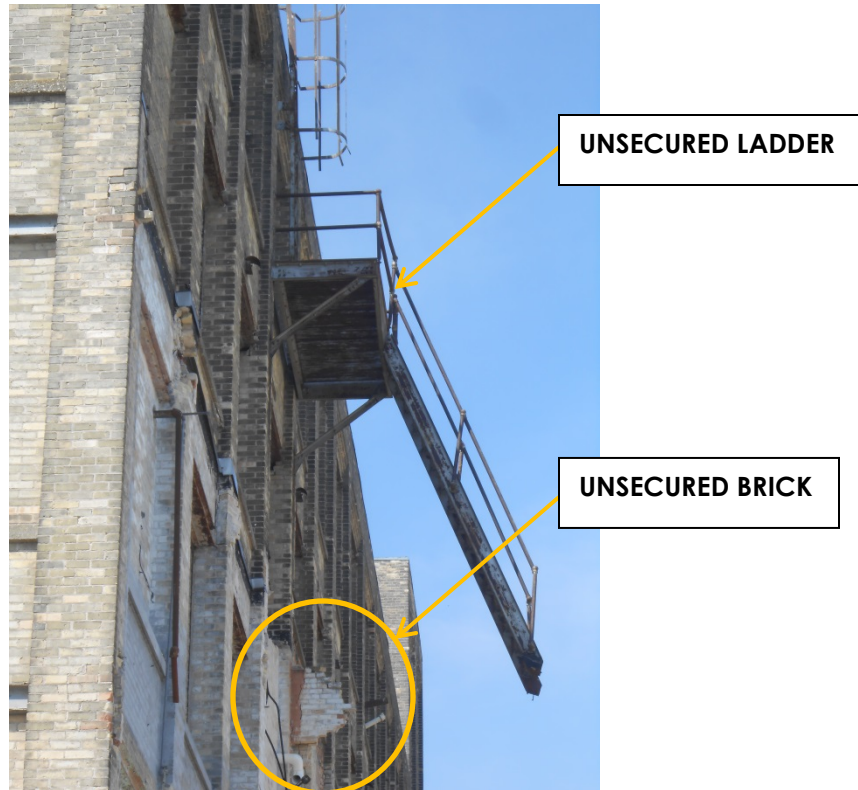
Some of the other potential hazards identified included unsecured building components left from the previous demolition activities. These included a flight of fire exit stairs and unreinforced projections of brick, left dangling several stories overhead. ALL PERSONNEL entering the site should be warned of the potential safety hazards overhead, as well as at eye level.

**Photo No. 2 – Overhead Hazards**

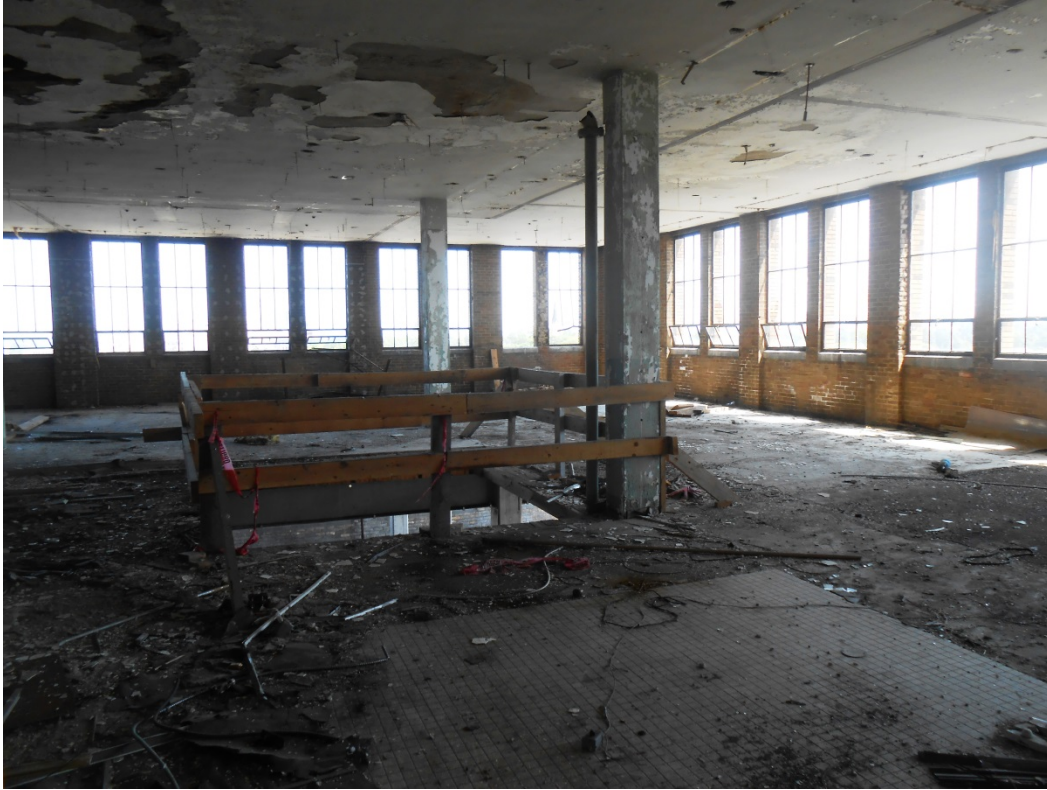
The many potential safety hazards observed consisted of both structural deficiencies and hazards created in the course of previous demolition or other intentional actions. Particularly in the south building, large holes had been cut through the floor to facilitate moving demolition debris from upper floors down to the ground level. The holes have wooden barricades around them, and currently are secure enough for workers involved with the buildings to work around. See Photo No. 3. The wood finish flooring had previously been stripped throughout the south building, which, fortunately, also permitted direct visual observation of the condition of the laminated wood floor slabs.

**Photo No. 3 – Existing Demolition Debris Opening**

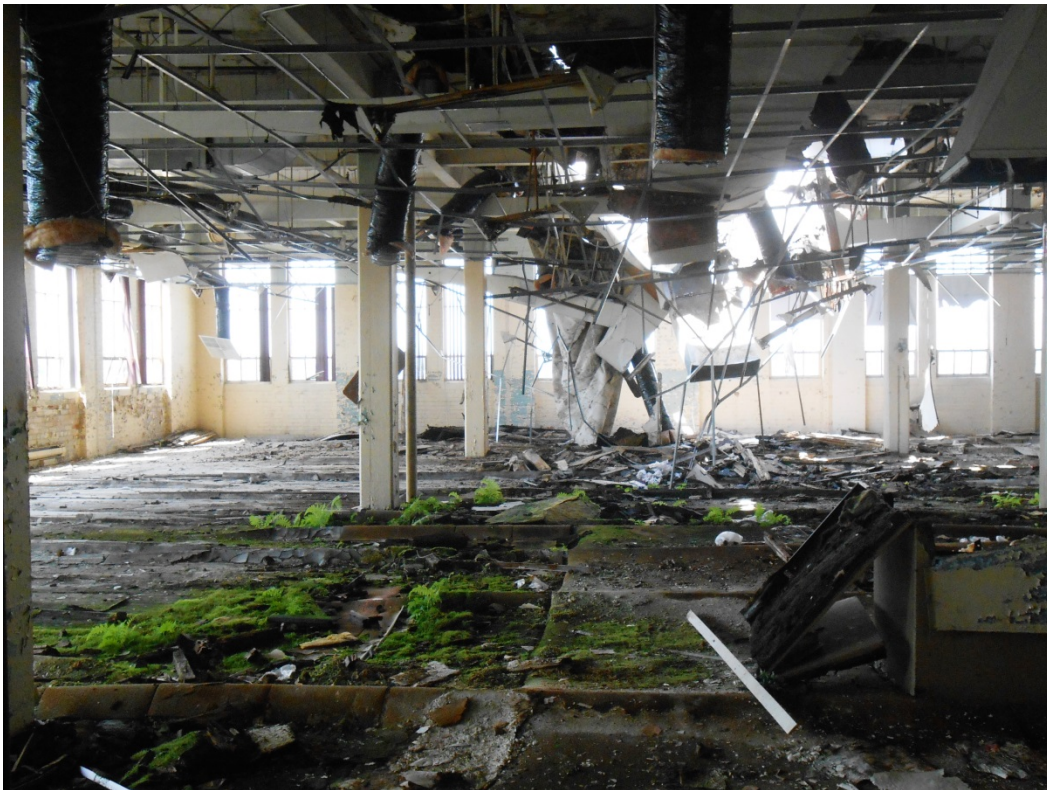
Due to the use of wood for framing the roof and floor decks in the south building, water intrusion has damaged several areas over several floor levels. Some of the locations with serious wood deterioration have collapsed, while others are not safe for personnel to walk on. See Photo No. 4. These areas were identified and marked off with CAUTION tape. The damage is localized within the taped-off areas, so areas outside the tape are considered to be safe. See Photo No. 5. Small, more localized areas of deterioration were marked with orange spray paint. They, too, should be avoided. For many of the areas, it was not immediately apparent that the floor was unsafe, so all personnel entering the site should be notified of the conditions and be made aware of the markings and restrictions. See Photo No. 6 (prior to taping off the area).

**Photo No. 4 – Collapsed Roof in Southwest Corner**

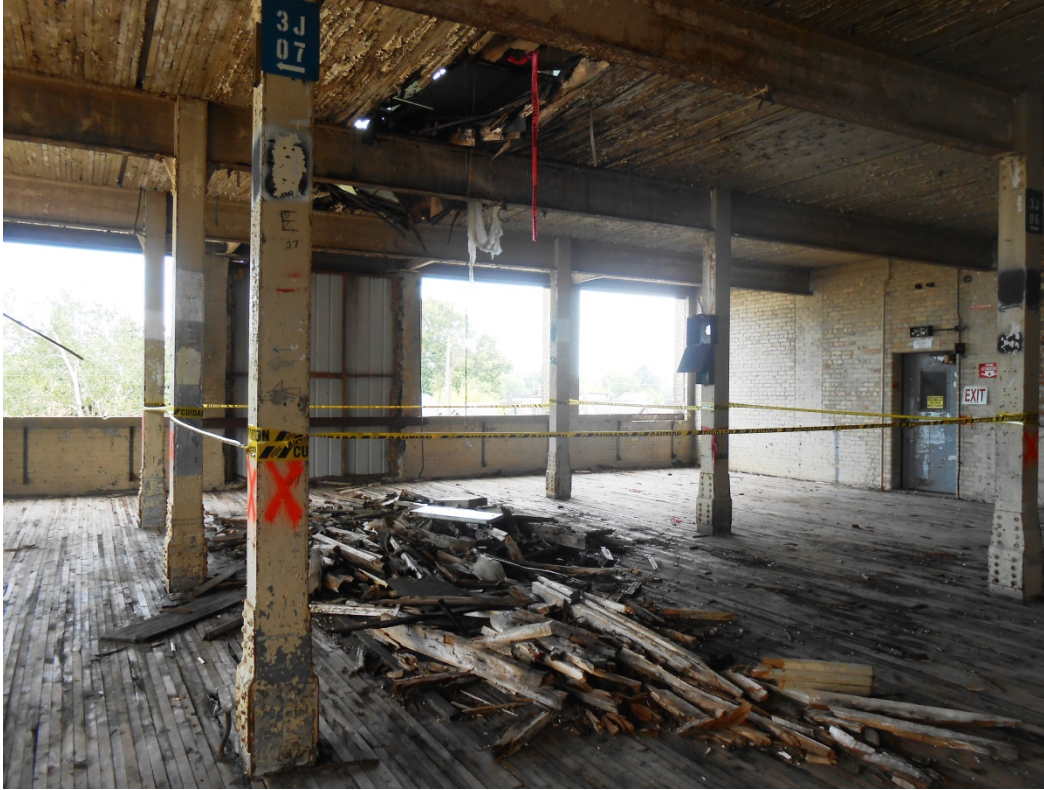
All of the areas marked off as unsafe were documented, and will be shown graphically in the final report. The CAUTION tape and paint are considered to be temporary, however, so they should be replaced with more durable barriers or be inspected and maintained routinely.

**Photo No. 5 – Typical Restricted Area Temporary Barrier**

If there is any significant time delay between now and when the buildings will be demolished, the temporary barriers should be replaced with more robust and durable barriers. In the meantime, all personnel accessing the site should be instructed to watch for hazards and to avoid the restricted areas.

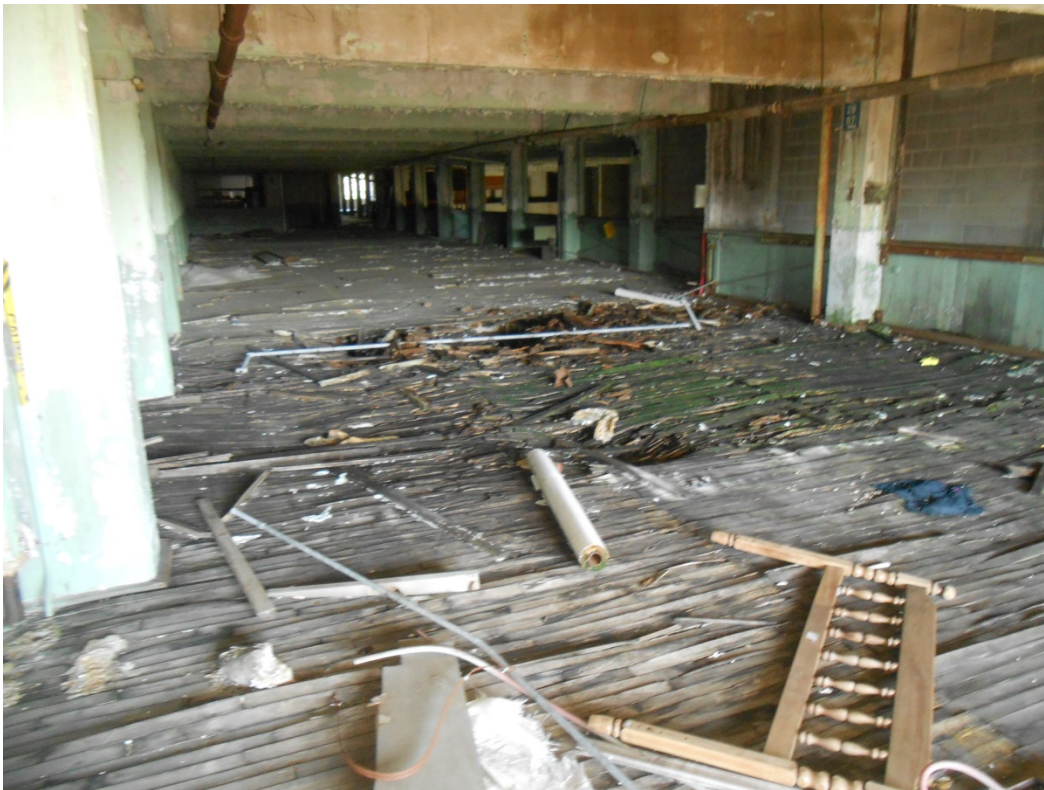
**Photo No. 6 – Unsafe Floor Area on 2<sup>nd</sup> Floor**

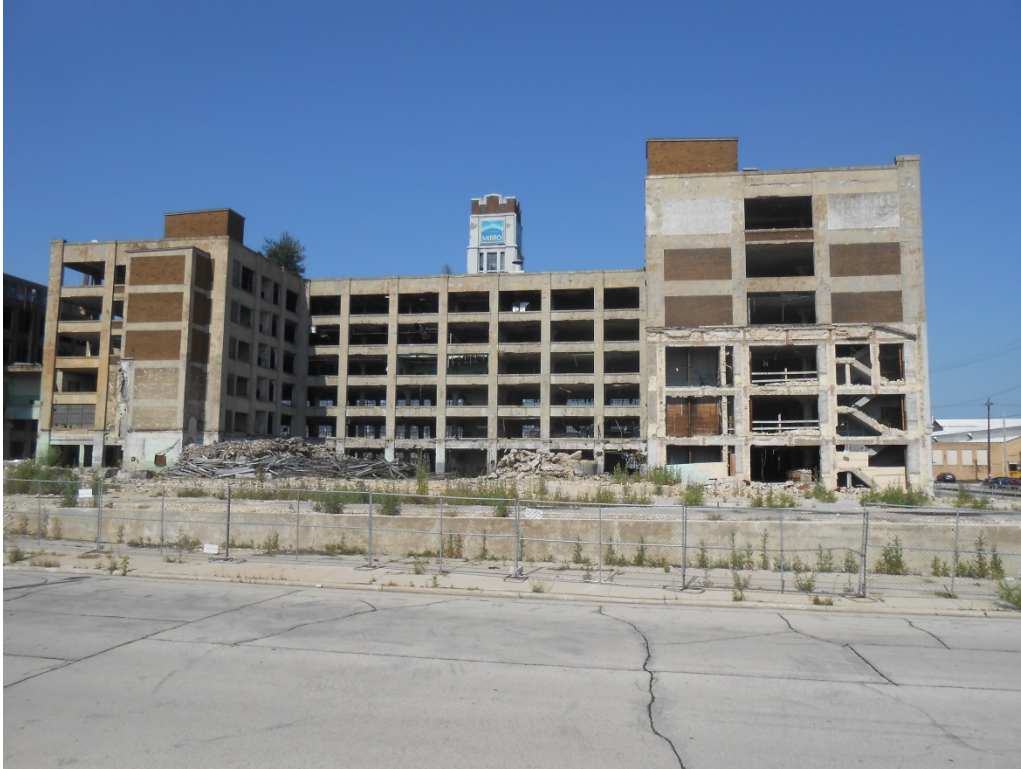
The north building, covering the northwest portion of the site, is constructed of cast-in-place concrete and is 6 stories in height. The structural system consists of cast-in-place concrete flat plate slabs, with large concrete columns, column capitals and drop panels. See Photo Nos. 7 and 8, attached.

**Photo No. 7 – North Building**

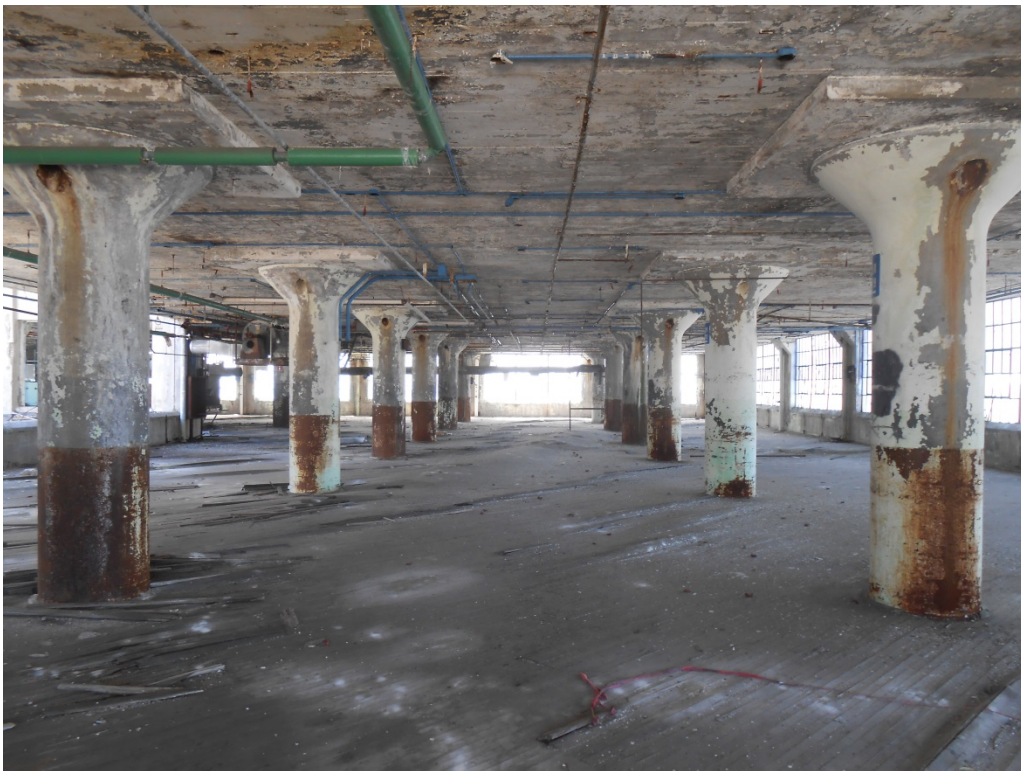
In the north building, no structural distress or deficiencies were observed. Because concrete doesn't rust or rot, exposure to moisture and extreme temperatures did not adversely affect the condition of the concrete. The majority of the windows had been removed, so the interiors of the floors had been exposed to rain and snow. Water saturation in the concrete floor slabs was evidenced by the presence of small calcium stalactites on the underside of the slabs. Significantly, no rust was observed, so it is assumed that there has been no reduction in the structural load capacity of the floors. See Photo No. 8.

**Photo No. 8 – Typical View of Structural System**
