Stantec Consulting Services Inc.  
2335 Highway 36 West, St. Paul MN 55113-3819

September 13, 2016

Reference: Mirro Building Structural Condition Assessment  
Stantec Project No. 193703139

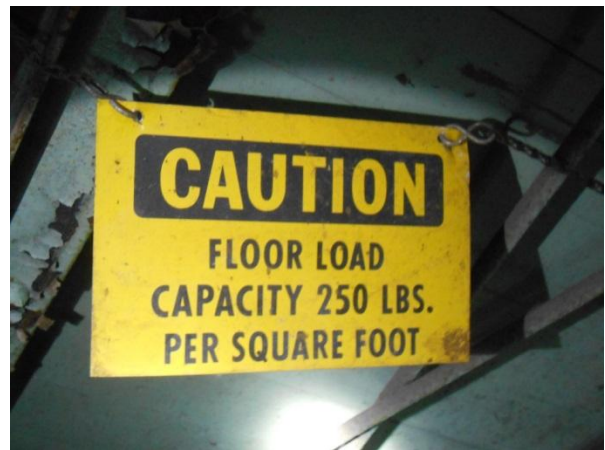
Maximum permitted Live Load signs were posted in various areas throughout the building, indicating that the maximum allowable floor loading was 250 pounds per square foot (psf). See Photo No. 3.1-1.

This indicates that this, and all similar floor framing, was designed for heavy industrial loads, so that even with some loss of strength due to material deterioration, the structure may have sufficient reserve strength for pedestrian live loads.

Photo No. 3.1-1: Floor Load Posting

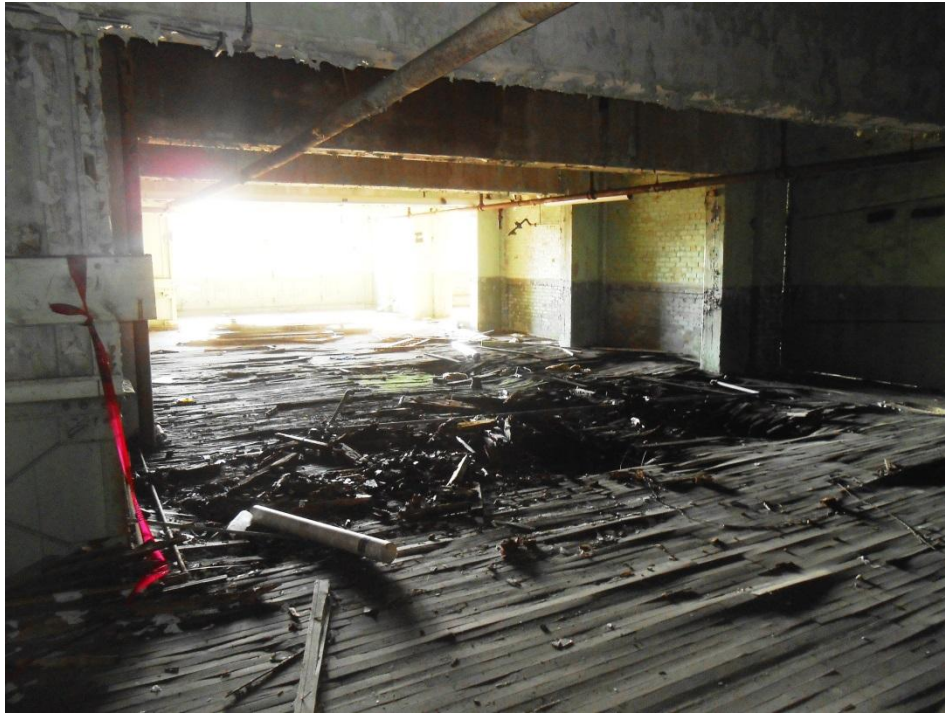
A large area of the roof over the southwest corner of the south building had collapsed. See Photo No. 9. Once the roof was breached, rain and snow were allowed to enter, which has caused significant deterioration – to the point of collapse – on many levels directly below. In other areas, such as the north side of 2<sup>nd</sup> Floor, the cause of the deterioration and collapse was not readily apparent, but the damage to the structure was significant. See Photo Nos. 3 and 4.

Photo No. 3 – South Building: 2<sup>nd</sup> Floor Timber Decking Collapse

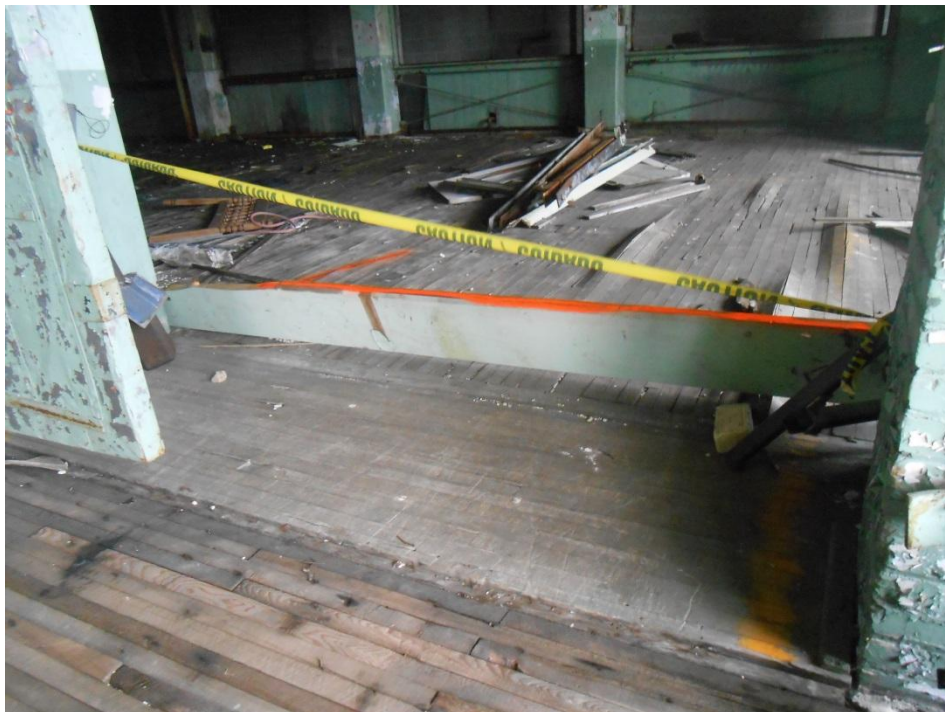
Photo No. 4 – South Building: Barricade Tape and Plywood Restricting Access

Because potentially serious structural safety hazards were identified during the assessment, and due to the localized nature of those hazards, all of the hazardous areas identified were immediately barricaded with CAUTION tape, some with boards and plywood found on the site, and the areas highlighted with orange marking paint to warn others. In addition, an interim memo was issued to the City, dated July 25, 2016, that described the observations and provided notice of the hazards. This report is intended to provide additional detail and follow-up information to permit City staff to locate the areas and replace the barricade tape if more robust barricade materials are desired, or if it is damaged or removed.

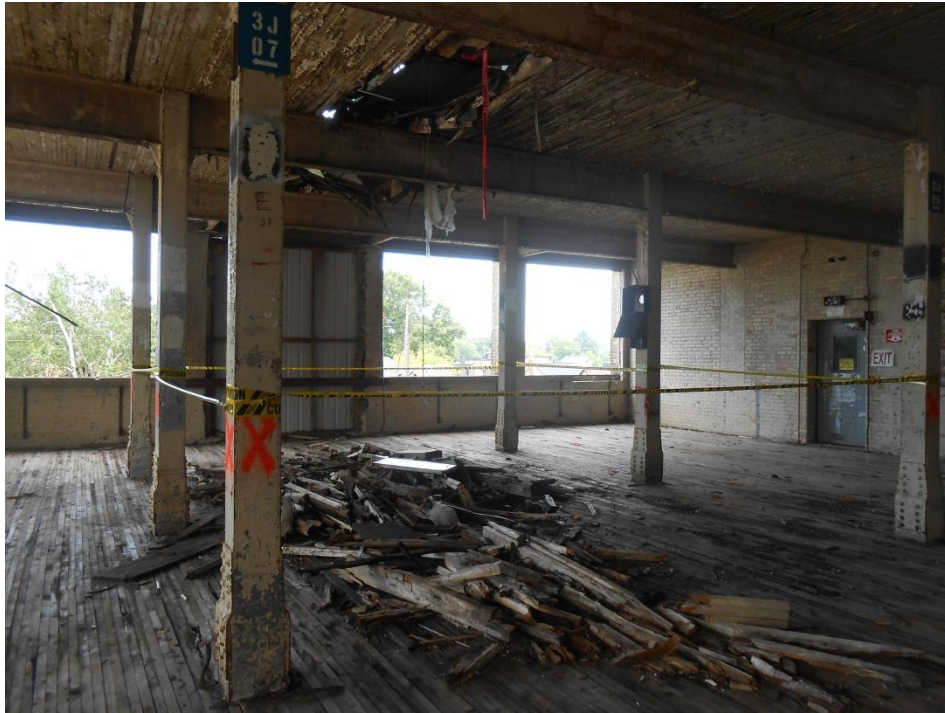
Photo No. 5 – South Building: Timber Decking Collapse at 3<sup>rd</sup> Floor

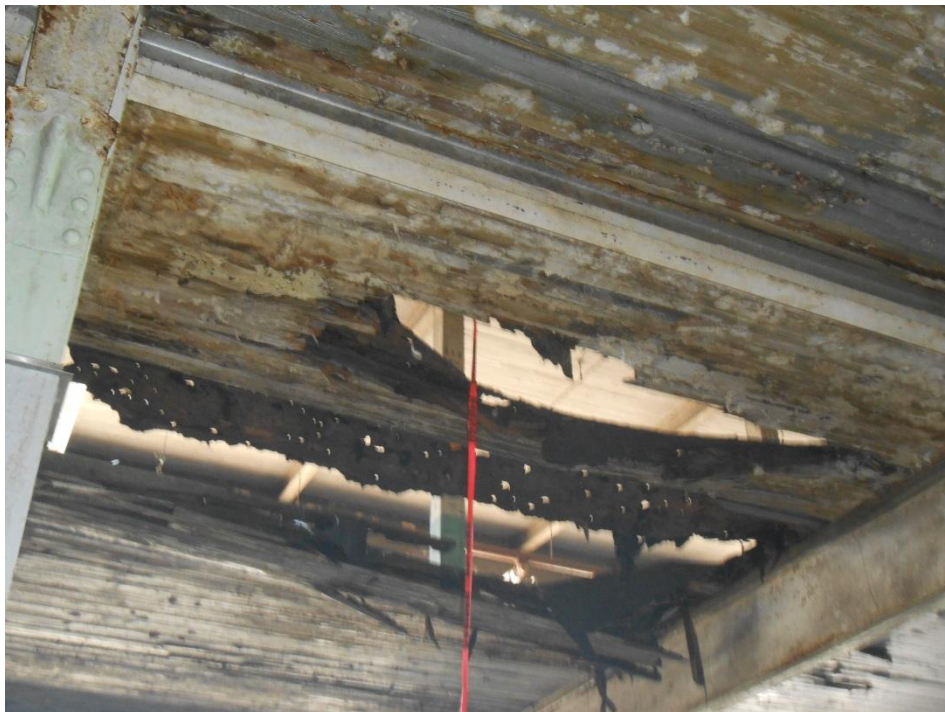
Photo No. 6 – South Building: Timber Decking Collapse at 4<sup>th</sup> Floor

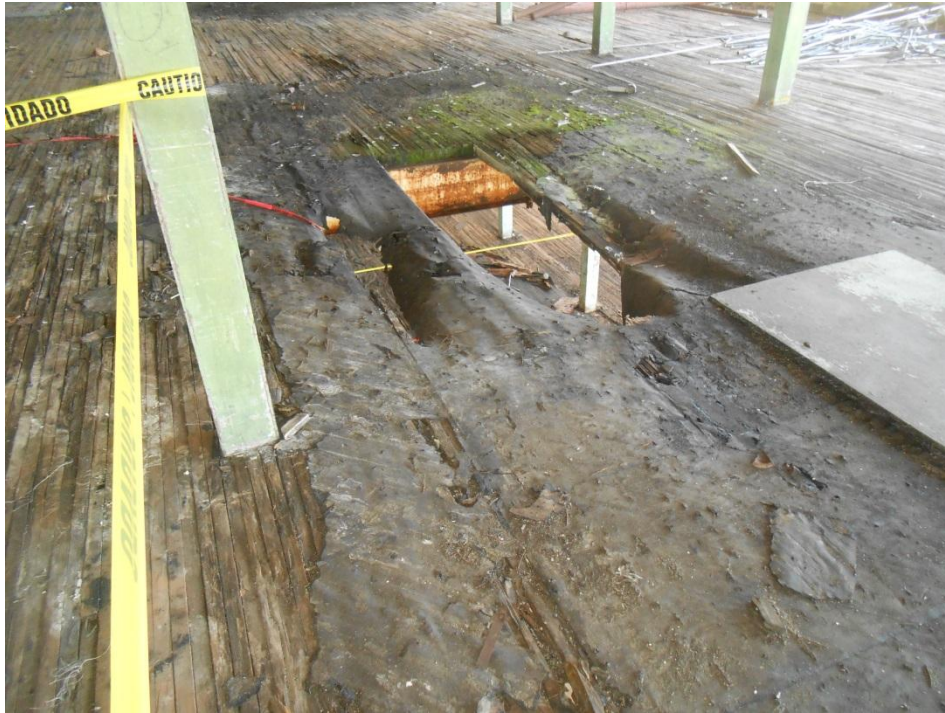
Photo No. 7 – South Building: Timber Decking Collapse at 5<sup>th</sup> Floor

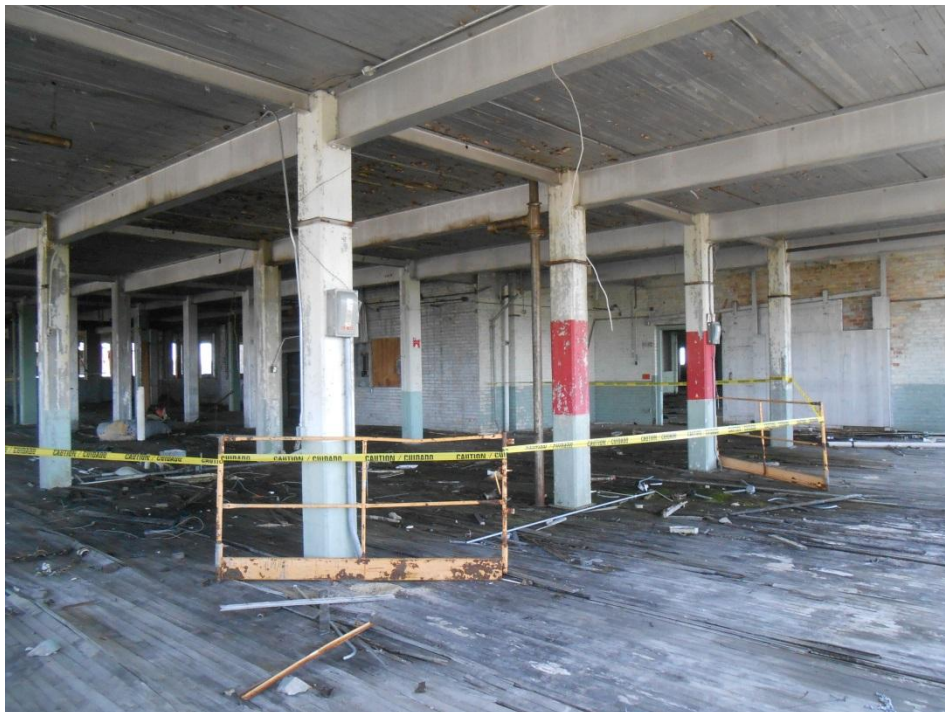
Photo No. 8 – South Building: Restricted Area at 6<sup>th</sup> Floor Collapse

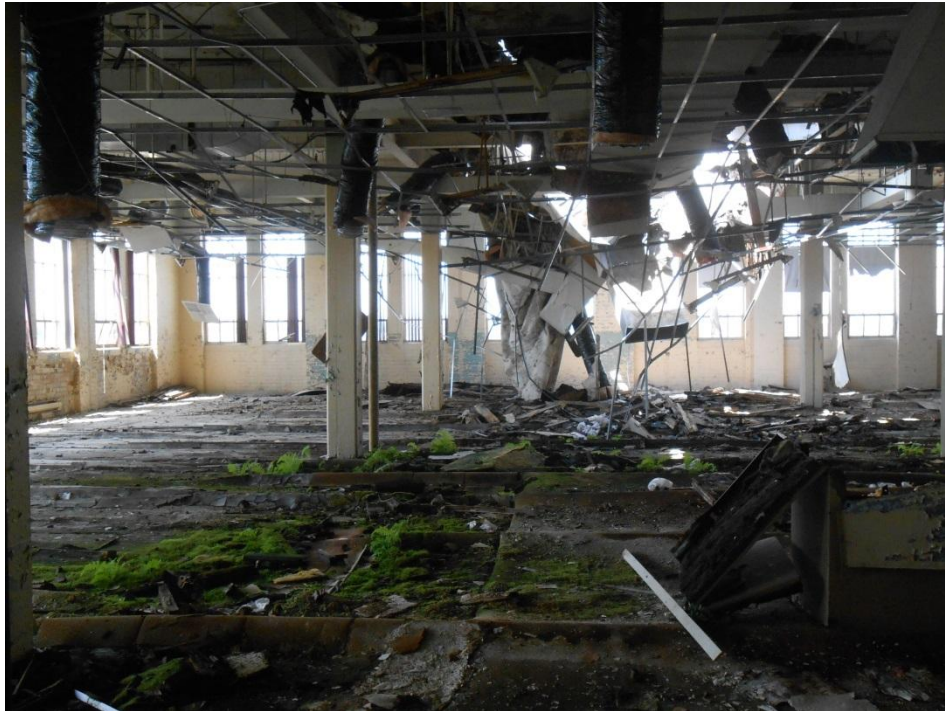
Photo No. 9 – South Building: Roof Deck Collapse in Southwest Corner

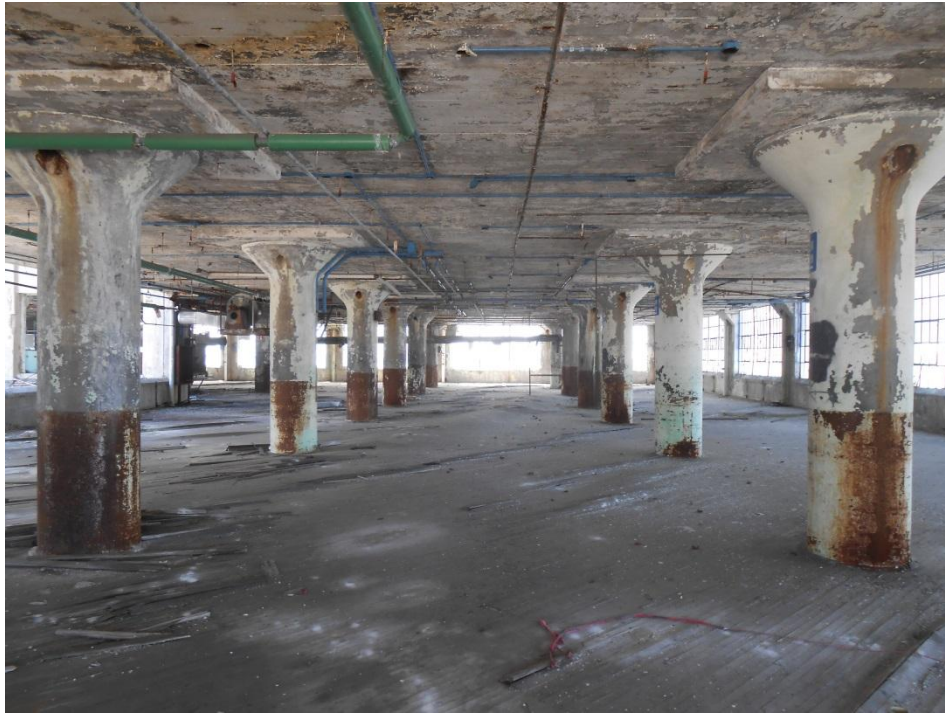
Unlike the South Building, the north building is constructed of concrete, which does not rust or rot and is still in very good condition, despite exposure to the elements. In addition, it has continuous, 2-way concrete floor slabs spanning between columns. This continuity provides load redistribution, contributing to its structural strength.

Photo No. 11 – North Building: Cast-In-Place Concrete Columns and Floor Slabs

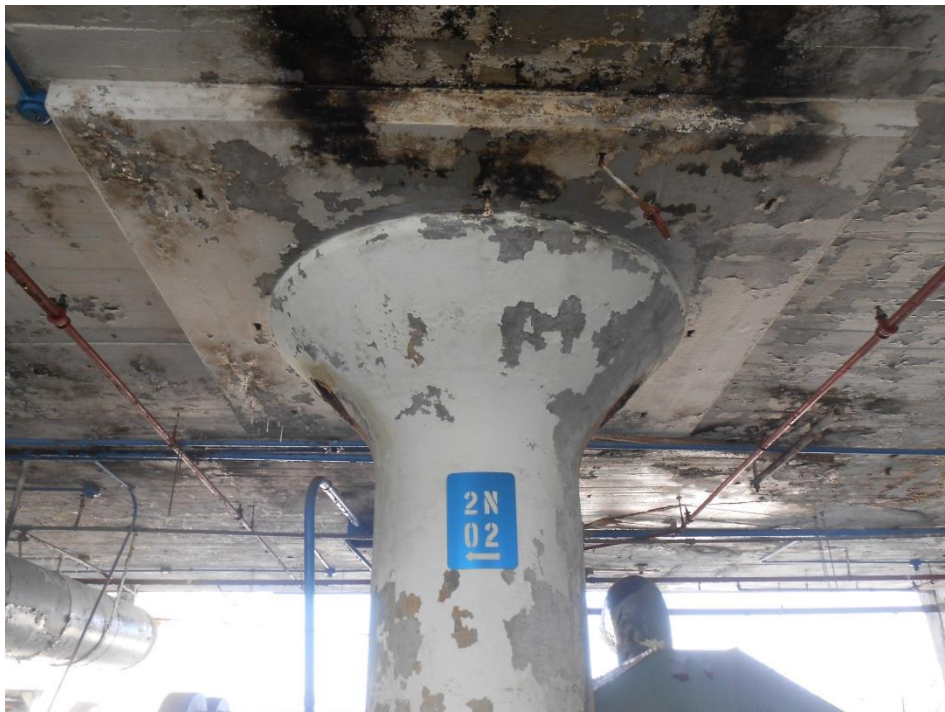
Photo No. 12 – North Building: Cast-In-Place Concrete Column Capital and Drop Panel

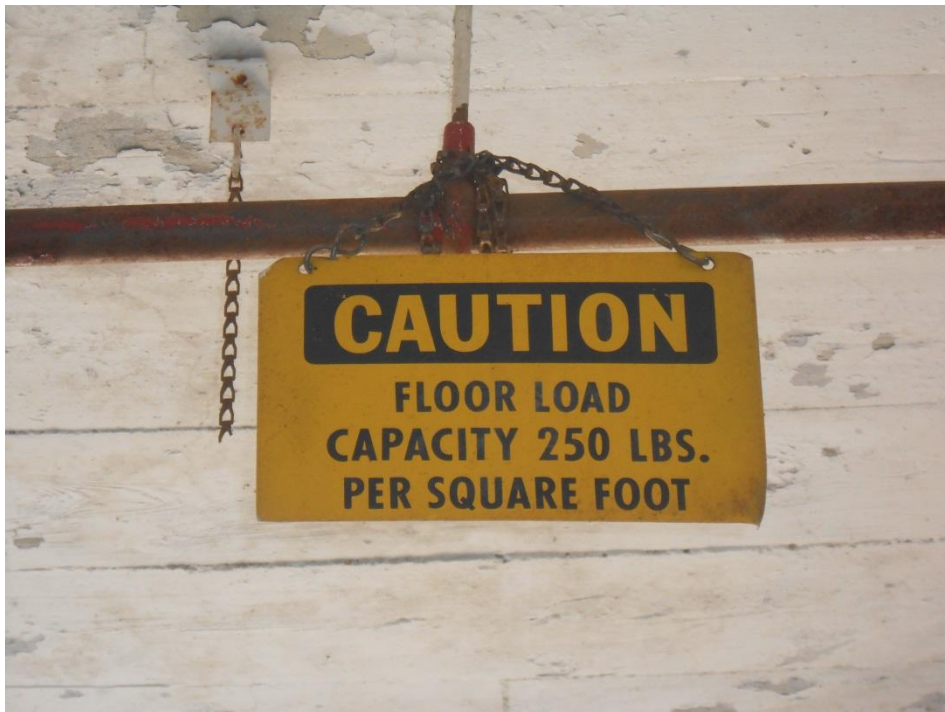
Given that the floor live load capacity of 250 psf was posted in several locations throughout the building, and there are no indications that the building has suffered any loss of structural strength or stability, no areas are considered to be off limits from workers and others who take proper precautions from nonstructural hazards.

Photo No. 14 – North Building: Maximum Floor Live Load Posting

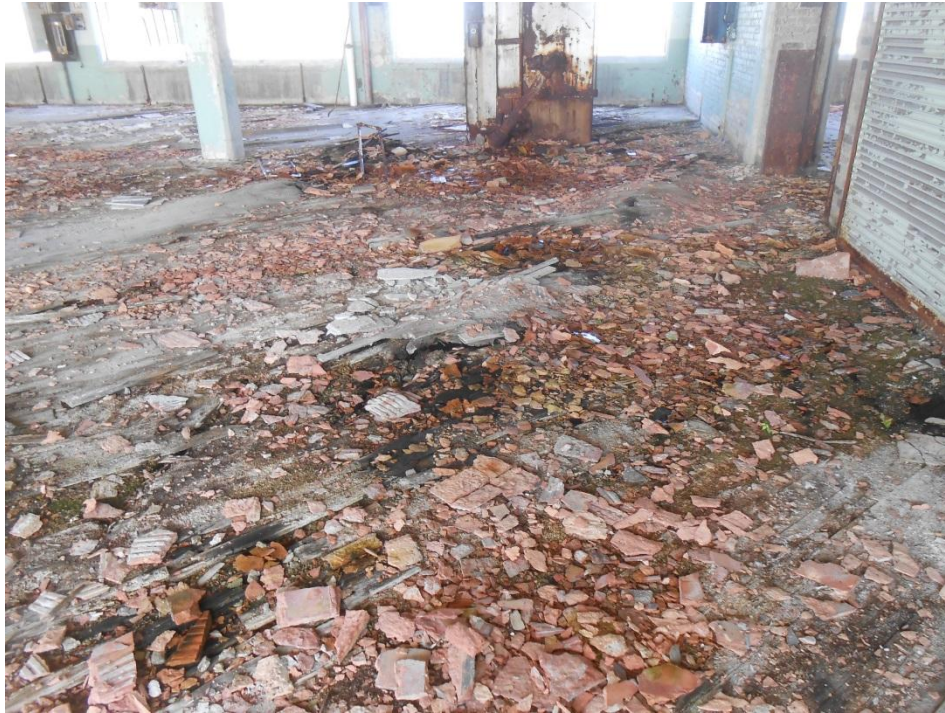
Photo No. 15 – North Building: Hollow Clay Roof Tile Debris on 6<sup>th</sup> Floor

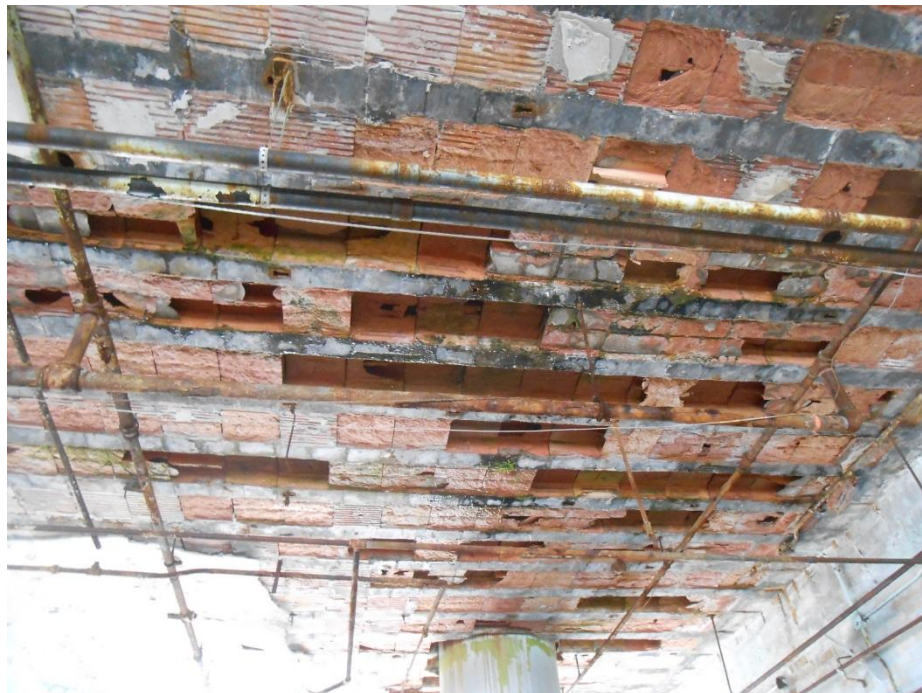
Photo No. 16 – North Building: Deteriorated Hollow Clay Roof Tile

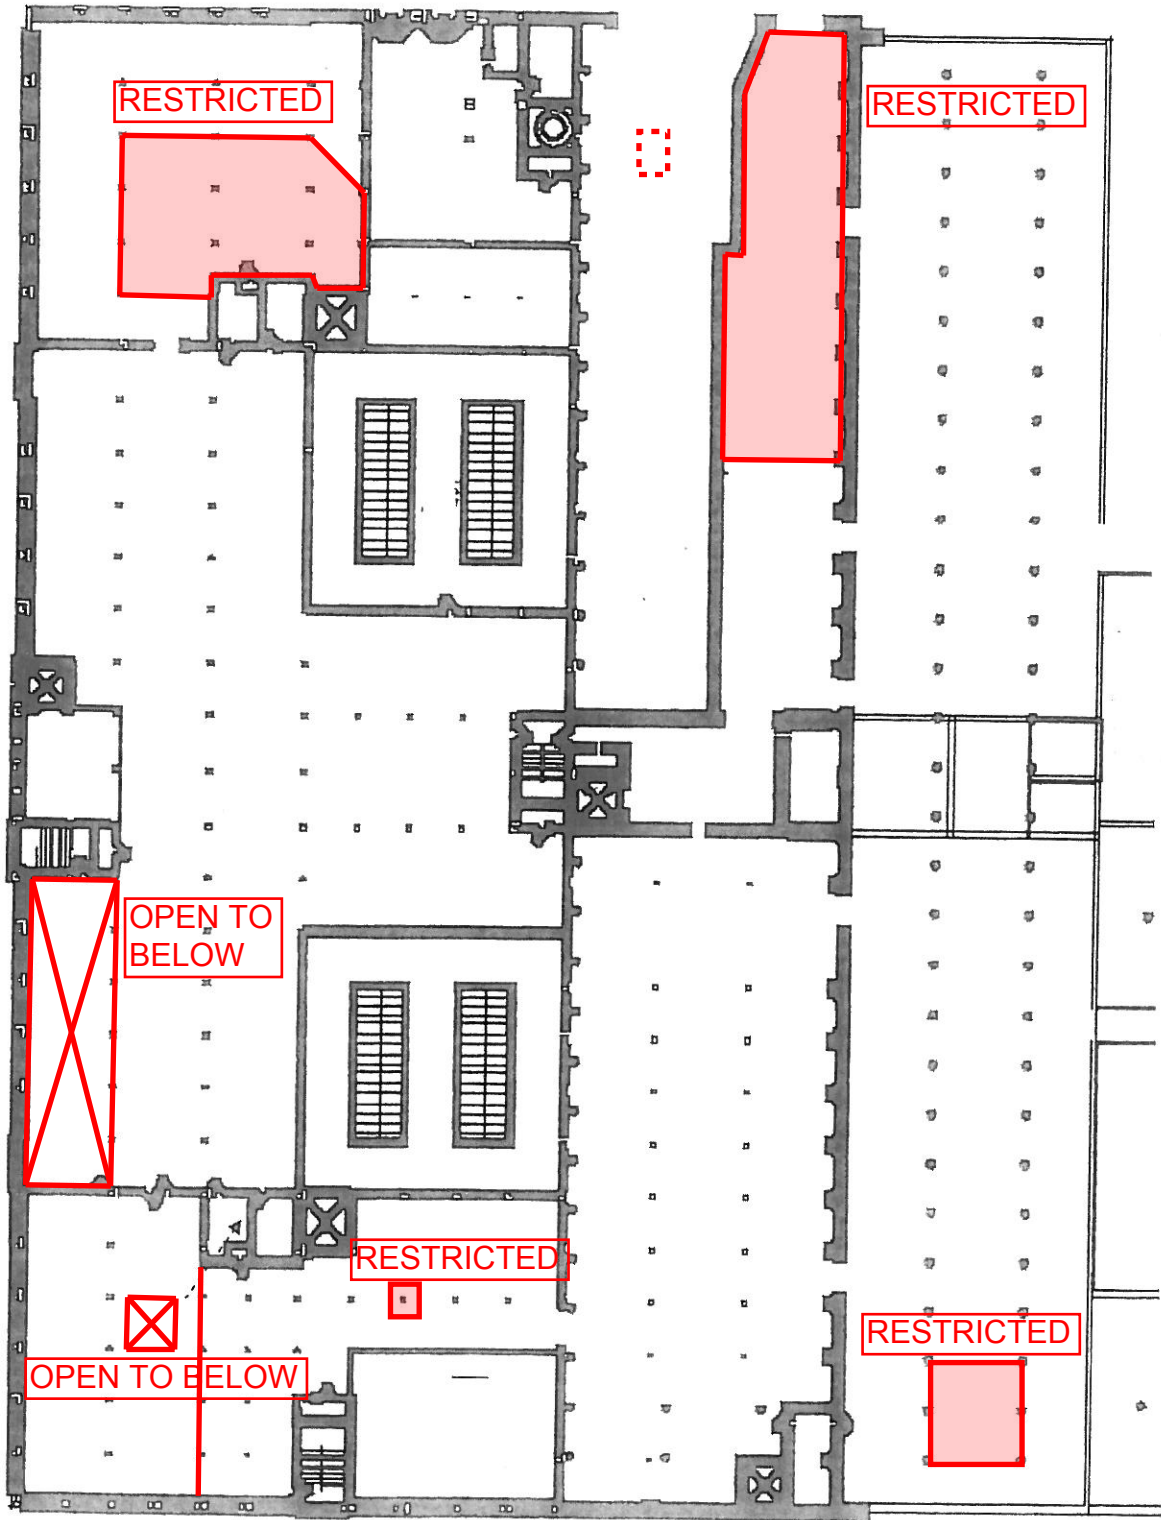
**Figure 1**

The boundary of each of the unsafe floor areas was documented and noted, in the event that the CAUTION tape or paint markings are disturbed. These areas are shown in the plan views of each floor level in Figure Nos. 1 through 6 in Appendix B.

**2nd FLOOR**

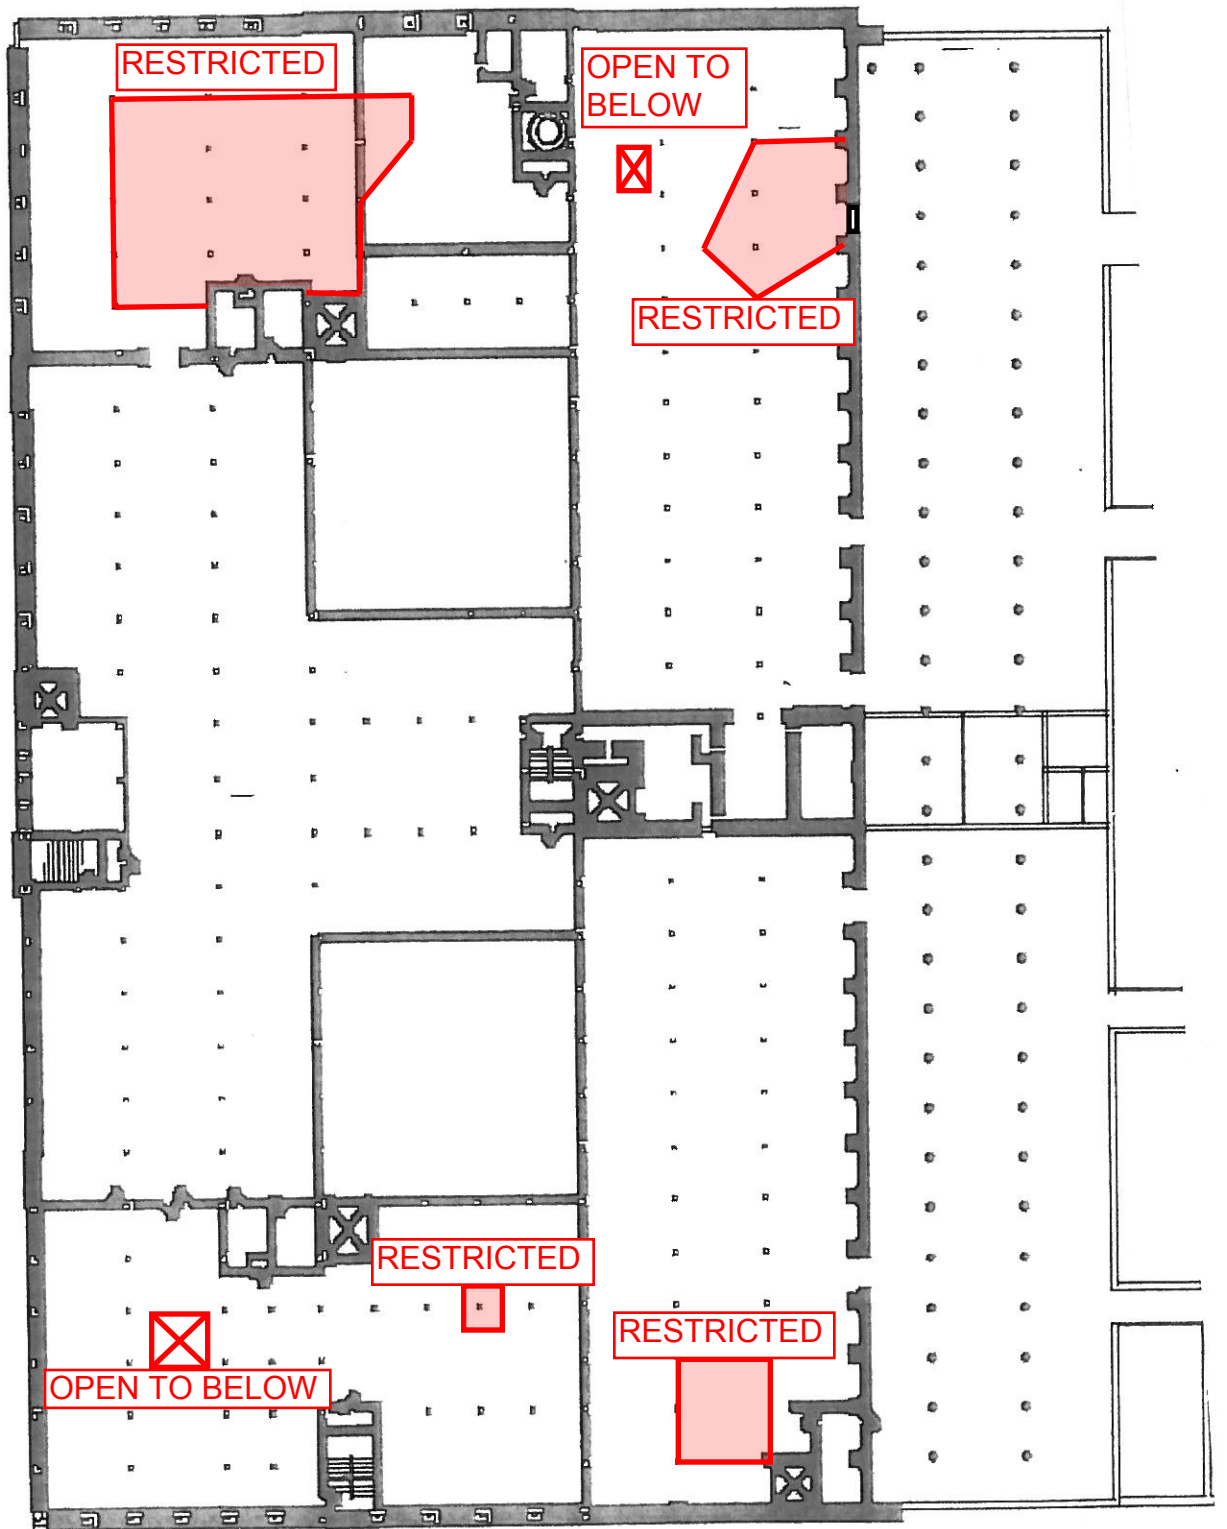
**Figure 2**

**3rd FLOOR**

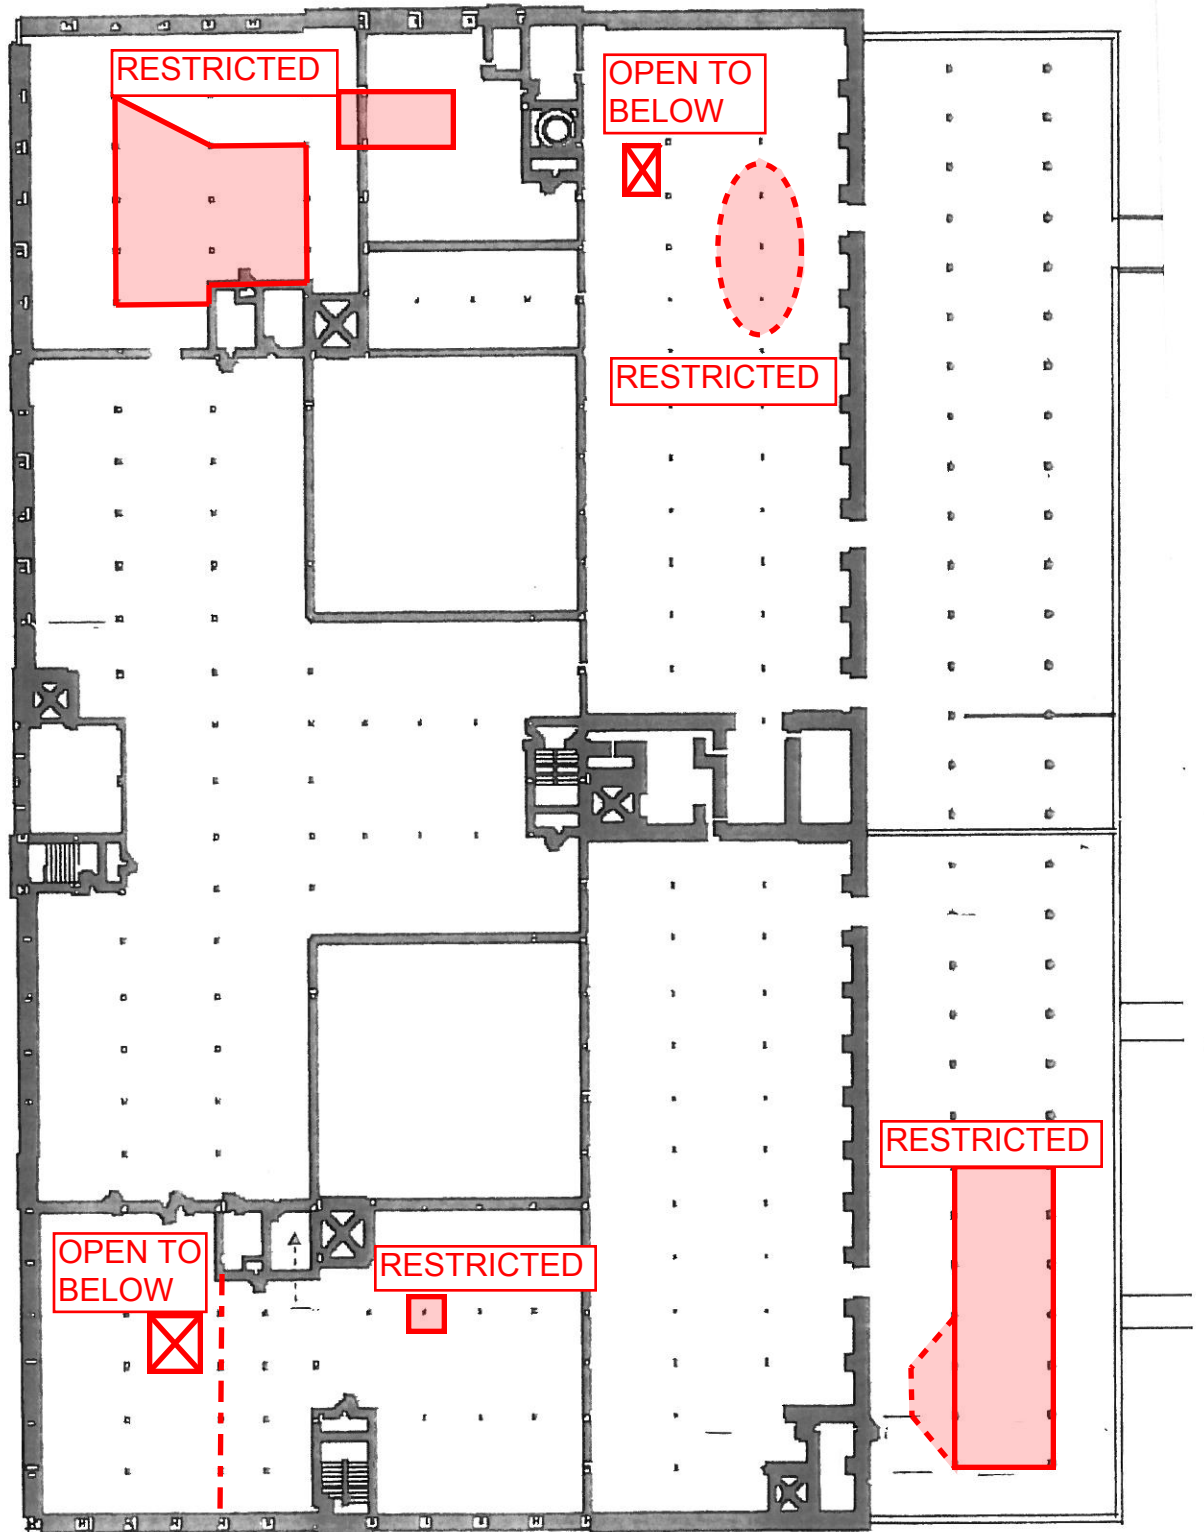
**Figure 3**

**4th FLOOR**

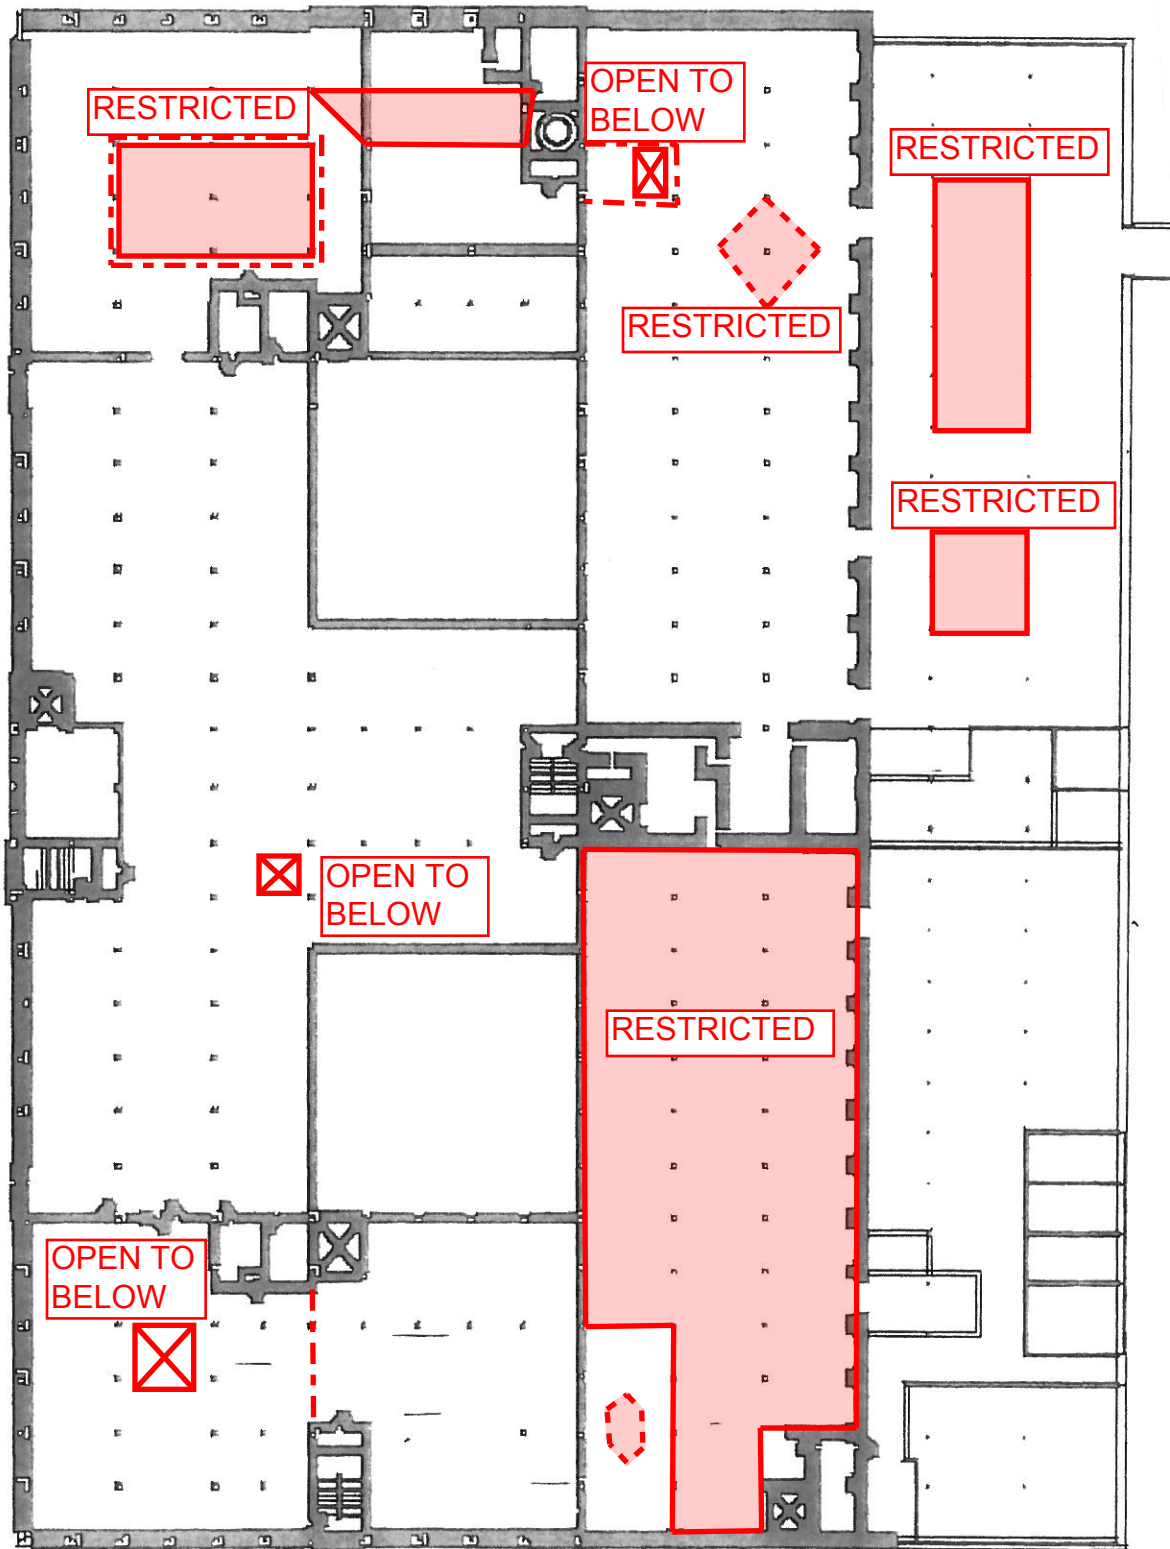
**Figure 4**

**5th FLOOR**

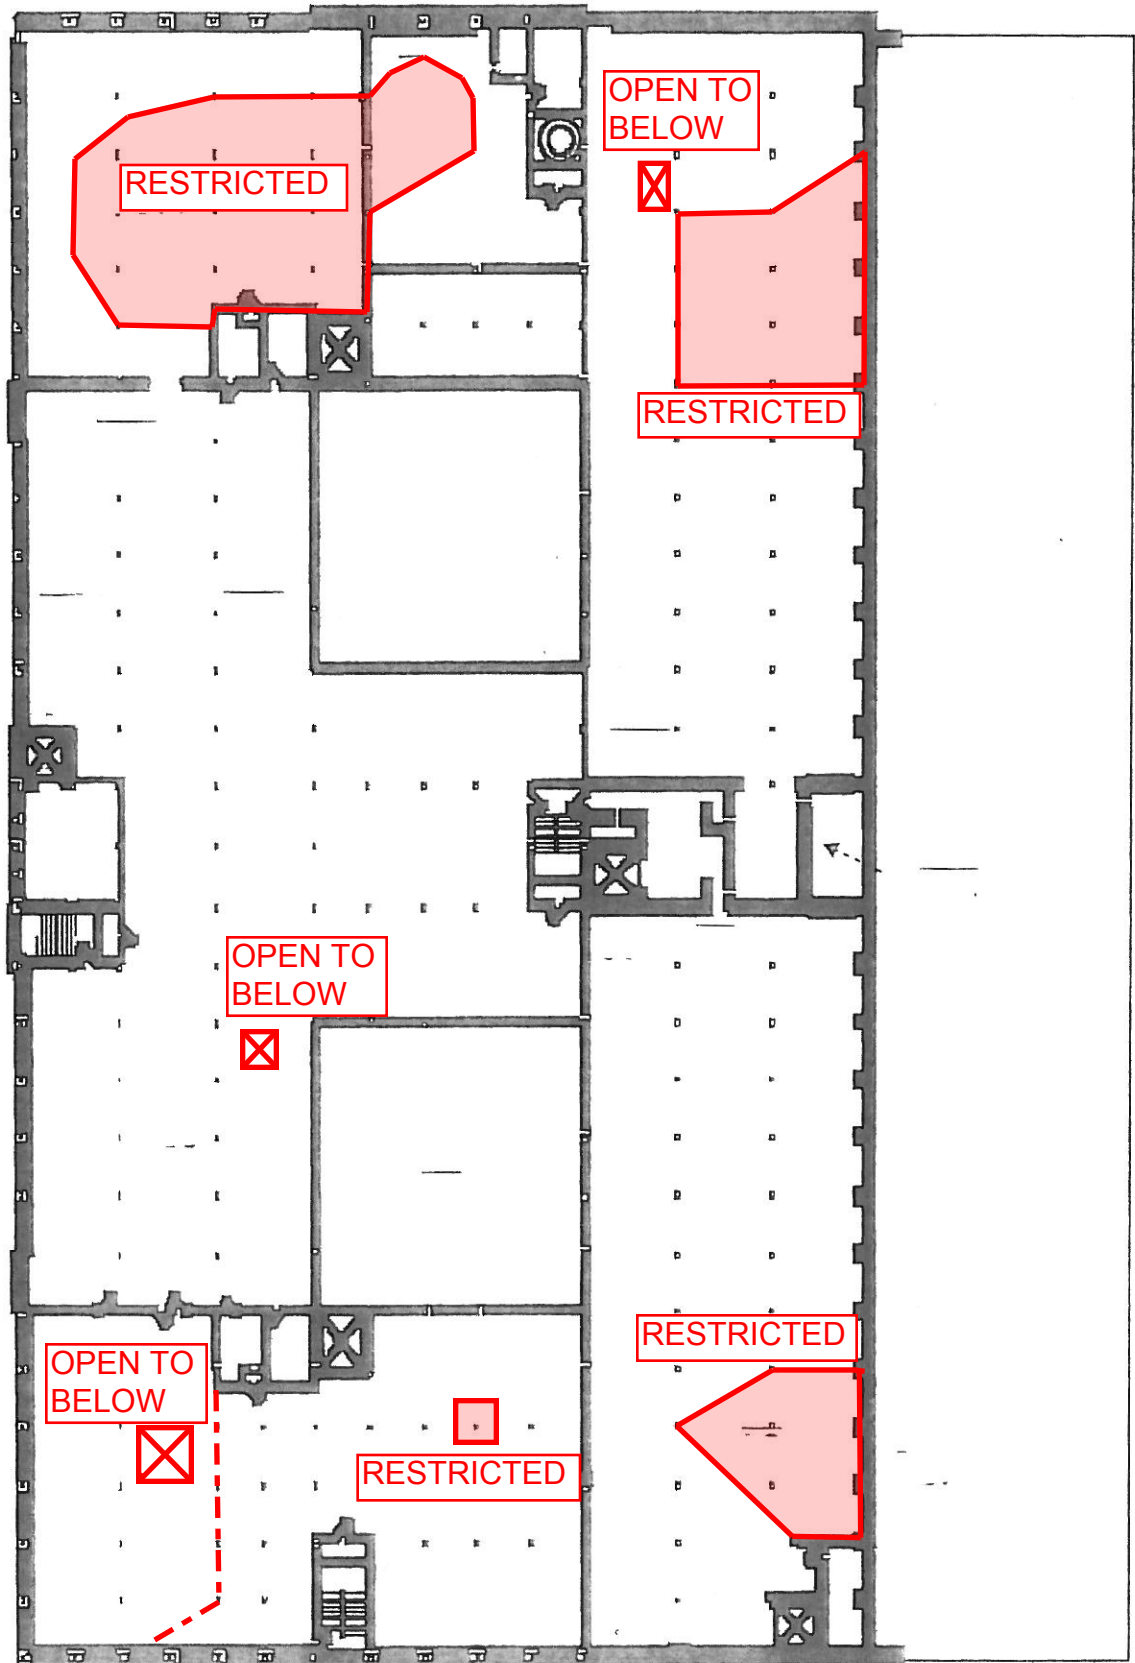
**Figure 5**

**6th FLOOR**

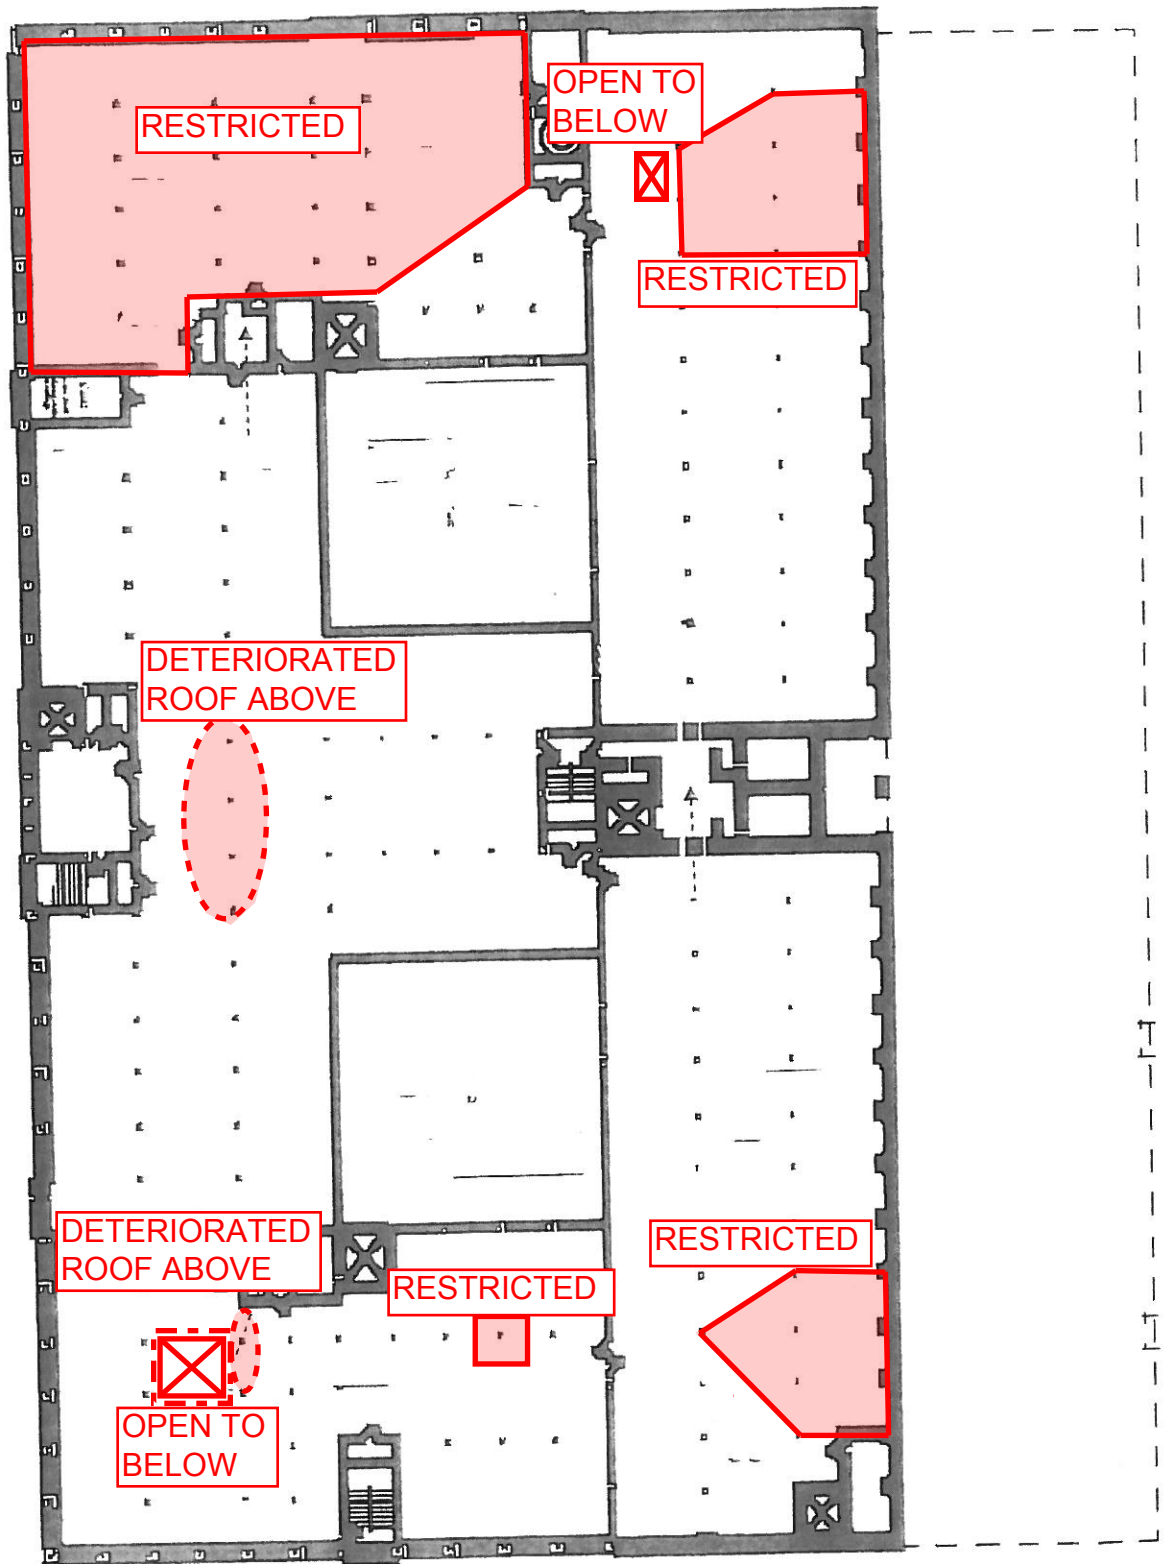
**Figure 6**

**7th FLOOR**
