**Reference: Pre-Demolition Inspection for Asbestos and Lead Paint**  
**1512 Washington Street Manitowoc, Wisconsin**  
**USEPA Cooperative Agreement No. BF-00E01529-0**  
**Stantec Project No. 193703931**

Site Address:	Mirro Building No. 9 1512 Washington Street Manitowoc, WI 54220			
County:	Manitowoc County			
Structure Type:	Commercial			
Bldg Age:	1904 (approximate original), Multiple Additions			
Size (ft <sup>2</sup> ):	750,000 ft <sup>2</sup>			
Floors:	7 (south), 5 (center), 6 (north)			
# of Structures:	3 main structures			
Inspector:	Aaron Stroud	Cert:	All-108183	Asbestos Company: CAP-925800
Survey Date:	August 11 to 17, 2016 September 6 & 9, 2016			
Comments:	Some areas of the building were unsafe at the time of inspection due to leaks from unmaintained roofing. No current roofing samples were taken. Please refer to previous sampling data. Any suspect materials, if encountered, which differ from those tested should be assumed to contain asbestos and sampled if/when necessary.

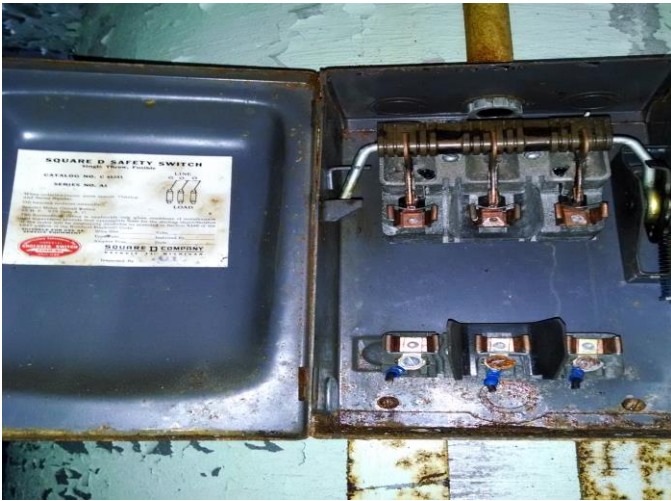
Photo 7: Square D – Transite Panel

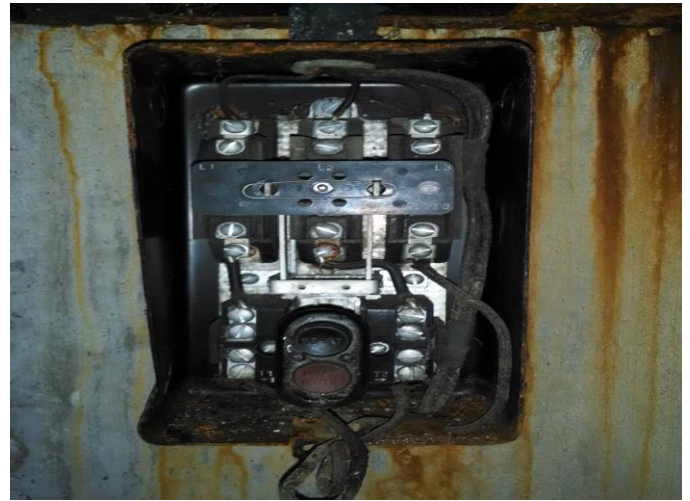
Photo 10: AB – Push Button

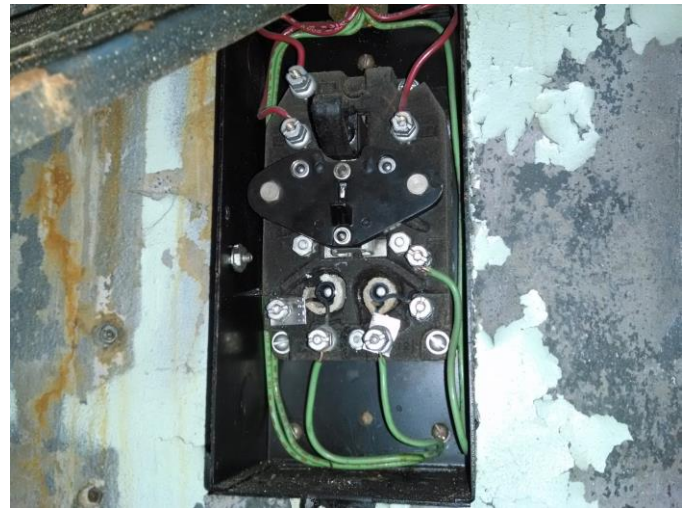
Photo 11: Cutler Hammer – Motor Control

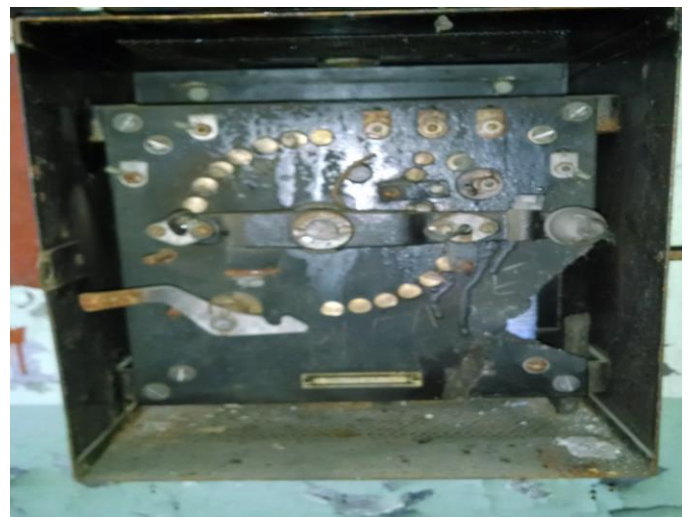
Photo 12: GE Slate Electrical Panel

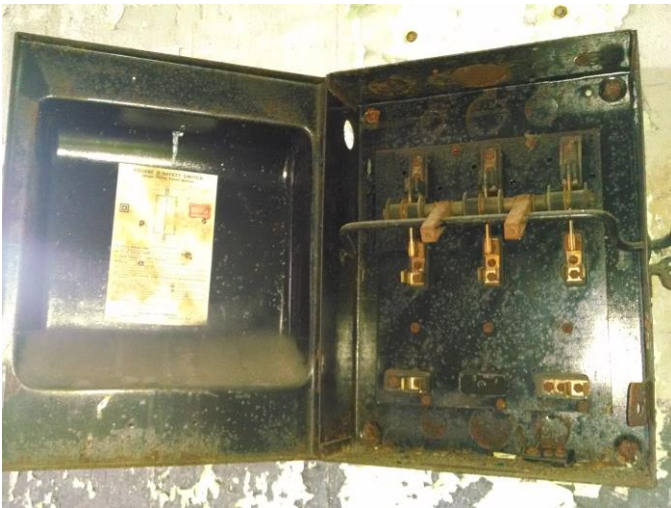
**Photo 14: Square D: Small Black Isolators**

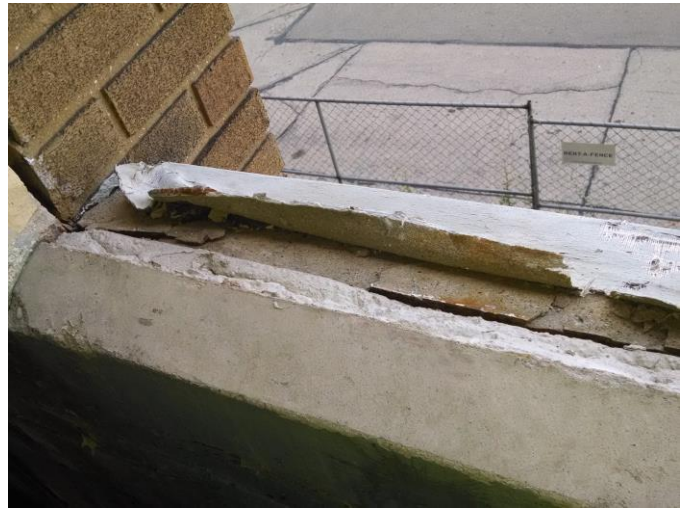
**Photo 17: Gray Fiberglass Window Sill Wrap (south building)**

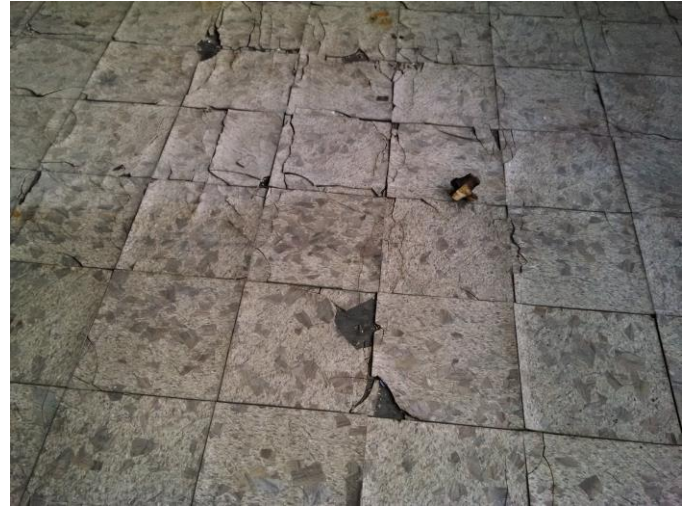
**Photo 22: 12" Tan Floor Tile**

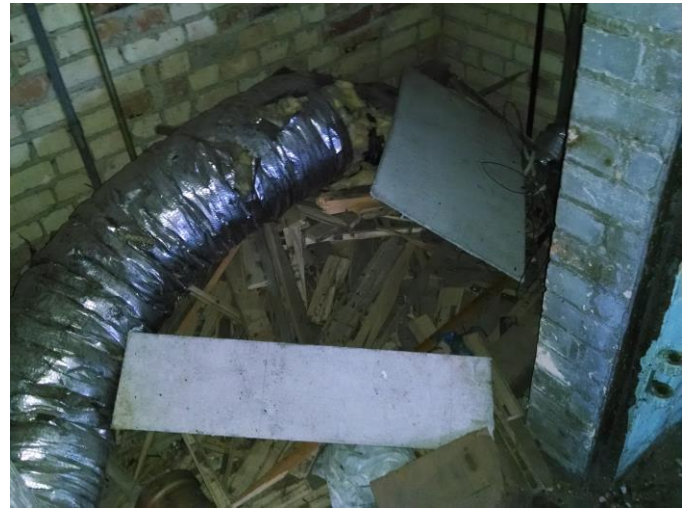
**Photo 23: White Ceiling Board / White Panel**

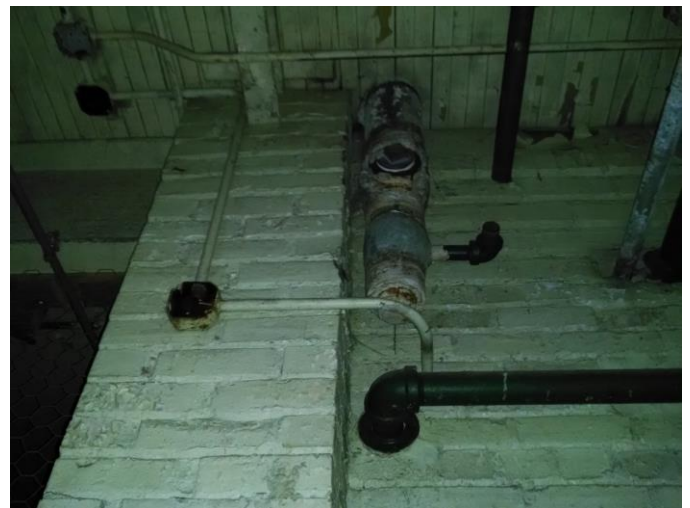
**Photo 24: Pipe Insulation & Pipe Fittings (representative)**

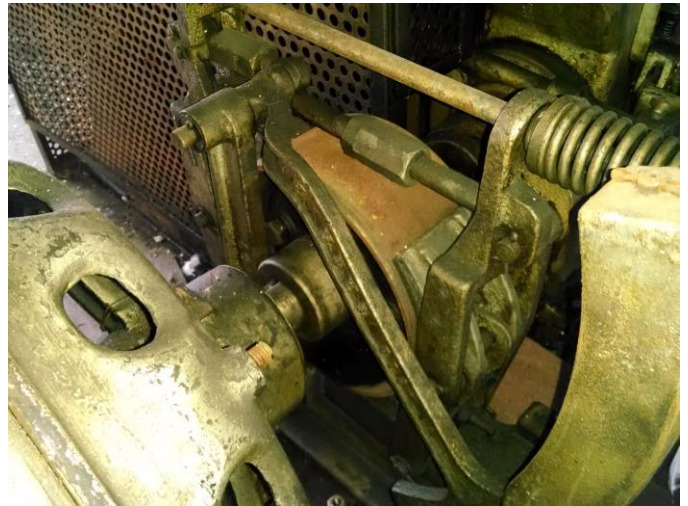
**Photo 29: Elevator Brake Shoe (representative)**

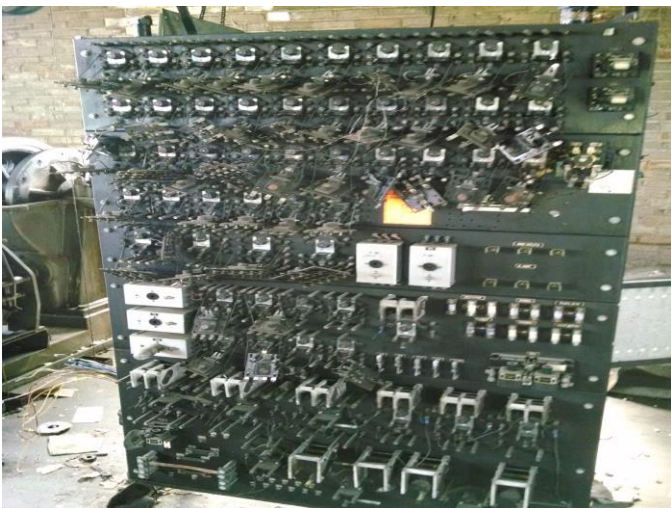
**Photo 27: Elevator Electrical (representative)**
