**ANALYSIS OF BROWNFIELDS CLEANUP ALTERNATIVES**  
**1512 Washington Street**  
**Manitowoc, Wisconsin**

**Prepared for:**  
City of Manitowoc  
900 Quay Street  
Manitowoc, Wisconsin 54220

October 7, 2016  
Stantec Project No. 193702757

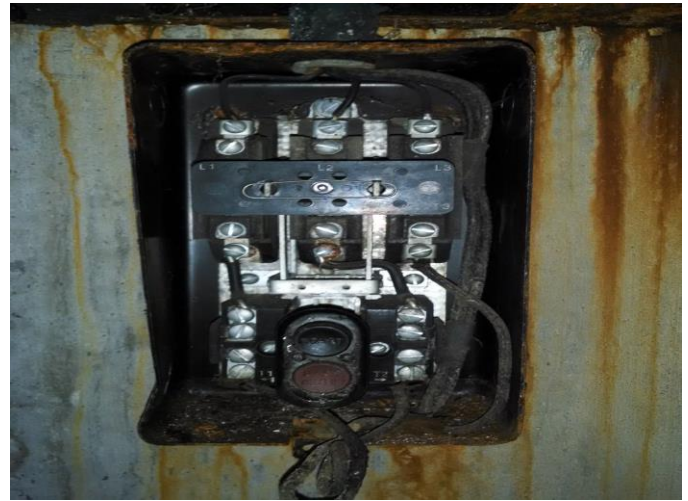
Photo 10: AB – Push Button

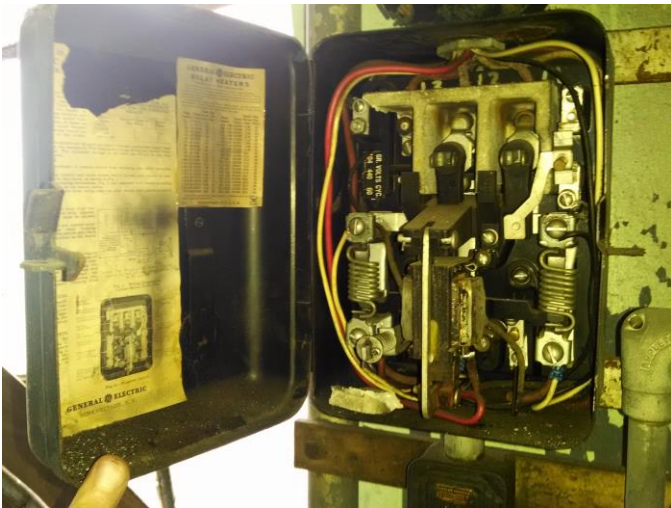
Photo 8: GE – Transite Panel

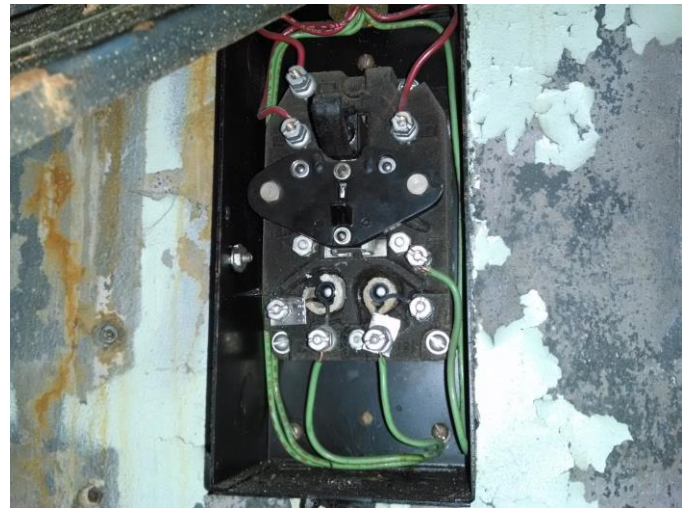
Photo 11: Cutler Hammer – Motor Control

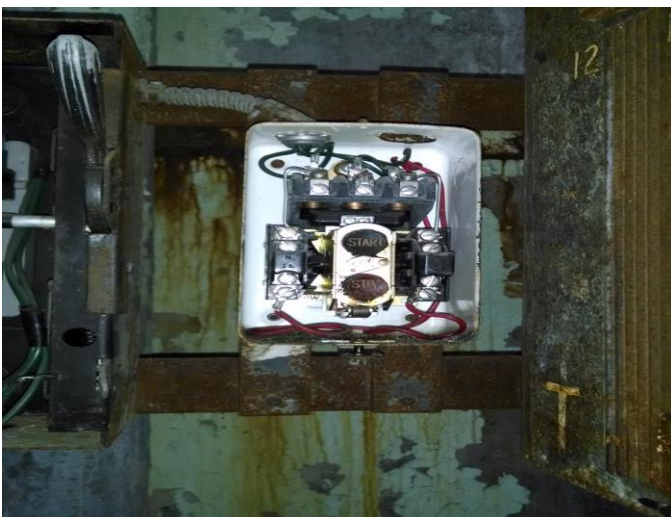
Photo 9: Cutler Hammer – Push Button

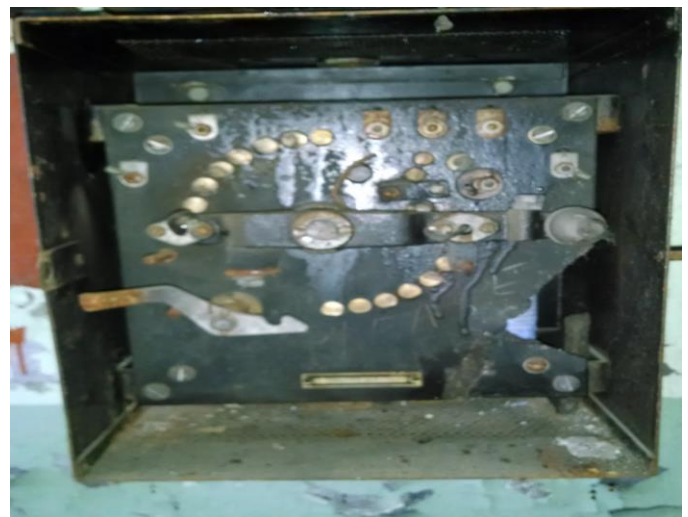
Photo 12: GE Slate Electrical Panel

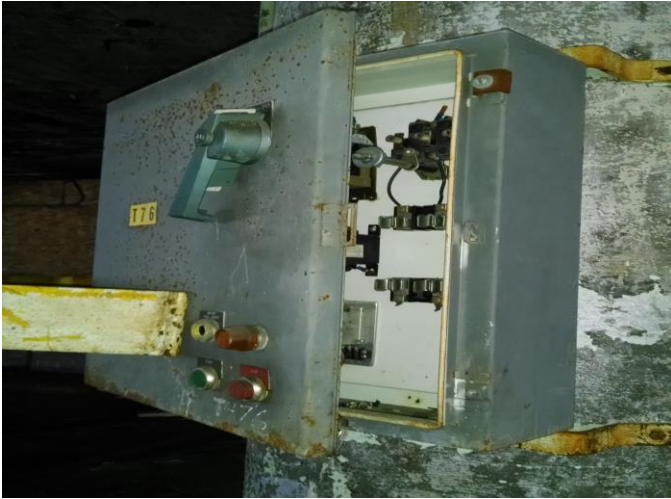
**Photo 13: Transformer Box: Black Isolator**

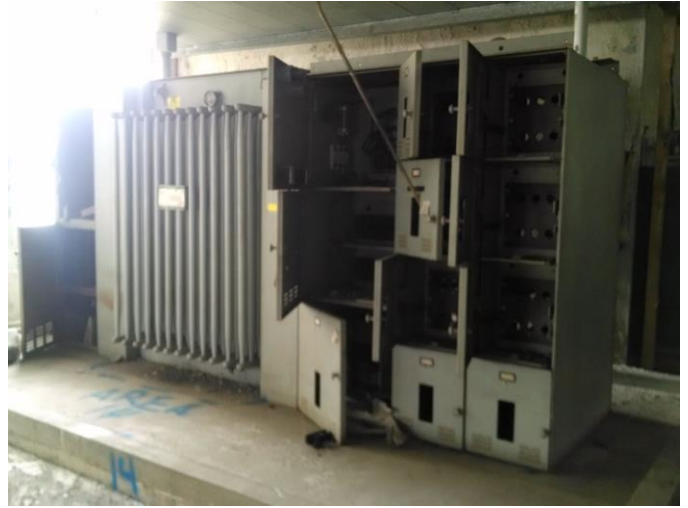
**Photo 16: Large Transformer: Black Box Electrical**

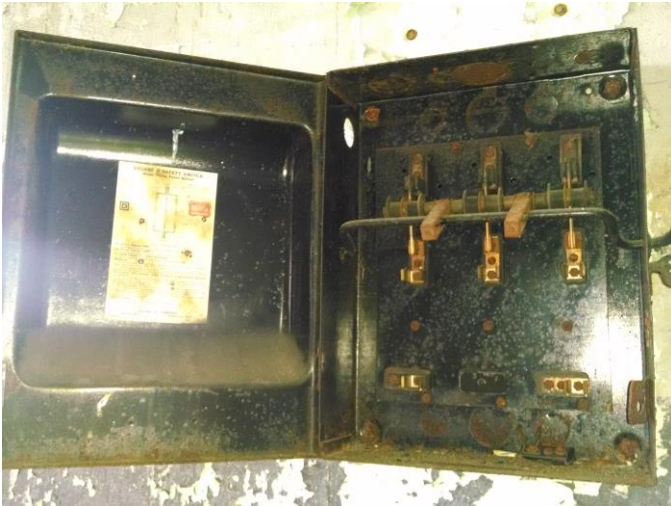
**Photo 14: Square D: Small Black Isolators**

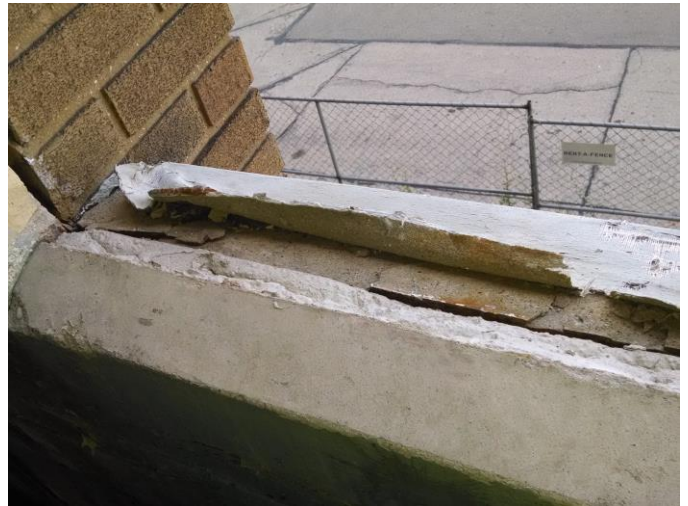
**Photo 17: Gray Fiberglass Window Sill Wrap (south building)**

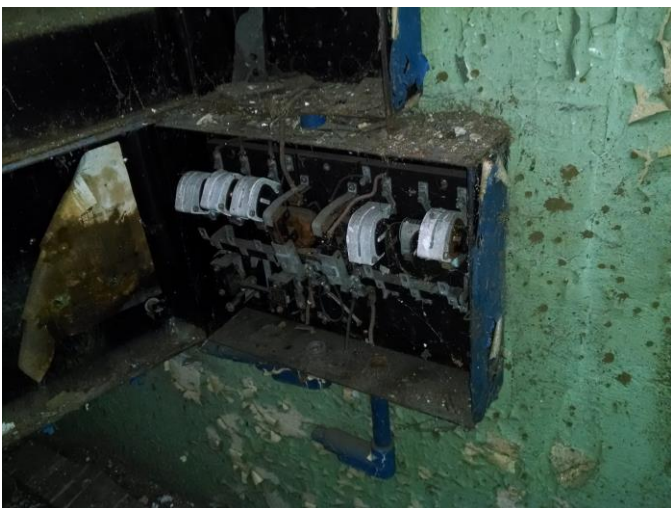
**Photo 15: Cutler Hammer: White Isolator**

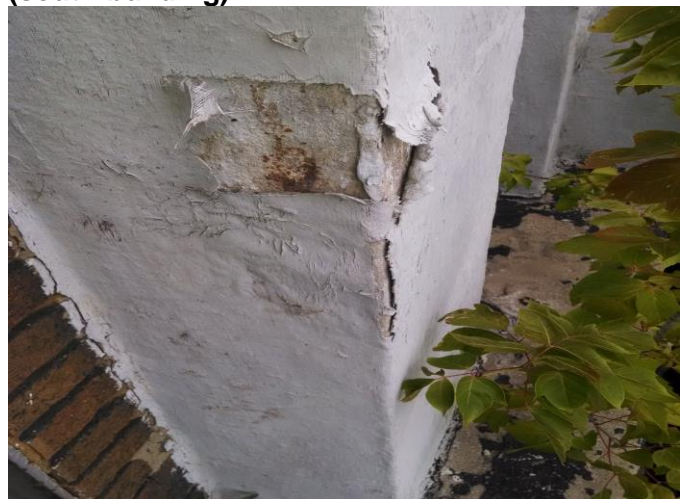
**Photo 18: Gray Fiberglass Window Sill Wrap (north building, tower)**

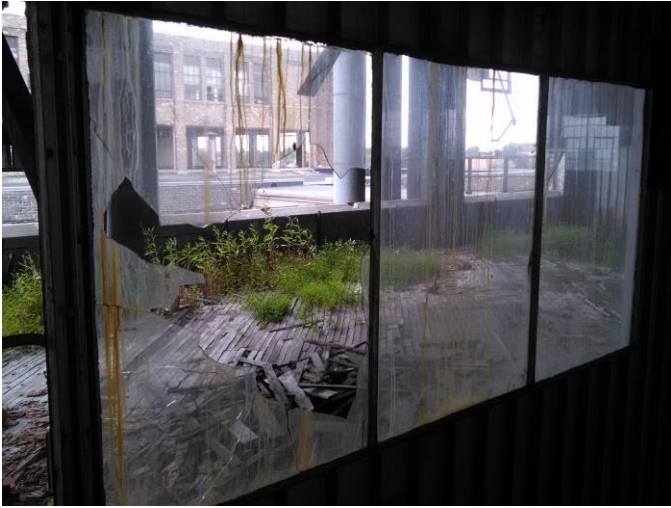
**Photo 19: Black Window Glazing**

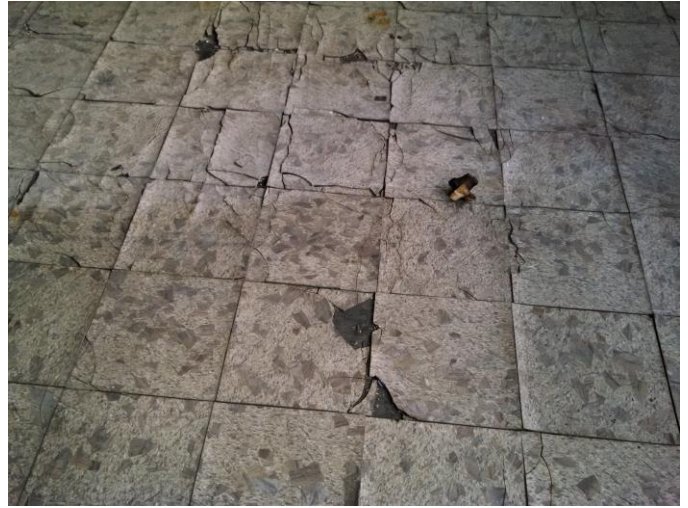
**Photo 22: 12" Tan Floor Tile**

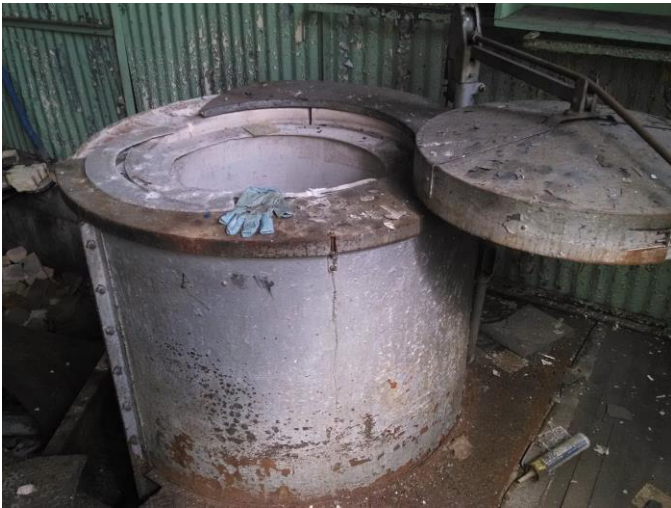
**Photo 20: Kiln Gasket**

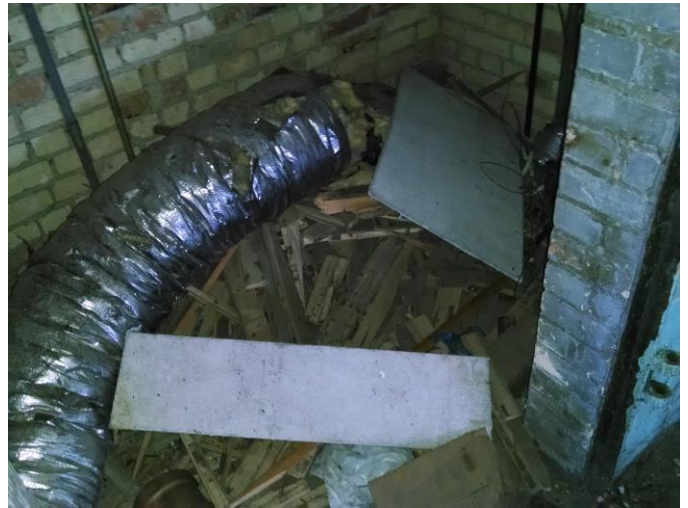
**Photo 23: White Ceiling Board / White Panel**

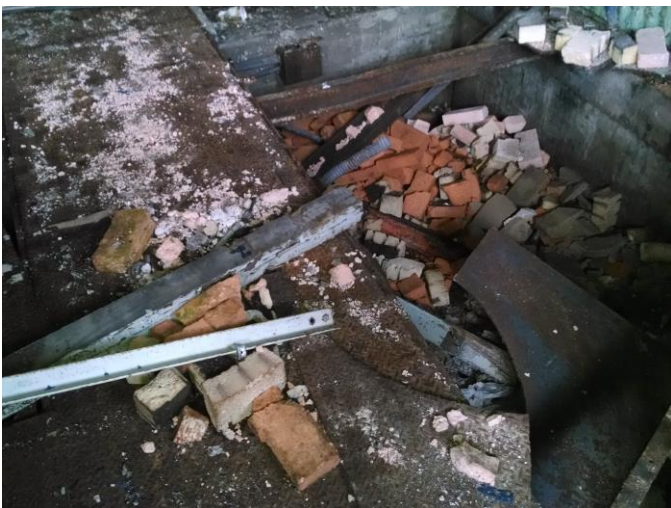
**Photo 21: Red Brick Debris**

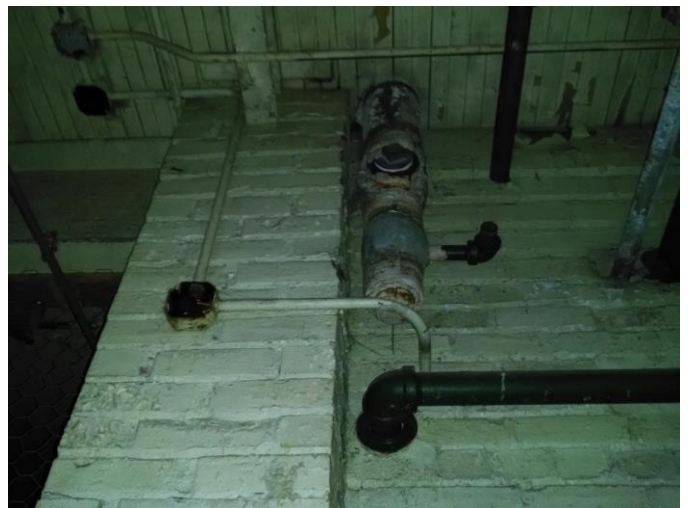
**Photo 24: Pipe Insulation & Pipe Fittings (representative)**

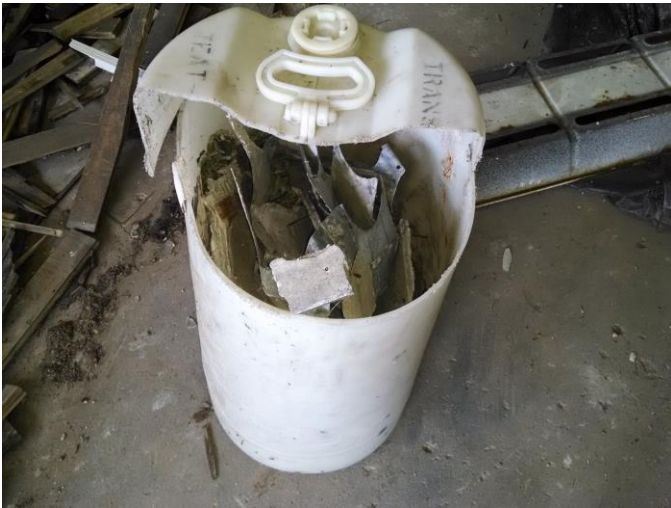
**Photo 25: Transite Debris**

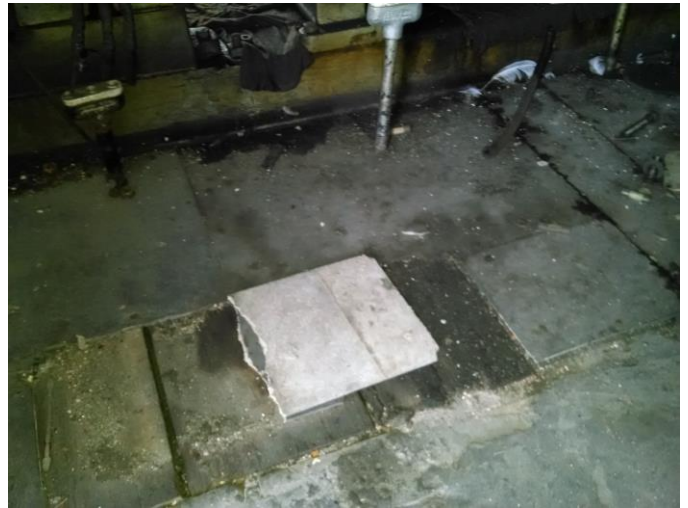
**Photo 28: Elevator Transite (representative)**

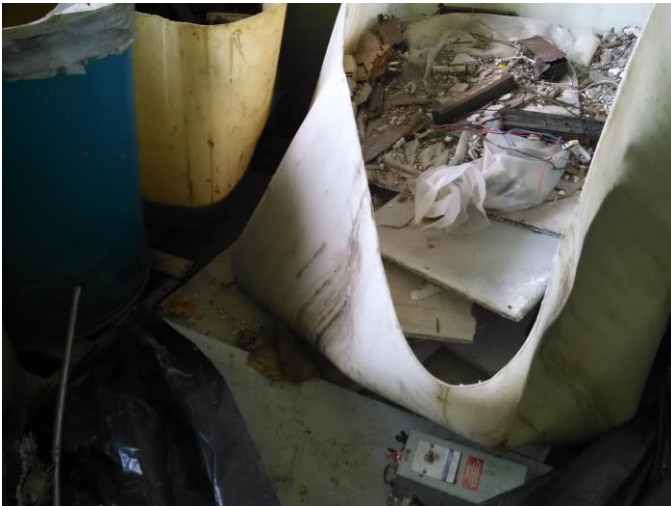
**Photo 26: Transite Debris**

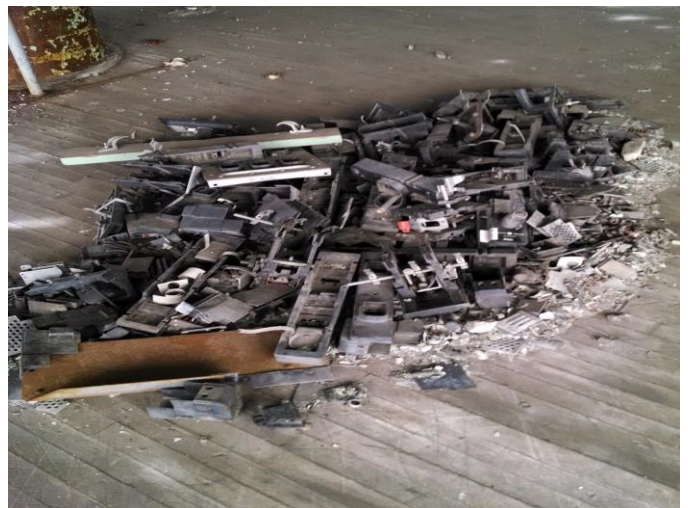
**Photo 30: Electrical Isolators (debris pile)**
