**GROUNDWATER INJECTION SUMMARY**

Re: Groundwater Injection Summary  
Prestige One Hour Dry Cleaners  
4419 W. Fond du Lac Avenue, WI  
BRRTS# 02-41-548258

KPRG Project No. 24413

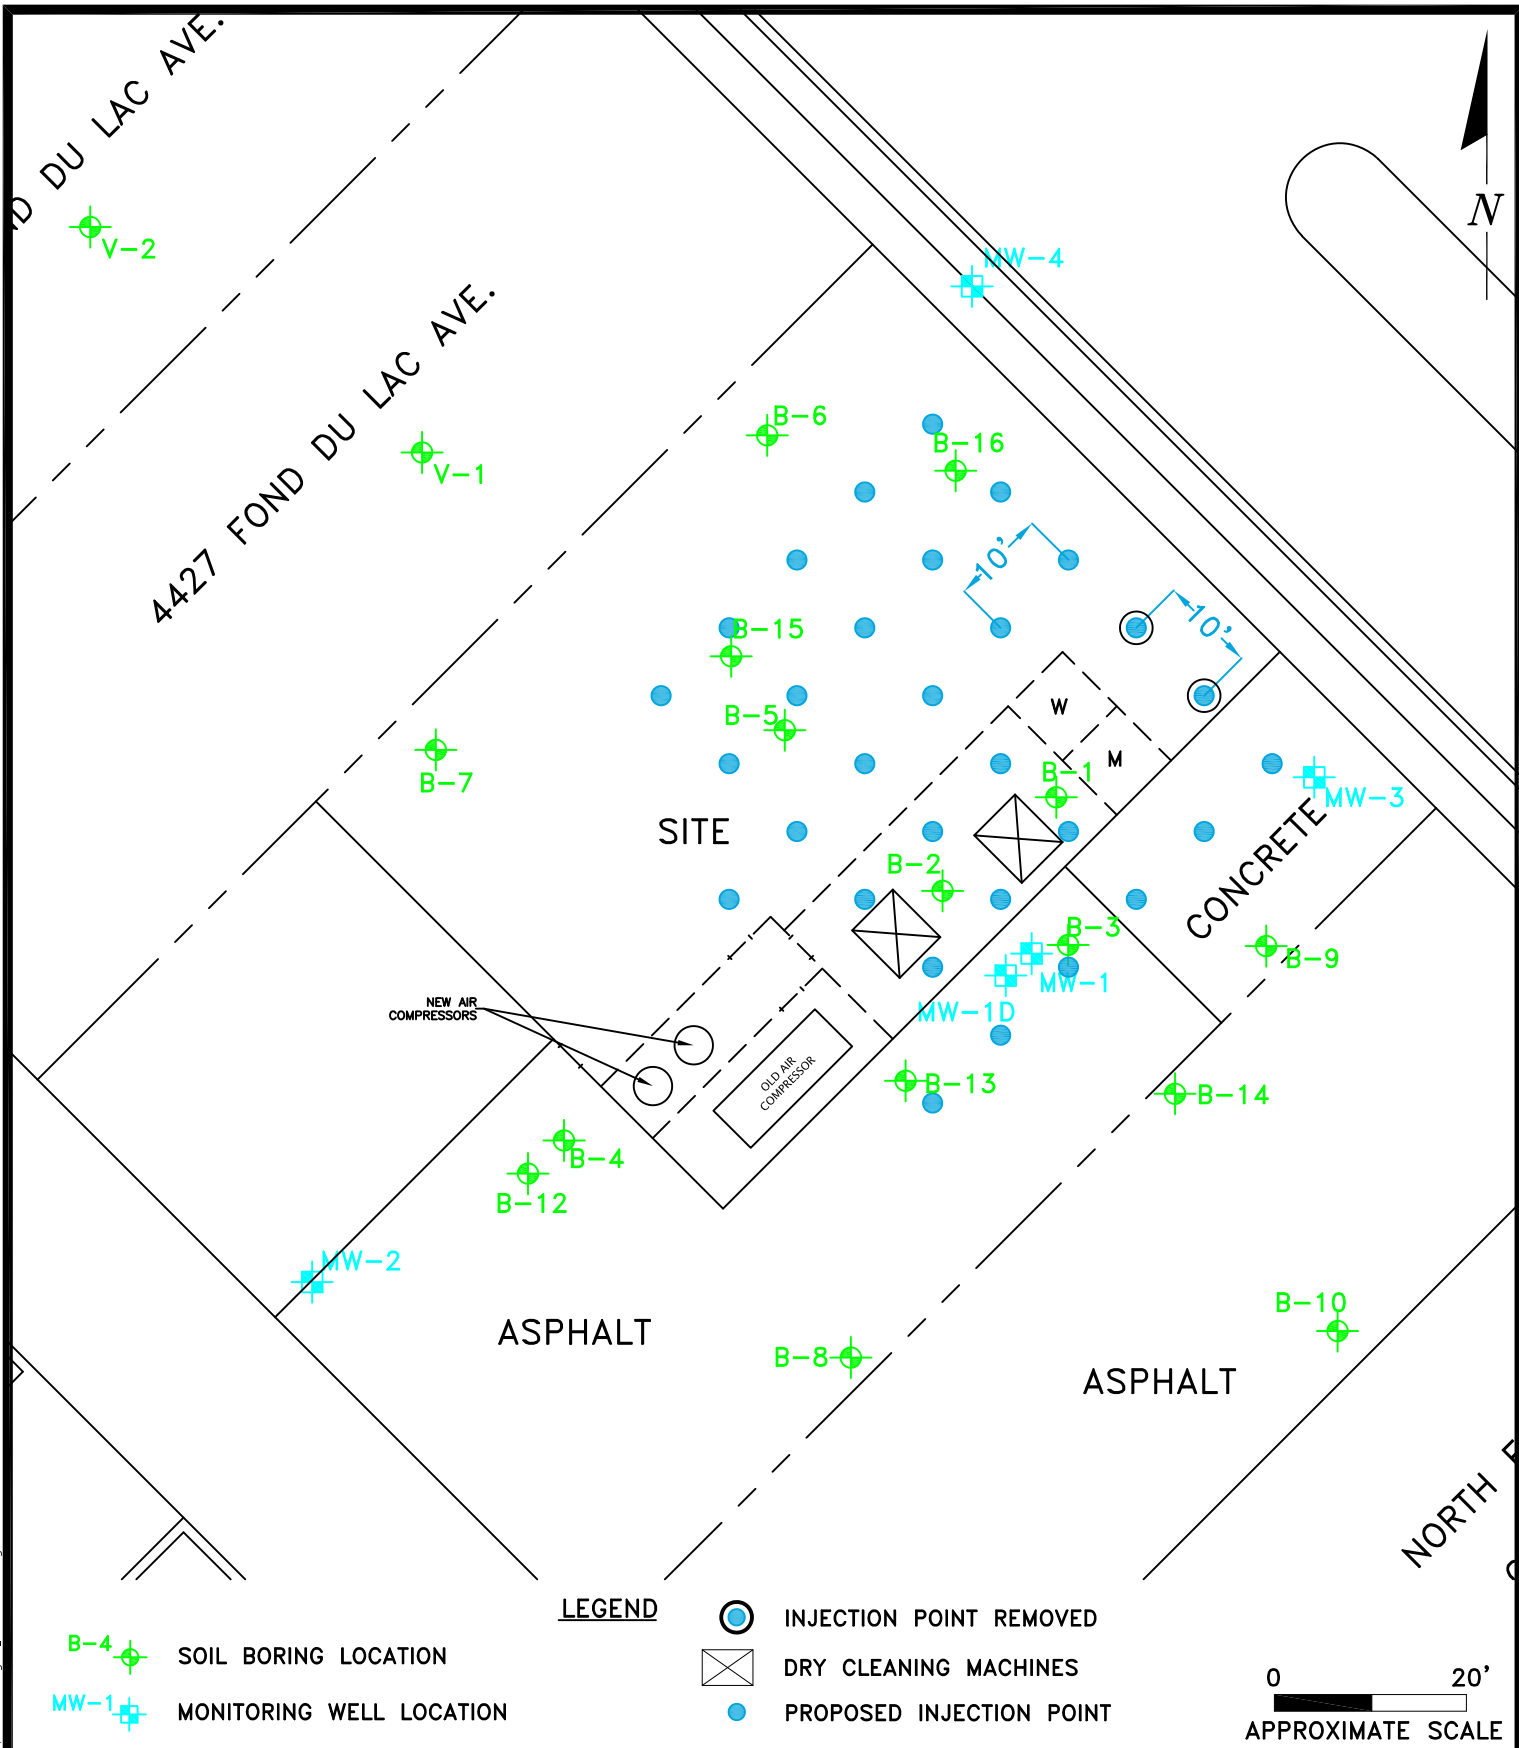
FIGURE 1

The remediation proposal proposed a total of 30 injection points, however only 28 injection points were performed. Two injection points were eliminated due to the location of underground utilities; these two points are identified on Figure 1. The injectate volume for the eliminated points was added to the adjacent injection points.
