**Technical Assistance, Environmental Liability
Clarification or Post-Closure Modification Request**

This request was developed using information previously provided to the WDNR in Ramboll's February 23, 2022, *NR 716 Site Investigation Report* (the "2022 SIR") and other pertinent information found through a review of the Wisconsin WDNR Bureau for Remediation and Redevelopment Tracking System (BRRTS) on the Web (BOTW) database for this site.

HISTORICAL SITE FEATURES AND POST-2004 PCB IMPACTS

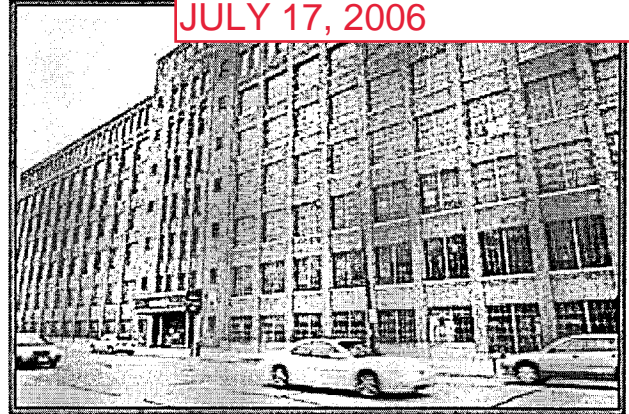
The nearly 1-million-square-foot Mirro building off of Washington Street in Manitowoc has fallen into disrepair. The building's new owners have been ordered to make some changes or risk citations.
Sue Pischke/Gannett Wisconsin Newspapers

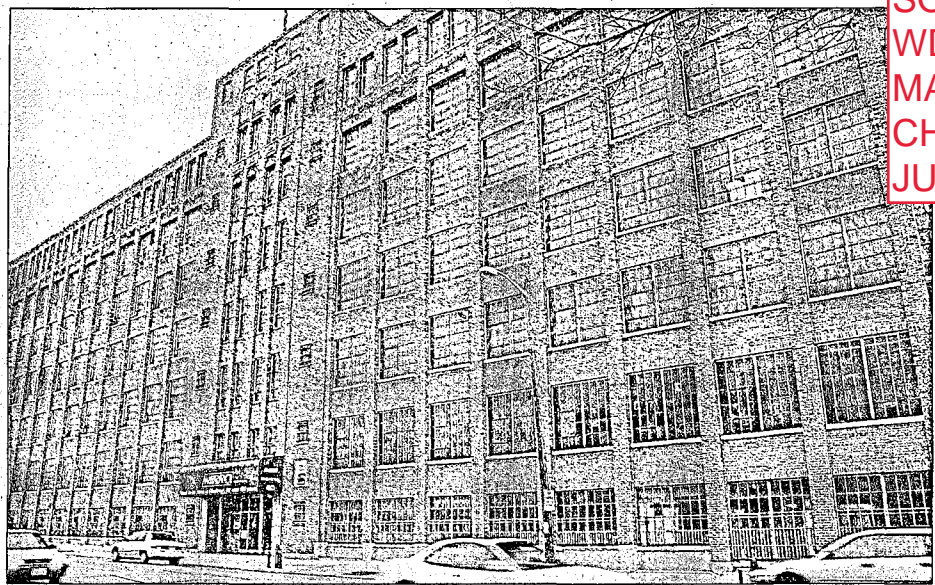
The nearly 1-million-square-foot Mirro building off of Washington Street in Manitowoc has fallen into disrepair. The building's new owners have been ordered to make some changes or risk citations. Photos by Sue Pischke/Gannett Wisconsin Newspapers

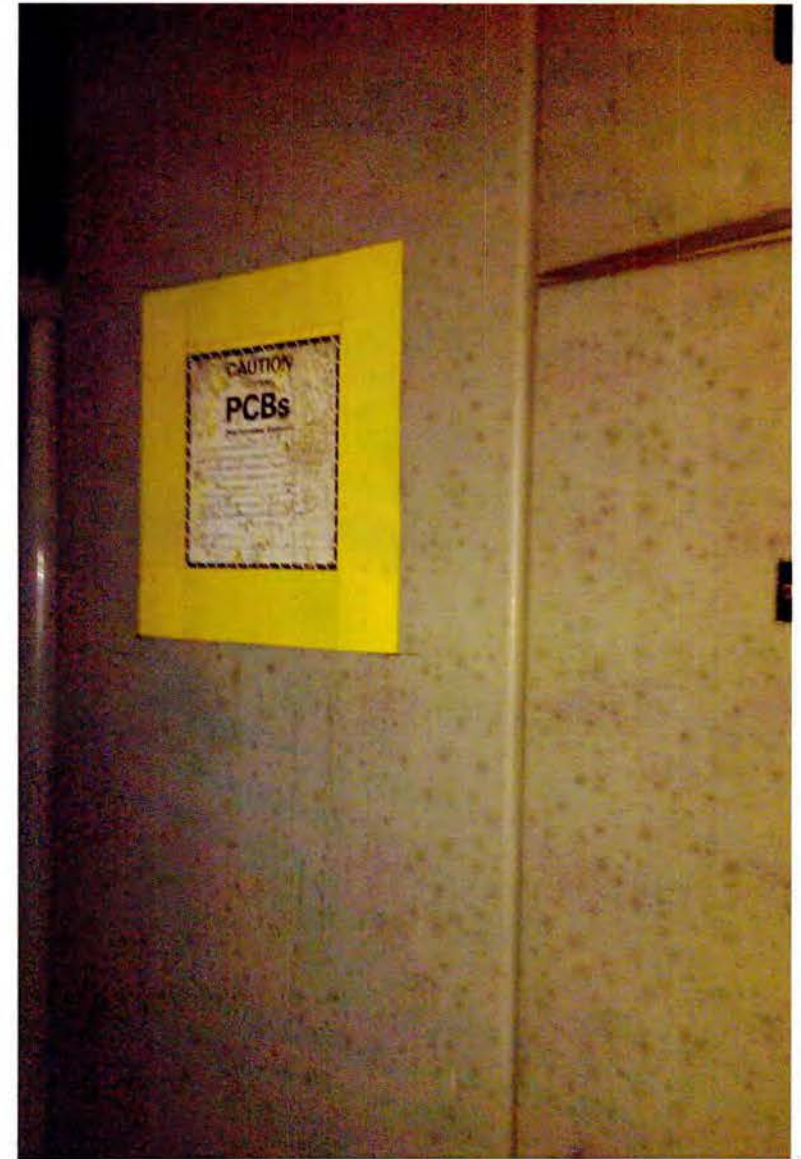
Photos by Mike Burghen AES
Oct 20, 2010
1st floor PCB area

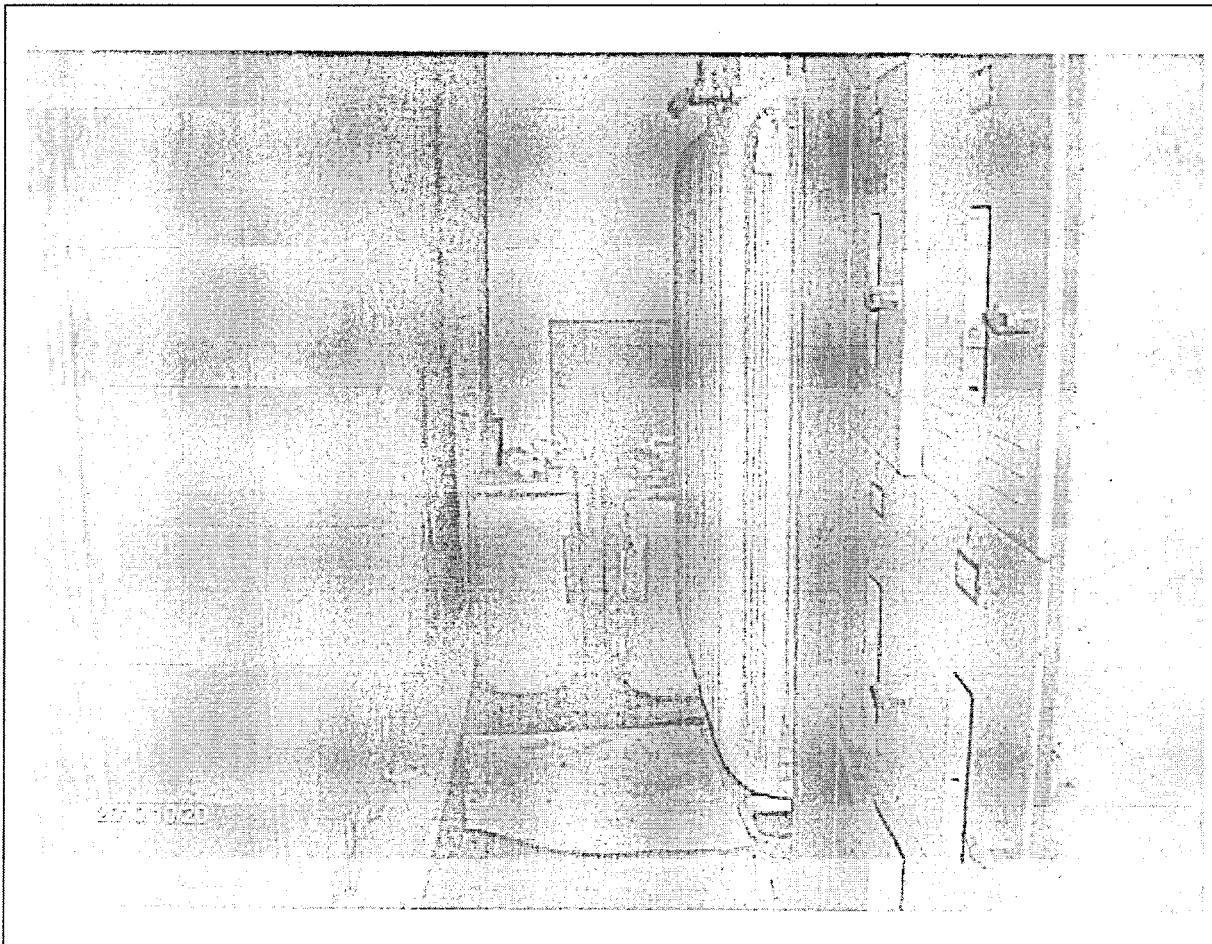
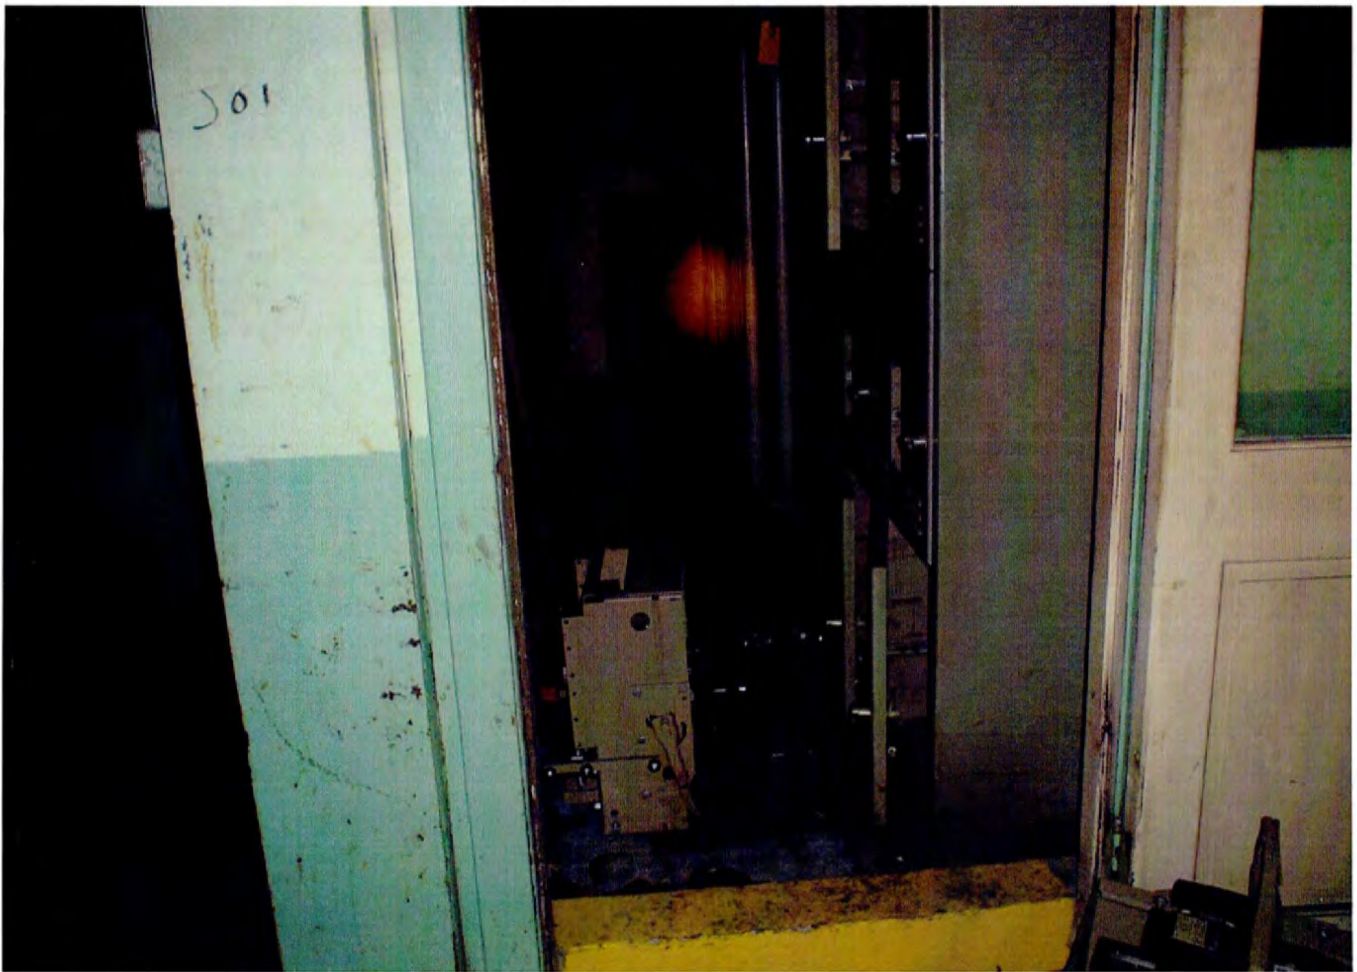
See the attached photo from 2006
And compare to the one below from 2010. It sure looks like the same area.
The drums were not there in 2006.
Annette~

Mar 2006 no drums in the location

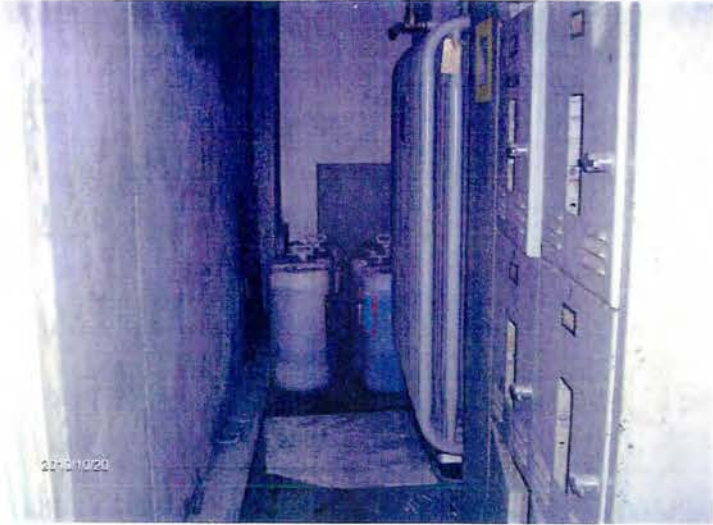
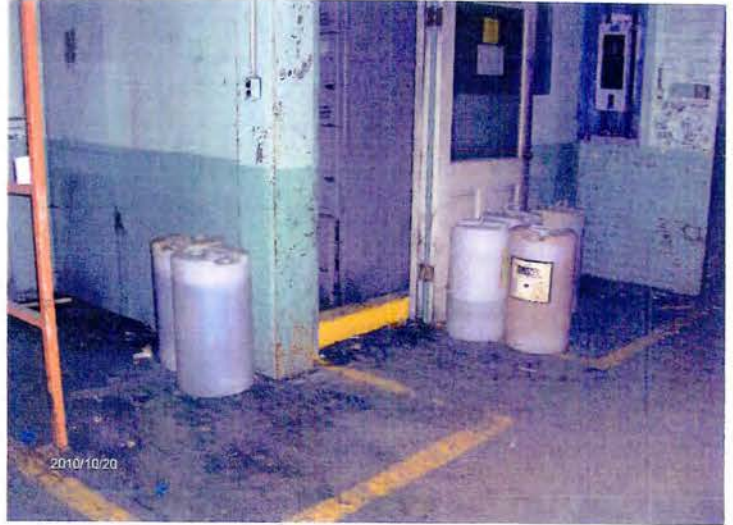
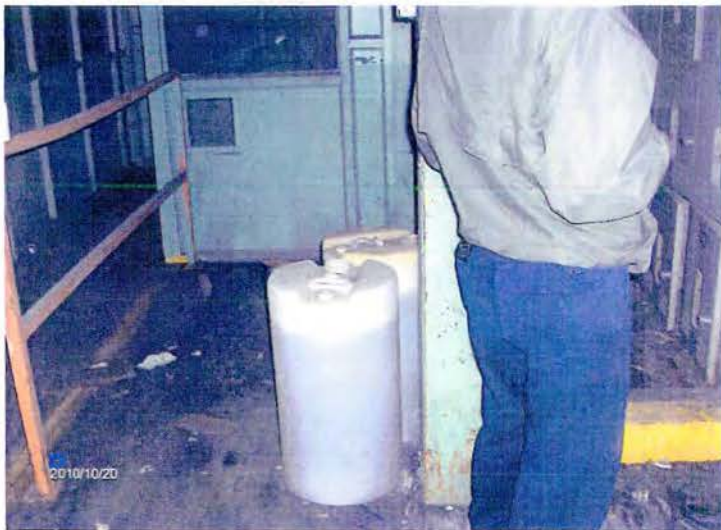
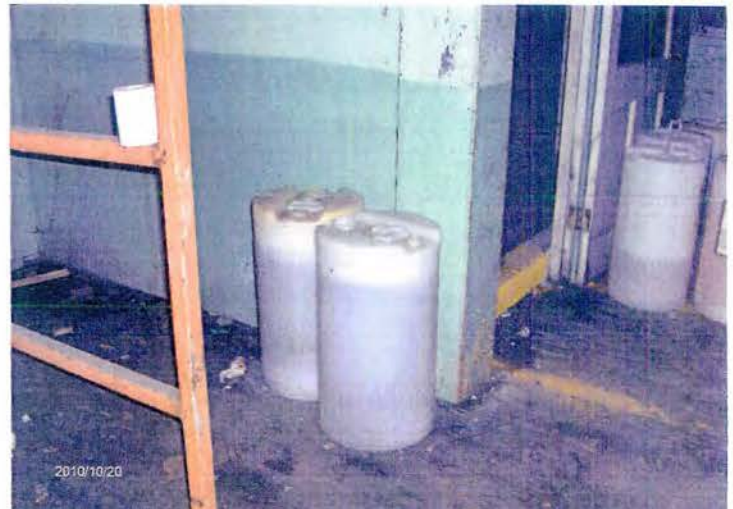
Mirro-Spirtas, 1512 Washington Street, Manitowoc, photos by David Less, City of Manitowoc
PDF #1 views of drums on first floor

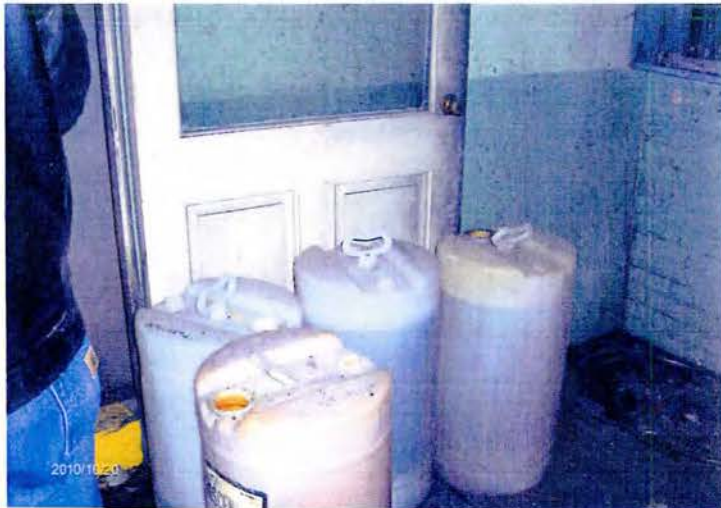
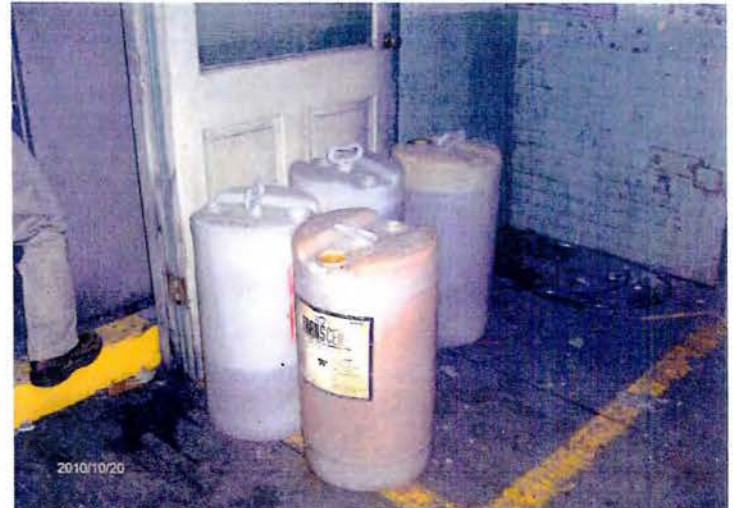
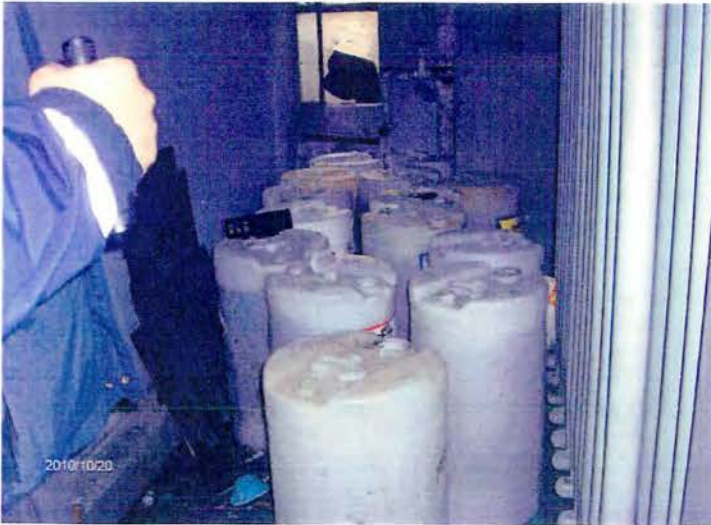
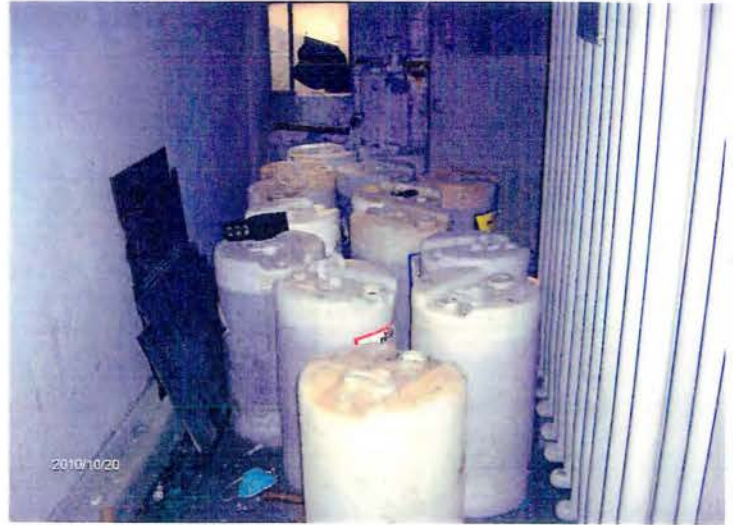
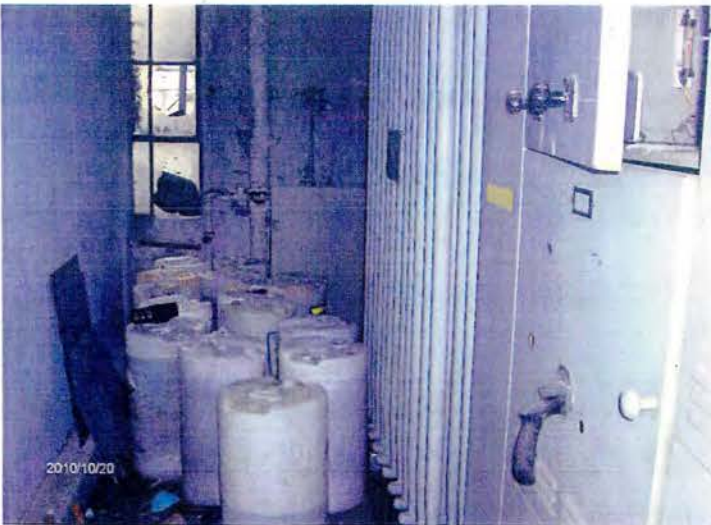
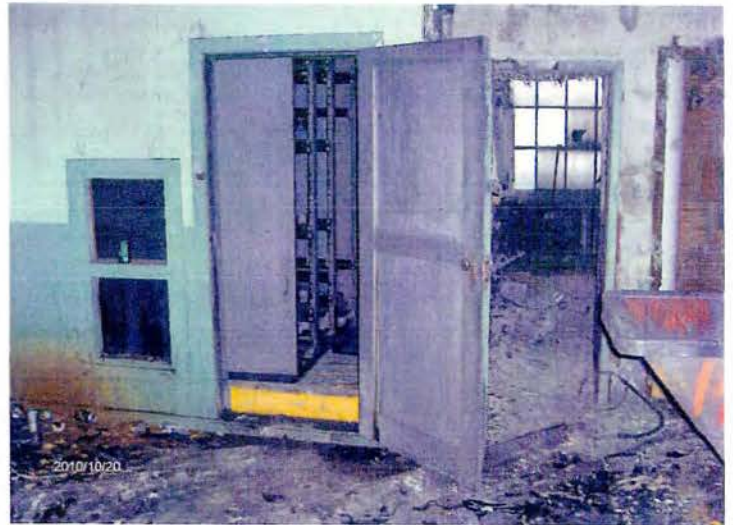
Mirro-Spirtas, 1512 Washington Street, Manitowoc, photos by David Less, City of Manitowoc
PDF #2 views of drums on second floor

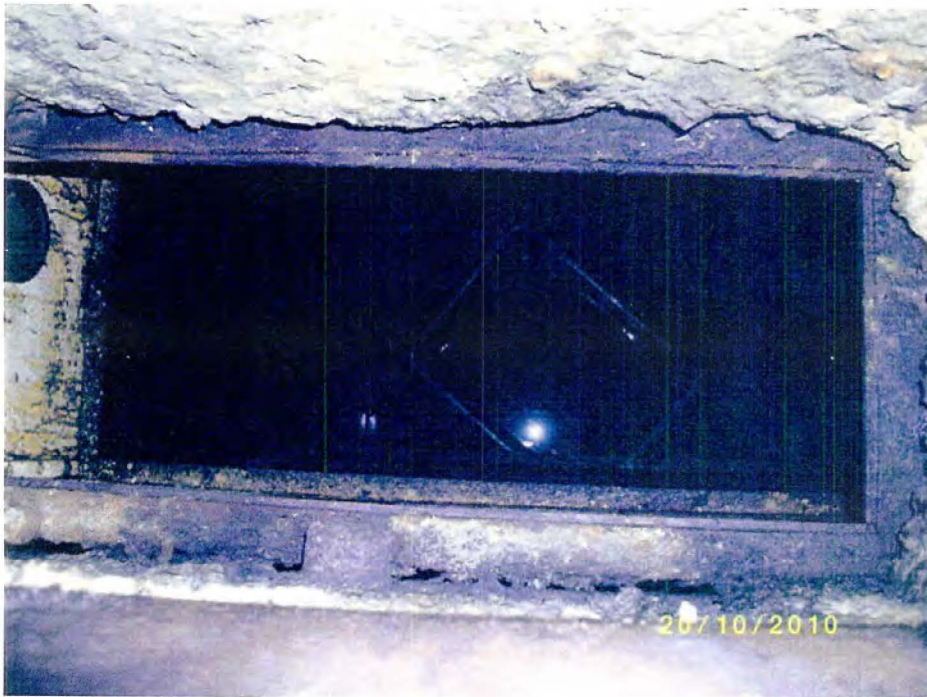
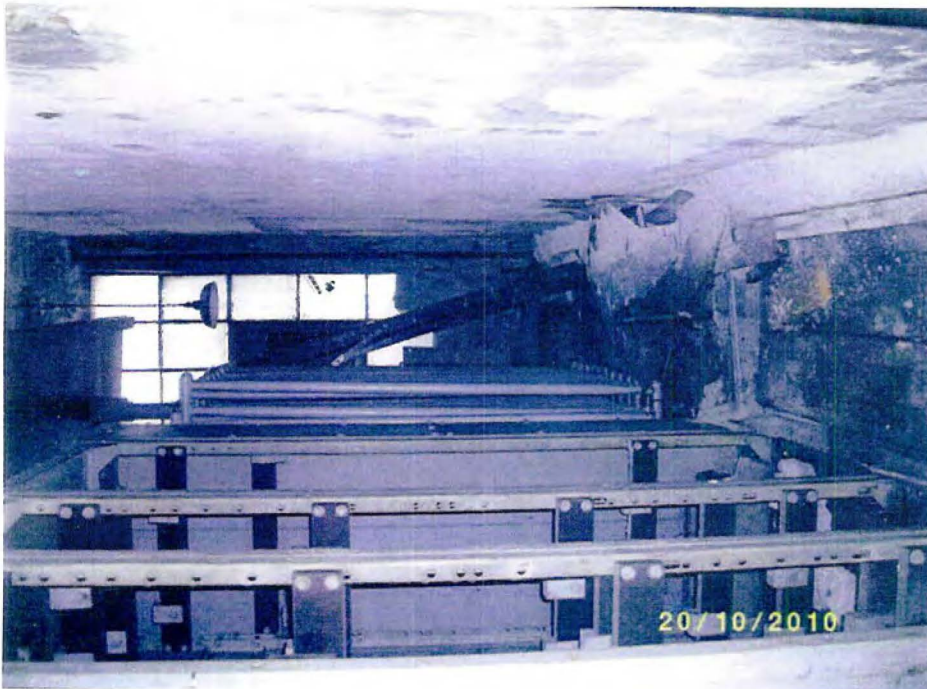
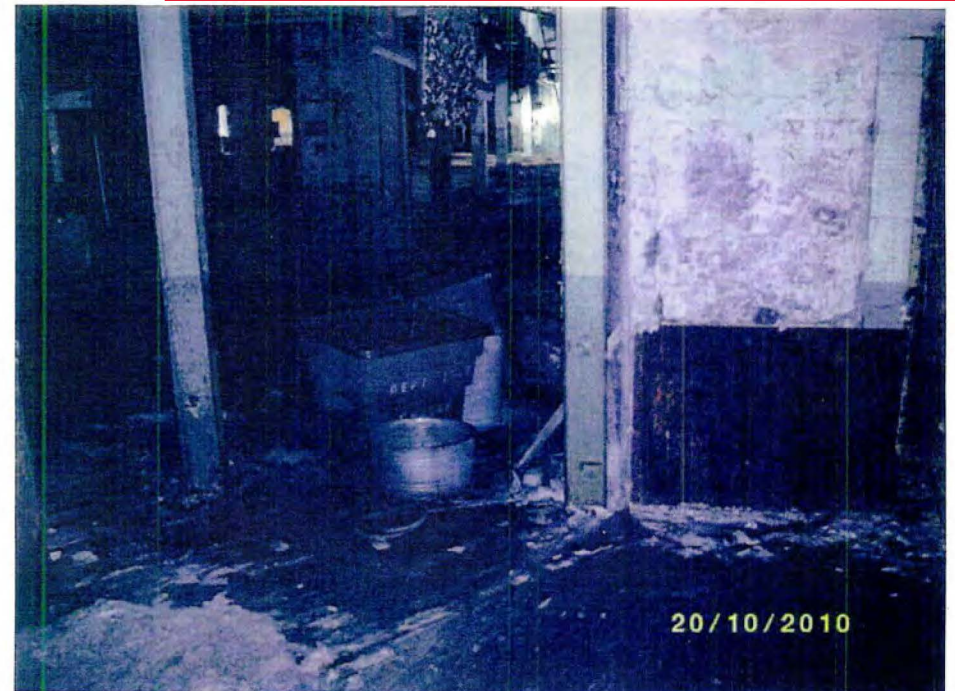
Mirro-Spirtas, 1512 Washington Street, Manitowoc,
photos by David Less, City of Manitowoc
PDF #3 views of floor drain on first floor

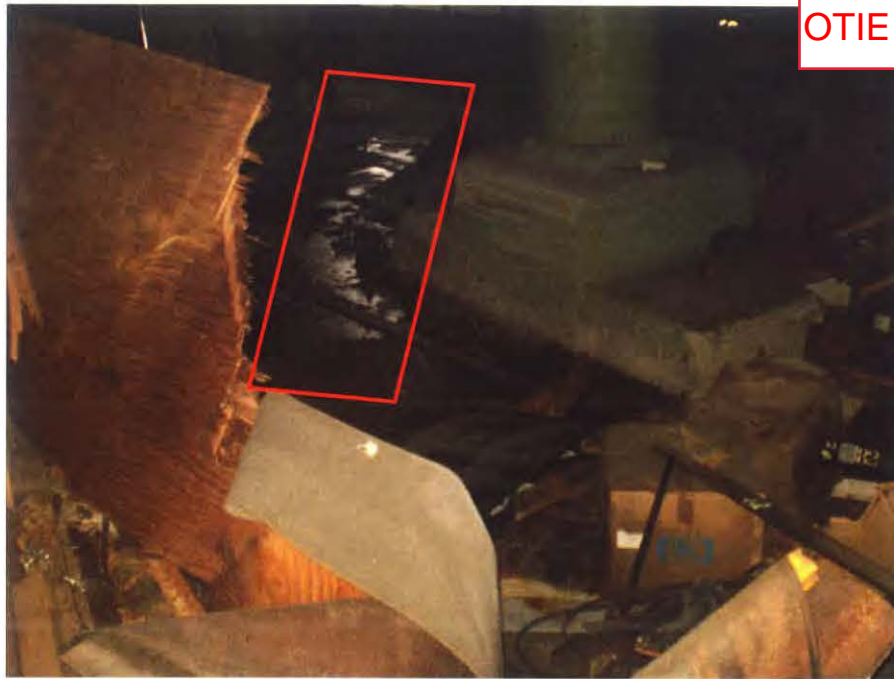
Photograph No.: 1 **Photographer:** Caitlin Ruza **Area:** Bldg K-Loading Dock
TDD Number: TO-05-10-12-0002 **Contract:** EP-S5-10-10, OTIE **Date:** January 24, 2011
Site Name & Location: Mirro-Spirtas Site, Manitowoc, Manitowoc County, Wisconsin
Photograph Subject: Dumped material and oil sheen leading to the drain inside the loading dock in Building K

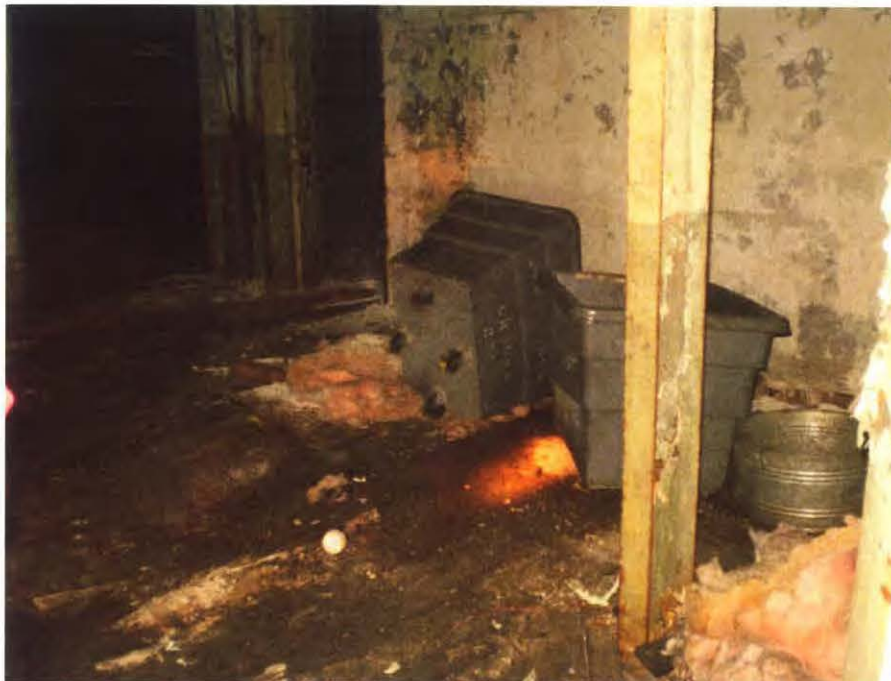
Photograph No.: 2 **Photographer:** Caitlin Ruza **Area:** Bldg K-Loading Dock
TDD Number: TO-05-10-12-0002 **Contract:** EP-S5-10-10, OTIE **Date:** January 24, 2011
Site Name & Location: Mirro-Spirtas Site, Manitowoc, Manitowoc County, Wisconsin
Photograph Subject: Two wheeled bins in the loading dock area of Building K. One bin is tipped over and one contains the contents which has been drained from the transformer on the second floor above

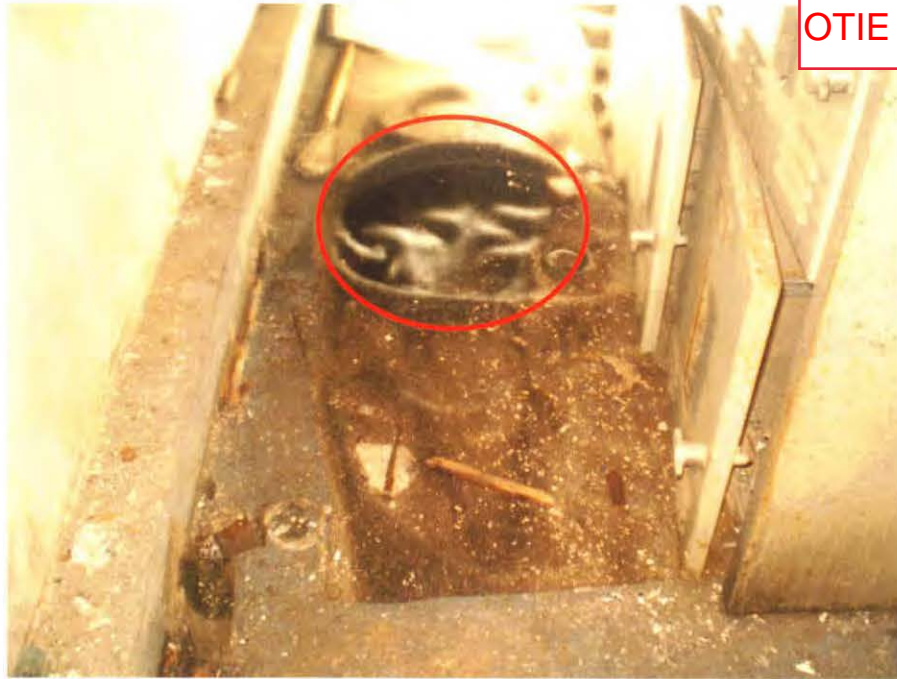
Photograph No.: 11 **Photographer:** Caitlin Ruza **Area:** Bldg I-Transformer
TDD Number: TO-05-10-12-0002 **Contract:** EP-S5-10-10, OTIE **Date:** January 24, 2011
Site Name & Location: Mirro-Spirtas Site, Manitowoc, Manitowoc County, Wisconsin
Photograph Subject: MS-WP-6 collected from puddle on plastic matting in the transformer room in Building I (approximate sample area shown)

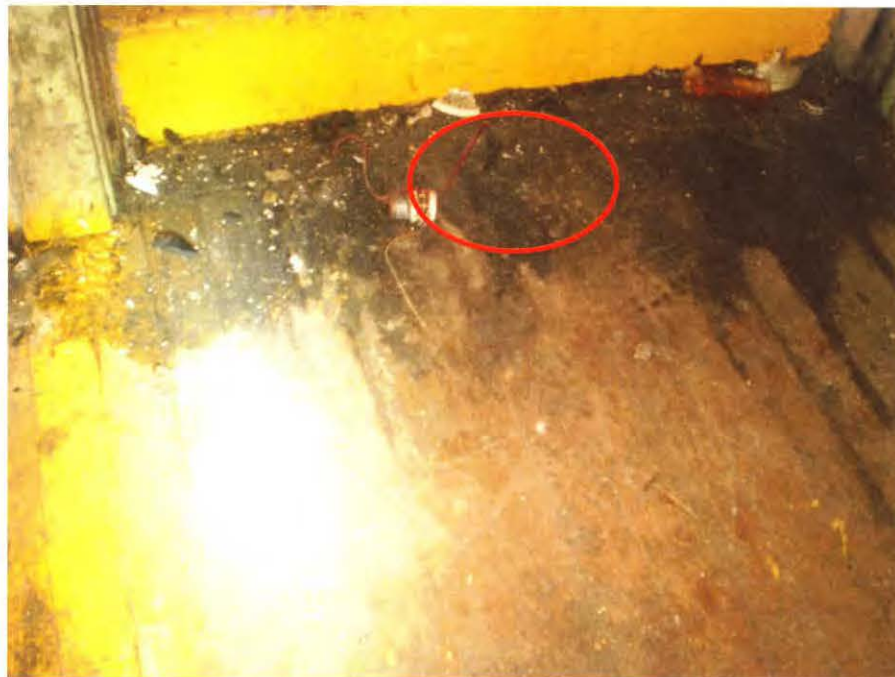
Photograph No.: 12 **Photographer:** Caitlin Ruza **Area:** Bldg I-Transformer
TDD Number: TO-05-10-12-0002 **Contract:** EP-S5-10-10, OTIE **Date:** January 24, 2011
Site Name & Location: Mirro-Spirtas Site, Manitowoc, Manitowoc County, Wisconsin
Photograph Subject: MS-WP-7 collected from stained area outside of entranceway to the transformer room in Building I (approximate sample area shown)

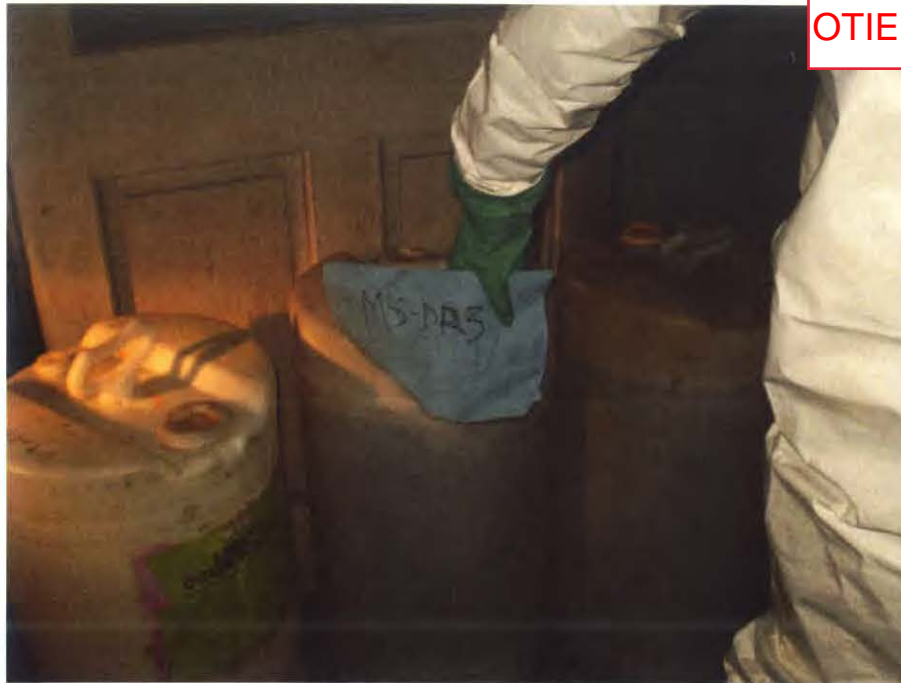
Photograph No.: 13 **Photographer:** Caitlin Ruza **Area:** Bldg I-Transformer
TDD Number: TO-05-10-12-0002 **Contract:** EP-S5-10-10, OTIE **Date:** January 24, 2011
Site Name & Location: Mirro-Spirtas Site, Manitowoc, Manitowoc County, Wisconsin
Photograph Subject: MS-DR-3 was collected from the middle drum of three drums located to the right of the entranceway of the room containing the transformer in Building I

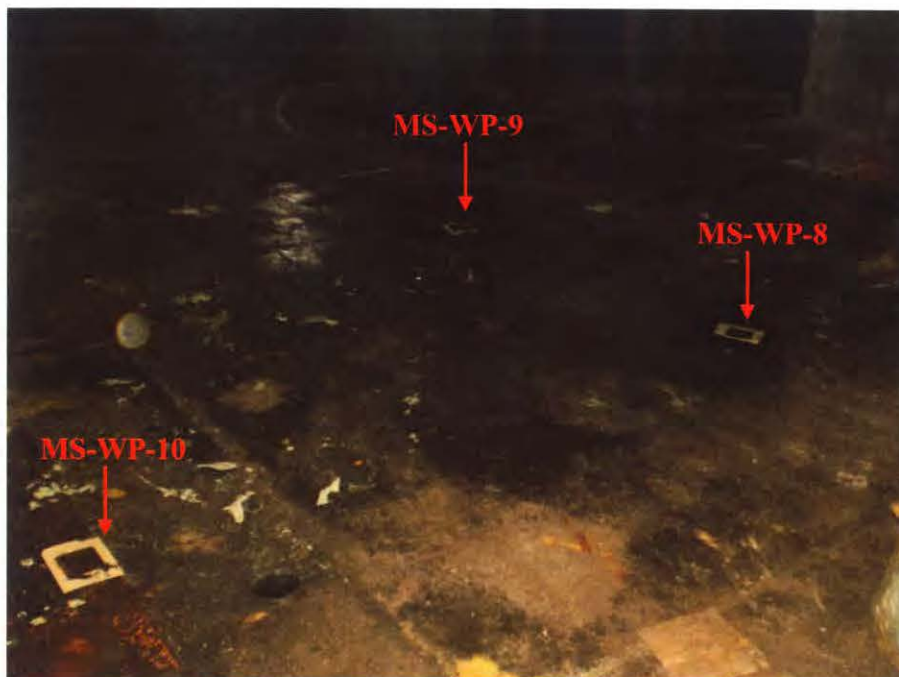
Photograph No.: 14 **Photographer:** Caitlin Ruza **Area:** Bldg K-Loading Dock
TDD Number: TO-05-10-12-0002 **Contract:** EP-S5-10-10, OTIE **Date:** January 24, 2011
Site Name & Location: Mirro-Spirtas Site, Manitowoc, Manitowoc County, Wisconsin
Photograph Subject: MS-WP-8 was taken directly in front of the bins in the loading dock in Building K. MS-WP-9 was taken adjacent to MS-WP-8. MS-WP-10 was taken in front of Door #7 of the loading dock in Building K (template areas shown)

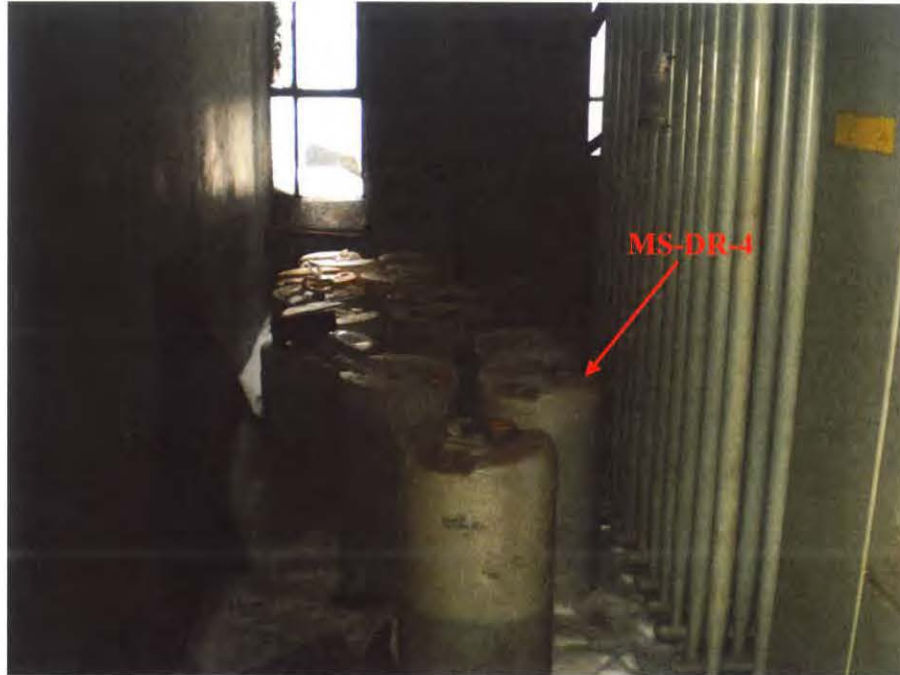
Photograph No.: 17 **Photographer:** Caitlin Ruza **Area:** Building K-Transformer
TDD Number: TO-05-10-12-0002 **Contract:** EP-S5-10-10, OTIE **Date:** January 24, 2011
Site Name & Location: Mirro-Spirtas Site, Manitowoc, Manitowoc County, Wisconsin
Photograph Subject: MS-DR-4 was collected from the second drum back from the front of the photo on the right.
These 14 drums are located inside the transformer room in Building K

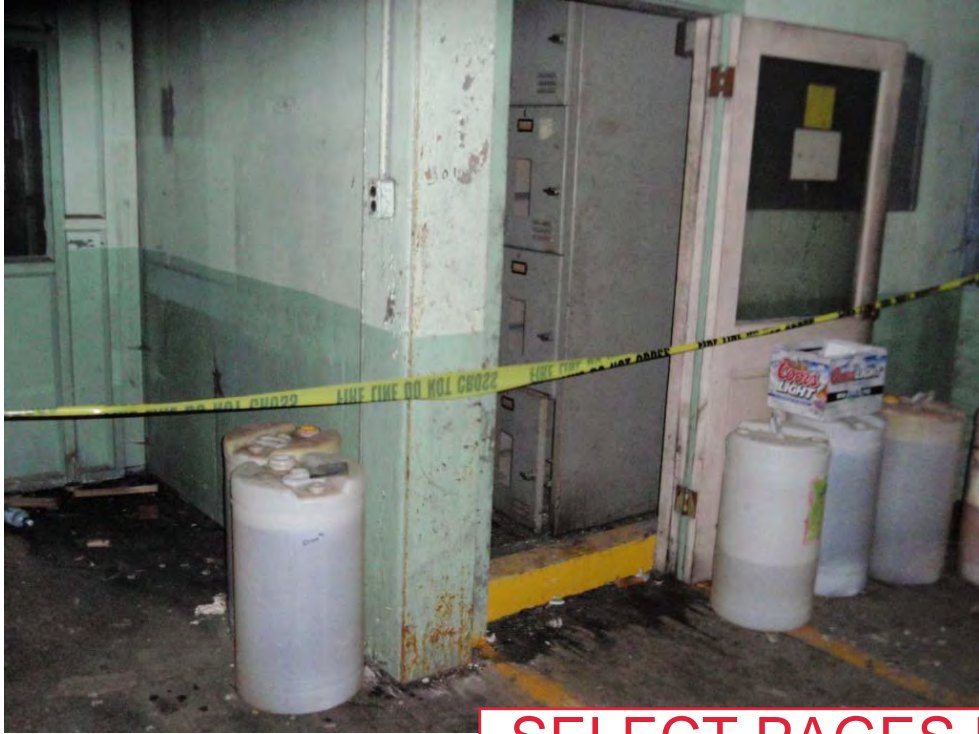
First floor transformer drum area. Drum No. 1 located in the lower left of photo was sampled for PCBs.

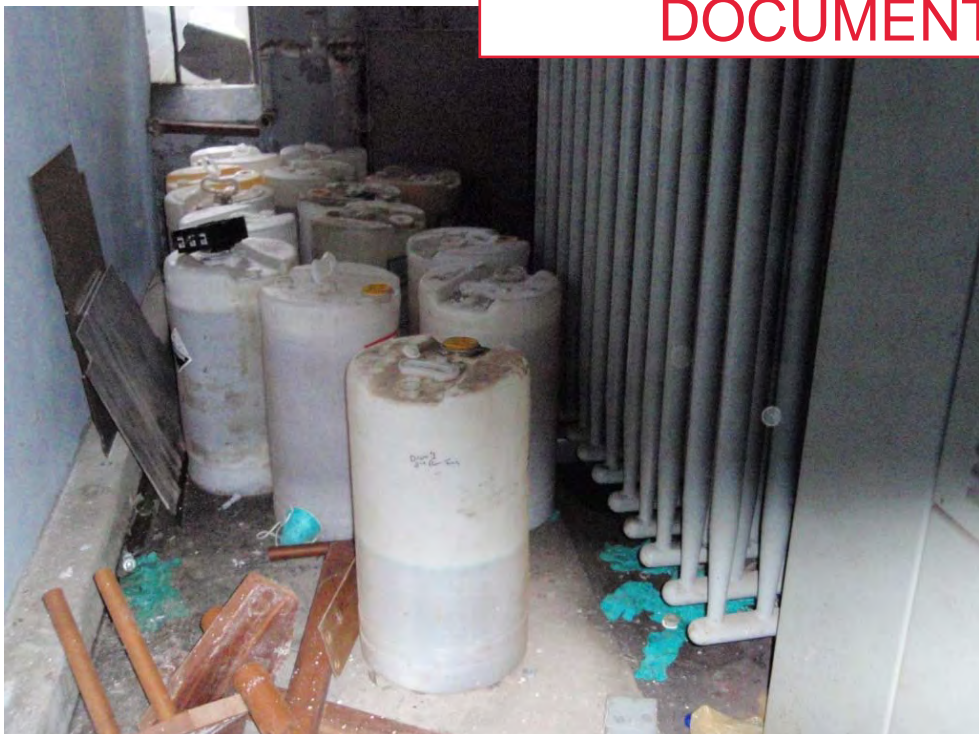
Photo No. 12	Date: 10-29-10
------------------------	--------------------------

Second floor transformer drum area. Drum No. 1 located in foreground was sampled for PCBs.
