BRRTS ID No. 02-28-549758

Review Date: 08/09/2023

Site Name: Hwy 26 Coin Laundry & Drycleaning

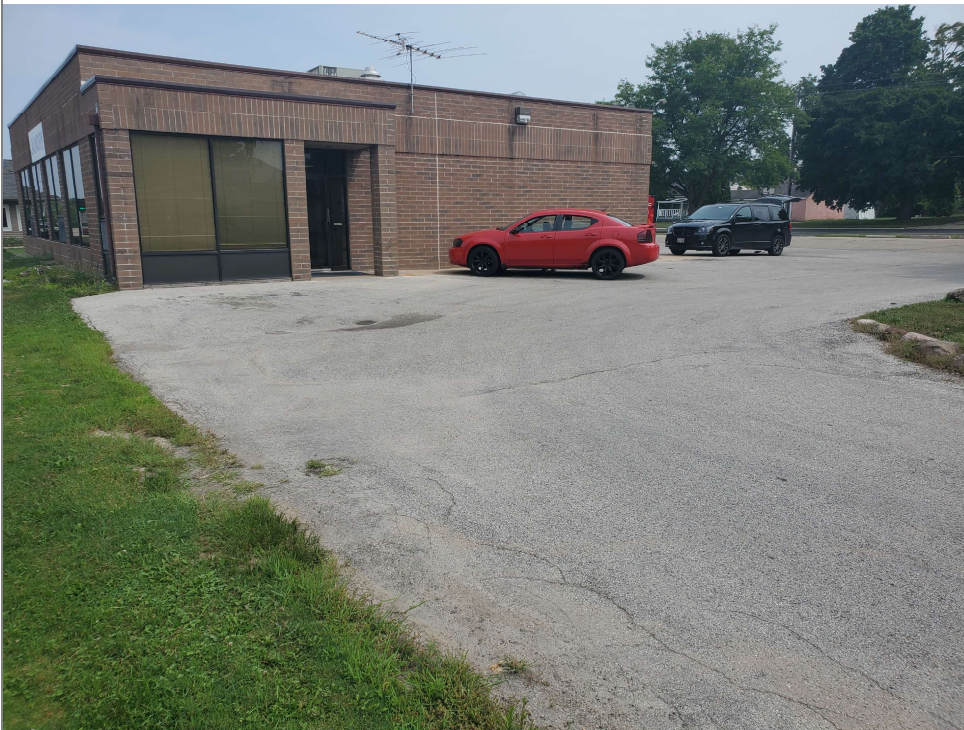
Title: looking northeast. The building and sidewalk (together, the cap) are still in good condition.

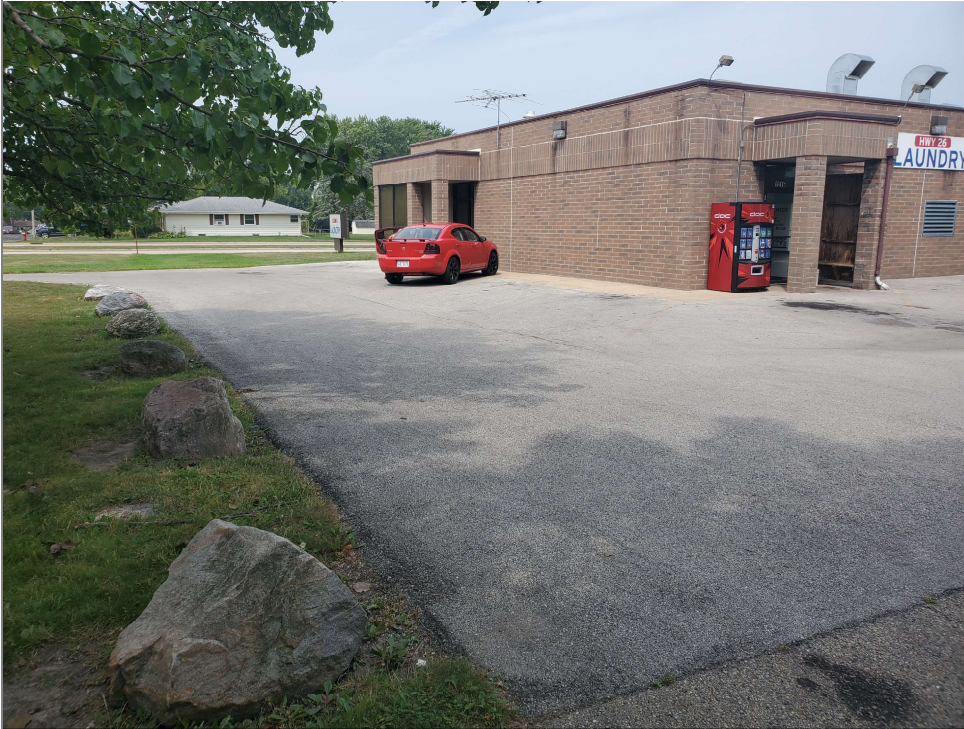
Portions of the parking area have been resurfaced but the asphalt is outside of the required cap, which is the building and the sidewalk.

Title: looking northwest at building and sidewalk. The junction of old and new pavement (which is not part of the cap) are visible in the foreground.
