Re: **Data Transmittal**
 Clare Central Apartments
 1003 and 1033 West Atkinson Avenue
 Milwaukee, Wisconsin
 Terracon Project No. 58107058A
 WDNR BRRTS #02-41-549867
 VPLE BRRTS #06-41-560680

Data Transmittal

Clare Central Apartments ■ Milwaukee, Wisconsin
September 21, 2016 ■ Terracon Project No. 58107058A

Post Mitigation Report For Two Mitigation Systems

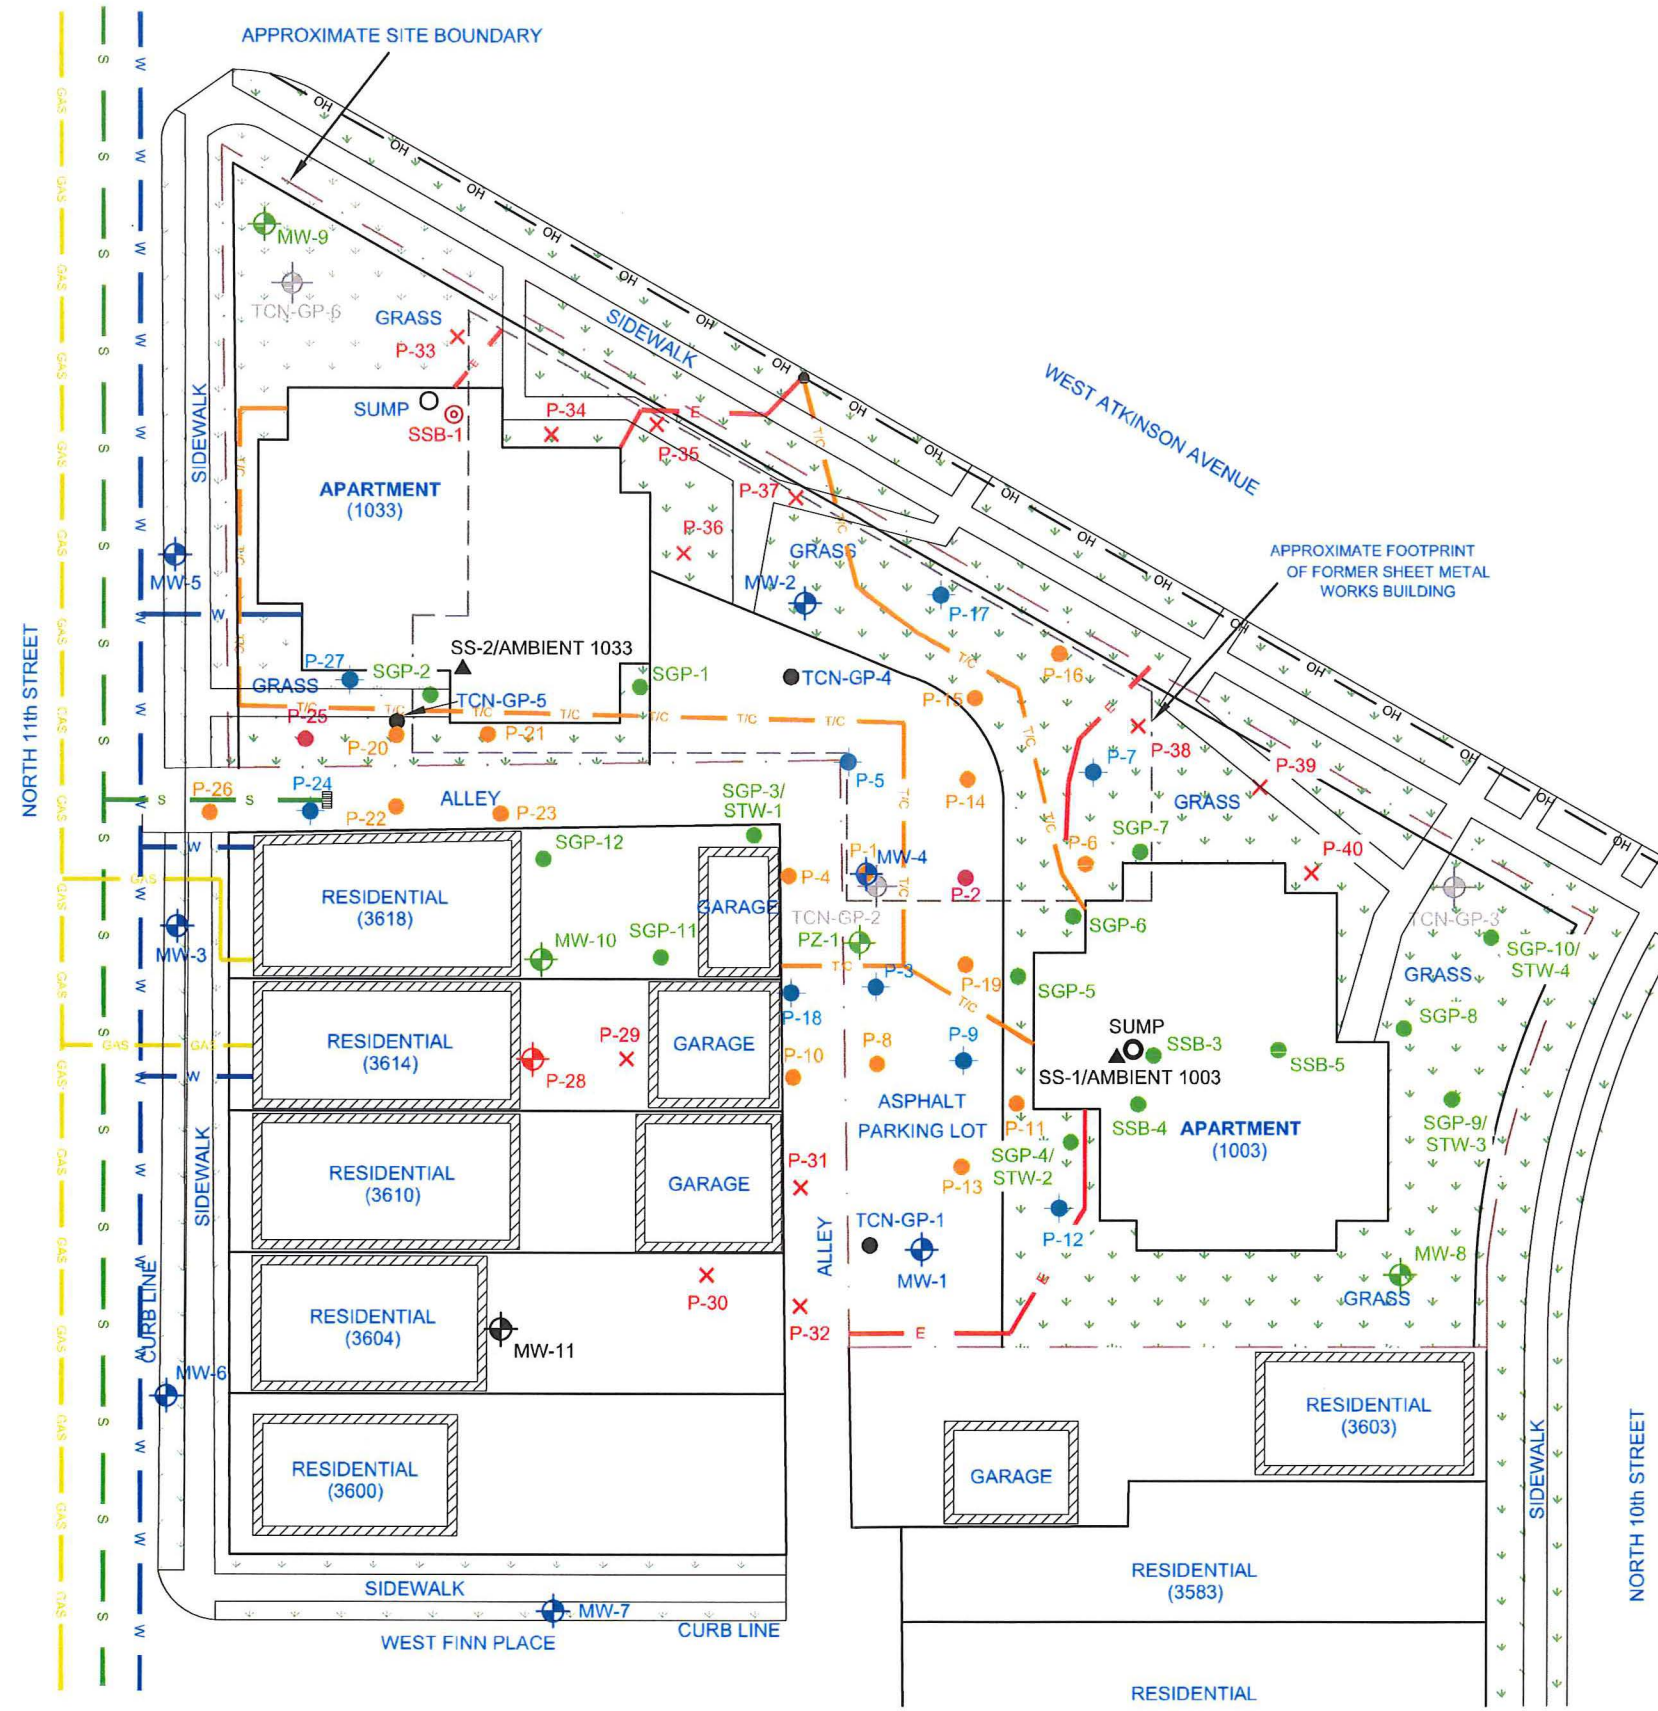
FIG. No.
1

On June 23, 2016, Terracon supervised the installation of soil borings P-28 and P-29 at 3614 North 11th Street, soil boring P-30 and groundwater monitoring well MW-11 on the 3604 North 11th Street property, soil borings P-31 and P-32 in the alley, and eight (8) soil borings (P-33 through P-40) on-site along West Atkinson Avenue. The locations are presented on the attached Site Diagram. A review of the analytical results indicate soil to groundwater residual contaminant level (RCL) exceedances in several

borings along Atkinson Avenue. Trichloroethane (TCE) was detected at concentrations above its soil to groundwater RCL in borings P-33, 34, 35, 36, 39, and 40; however, the detected concentrations are below the non-industrial, direct-contact RCL. The soil analytical results are below RCLs, and/or method detection limits in borings P-37 & P-38 (along Atkinson Avenue), P-31 & P-32 (in the alley), P-28 & P-29 (3614 North 11th Street property) and P-30 & MW-11 (3604 North 11th Street property). The soil analytical results are summarized on Table 1.

On June 23, 2016, Terracon supervised the installation of groundwater monitoring well MW-11 in the backyard of the 3604 North 11th Street property. Groundwater monitoring wells MW-10 and MW-11 were subsequently sampled, and the groundwater results from MW-10 (3618 North 11th Street property) indicate a Wisconsin Administrative Code, Chapter NR 140 Preventive Action Limit (PAL) exceedance for TCE, though the result was well below the NR 140 enforcement standard (ES). Groundwater from groundwater monitoring well MW-11 did not contain volatile organic compounds (VOCs) at concentrations above the method detection limits.
