Summary of Site Investigation Results/ Evaluation of Exposure Risk Pathways

Clare Central
1003 and 1031 West Atkinson Avenue
Milwaukee, Wisconsin

August 24, 2020

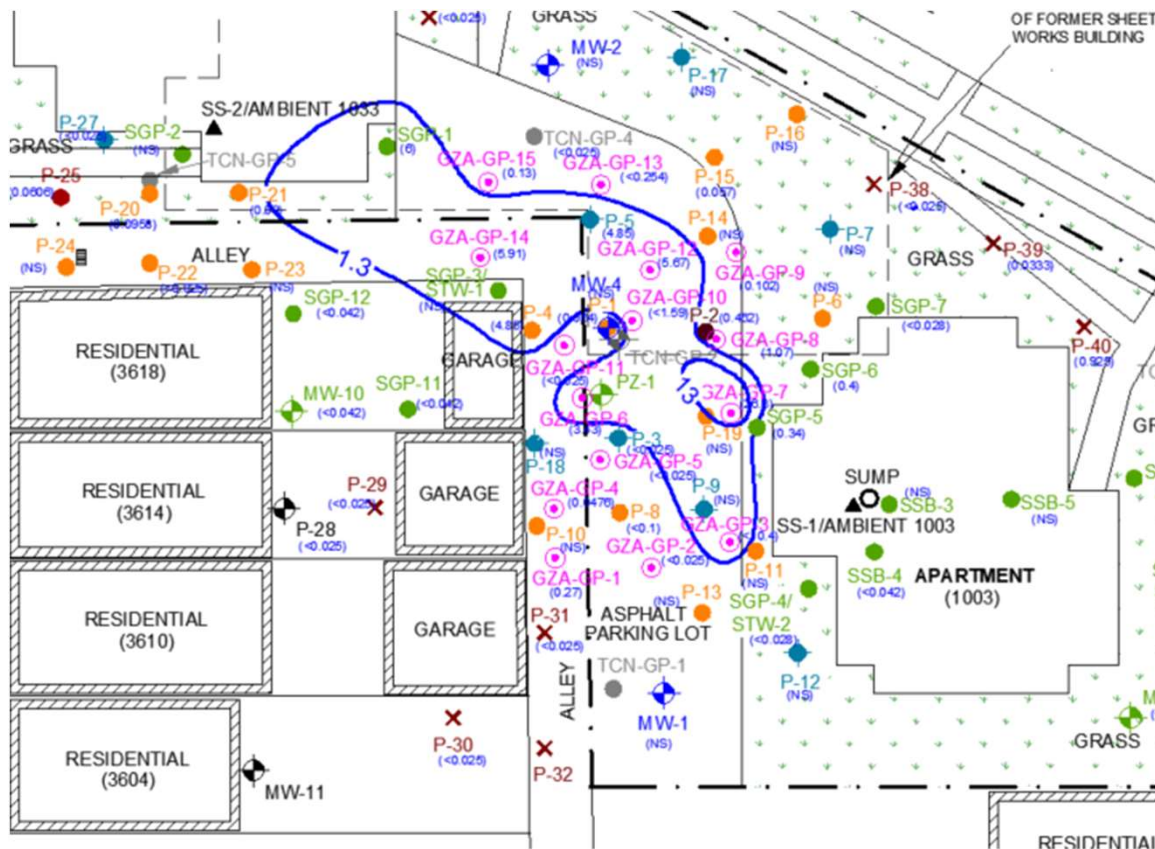
TCE Soil Distribution 0 to 4 Feet bgs

- Total TCE mass in soils to 8 feet bgs is approximately 104 lbs TCE
- Direct contact soil within alley and near buildings is accessible for remedial efforts

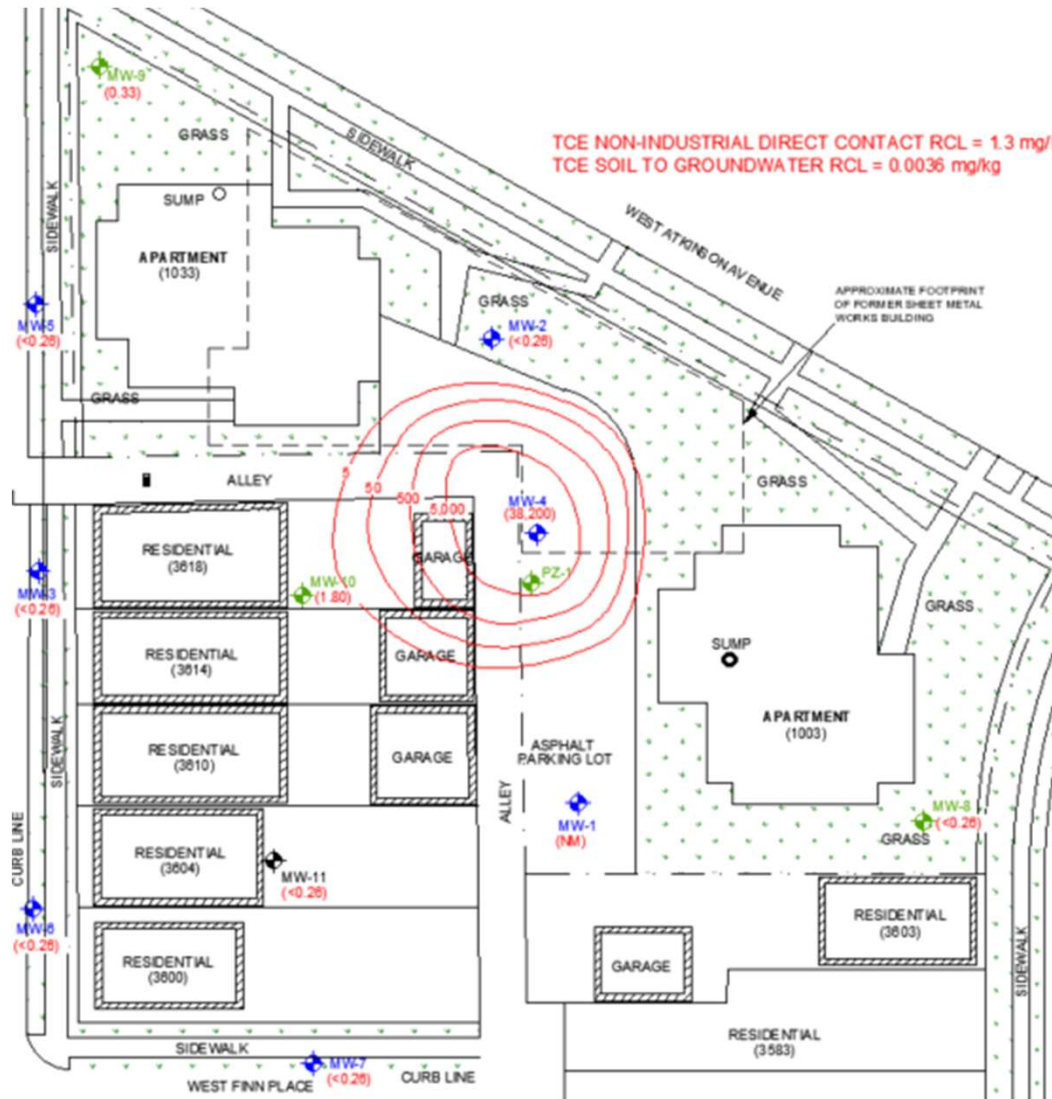
TCE Groundwater Distribution 8/26/2019

- Extent of TCE is limited to area around MW-4, near former building
- Low conductivity clay soils limit horizontal and vertical groundwater movement and contaminant migration
- Horizontal delineation complete
- Piezometer PZ-1 TCE concentration less the ES; vertical delineation complete

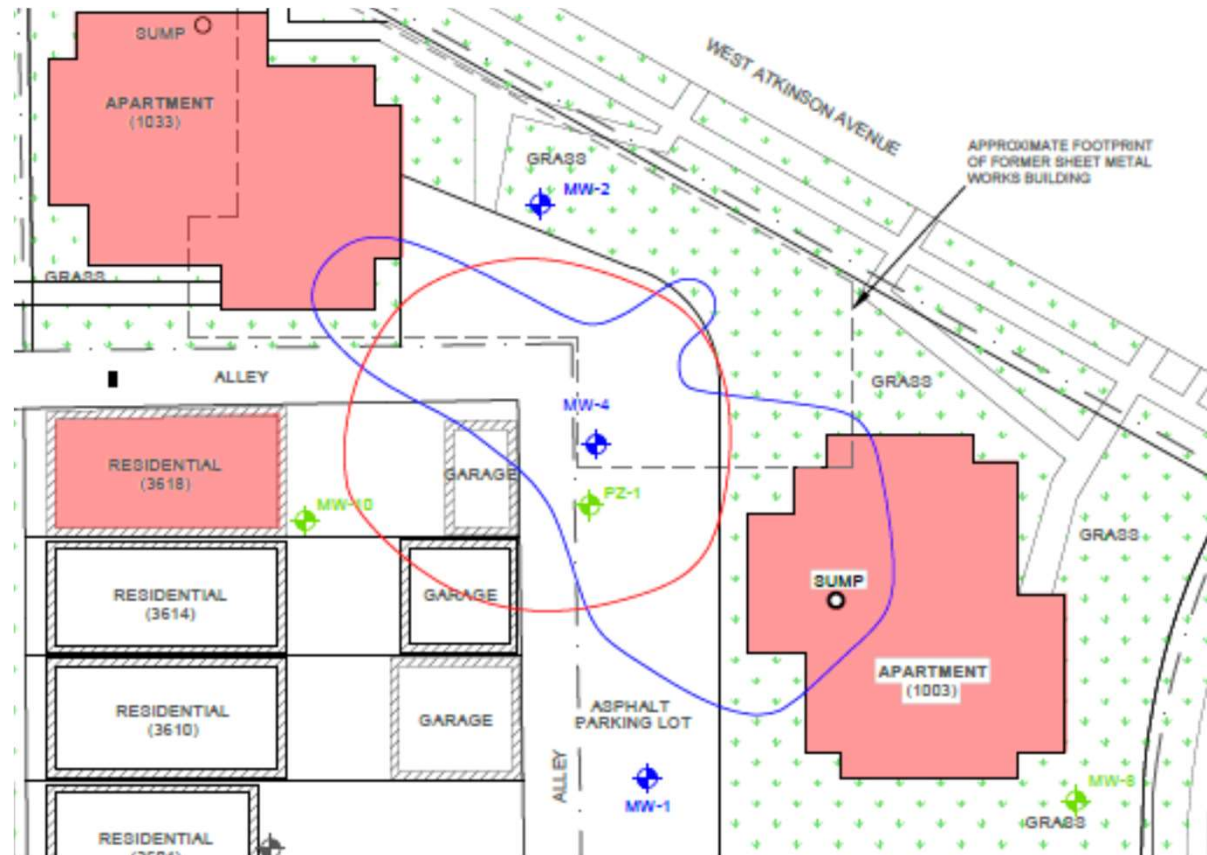
Vapor Mitigation Systems

Buildings with Vapor Intrusion and active vapor mitigation systems

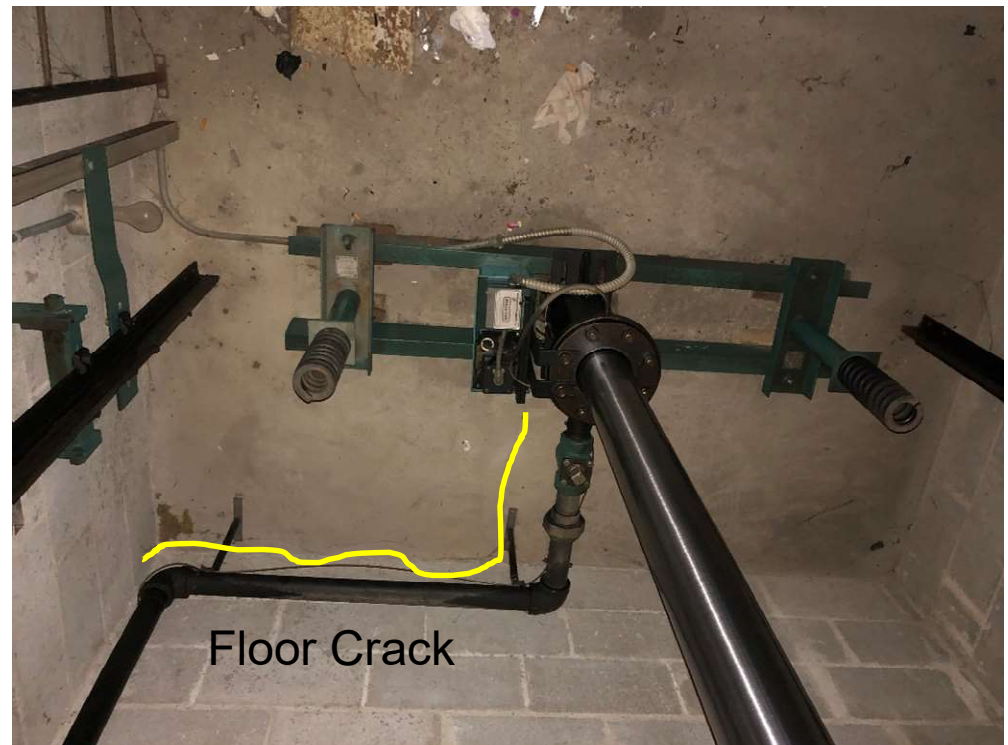
- GZA conducted ambient air sampling in August 2019 within each apartment unit for both buildings.
- An inspection of the elevator pits for both buildings was conducted in 2019. The elevator pit in Building 1033 did not have visual evidence of cracks. The elevator pit in Building 1003 did have observed floor crack around the shaft which needs to be sealed.
- No response from the residence located 3618 11th Street to inspect mitigation system.

- Inspection of vapor mitigation systems
- Sealing the pits in elevator mechanical rooms
- One additional round of ambient samples from the apartments and residence to confirm conditions
- Submittal of Site Investigation Report for WDNR review and approval
- Preparation of the Remedial Action Work Plan
 - Coordination with the City of Milwaukee
- Prepare Remedial Construction Documentation Report
- Prepare Closure Request with continuing obligations for cap and vapor mitigation units.

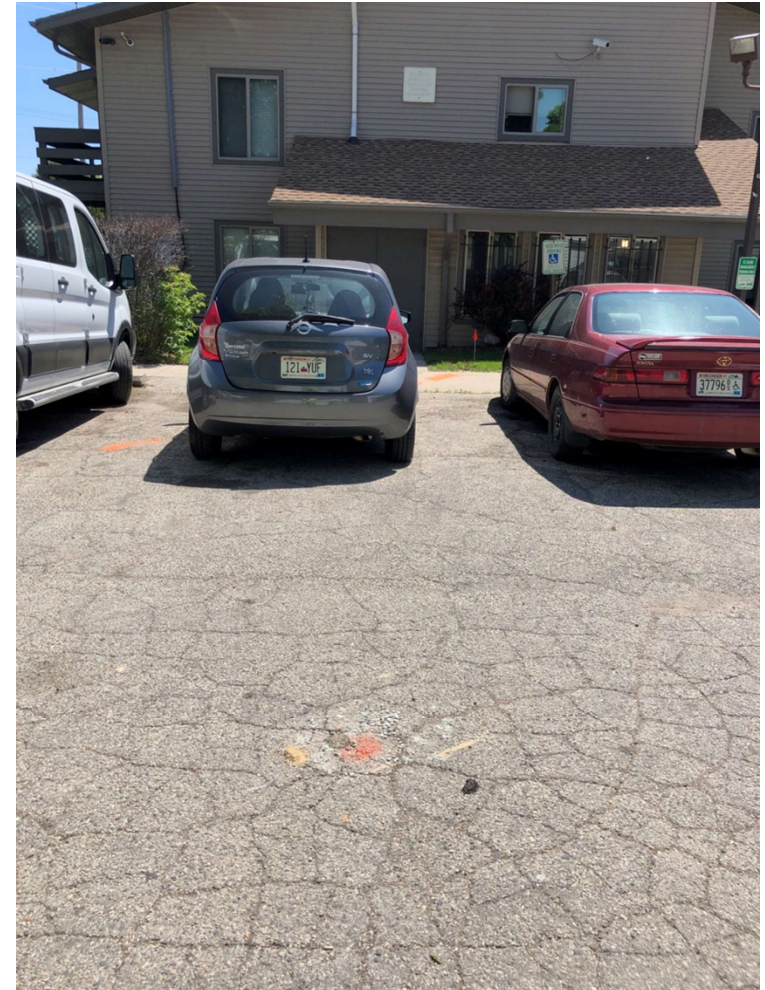
- June 15, 2020, GZA conducted additional soil sampling in the direct contact zone within the alley way. Sampling provided delineation of soil concentrations exceeding the direct contact. Concentrations of TCE within the upper four feet in the parking lot area range from 0.47 mg/kg to 23.6 mg/kg in GP-7 (in parking area for Building 1003)
- Vinyl chloride was also identified in the samples collected from the direct contact zone.
- Soil samples exceeding the direct contact RCL extend onto both apartment buildings.
