Discussion of Remedial Action Plan

Clare Central Apartments - VPLE Site
1003-1033 W. Atkinson Avenue
Milwaukee, Wisconsin

August 13, 2021

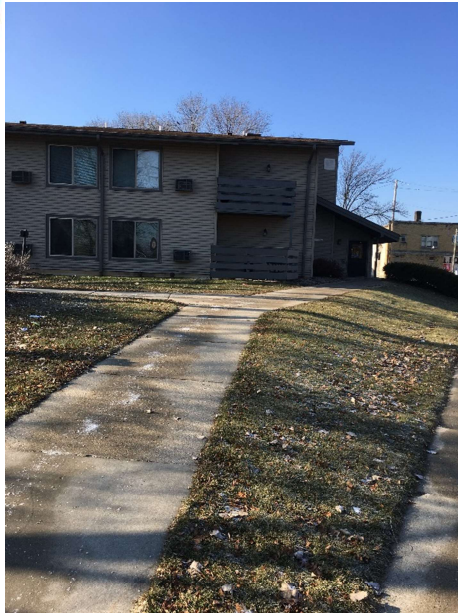
Looking to the west along W. Atkinson Ave, limited work area for remediation and apartment access updates

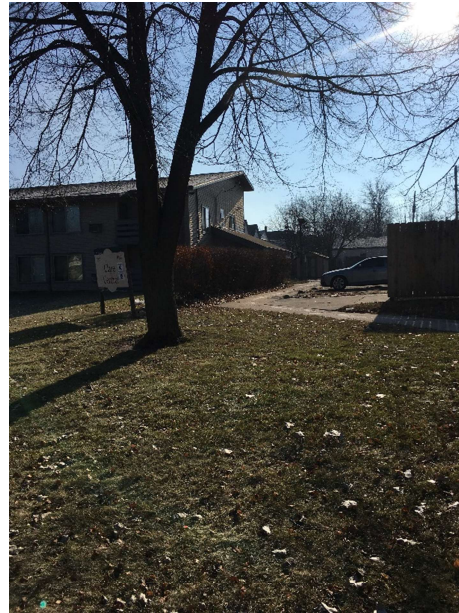
Looking to the south from W. Atkinson Ave, limited work area for remediation

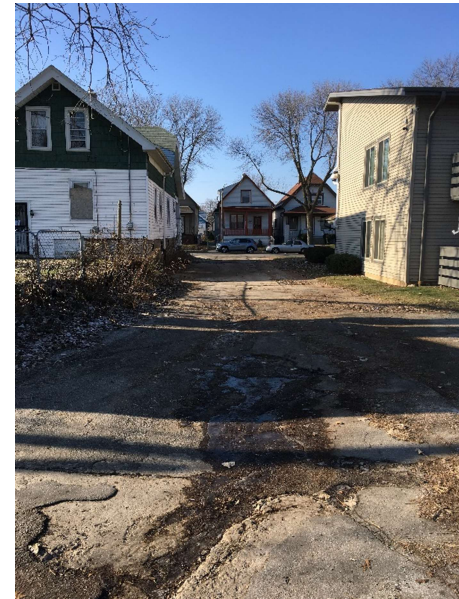
Looking to the west along alley, catch basin located at end of alley

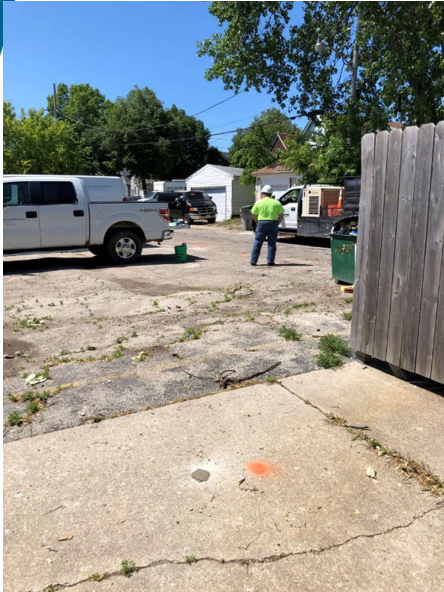
Looking to the south along alley, limited remedial work area

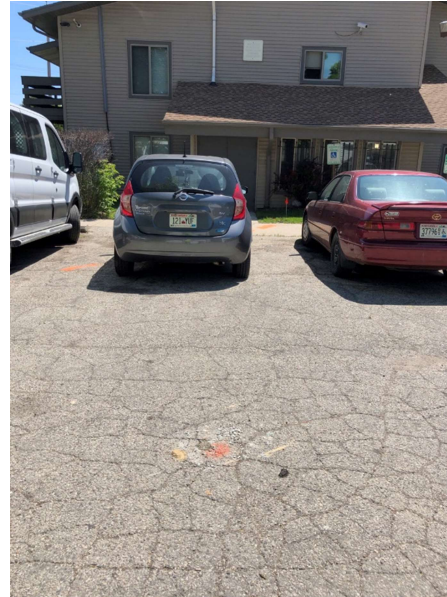
Looking to the east within alley and proposed remedial area

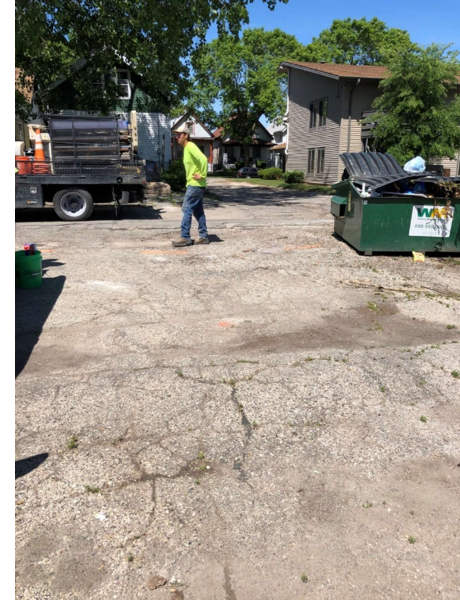
Looking to the west within alley and proposed remedial area

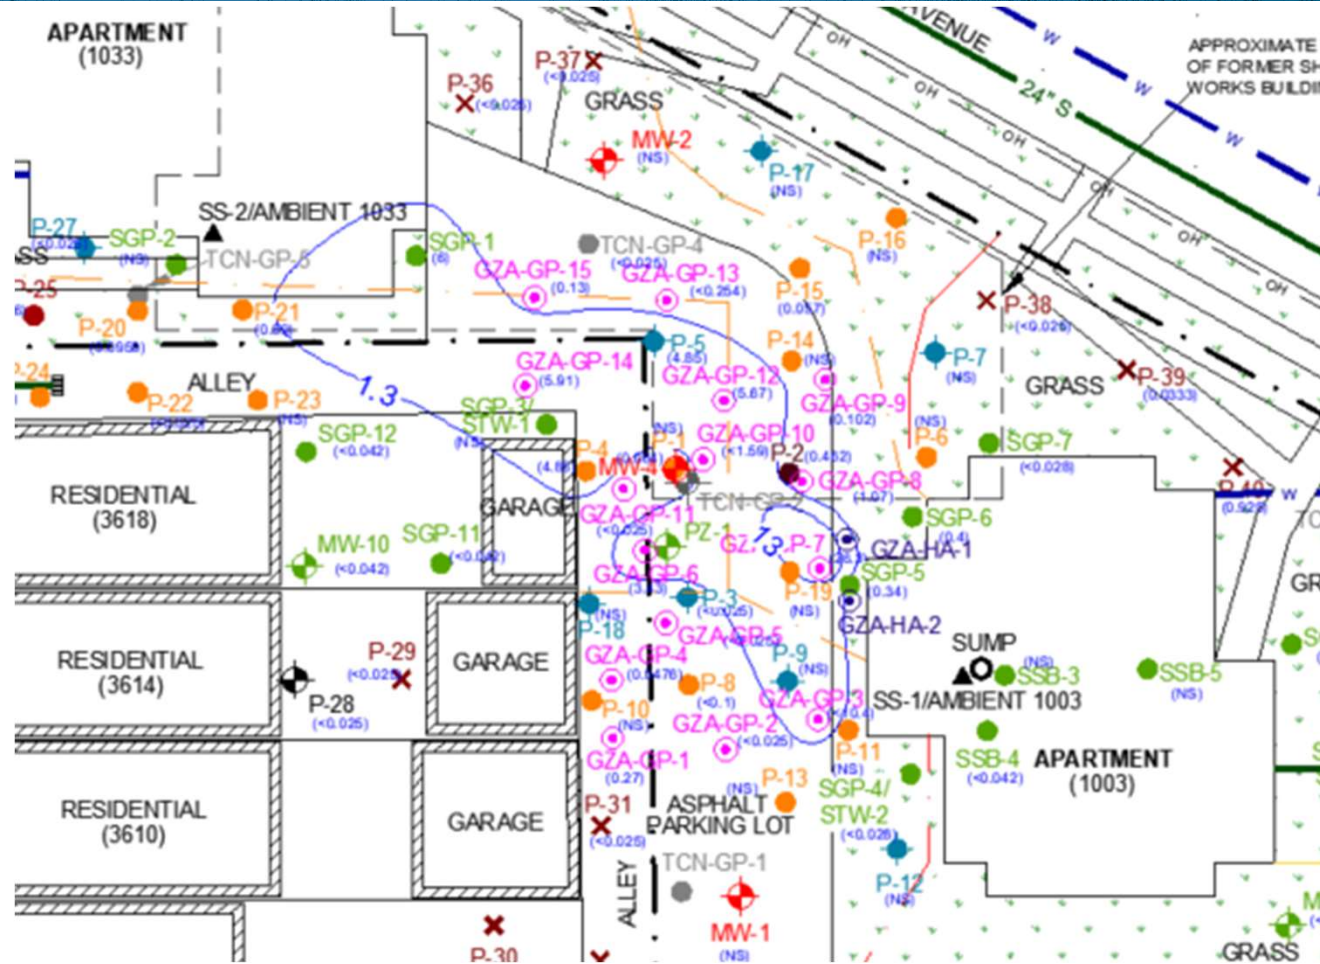
Soil TCE Distribution 0-4 Feet

- REC identified former use of site as wire factory and auto repair
 - Documented use of TCE as a solvent degreaser
- GZA estimated that approximately 130 lbs of TCE was released to soil
- Soil and groundwater delineation completed in accordance with NR 716
- Highest concentrations between 4 and 12 feet, exceed TCE “contained-out” value of 8.8 mg/kg
- No exceedance of TCE TCLP

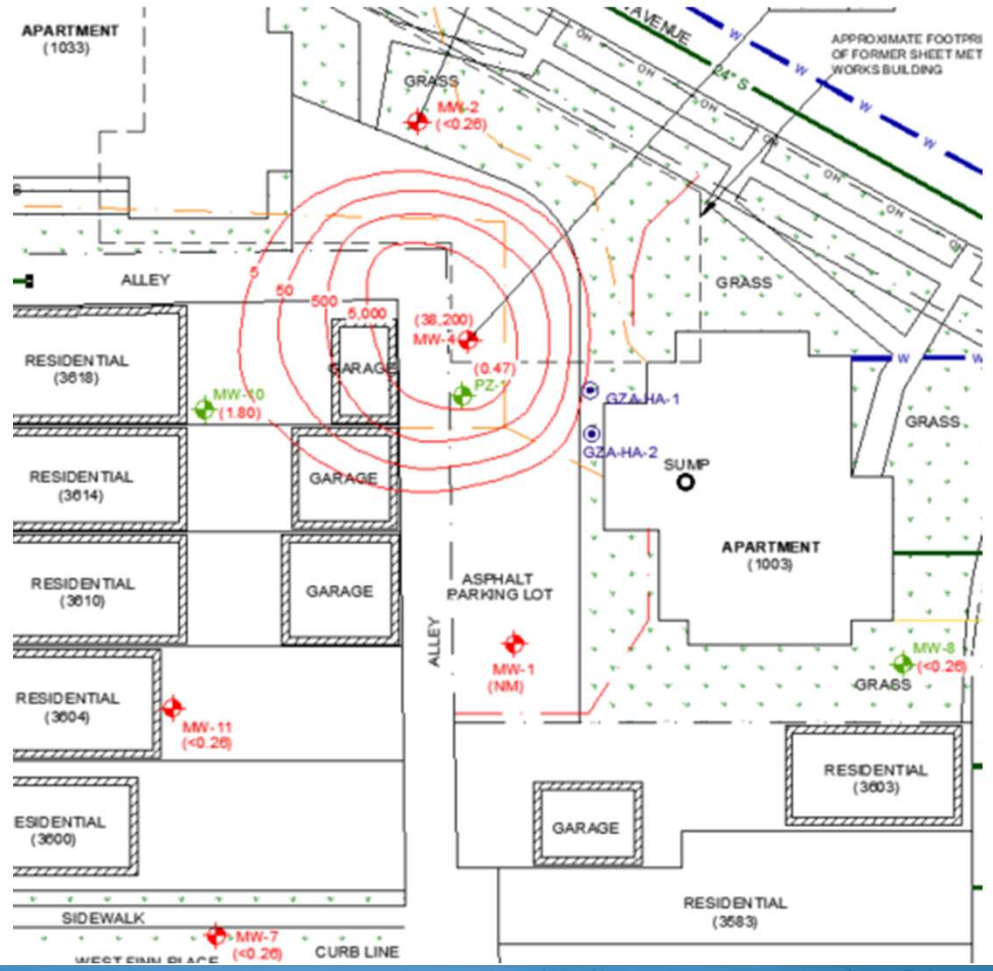
Groundwater VOC

- Groundwater Monitoring Well Network Sampled by GZA on March 21, 2019
 - Results of TCE remain consistent to previous sampling events with MW-4 within the alley way having the highest concentration of TCE at 30,000 ug/L
- Subsurface Conditions are not favorable to natural attenuation based on the geochemical parameters recorded for the groundwater.
 - Positive oxidation reduction potential and low dissolved oxygen.
- The mass of TCE released to the soils (0 to 12 ft bgs) is estimated at 130 lbs, with over 90% of that remaining in soils. TCE is not partitioning to groundwater.

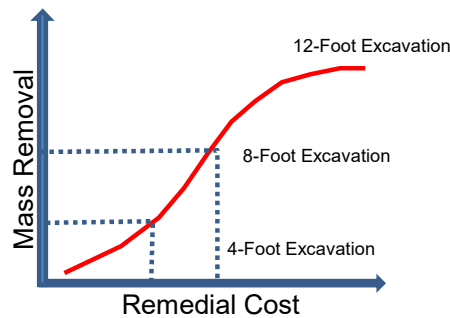
8-Foot Excavation Evaluation

0-4' = 8 lbs TCE
 4-8' = 96 lbs TCE
 8-12 = 48 lbs TCE
 Total = 152 lbs TCE

- Additional soil mass removal in the western half of the excavation area
- **Residual soil concentrations >8.8 mg/kg beneath Building 1003**
- **Soil concentrations require additional excavation and treatment prior to off-site disposal**
- Requires excavating below the building foundation depth for Building 1003 and will require sloping of soils beneath the footing
- Backfill of excavation from 4 to 8 feet with “self-compacting” aggregate will create void spaces and will create ponded water in contact with the building foundations
- **Require removal of monitoring well MW-4; there is not a suitable location for re-installation of his well due to backfilled excavation**

Estimated 70 lbs (~50%) of TCE will be left in place adjacent to or beneath Building 1003
