State of Wisconsin \ DEPARTMENT OF NATURAL RESOURCES

June 4, 2009

Subject: Responsible Party Letter and Reported Contamination at Hillcrest Landscaping Co., 8655 North 43rd Street, Brown Deer, WI

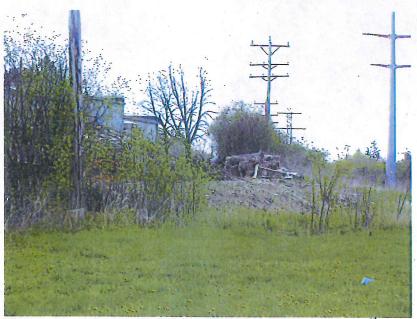
View to the south, looking towards the west side of 8655 N. 43rd Street lot. Note fill material and wood debris.

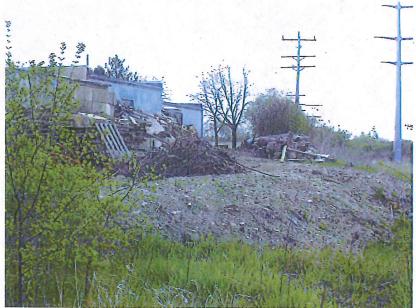
View to the south, west side of 8655 43rd Street lot. Two building corners visible on the left.

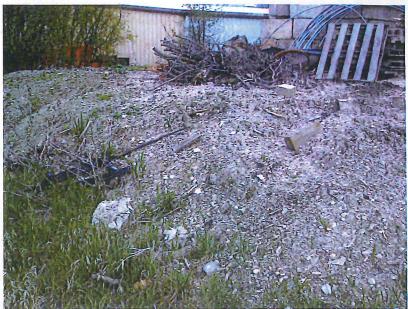
Close up view of the fill material.

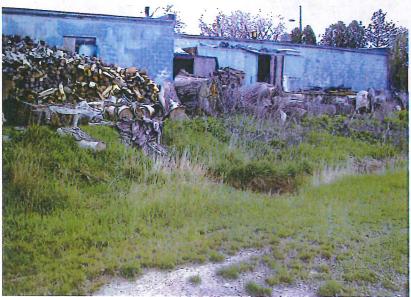
View to the southeast, west side of 8655 N. 43rd Street. Discharge area visible in the center of the photo.

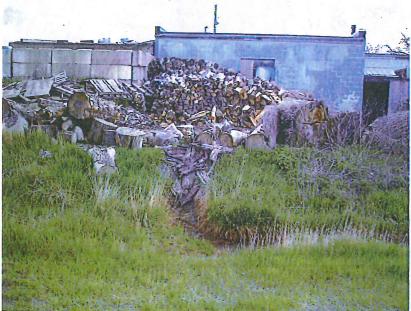
View directly to the east, looking at the west side of 8655 43rd Street. Discharge area in the middle of the photo.

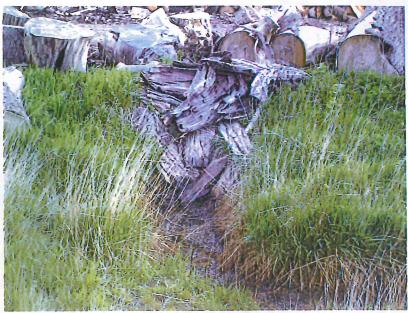
View to the east from ROW of the discharge area. Some petroleum odor, and staining of bark and vegetation. No visible oil sheen.

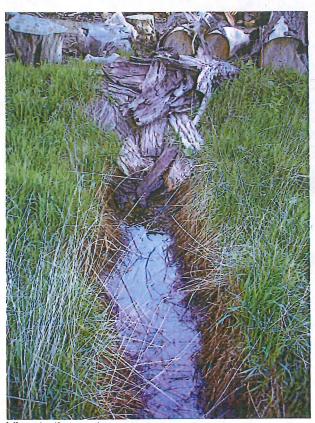
View to the east.
Water in the ditch dug away from the discharge point.

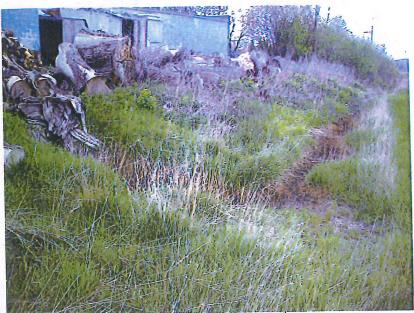
View to the southeast, west side of 8655 N. 43rd Street. Shows flow of discharge from under the bark and debris to the west, and then southward along east side of ROW.

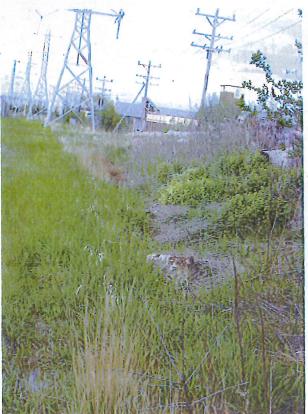
View to the north, west side of 8655 N. 43rd Street.

Discharge flows from the center of the photo towards the bottom of the photo.
